**FLAGLER PIER RESTAURANT
COST ESTIMATE FOR REPAIRS**

Prepared for Ray Barshay

Pier Restaurant Assessment:

**FLAGLER BEACH PIER RESTAURANT COMPLEX
STRUCTURAL INVESTIGATION FEBRUARY 2010**

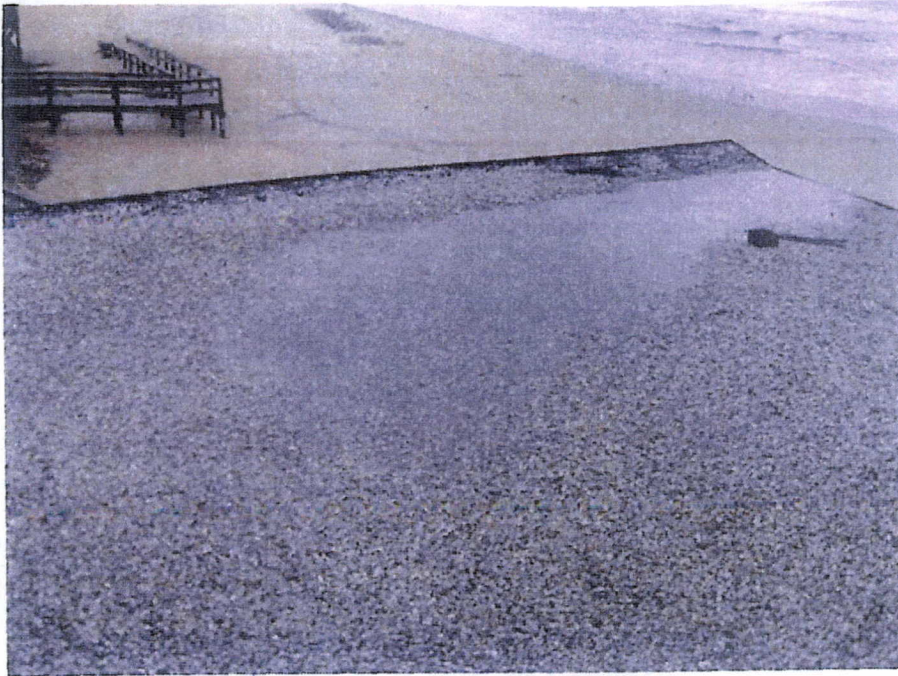
EXHIBIT 1 ✓

- a. Some areas of the dining area of the roof deck were not level and had ponding issues (Refer to Exhibits 1 and 2)) following recent rain. Over time, water standing on a roof surface will damage roof coatings and roofing materials. Standing water eventually leads to roof leaks, damage to roof and deck materials, and damage inside the structure. No visible leaks were noted during our visit but proactive measures should be taken to repair ponding at low areas to avoid future damage.
- b. Several bare spots were noted and should be repaired. (Refer to Exhibits 3 and 4)

- A. **Dining Area**
 - 1. **Roof Deck**
 - a. We recommend that low areas where water is shown ponding be repaired with a product such as Elastek #505 Puddle Plaster.
 - b. We recommend that all bare roof areas be cleaned thoroughly, coated with a 1/8" minimum thick layer of asphalt roof cement and covered with roof gravel.

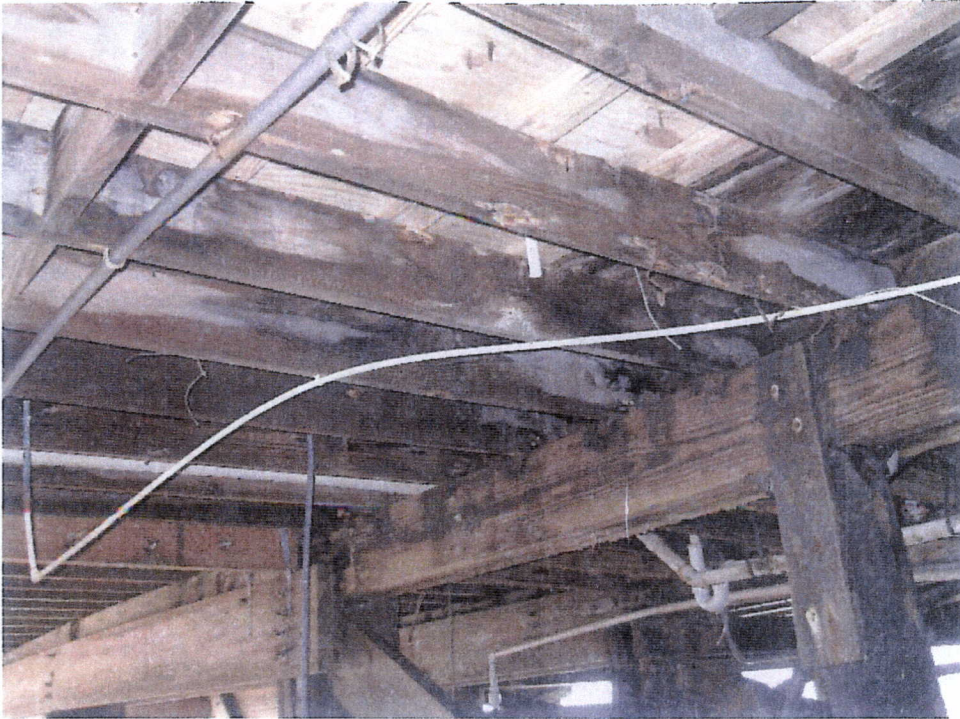
EXHIBIT 5

- a. The plywood deck above the 2nd pile from the south in the row of (7) piles below the Dining Area has minor upward bowing (Refer to Exhibit 5). Inspection of the underside of the deck revealed several water pipes attached to the underside of the framing which had imparted moisture to the deck above. In our opinion, this is the cause of warping in the deck. Repairs to this area will require significant cost, utility relocation and temporary closure to portions of the restaurant. We don't believe this is an imminent structural concern that warrants such an action.

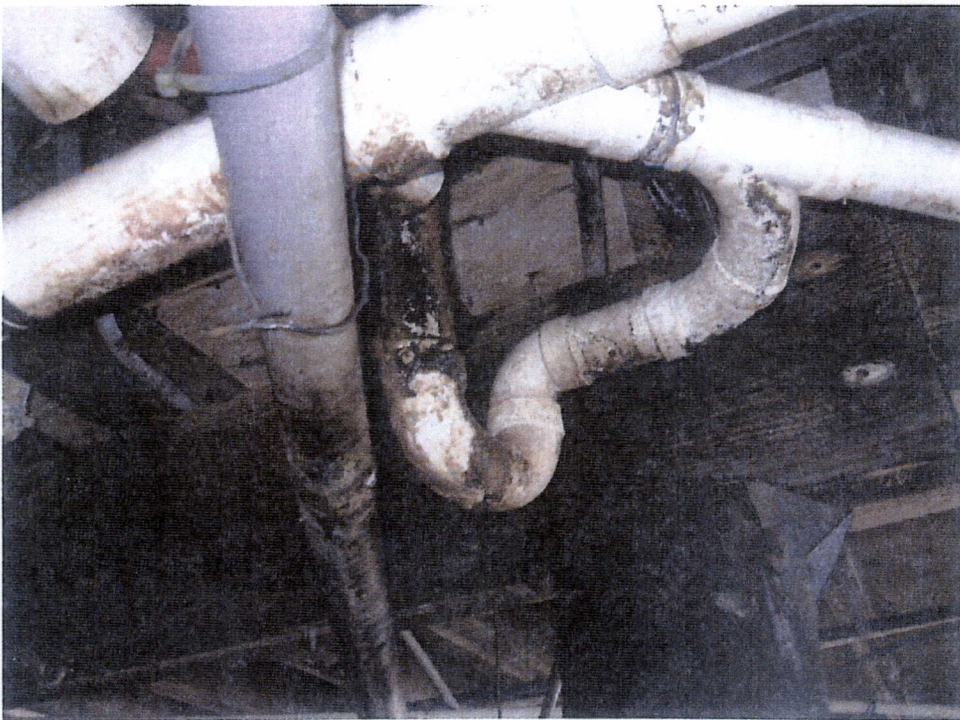
EXHIBIT 6

- b. The plywood deck above the 5th pile from the south in the row of (7) piles below the Dining Area also has minor upward bowing (Refer to Exhibit 6). Inspection of the underside of the deck revealed several water pipes attached to the underside of the framing which had imparted moisture to the deck above. In our opinion, this is the cause of warping in the deck. Repairs to this area will require significant cost, utility relocation and temporary closure to portions of the restaurant. We don't believe this is an imminent structural concern that warrants such an action.

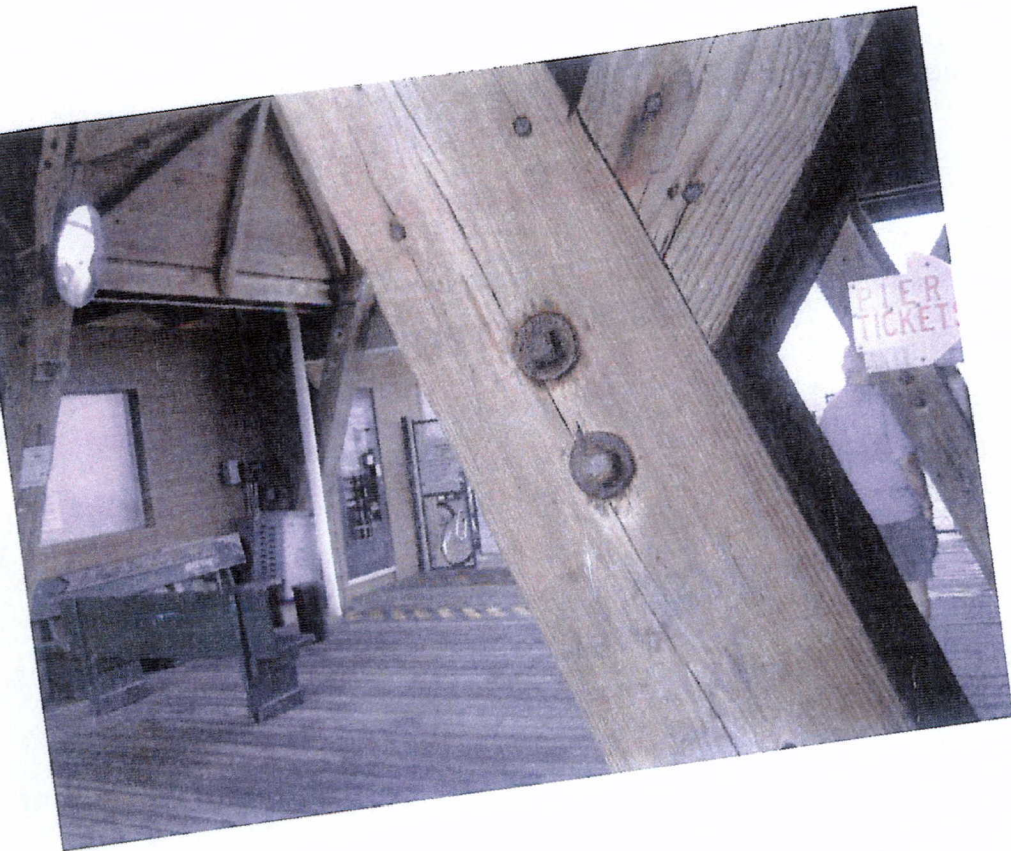
EXHIBIT 7

- 2. **Roof Trusses**
 - a. All timber appeared to be in good condition but almost all bolts and washers were badly corroded and will require remedial action. (Refer to Exhibit 7)

- a. We recommend that all exposed connection hardware be sandblasted clean and coated in the field with cold galvanizing paint. If, during sandblasting, any corroded connectors are damaged such that less than 80% of its intended section is visible, the connector shall be replaced.

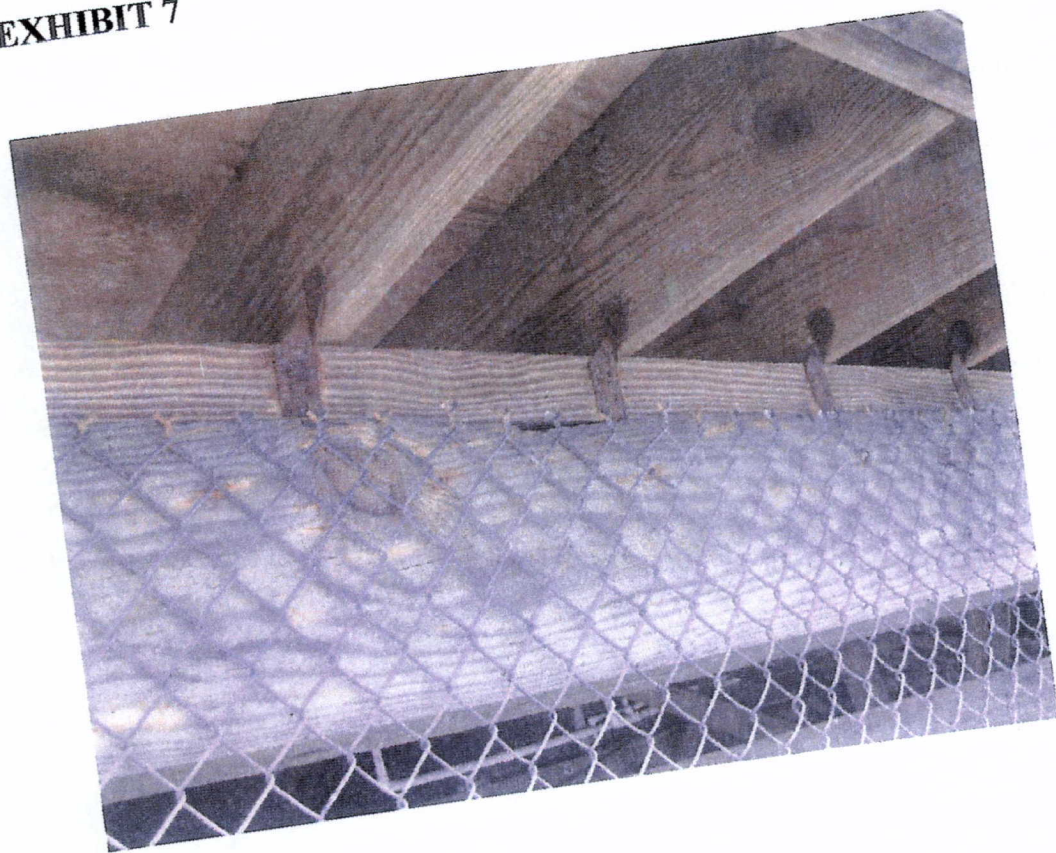
EXHIBIT 8

- 3. **Floor Deck**
 - a. No exceptions were noted
 - 4. **Floor Framing**
 - a. All timber appeared to be in good condition but almost all hurricane straps were badly corroded and will require remedial action. (Refer to Exhibit 8)

- a. We recommend that USP RT 8A hold downs be added at all floor trusses. All new hold downs must be either stainless steel or hot dip galvanized

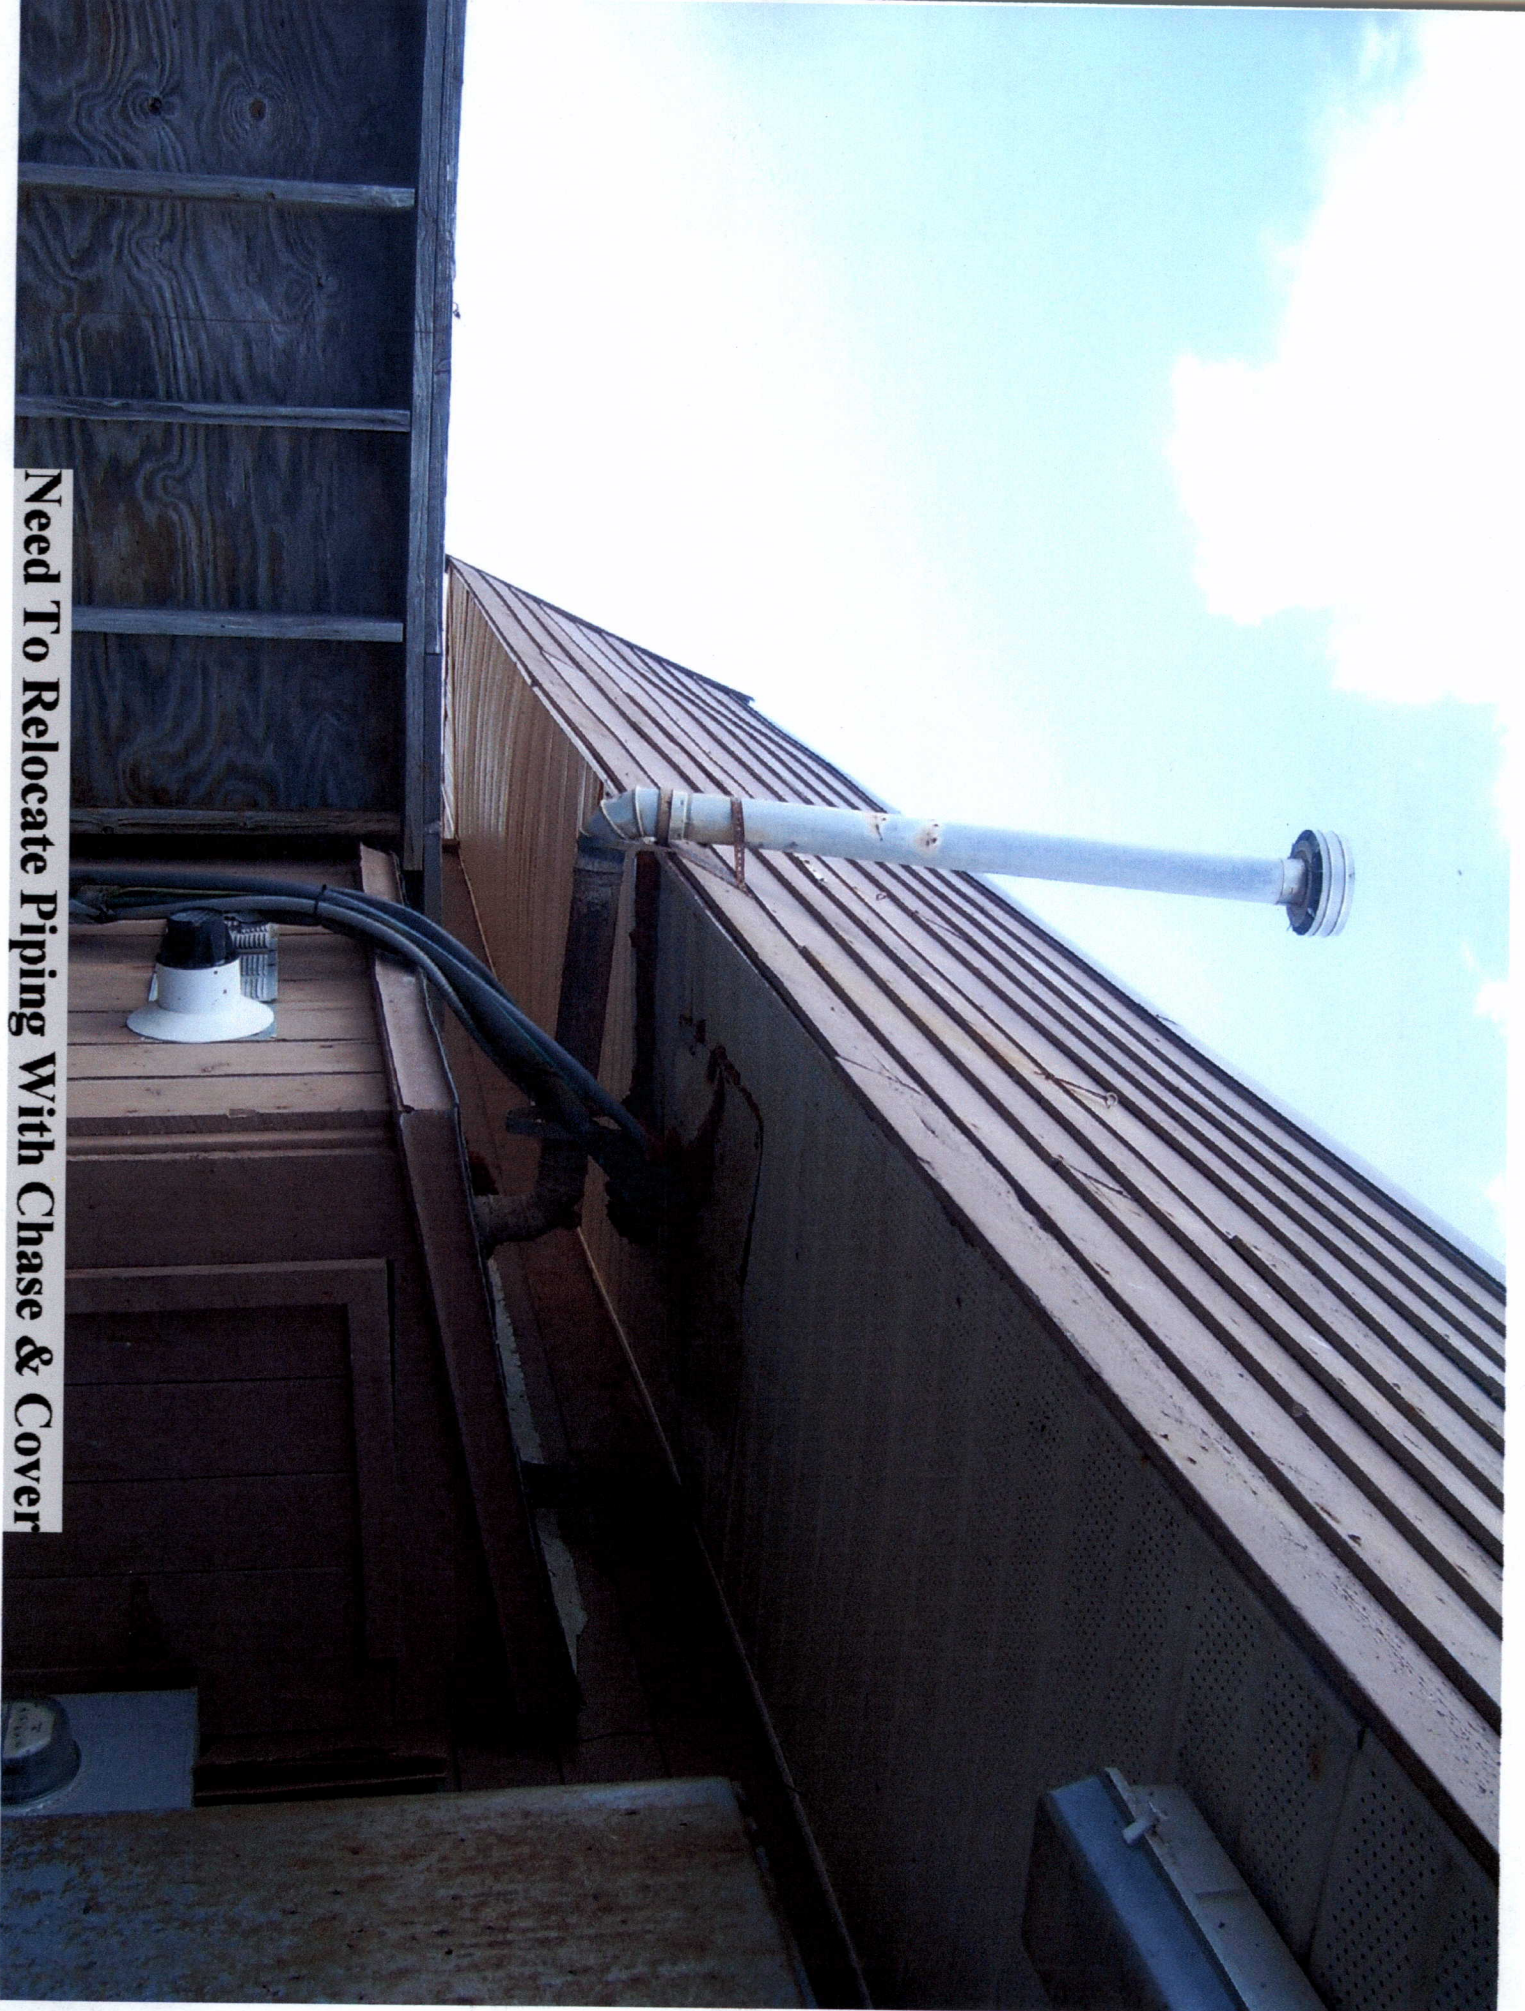
Need To Relocate Piping With Chase & Cover

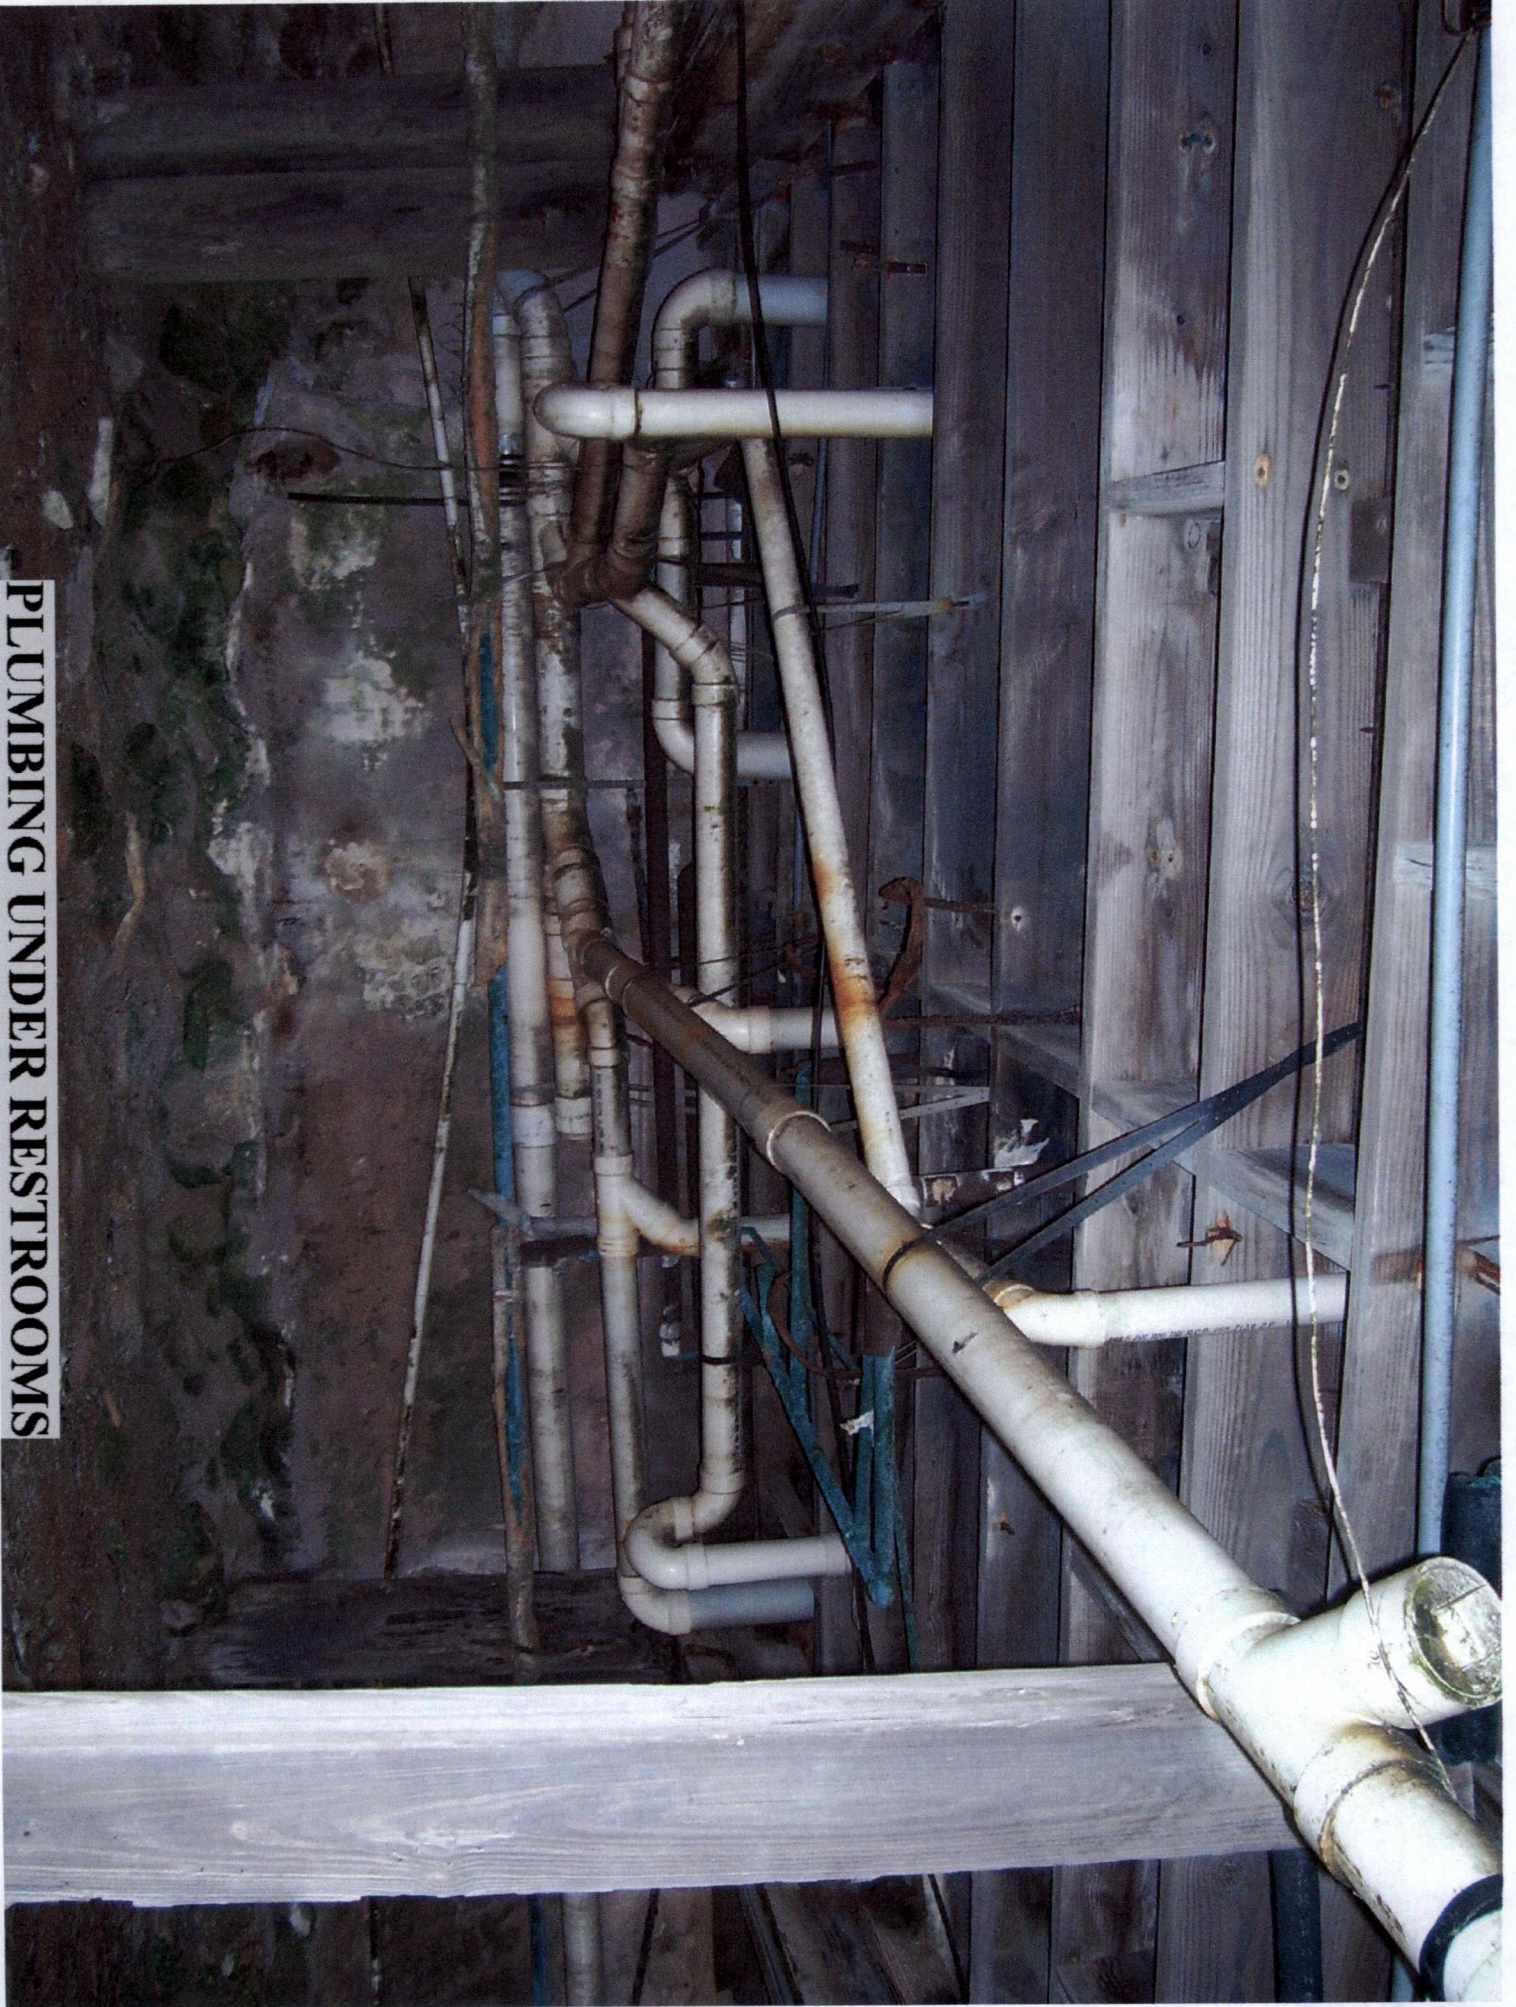
FLOOR DRAIN LEAKING

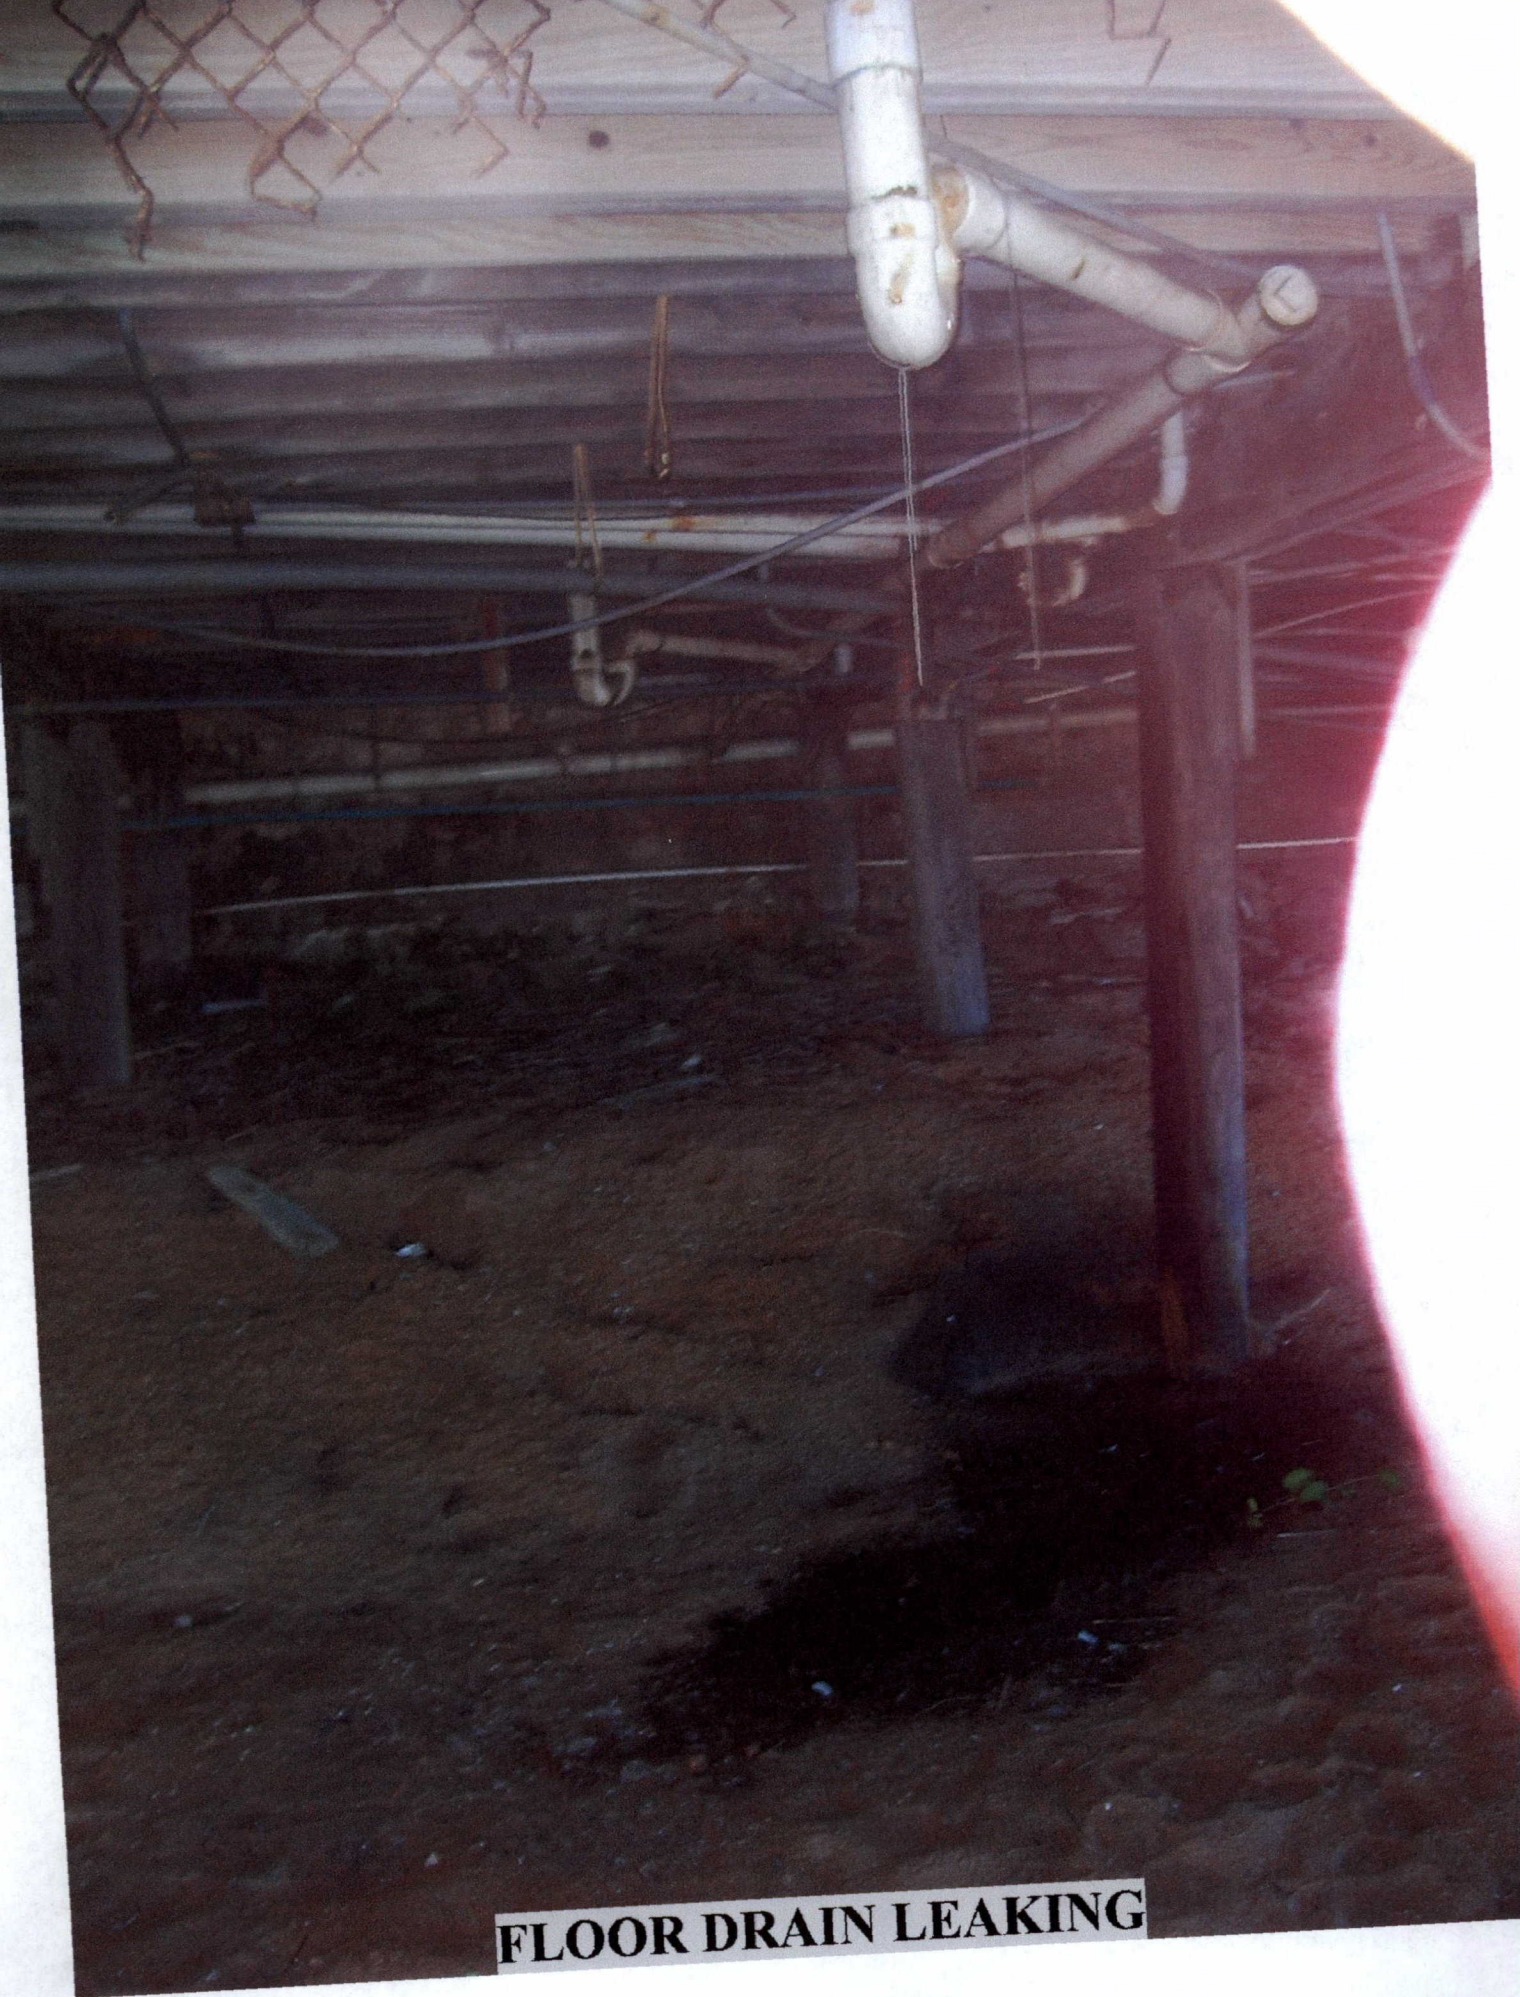
TRAP NOW ILLEGAL

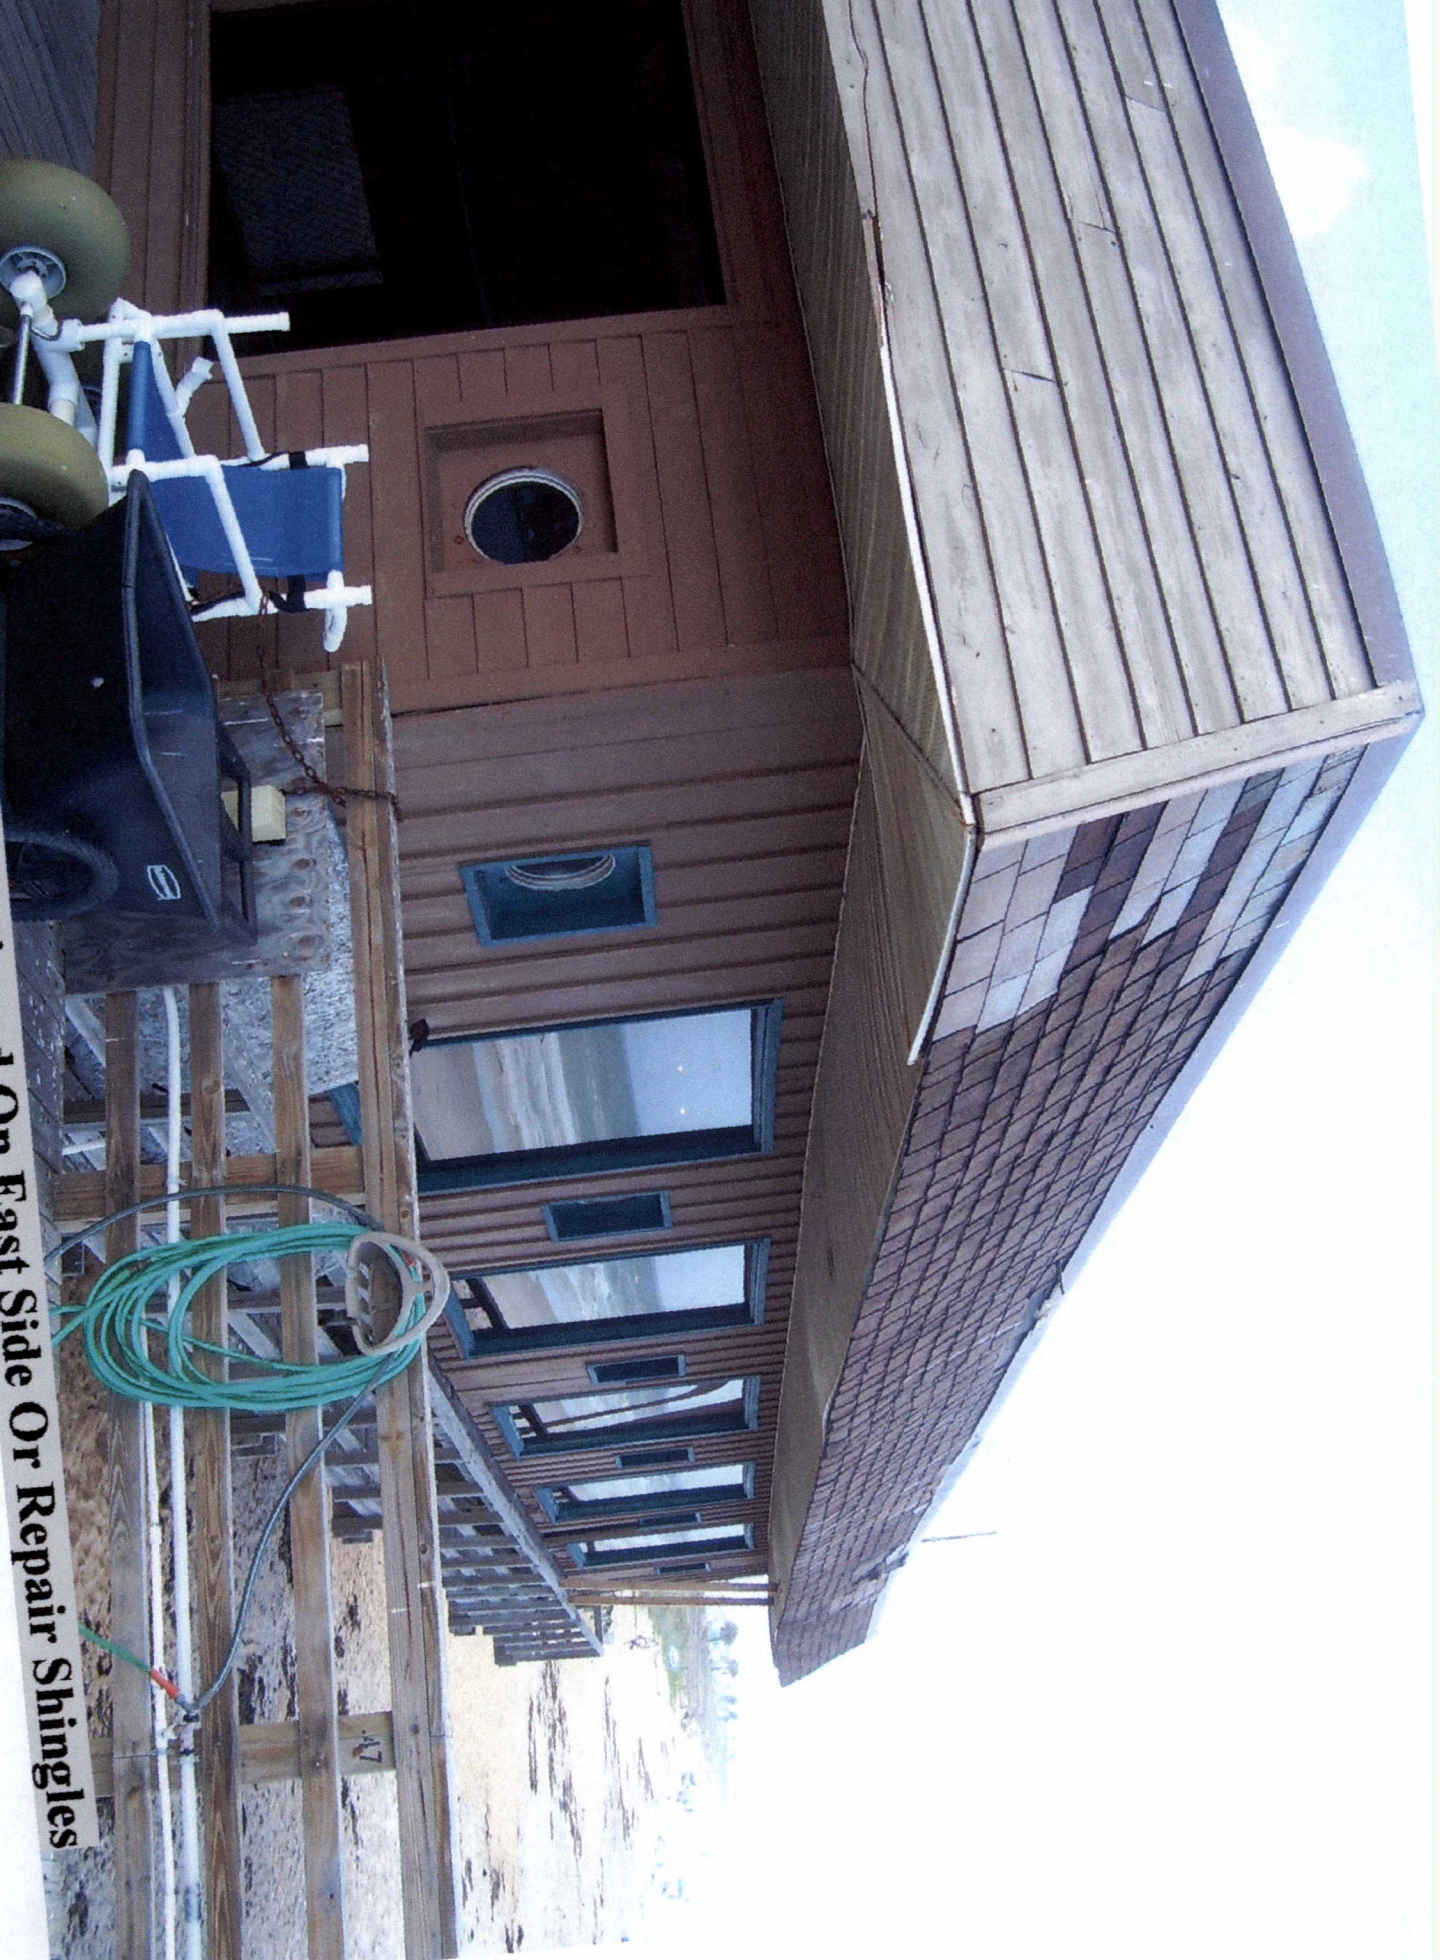
On East Side Or Repair Shingles

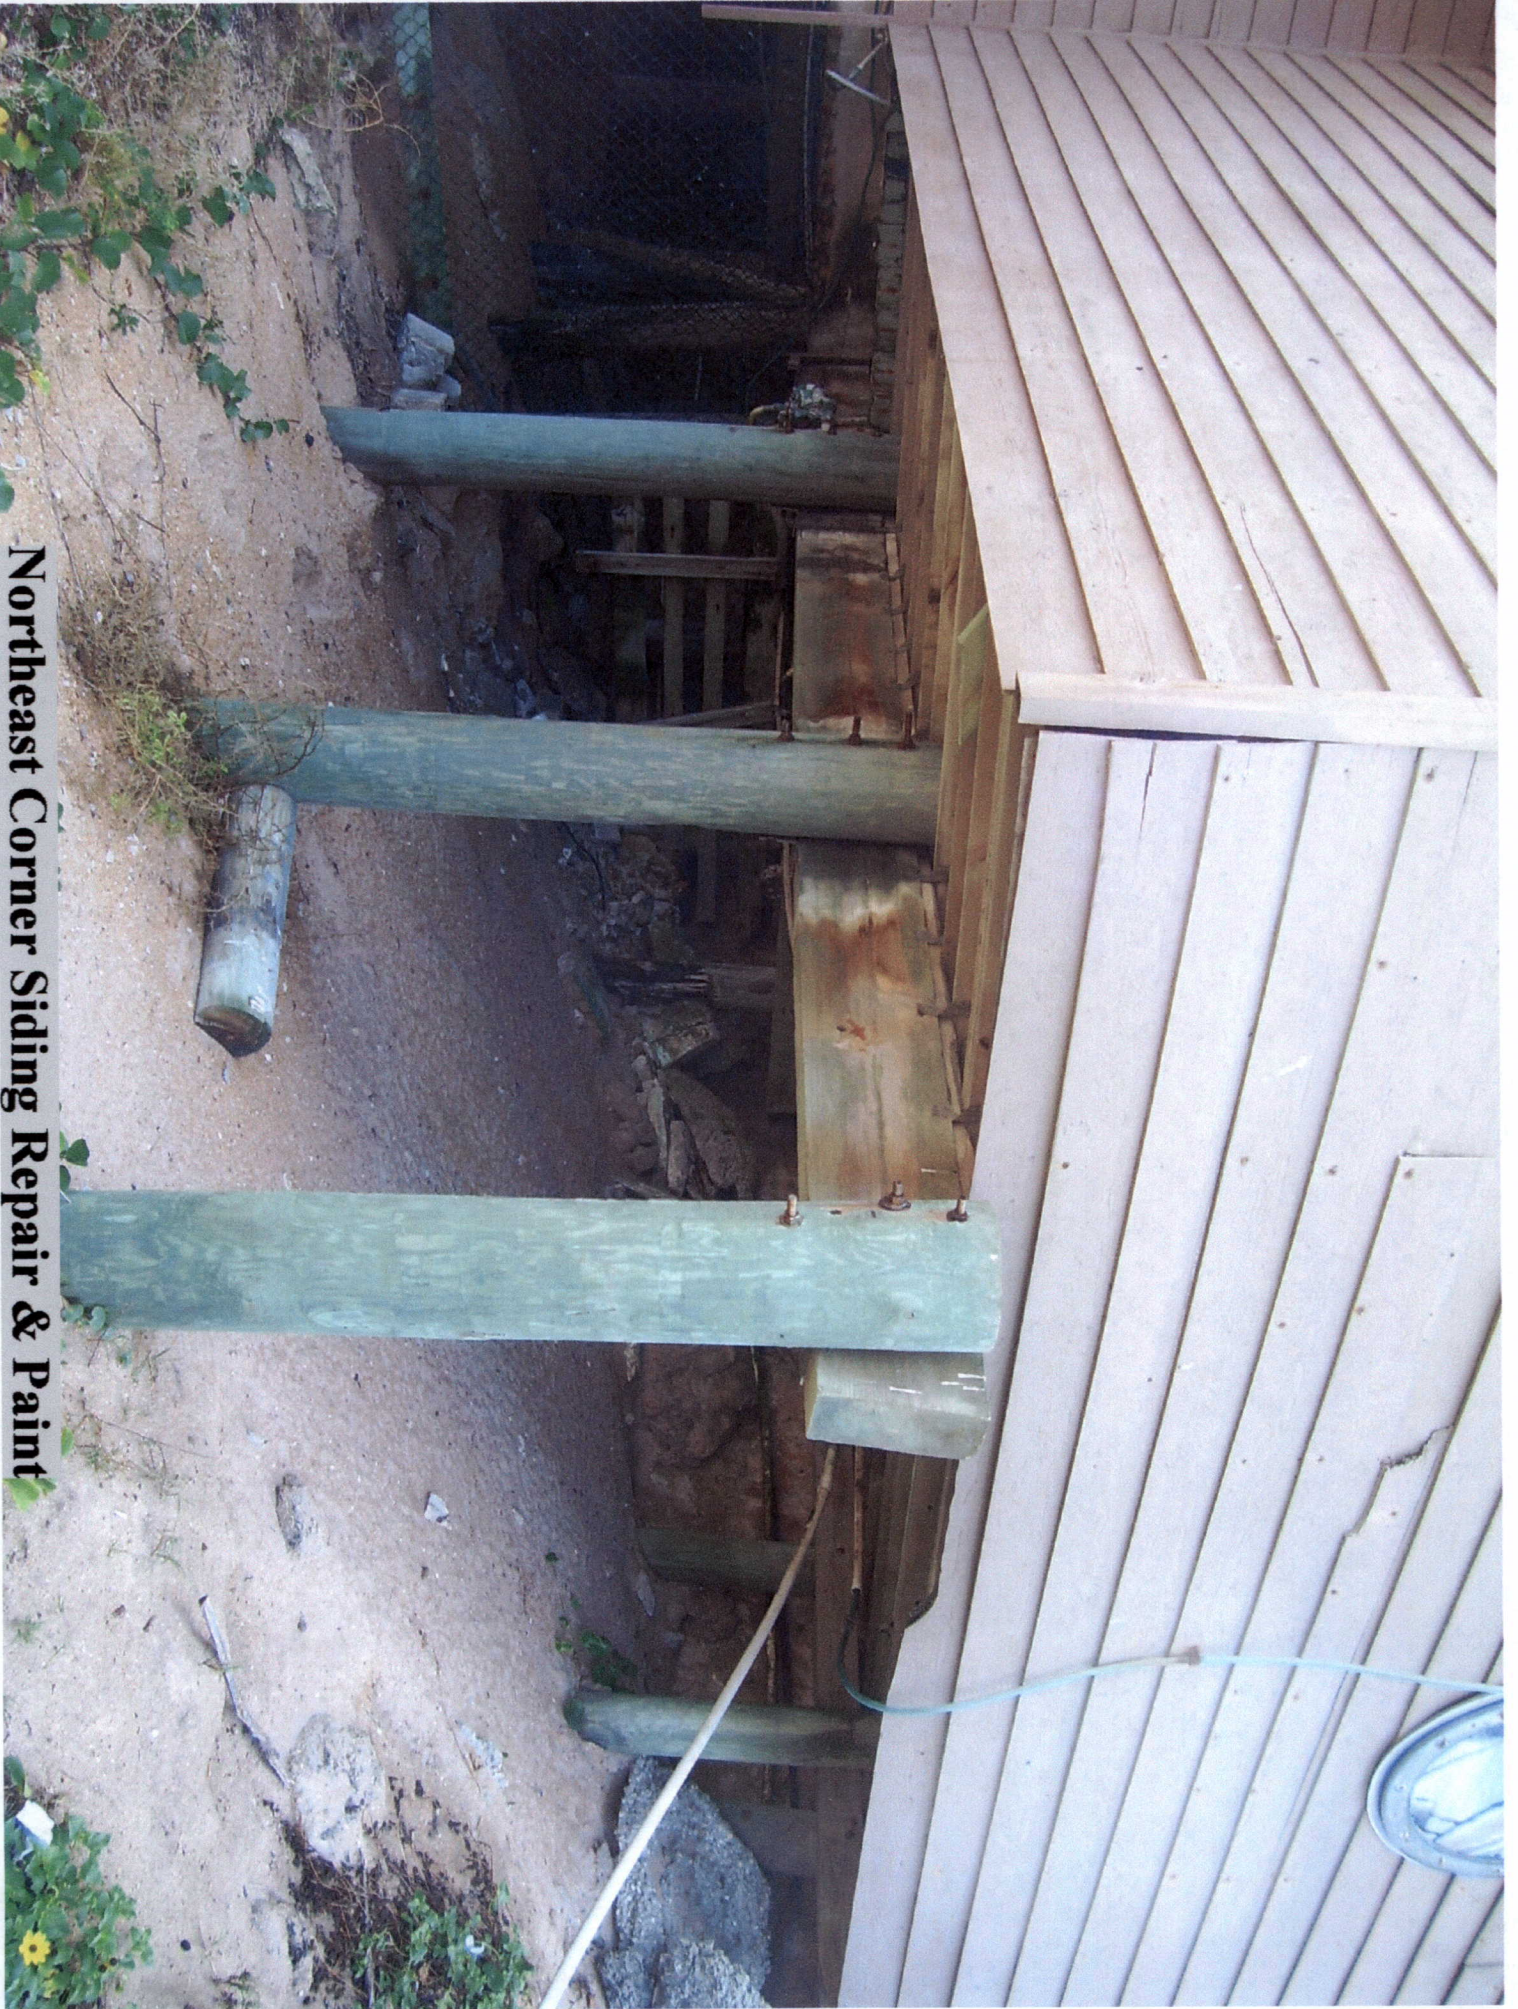
Northeast Corner Siding Repair & Paint

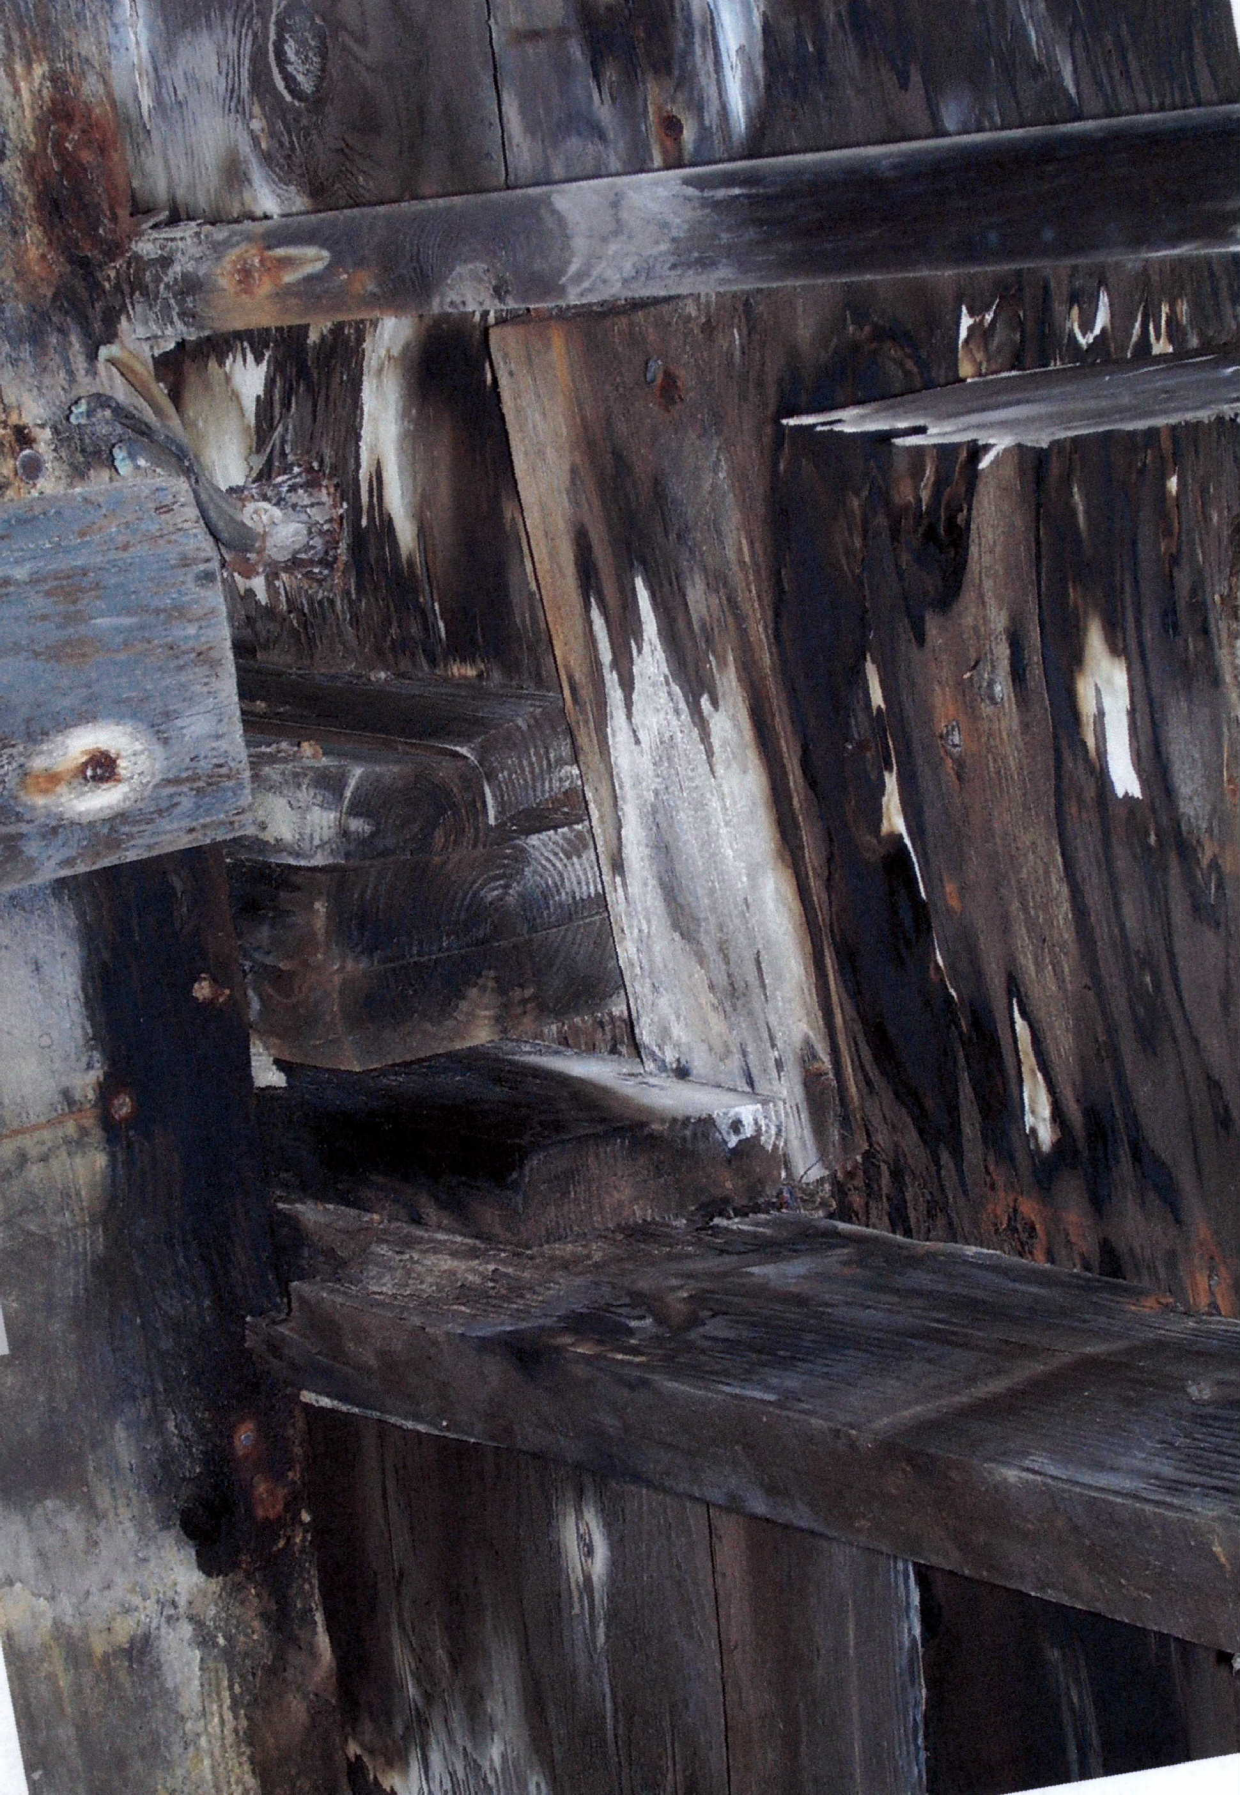
BEAM @ FLOOR HUMPS
