**FLAGLER PIER RESTAURANT
COST ESTIMATE FOR REPAIRS**

Prepared for Ray Barshay

Pier Restaurant Assessment:

**FLAGLER BEACH PIER RESTAURANT COMPLEX
STRUCTURAL INVESTIGATION FEBRUARY 2010**

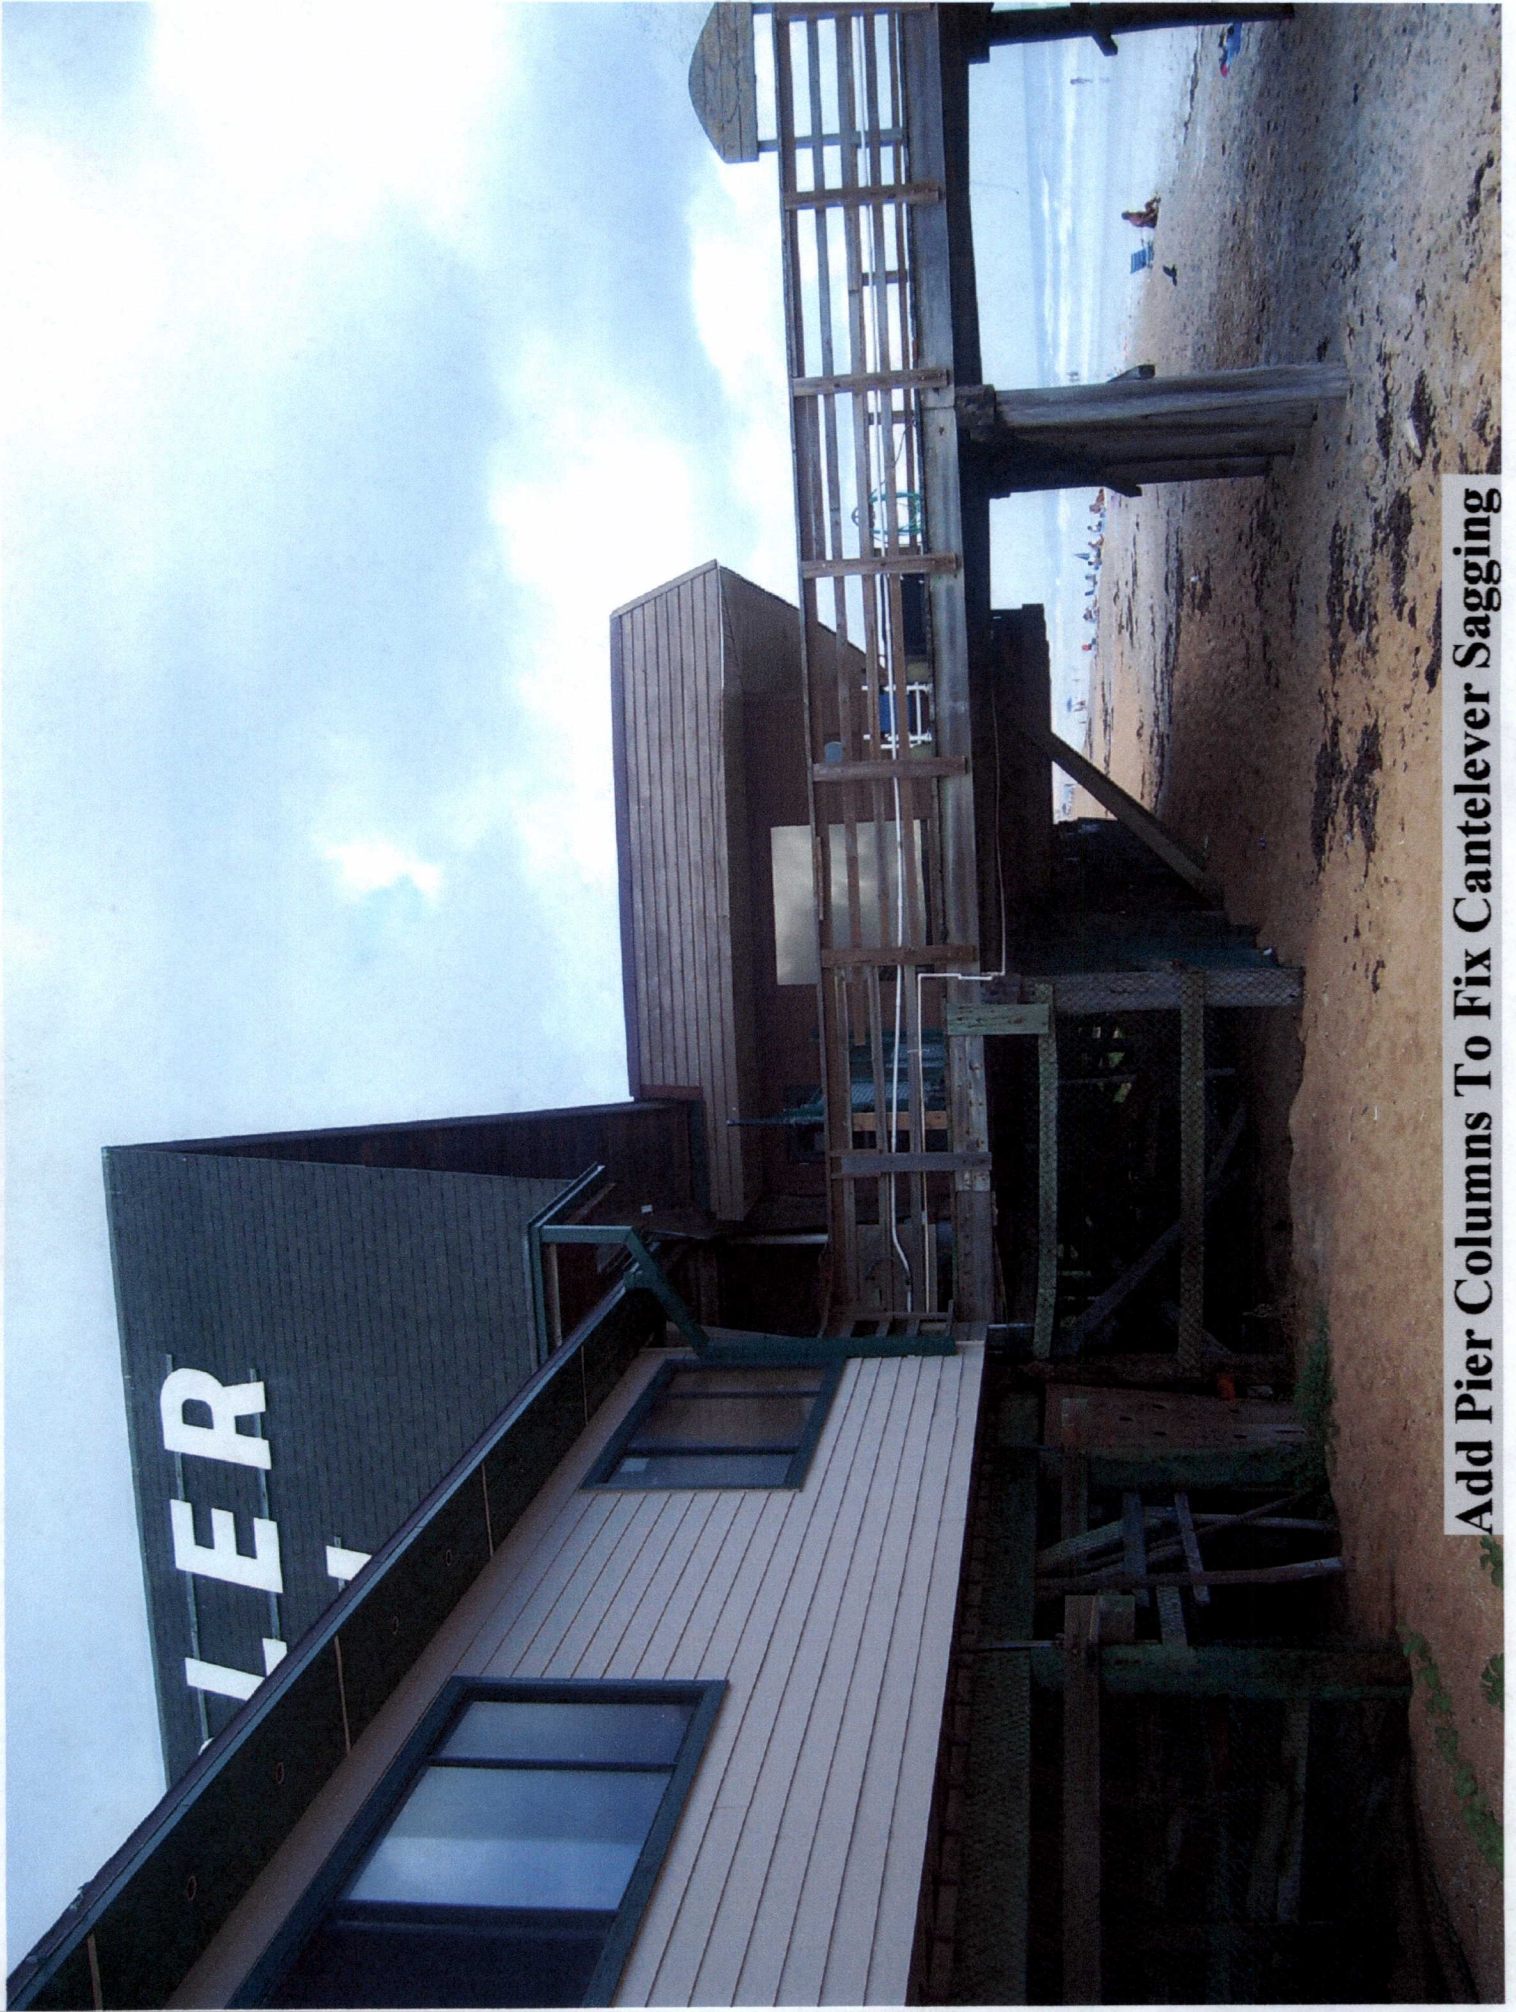
Add Pier Columns To Fix Cantelever Sagging

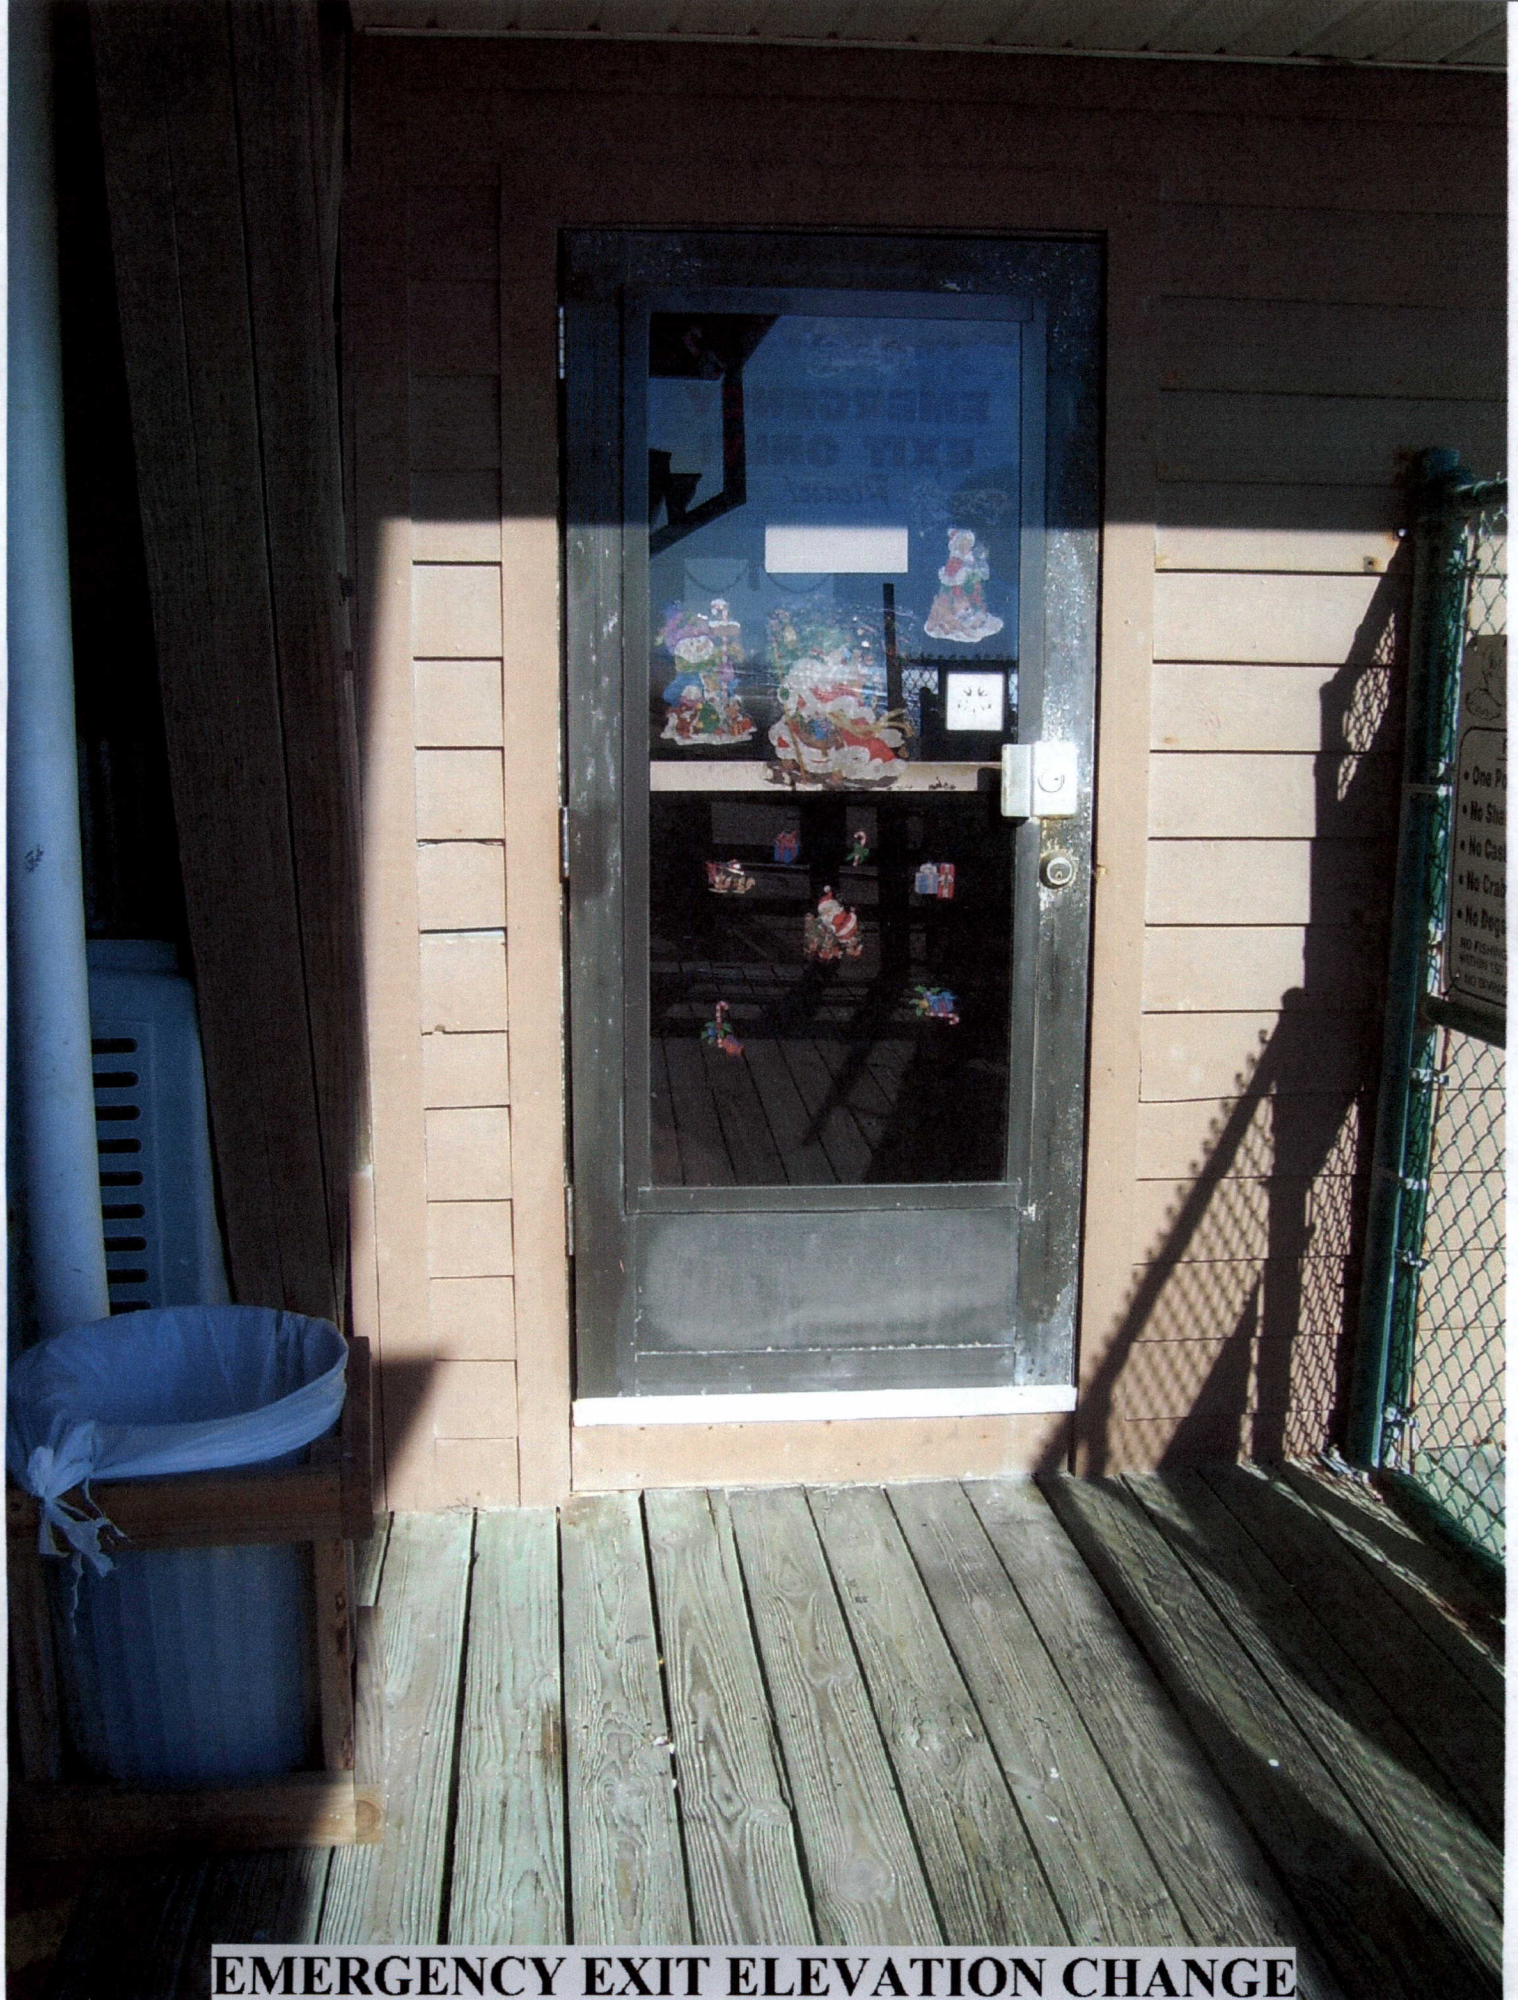
EMERGENCY EXIT ELEVATION CHANGE
