# Preliminary Report

Accident on **24 March 2015**  
at **Prads-Haute-Bléone**  
(**Alpes-de-Haute-Provence, France**)  
to the **Airbus A320-211**  
registered **D-AIPX**  
operated by **Germanwings**

**BEA**

## Controlled descent on autopilot, collision with terrain

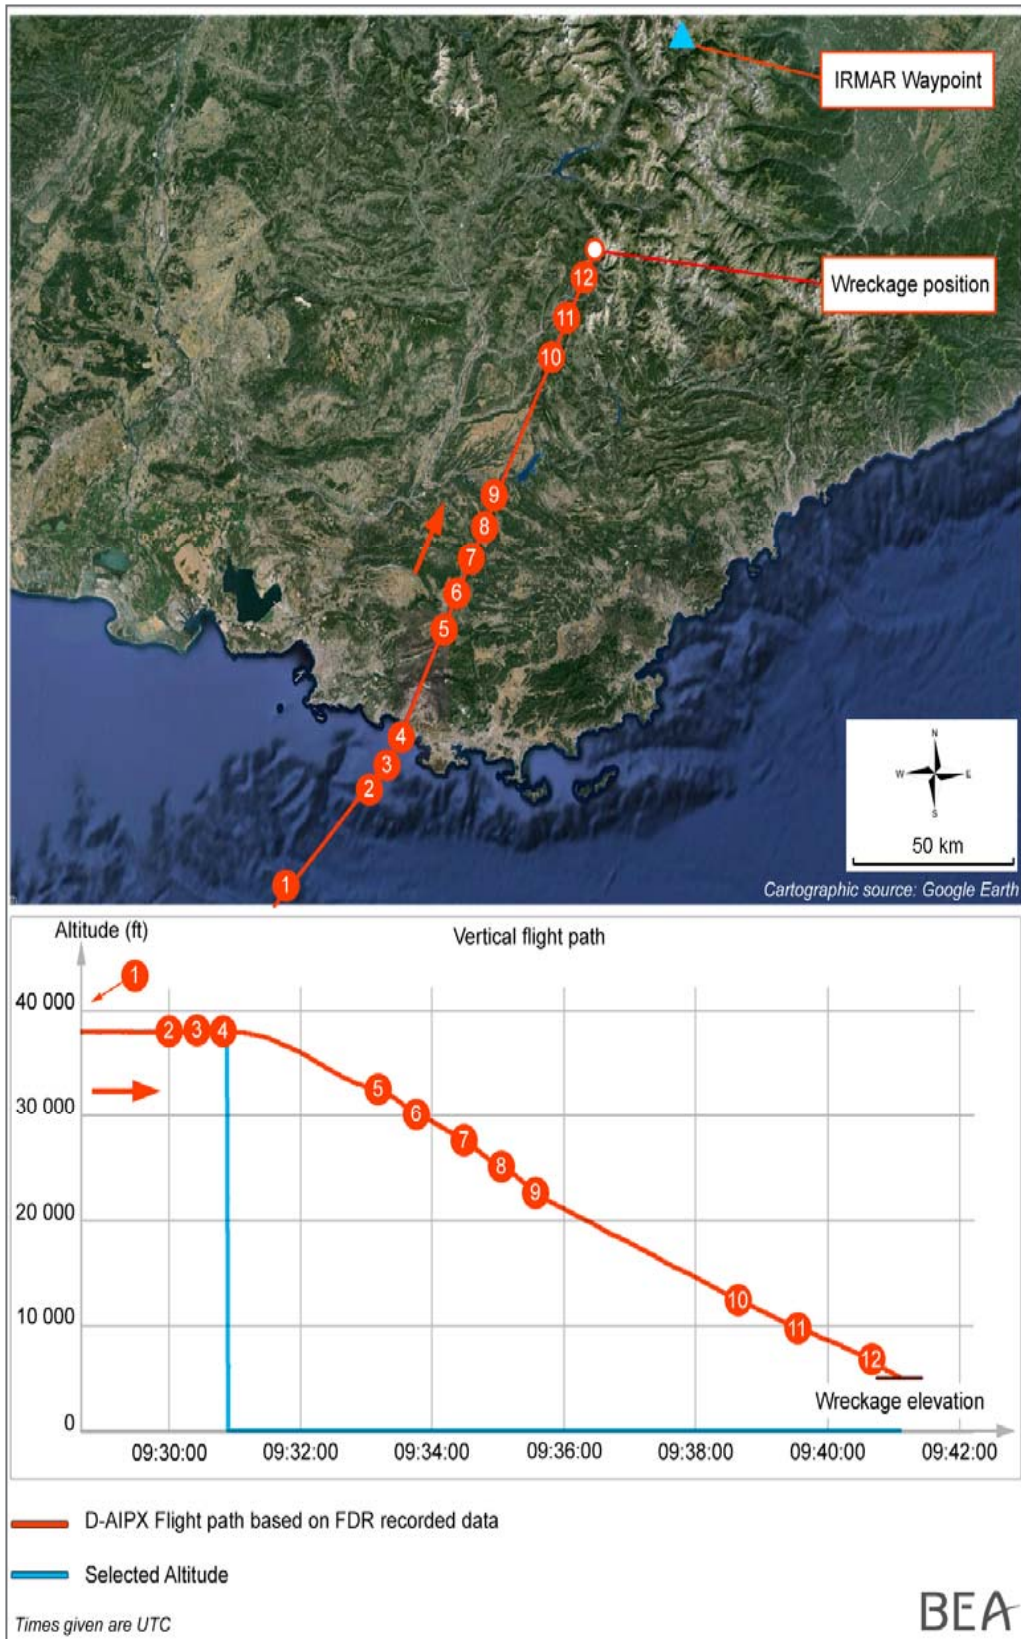
Figure 1 – accident flight trajectory

*Note: the following elements are based on the flight recorders, as well as on recordings of radio communications. The main points in the history of the flight below are referenced by the numbers on figure 1, page 10.*

At 9 h 30 min 53 (point ④), the selected altitude on the FCU changed in one second from 38,000 ft to 100 ft<sup>(2)</sup>. One second later, the autopilot changed to "OPEN DES"<sup>(3)</sup> mode and autothrust changed to "THR IDLE" mode. The aeroplane started to descend and both engines' rpm decreased.

At 9 h 33 min 12 (point ⑤), the speed management changed from "managed" mode to "selected"<sup>(4)</sup> mode. A second later, the selected target speed became 308 kt while the aeroplane's speed was 273 kt. The aeroplane's speed started to increase along with the aeroplane's descent rate, which subsequently varied between 1,700 ft/min and 5,000 ft/min, then was on average about 3,500 ft/min.

At 9 h 40 min 41 (point ⑫), the *"Terrain, Terrain, Pull Up, Pull Up"* aural warning from the GPWS triggered and remained active until the end of the flight.

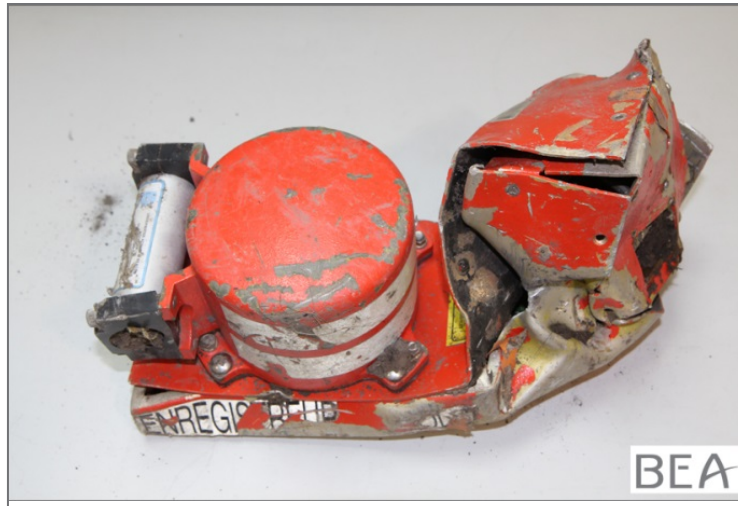
Figure 9 - cockpit voice recorder (CVR) – D-AIPX

Given the significant damage to the CVR, the memory card was extracted from the protected module, visually inspected and tested electrically. Reading the data on the manufacturer's official equipment made it possible to obtain six audio tracks:

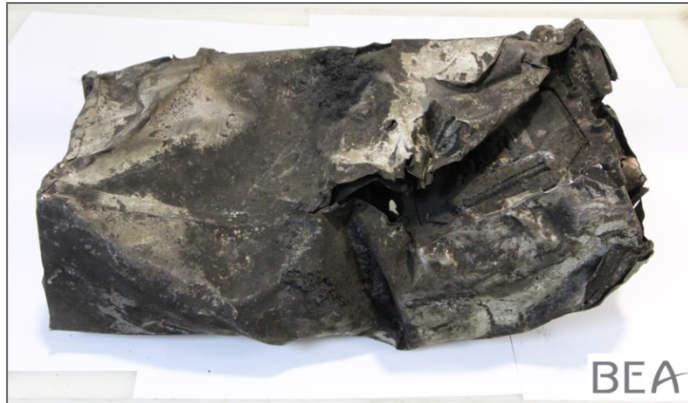
Figure 10 - Flight data recorder (FDR) - D-AIPX

It showed significant mechanical and thermal damage. All of the equipment was covered in soot. After removing the protected module from the recorder casing, the memory card was removed from the protected module.

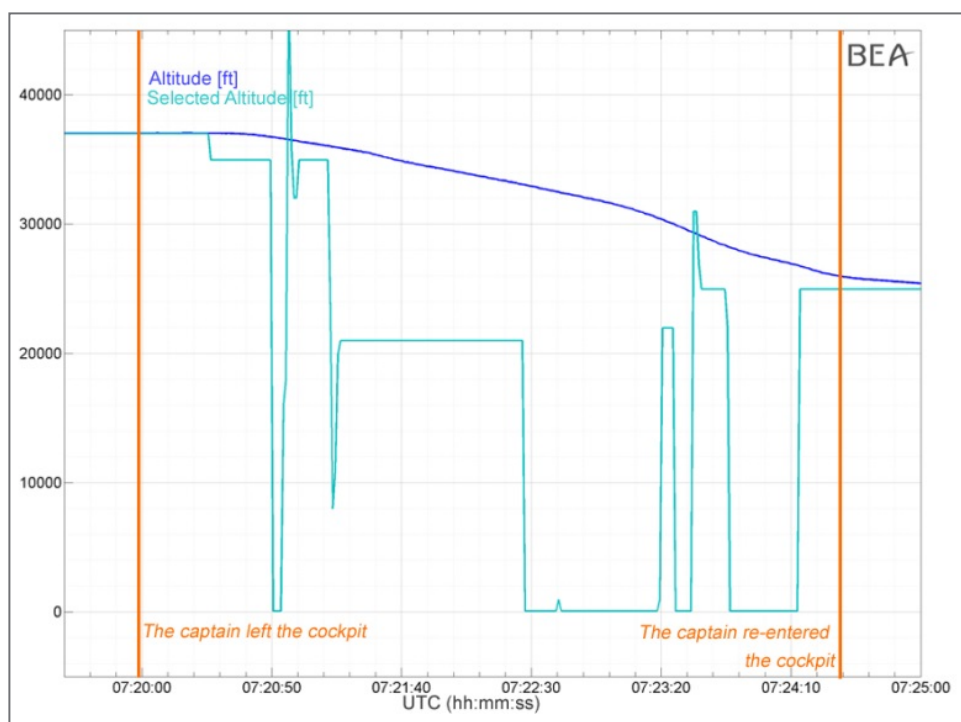
Figure 11 - descent during the previous flight

- ❑ at 7 h 20 min 50, the selected altitude decreased to 100 ft for three seconds and then increased to the maximum value of 49,000 ft and stabilized again at 35,000 ft;
- ❑ at 7 h 21 min 10, the Bordeaux control centre gave the crew the instruction to continue the descent to flight level FL210;
- ❑ at 7 h 21 min 16, the selected altitude was 21,000 ft;
- ❑ from 7 h 22 min 27, the selected altitude was 100 feet most of the time and changed several times until it stabilized at 25,000 ft at 7 h 24 min 13;
- ❑ at 7 h 24 min 15, the buzzer to request access to the cockpit was recorded;
- ❑ at 7 h 24 min 29 noises like those of the unlocking of the cockpit door then its opening was recorded and corresponded to the Captain's return to the cockpit.

The following graphs were extracted from the FDR and illustrate the variations in selected altitude.

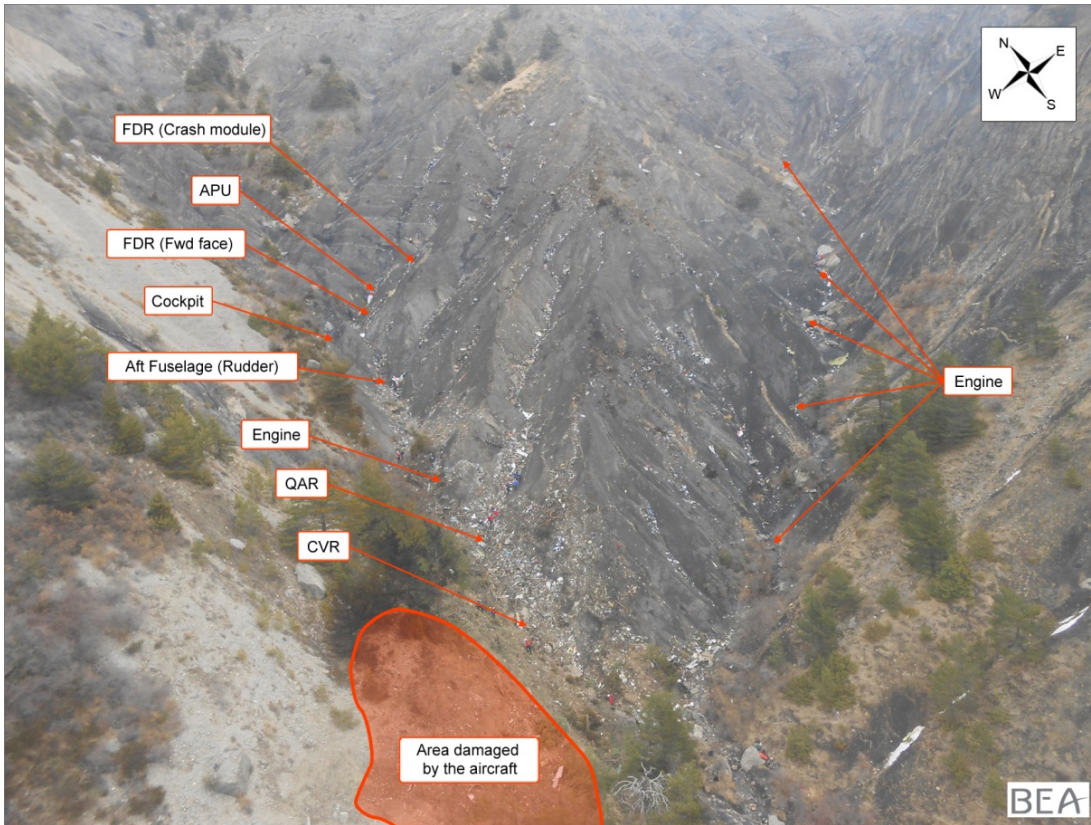
Figure 12 – general view of the accident site

On site, elements belonging to various parts of the aeroplane were identified. One of the engines was broken into many pieces in the main ravine. The debris of the other engine, concentrated in a small area, was found in the main west ravine.

The auxiliary power unit (APU) was located in the upper part of the site dozens of metres from the part of the rear fuselage to which the vertical stabilizer is attached. One of main landing gears was found near this part of the fuselage.

Parts from the cockpit (access door to the cockpit, sidestick, security camera) were also found in the upper part of the site.

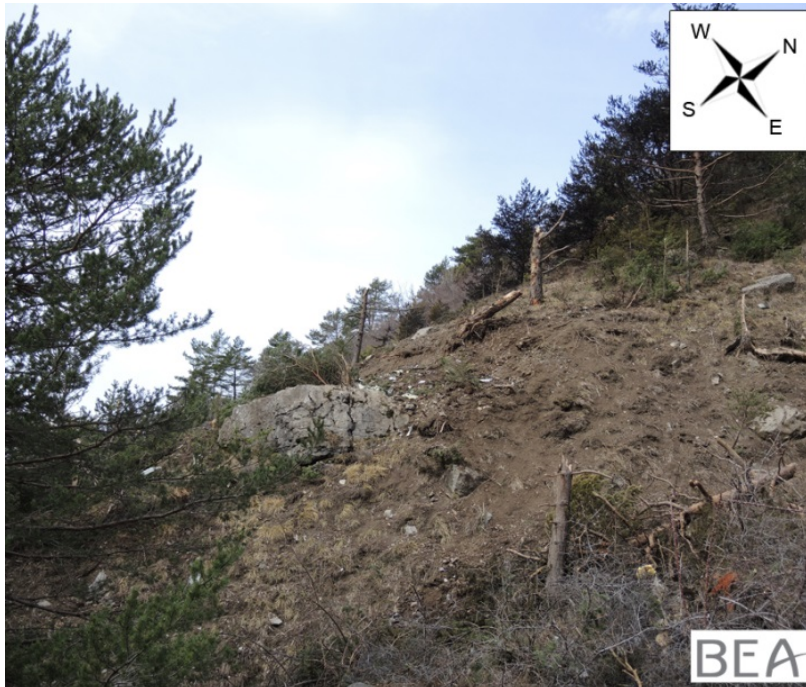
Figure 13 - contact area with vegetation

On the lower part of the site, about 20 m above the ravine, is an area where the vegetation had been torn up, tree trunks were uprooted, tree branches were broken and the ground churned up. Parts from the aeroplane's wings and fuselage were found in this area. Apart from this area and the final debris field, no other contact with the environment was observed around the accident site.
