Captain's BBQ at Bing's Landing

Potential Repairs Update
June 17, 2019 5PM

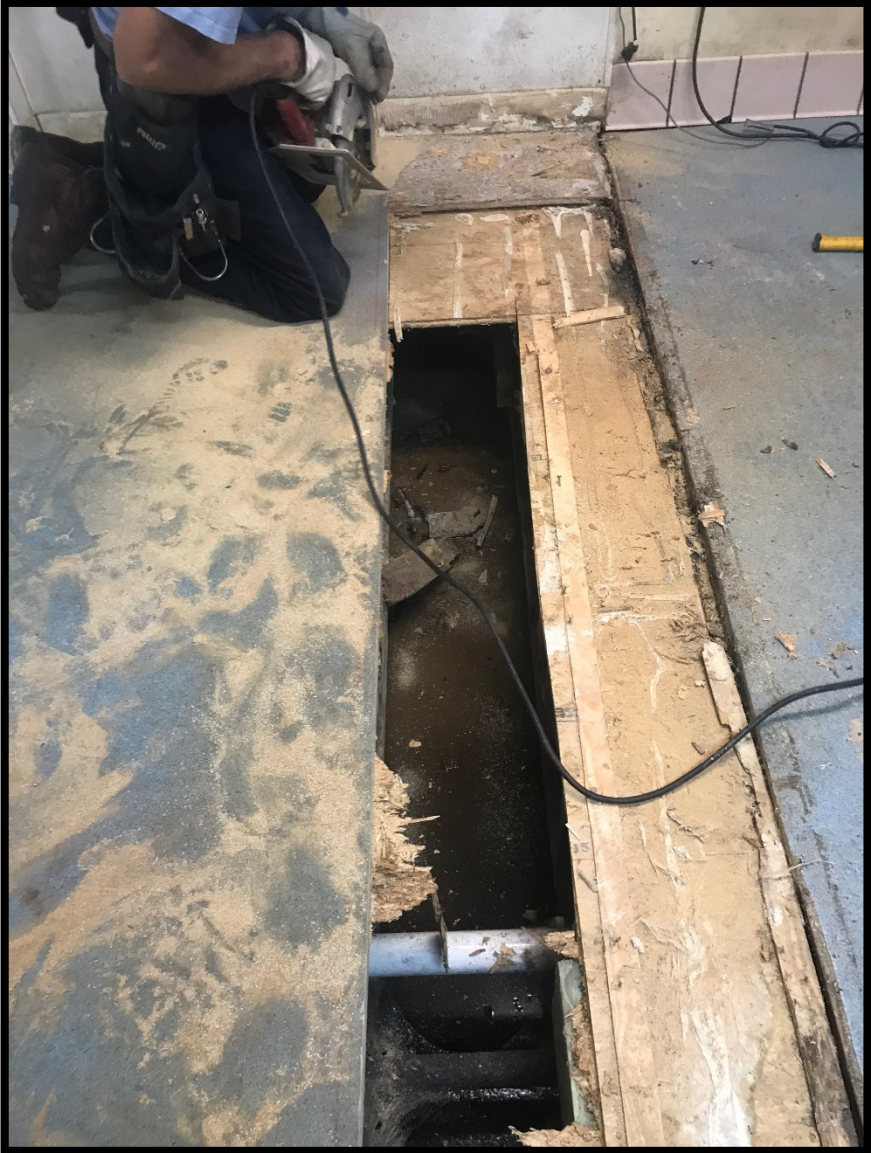
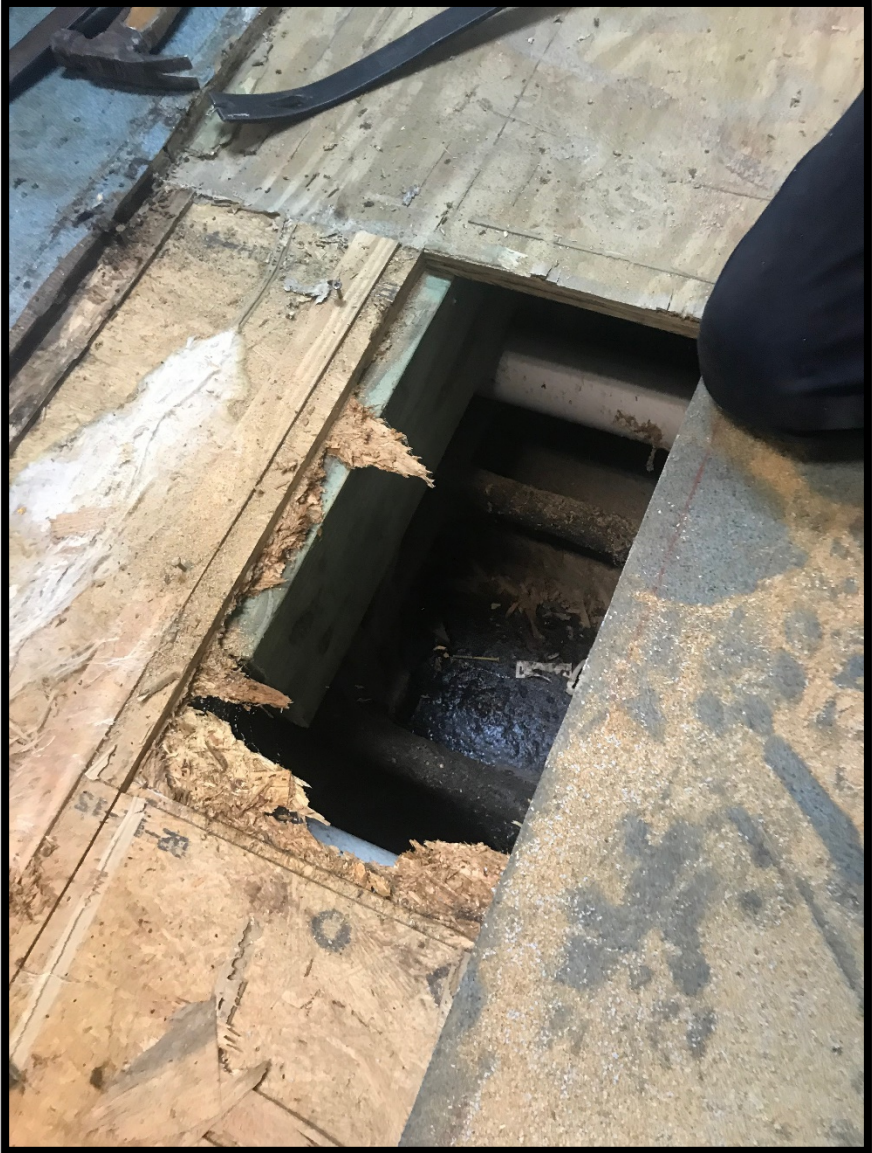
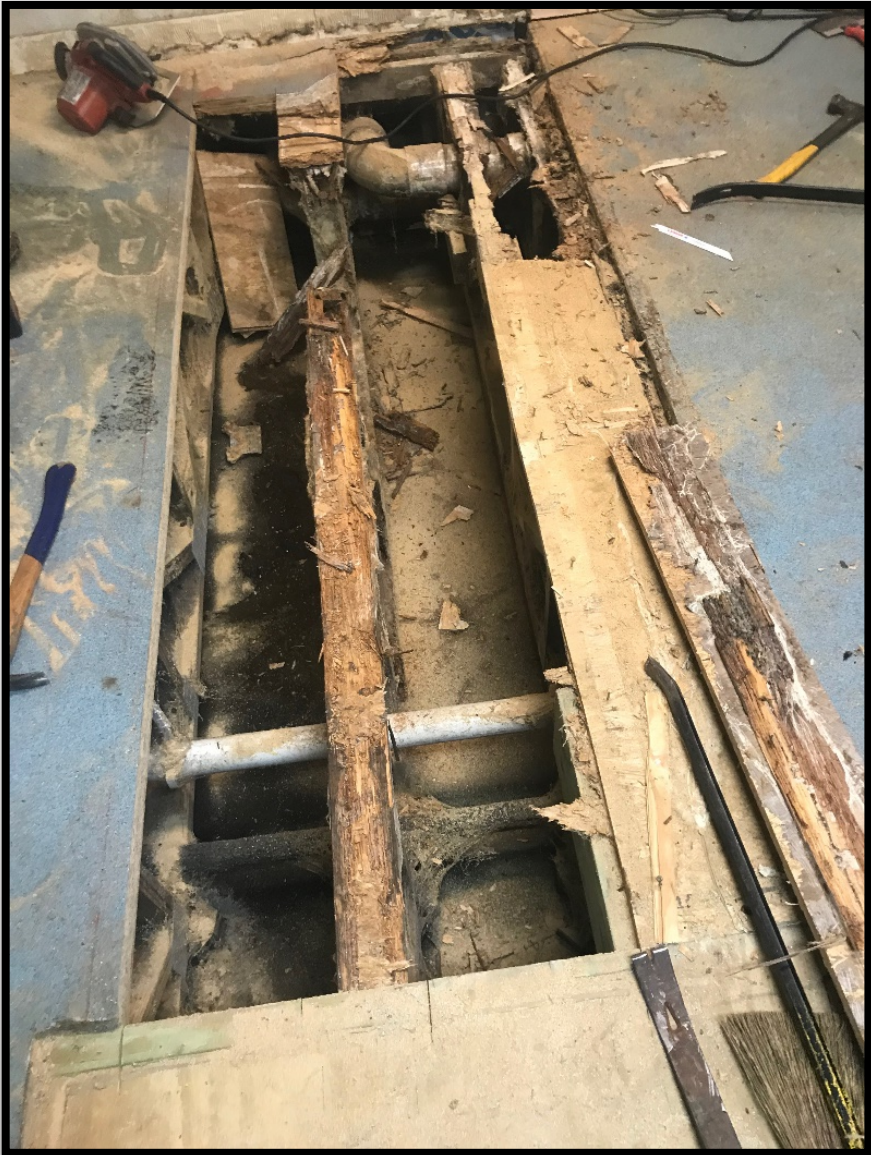
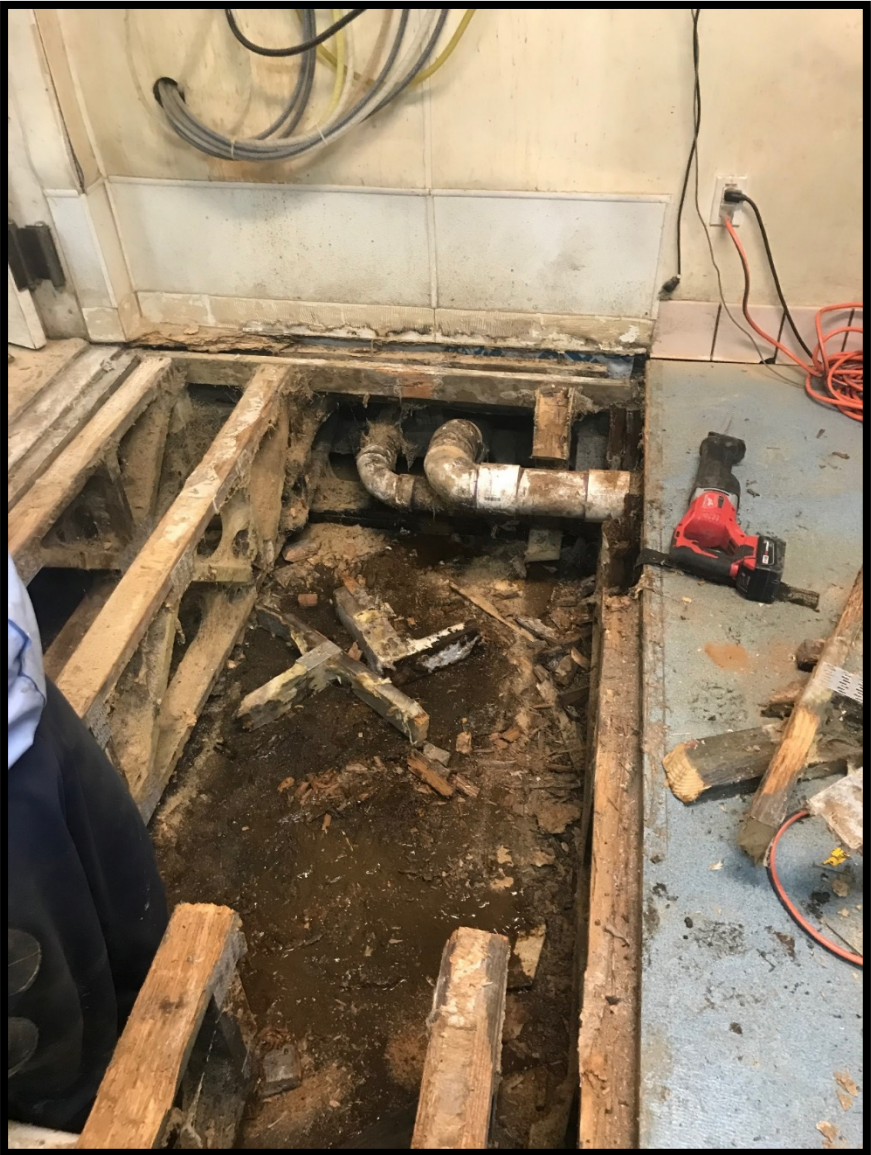
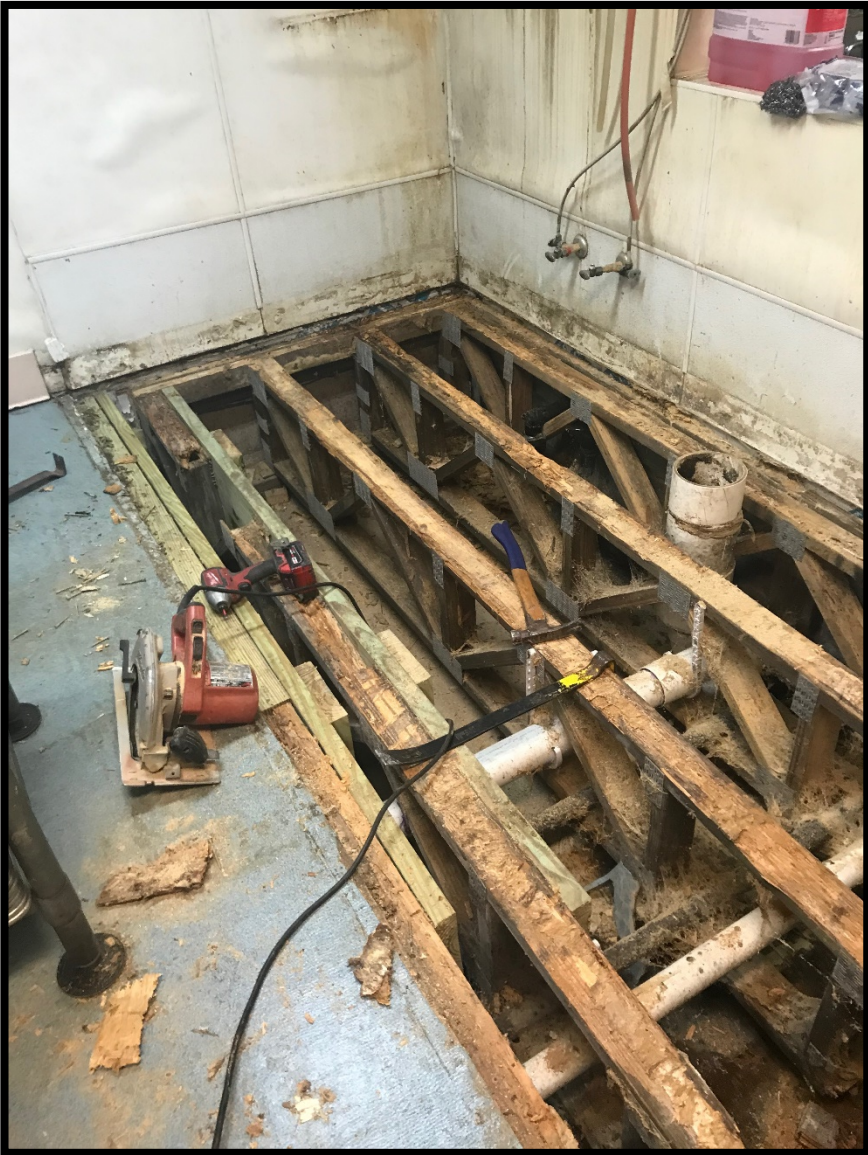
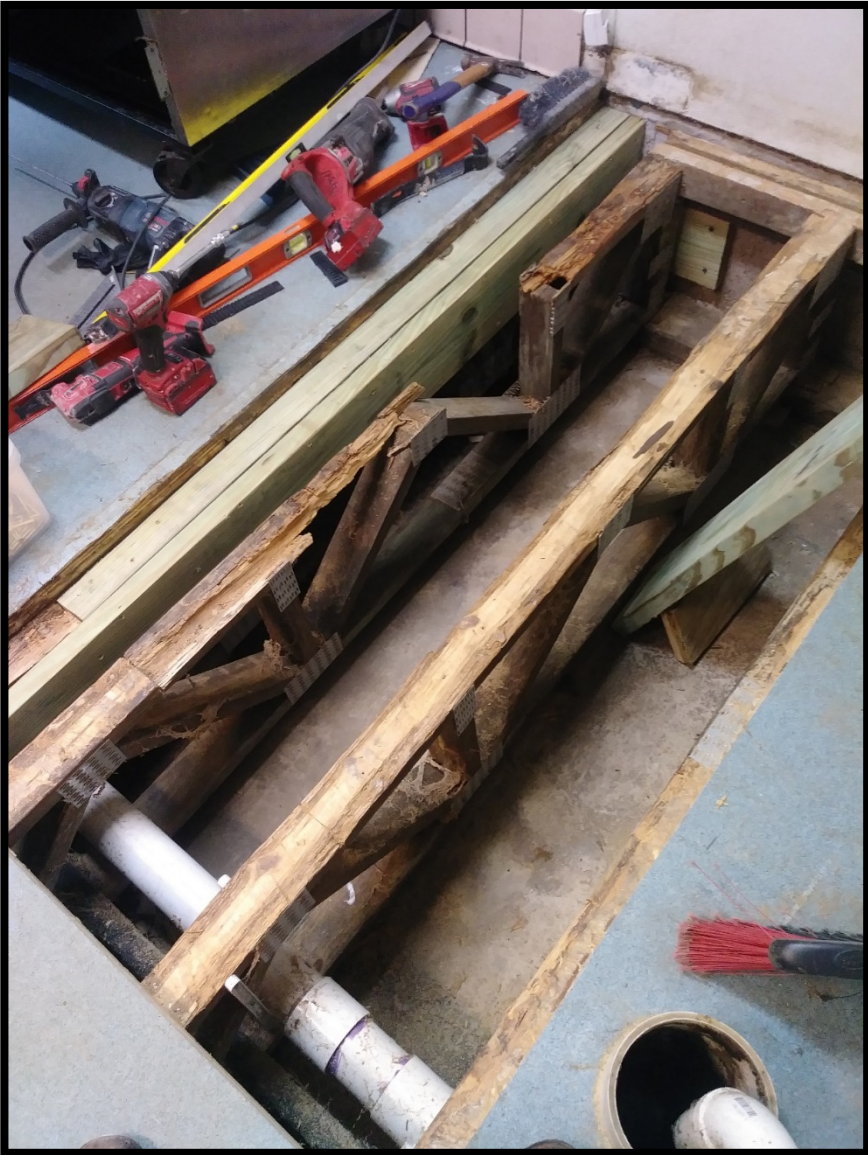
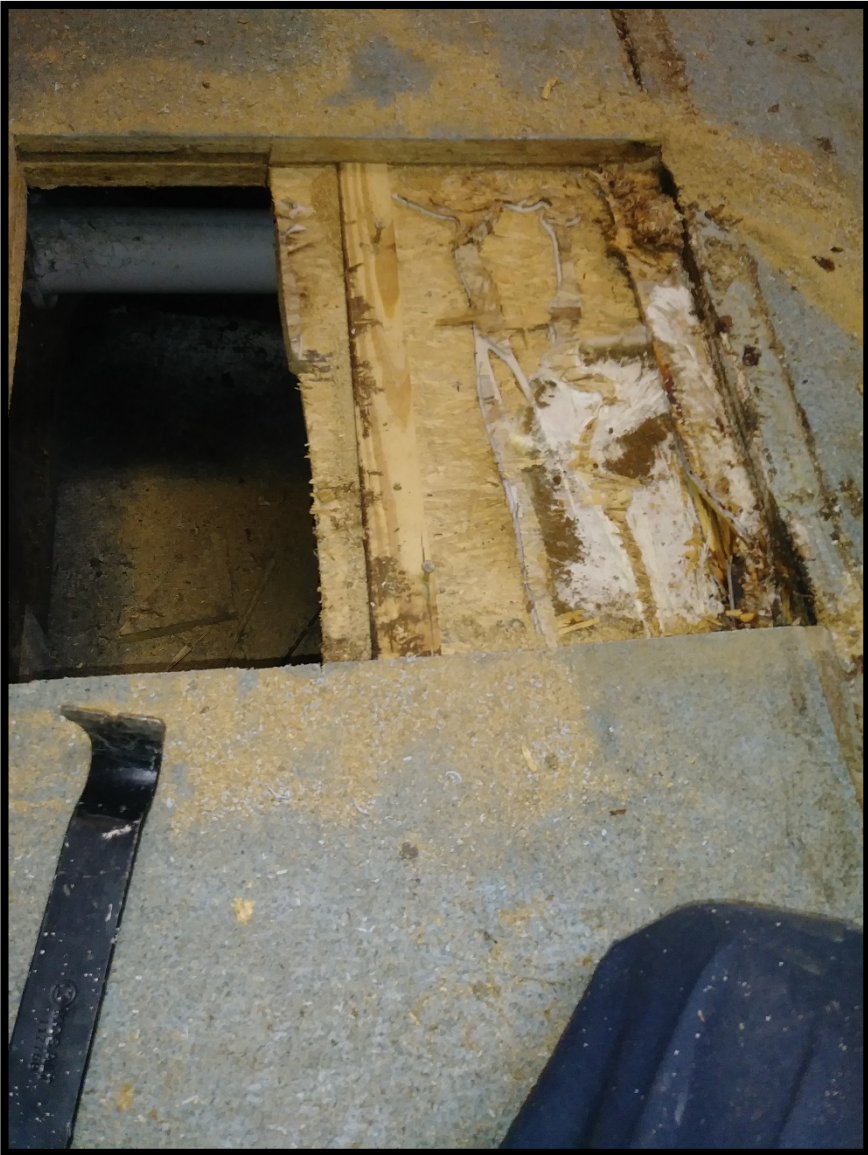
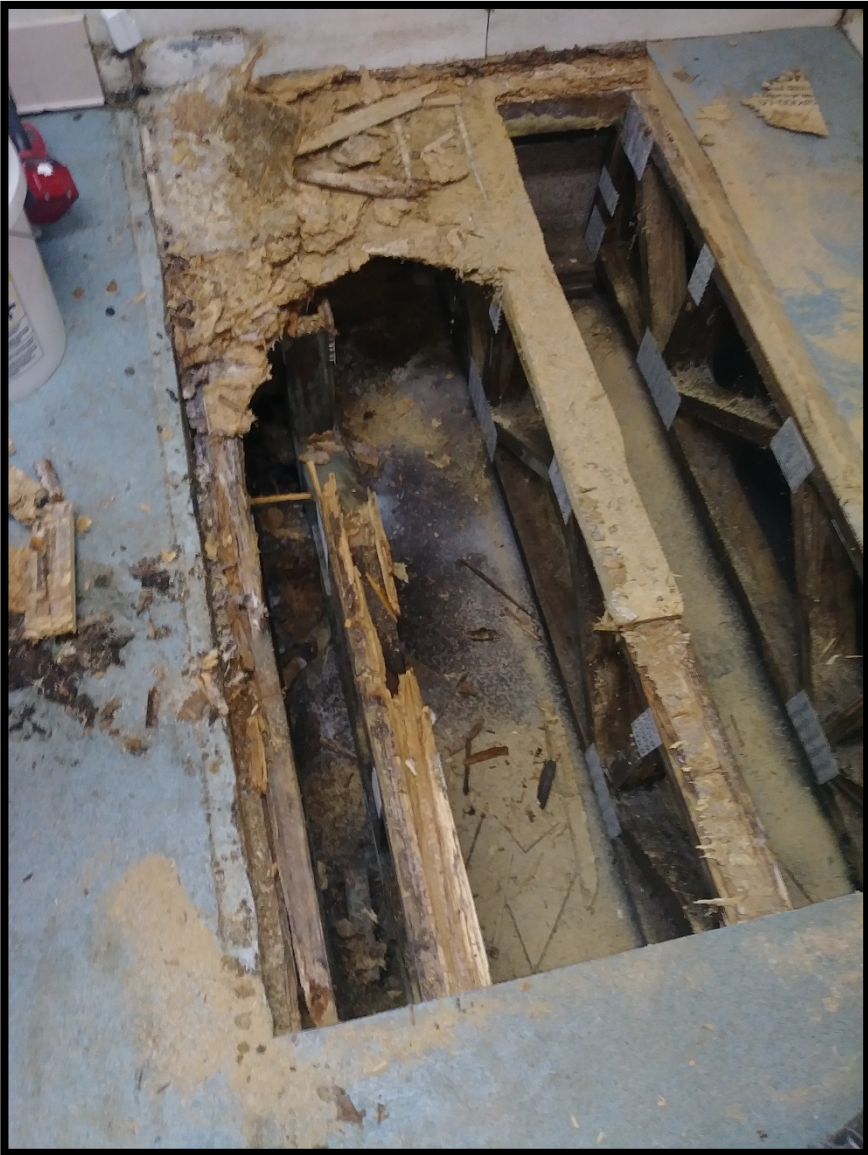
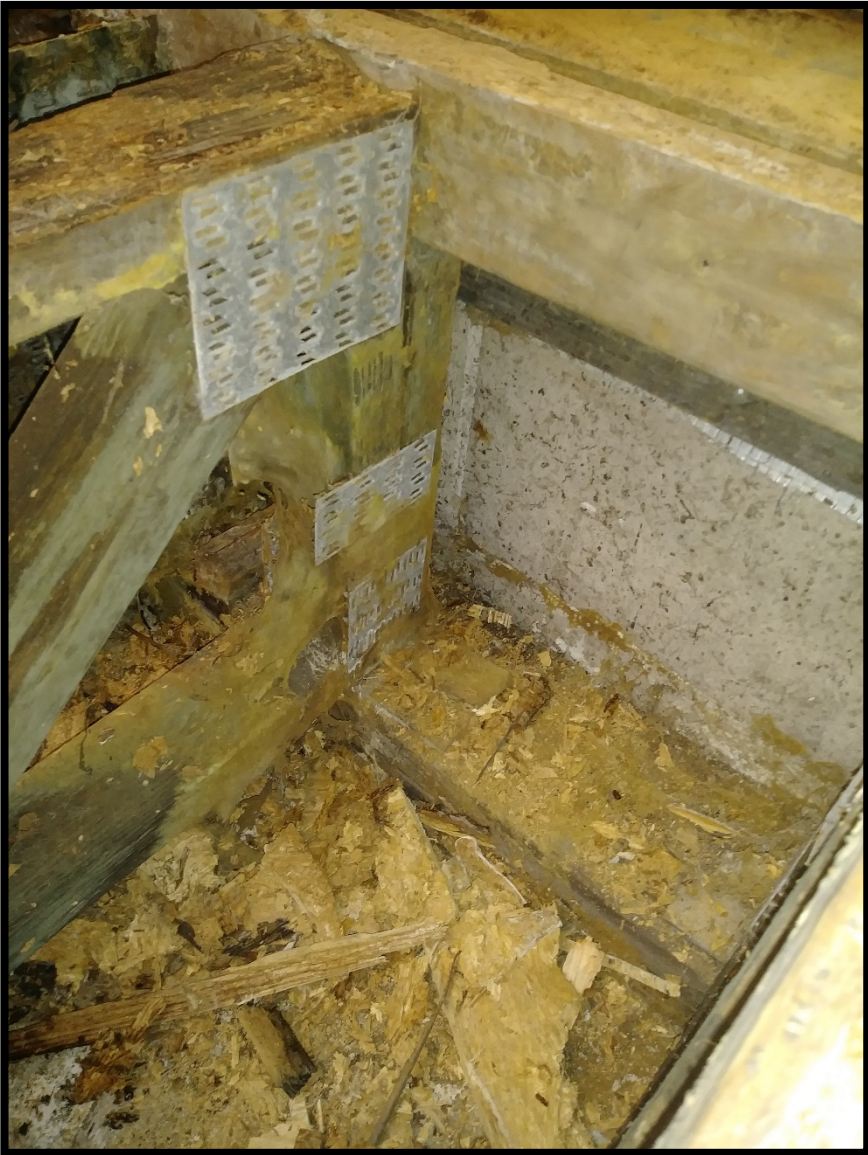
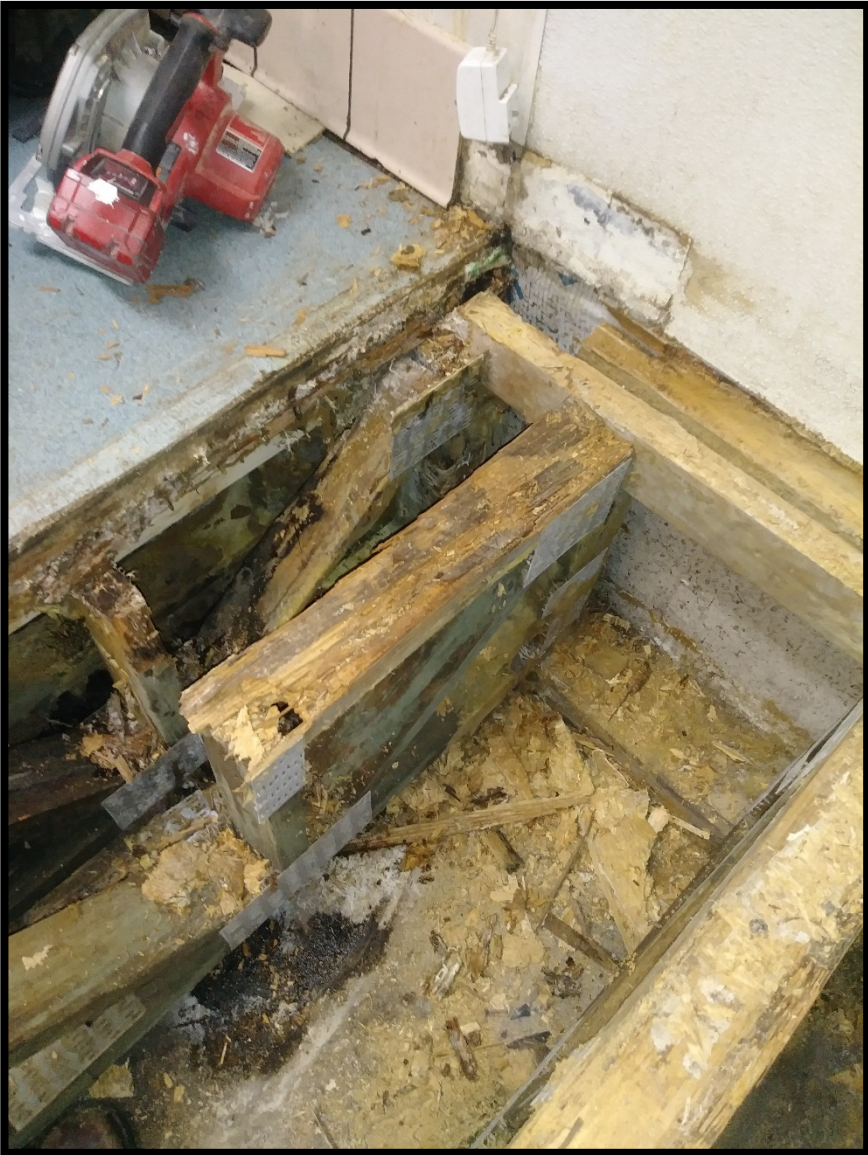
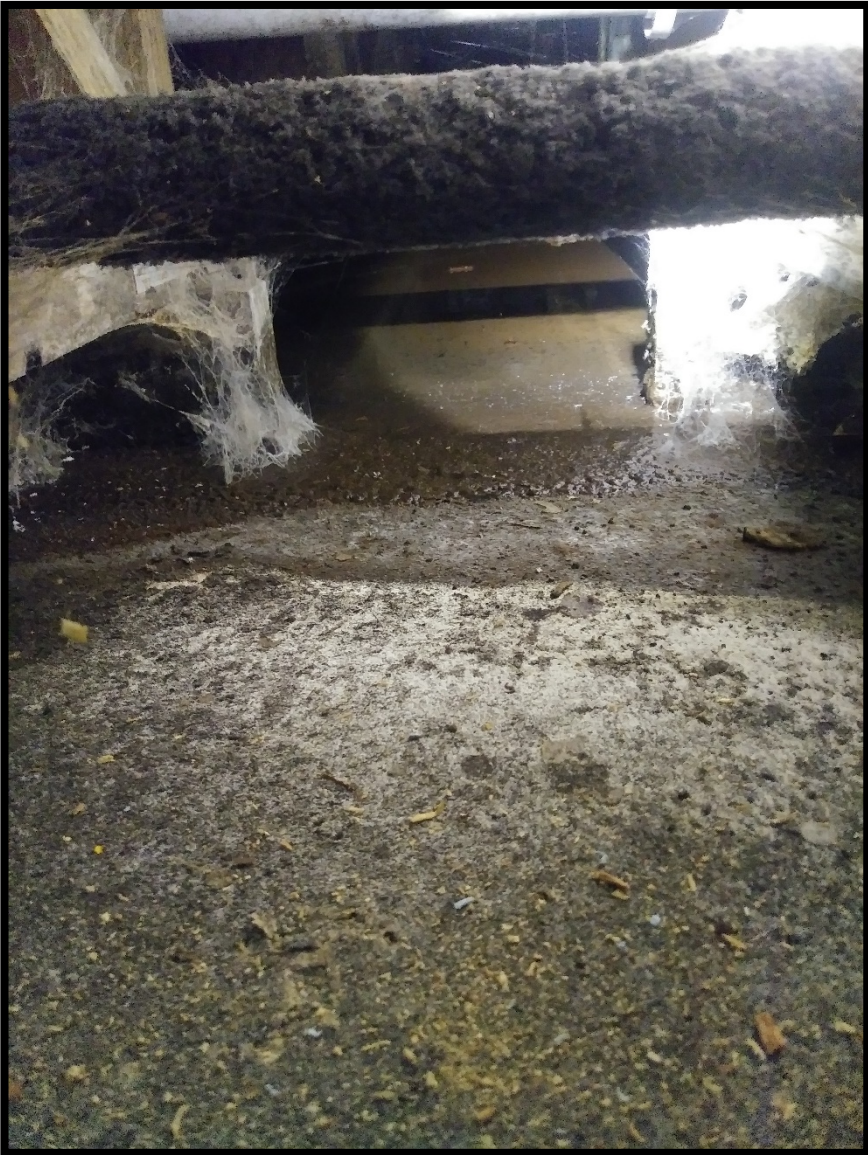
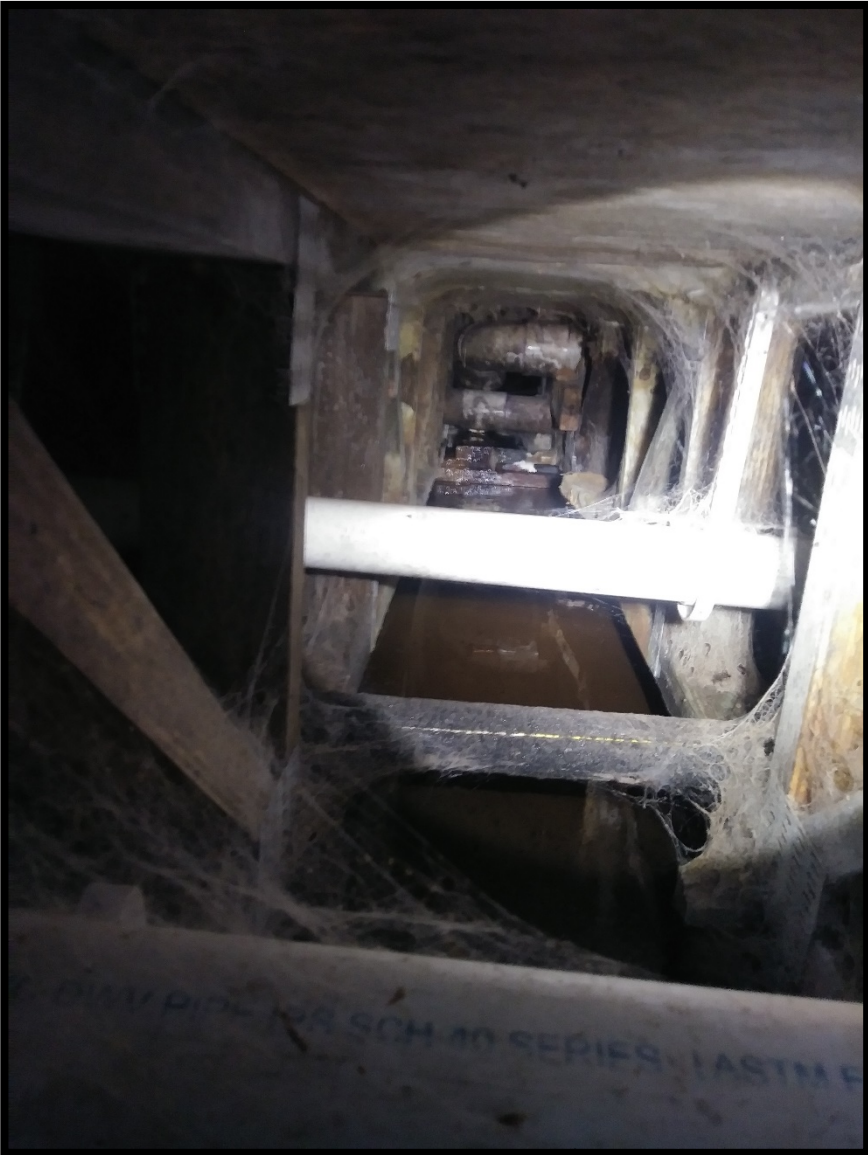
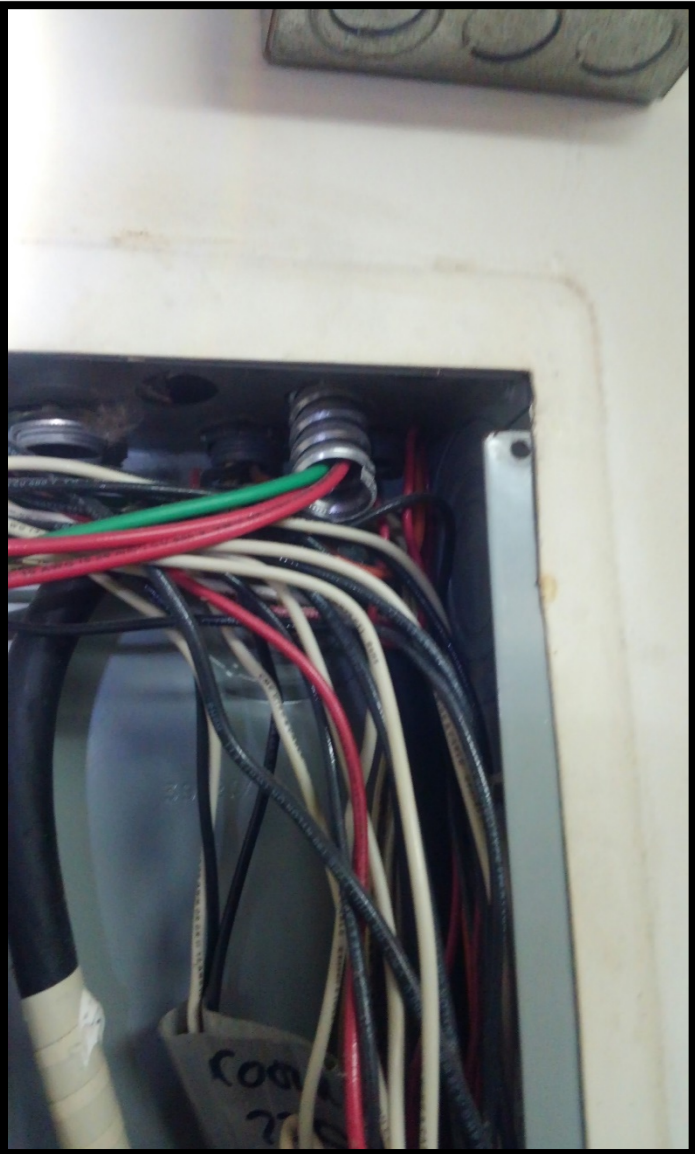
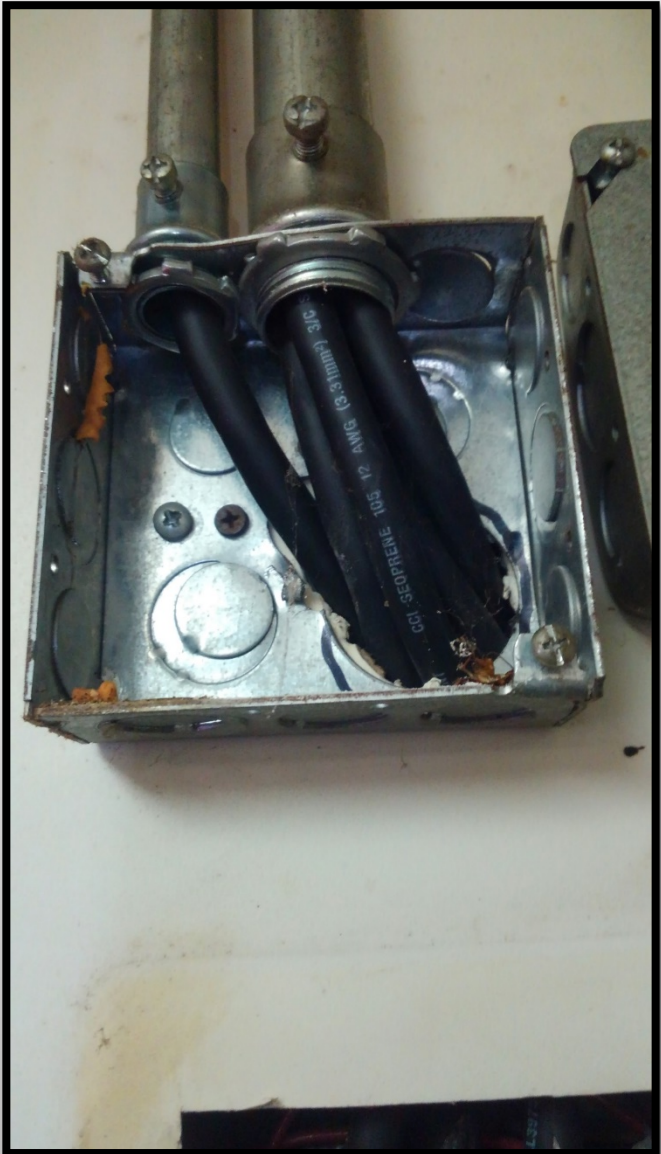
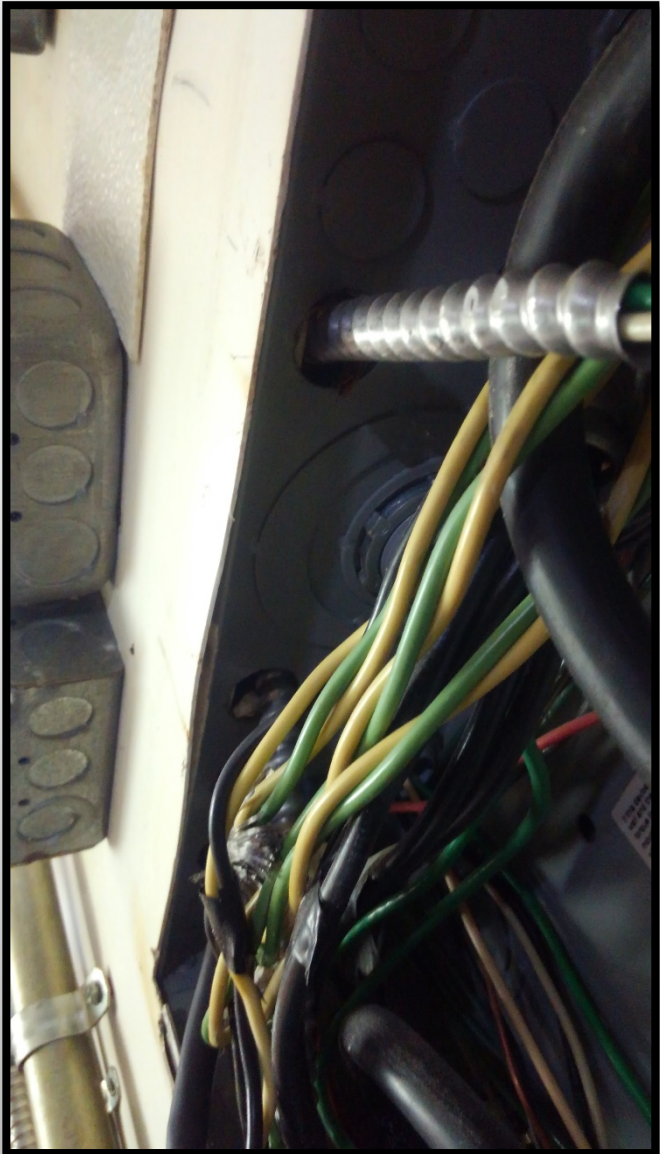
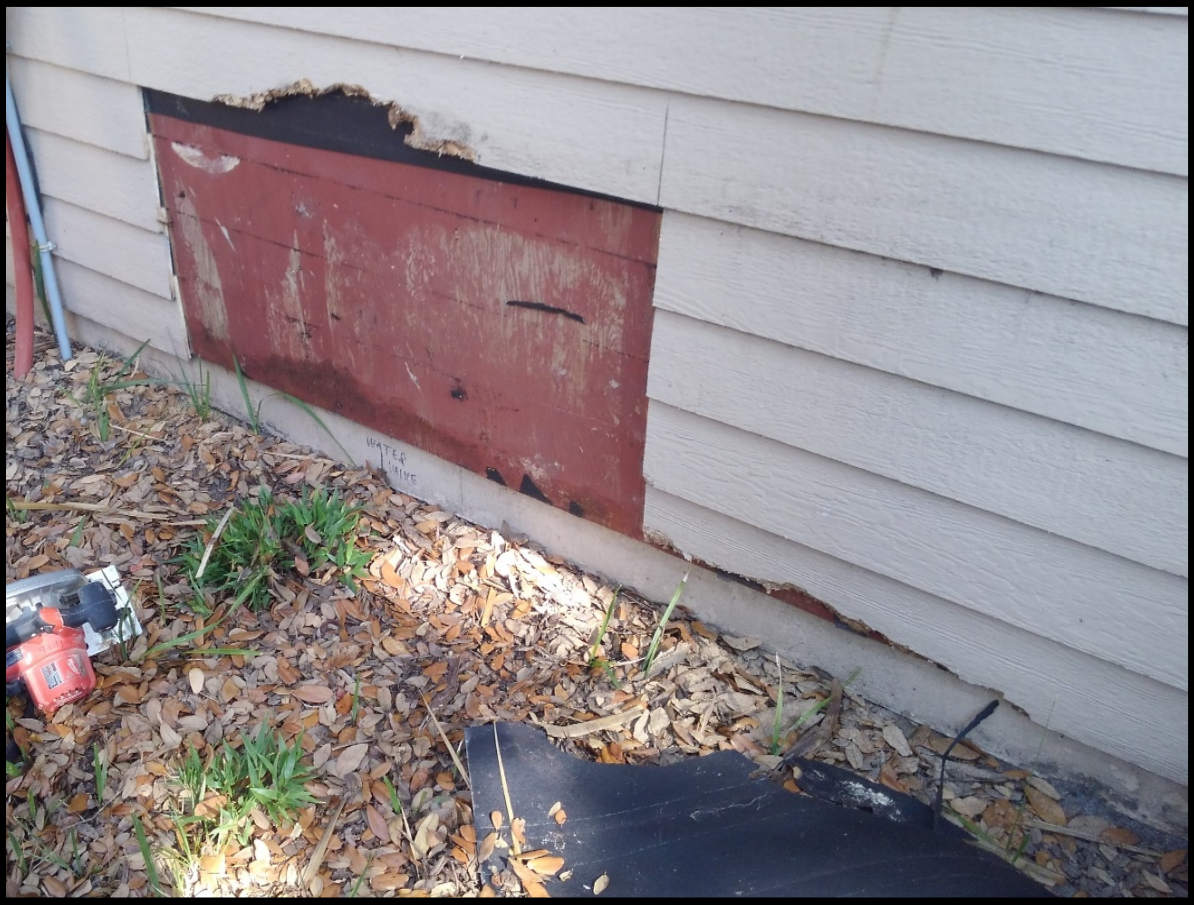
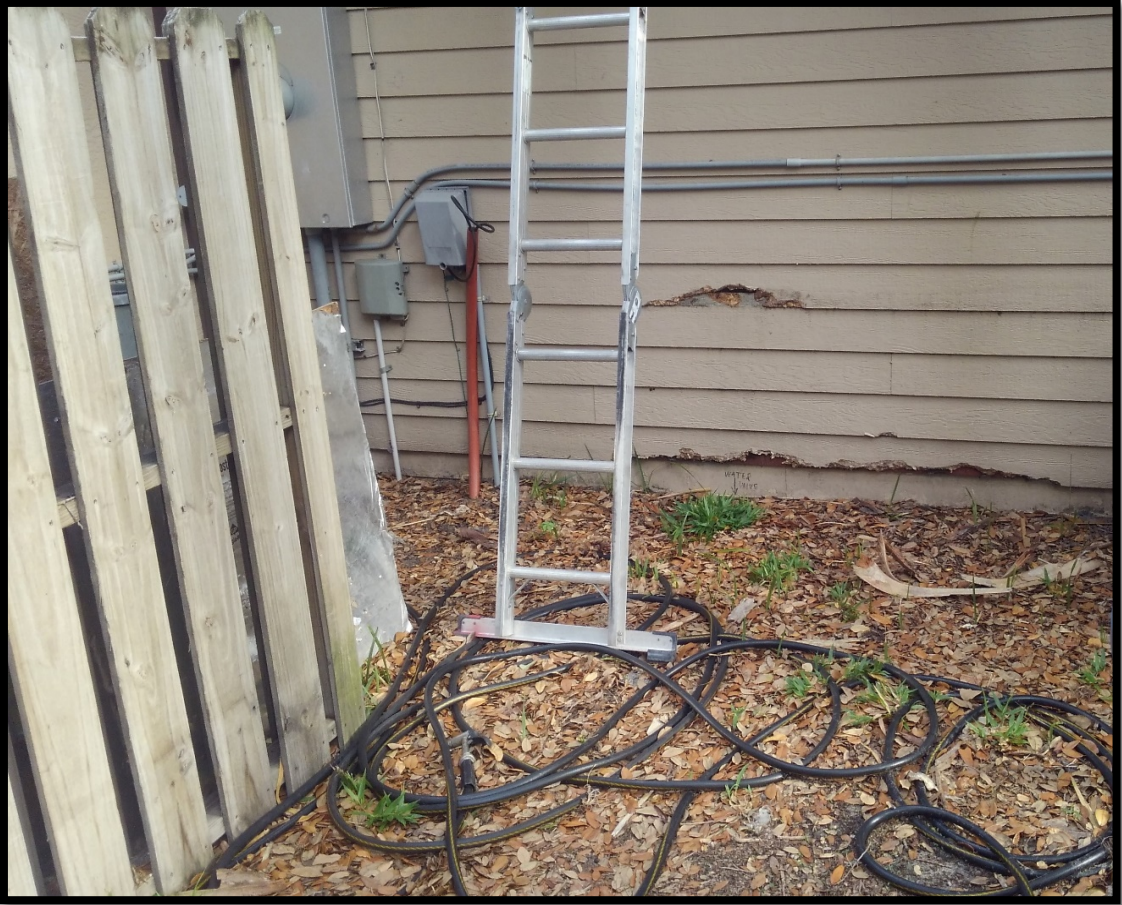
- Under the direction of the Board from the June 3, 2019 Regular Meeting, we were tasked with investigating what it would take to bring up noted deficiencies to make the facility usable for the remainder of the lease.
- General Services staff evaluation revealed prominent deficiencies were obvious with the subfloor and flooring, with noticeable soft spots within main dining area, kitchen and bathrooms.

- Additional evaluation was done by the County's Chief Building Official to determine the overall structural integrity of the building, which included the following systems: roofing, walls, electrical, HVAC, plumbing, and flooring.
- It was concluded that the overall integrity of the building was good with the only noted deficiencies being the floor system along with minor electrical and exterior siding corrections being needed.

Typical Deficiencies

- Flooring (\$46,000)
 - Scope includes removal of existing floor system and restrooms, cleaning and sealing of existing concrete, applying waterproofing material to all pressure treated replacement lumber, installation of new subfloor, sheathing and insulation, reconstruct both ADA restrooms, reset original fixtures and installation of new flooring tile throughout.
- Siding (\$4,800)
 - Scope includes removal of existing OSB siding and installation of new fiber cement siding
- Electrical (\$200)
 - Scope to include the installation of 2 plastic pull bushings, 3 MC Cable Connectors and 1 EMT Connector
