**Project Observation Minutes & Recommendations from Martin Aquatic
Holland Park IWF - Palm Coast**

Project:	Holland Park IWF		
Location:	Palm Coast, FL		
Report By:	Jonathan "JT" Toavs & Ken Martin		
Attendees:	JT, Ken, Mackenzie, and Drew from Martin Aquatic		
Issue Date:	2022.08.18	Revised Date:	
Subject:	IWF existing conditions Observation		
Weather:	Partly Cloudy

PlanGrid Task Report - Jul 23, 2022

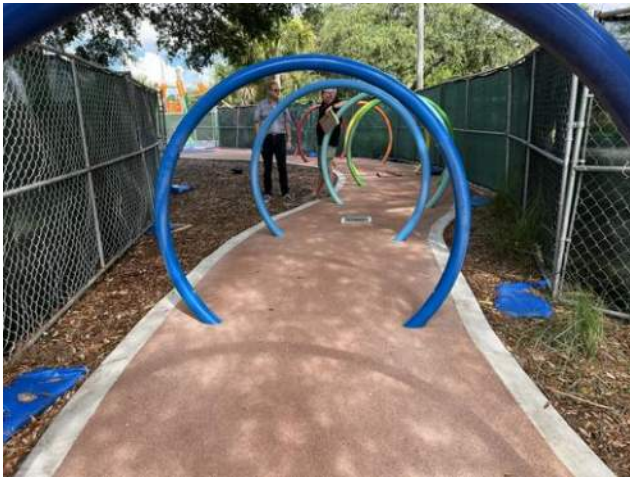
Multiple surface failures and lack of decking adjacent feature.

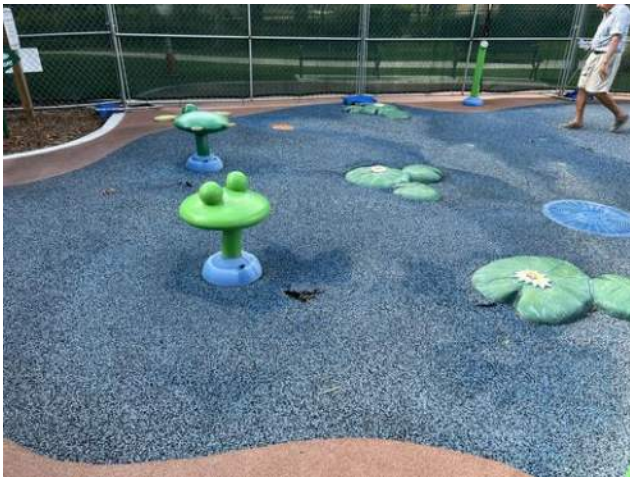
Area of slope and drainage concern and surface failures.

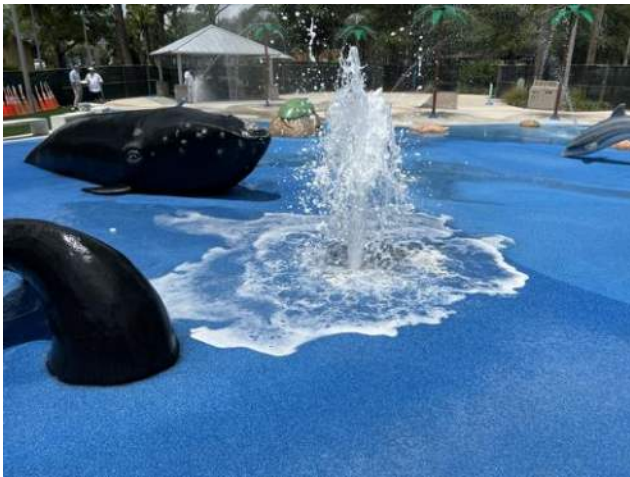
Area of slope and drainage concern and surface failures.

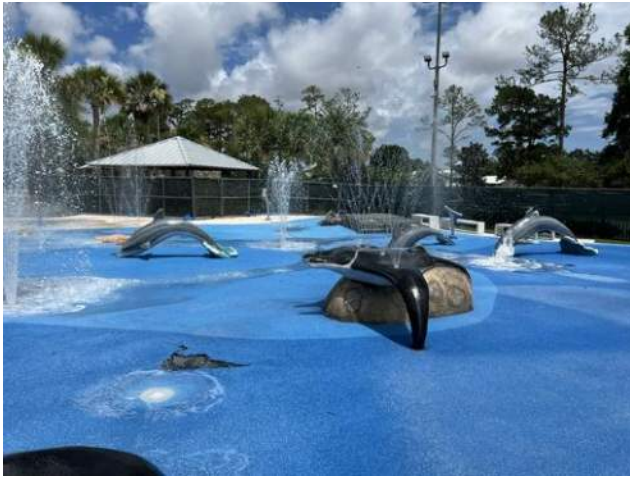
Area of slope and drainage concern and surface failures.

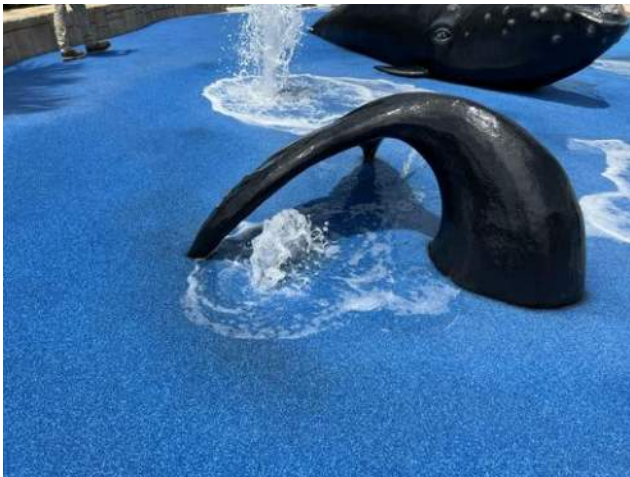
Area of slope and drainage concern and surface failures.

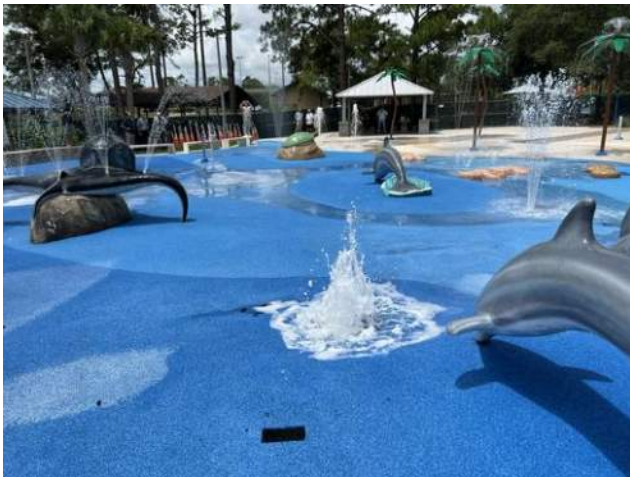
Area of slope and drainage concern and surface failures.

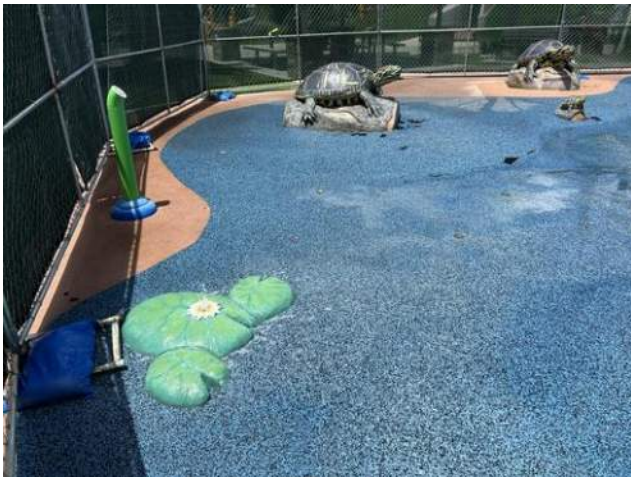
Area of slope and drainage concern and surface failures.

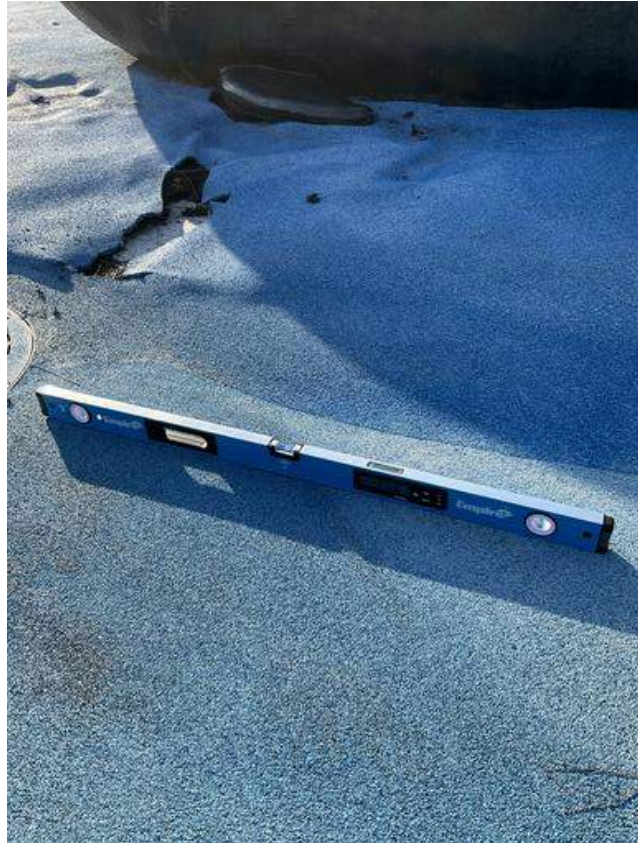
Slope at the drain for the record. The slope at thickened floor area creates trip hazards, typical at all raised floor edge conditions.
