**Growth Management Department  
Building**

MEMORANDUM

Date: June 11, 2019  
To: Jerry Cameron, County Administrator  
From: Mark Boice, Chief Building Official  
Subject: Captains BBQ

The purpose of this report is to provide you the results of an on-site inspection of Captains BBQ located at 5862 N. Ocean Shore Blvd on June 6, 2019. The observations of the structure are summarized below.

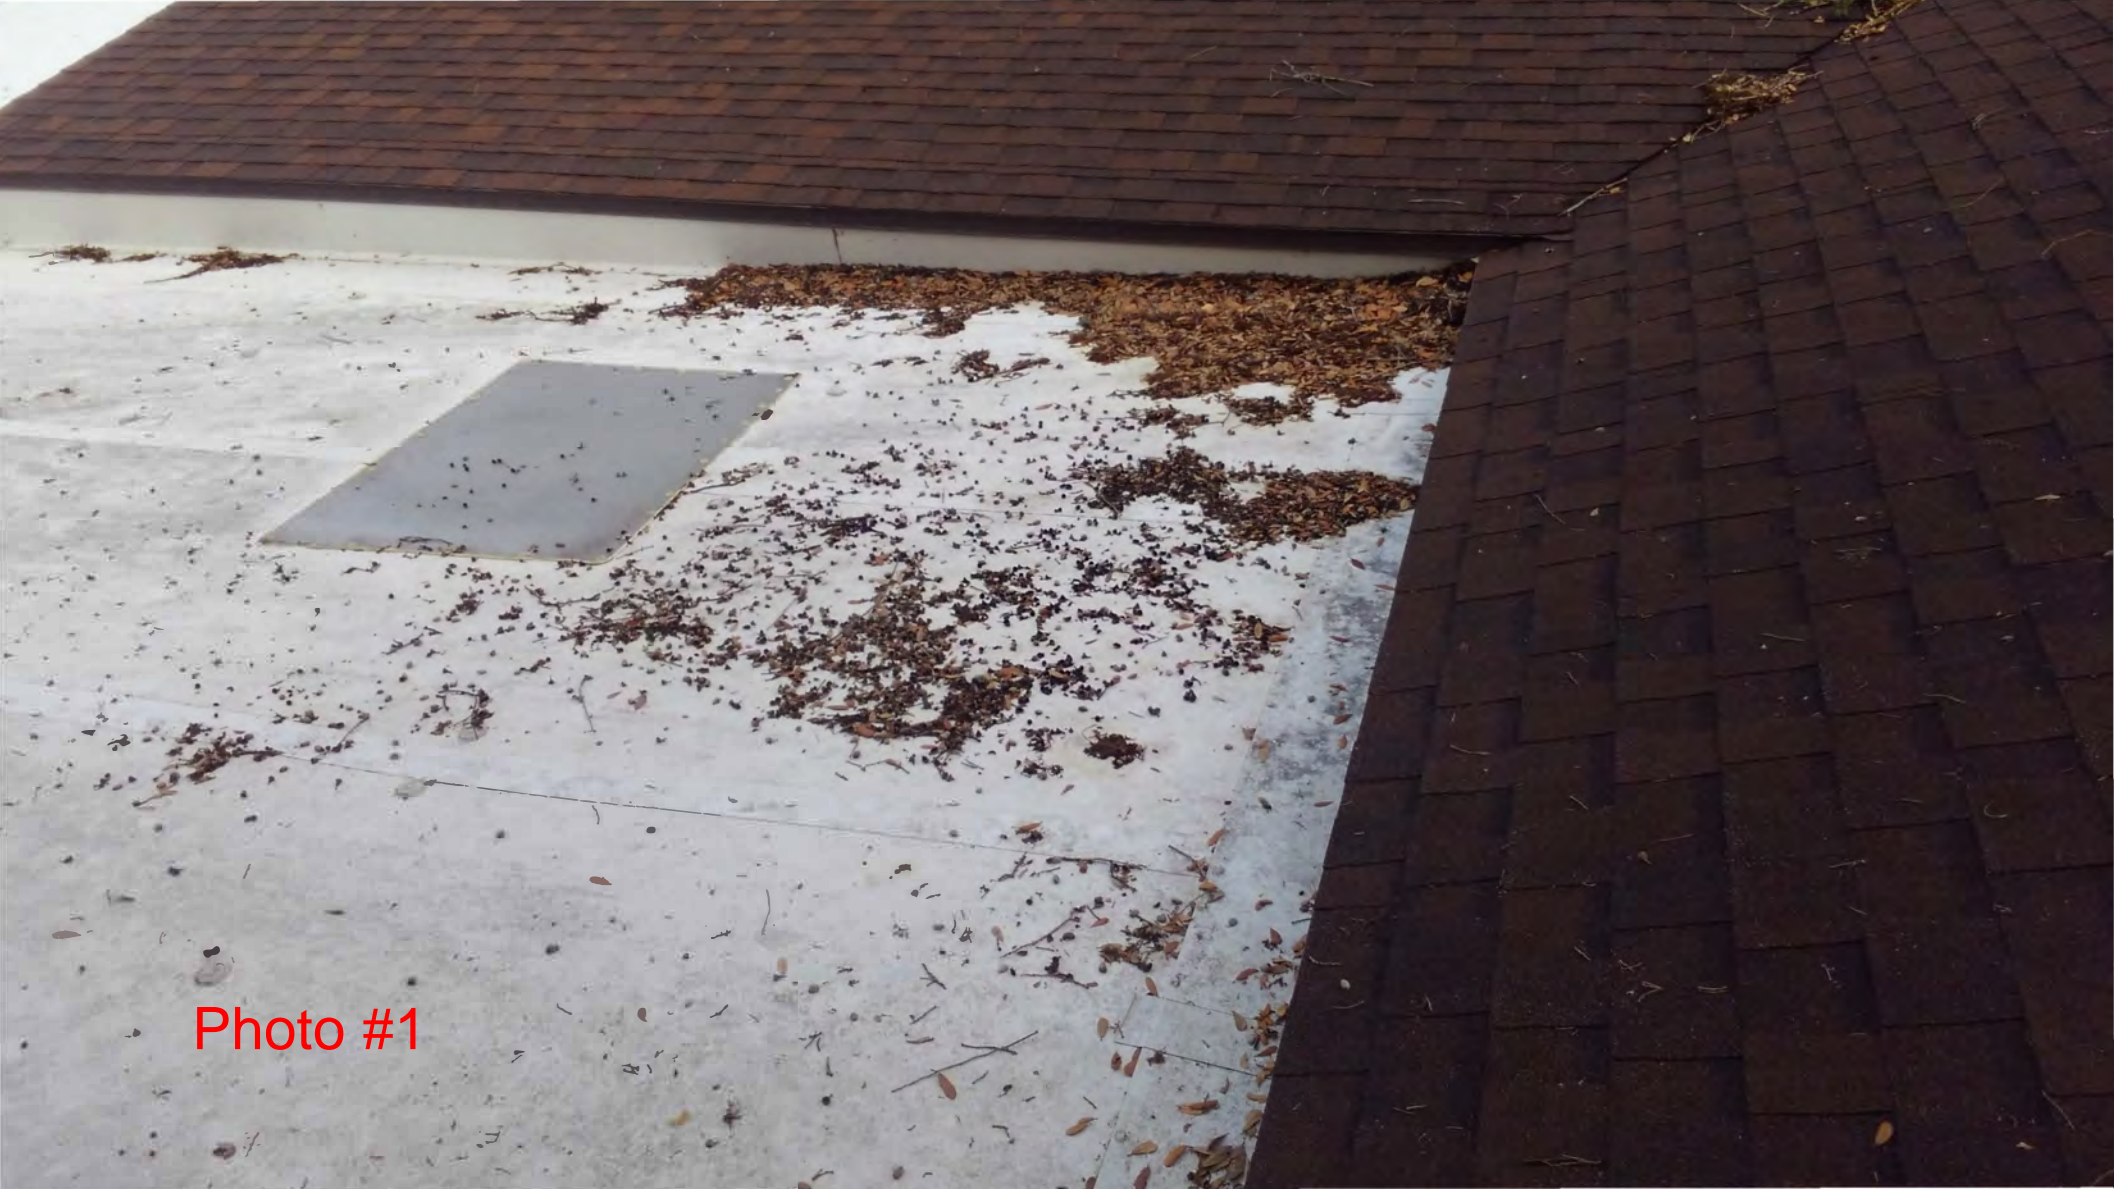
Photo #1

The asphalt shingles were installed in January of 2010. The shingles were observed to be in satisfactory condition for being 9 years old. Some granule wear was observed, but the shingles should last their life expectancy of at least 10 more years. The ridge vent is in need of additional screws to be installed in some locations.
