FIELD INSPECTION

FLAGLER COUNTY COASTLINE

FOLLOWING THE OCTOBER 2025 NOR'EASTER

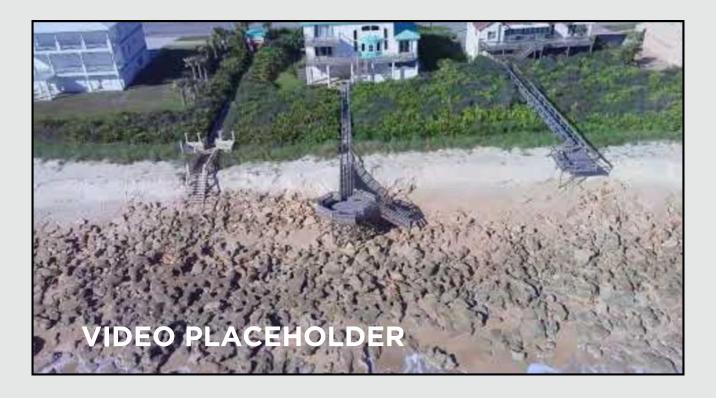
River-to-Sea Preserve: Very minimal scarping along the dune, the beach and dune handled the storm well. Drone footage of River-to-Sea to Surf Club taken at low tide.

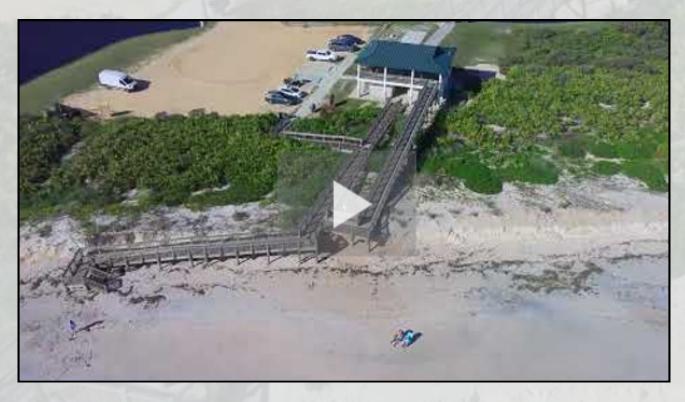
BAY DRIVE PARK DRONE FOOTAGE

Dune erosion but no evidence of overtopping of dune.

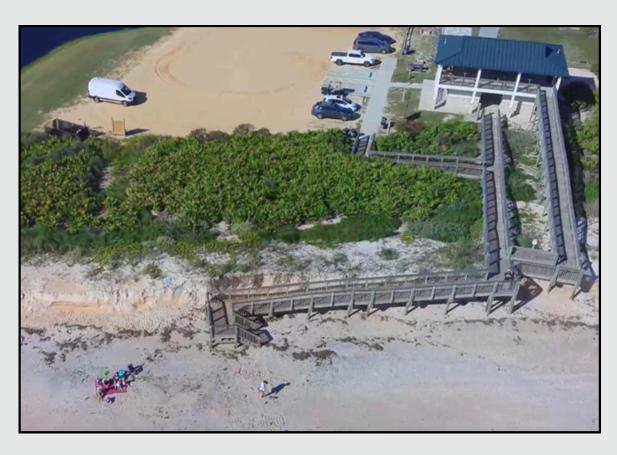
Major scarping along dune and recession of dune. Scarp appears to be at least 6-feet-high in the footage shown here.

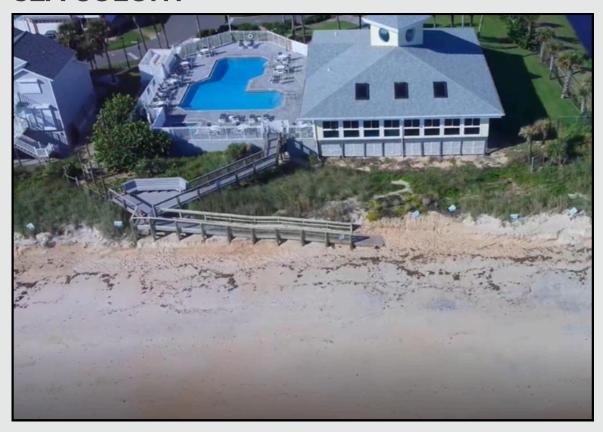
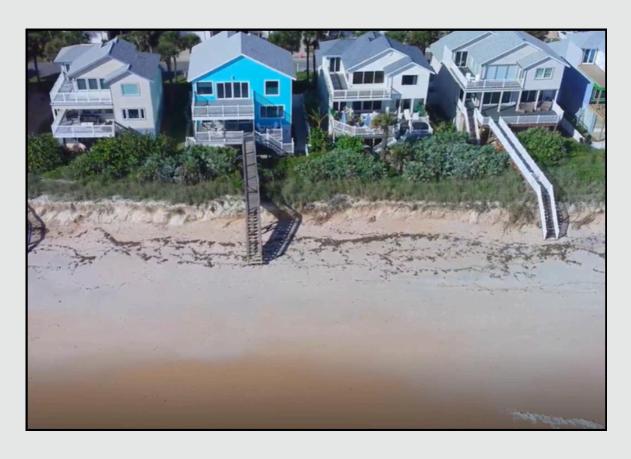
SEA COLONY

Sea Colony has about 10 to 20% of the 2023 dune project remaining.

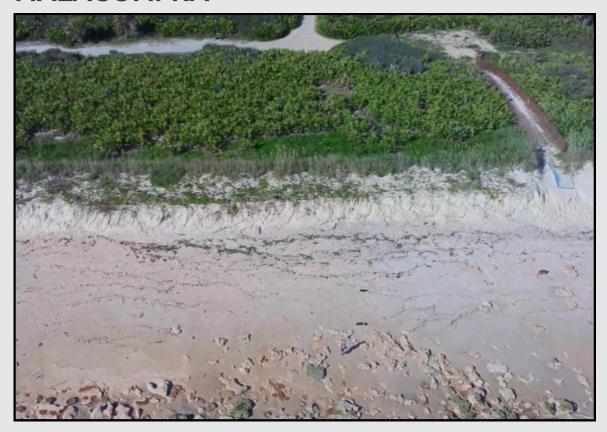
MALACOMPRA

Solee Road and northern MalaCompra have hardbottom outcrops exposed on the beach indicating a decrease in beach elevation. Large scarp evident along dune from 2023 dune restoration project.

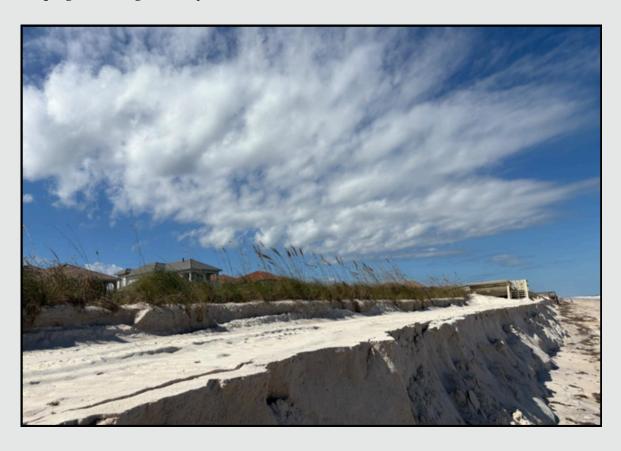
OCEAN HAMMOCK

Ocean Hammock Dune restoration project had about 50% of its sand eroded. Significant dune scarping indicating erosion of dune.

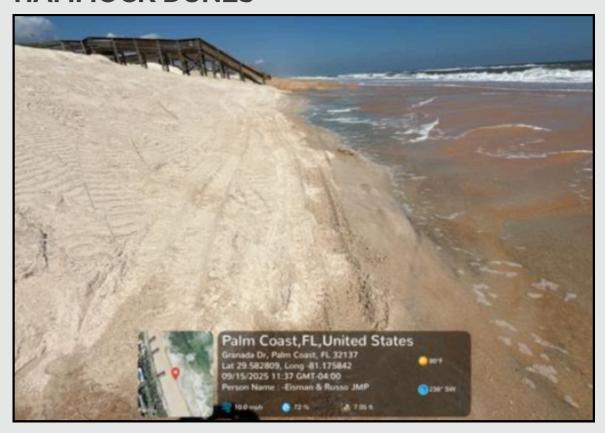
<u>Before:</u> Hammock Dunes south of Jungle Hut at Grand Mer. Scarping along the entire Hammock Dunes area ranged from 6 feet to 12 feet and generally increased from south to north with the most erosion at the northern end of the project.

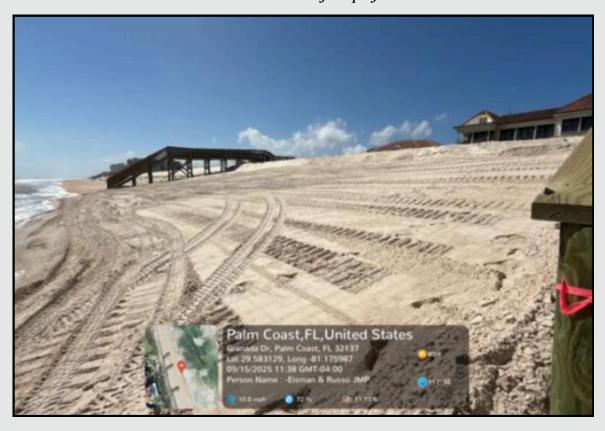
After: An estimated 80-90% of the sand has been eroded along the extreme northern end of the Hammock Dunes project in Grand Mer. Walkovers 2 and 3 were damaged in the nor'easter.

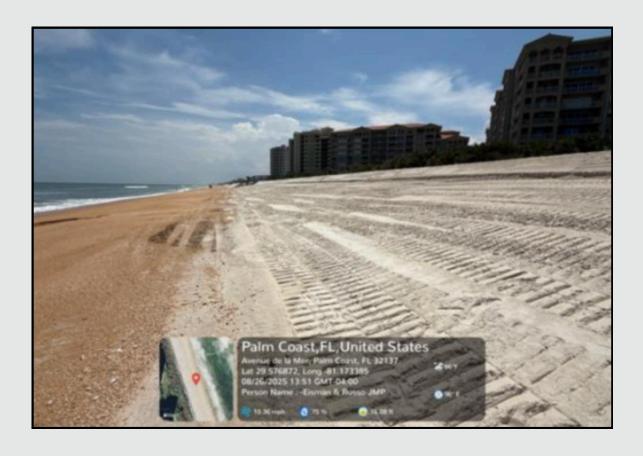
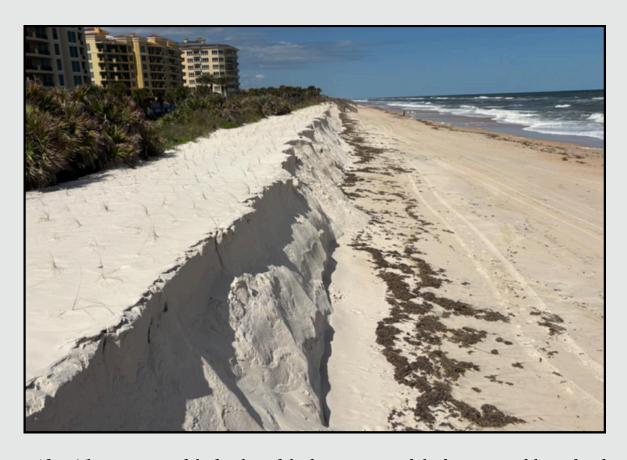
<u>After:</u> The entire area of the foreslope of the dune is gone, and the dune crest width is reduced from 20' to 10-12 feet wide. Approximately 8-foot scarps were observed.

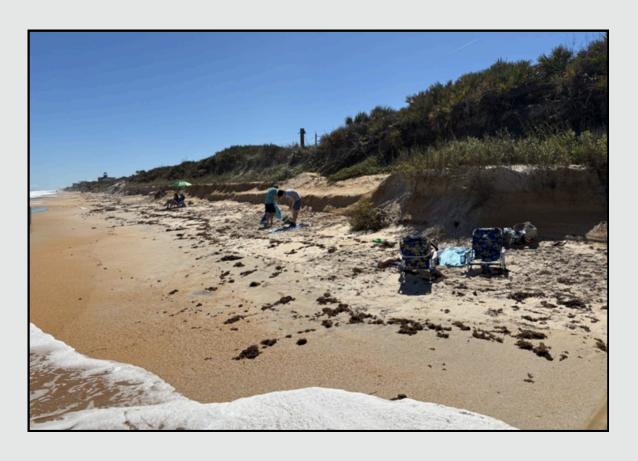
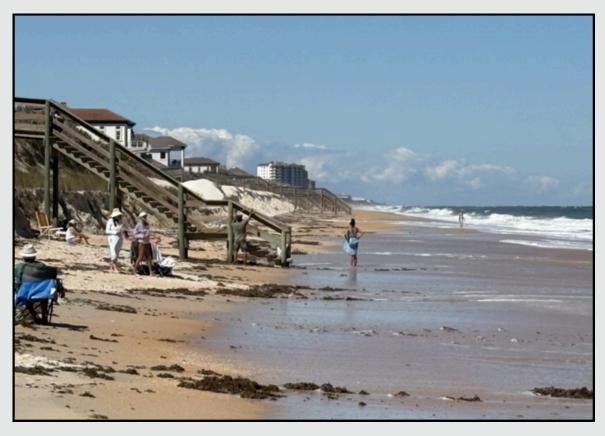
Varn Park and Hammock Dunes dune restoration project showing large scarping and erosion. The beach is deflated and flat providing very little recreational space at mid-tide conditions. Little to no beach at high tide.

Pilings (12+ feet) are exposed and vulnerable to damage in future nor'easters.

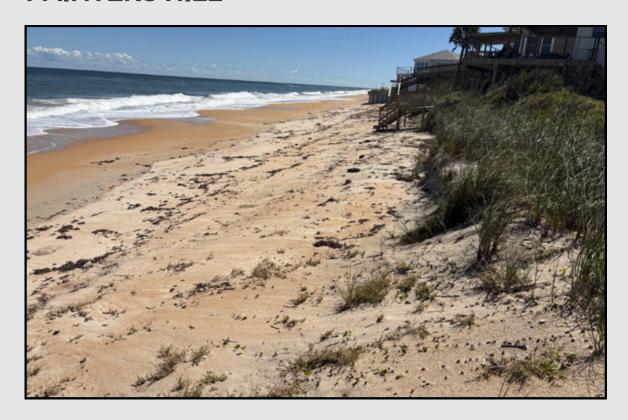
North of "Matthew seawall" looking south shows minimal scarping, a small amount of dune and vegetation from 2023 emergency project still in place.

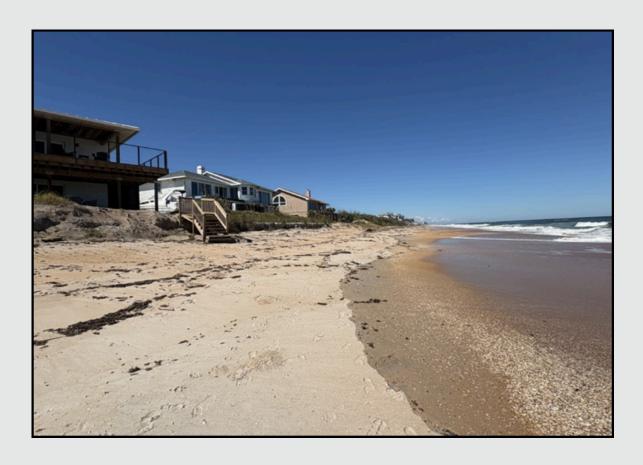
Looking north from "Matthew Seawall" shows north scarping and minimal erosion along the dune and elevated beach.

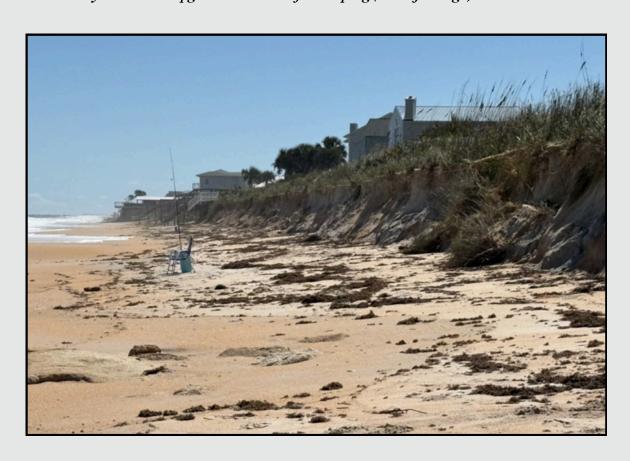
Treasure by the Sea Campground shows major scarping (6 to 8 feet high) and dune erosion.

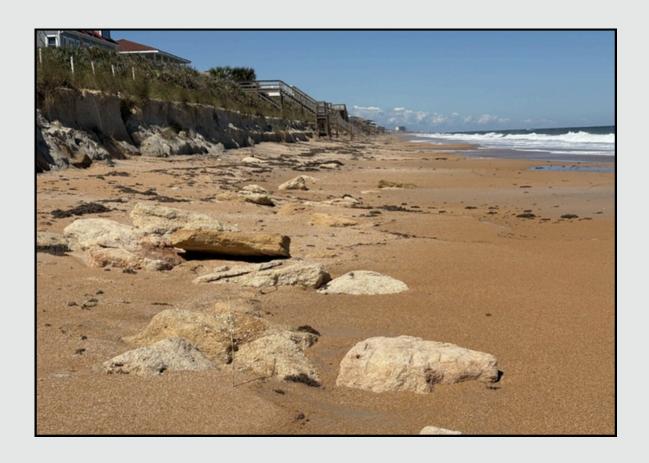
Exposed coquina rock in the lowered beach, looking north.

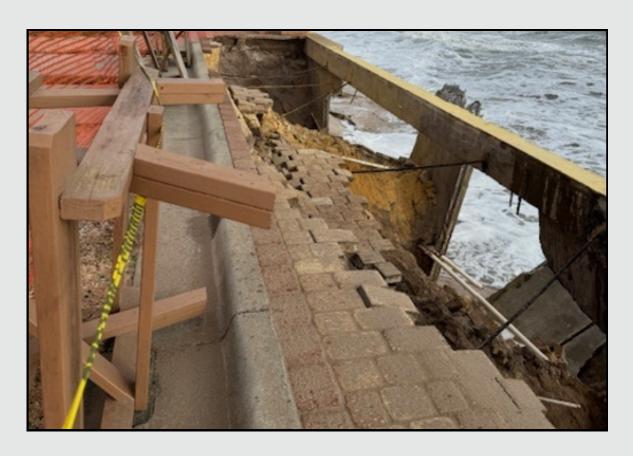
Beverly Beach Campground seawall failure.

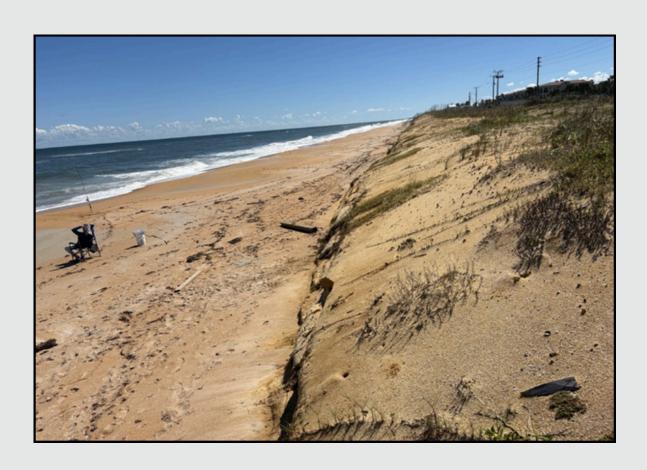
Beginning of secant wall with 2 to 3 foot scarp, looking south.

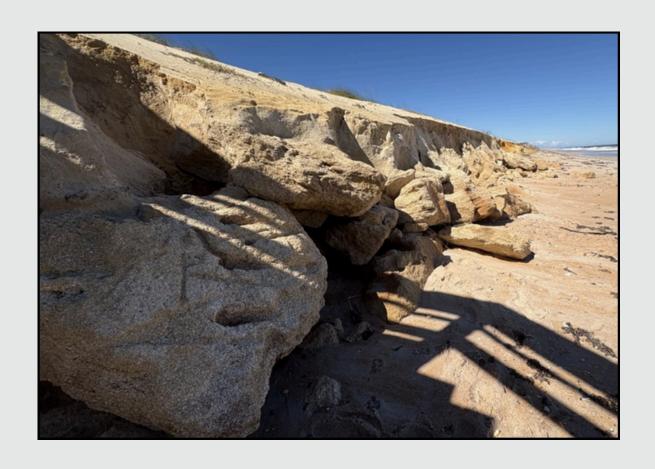
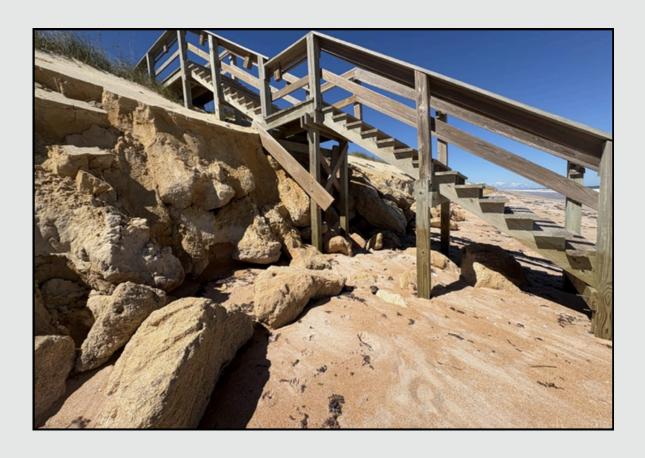
North 20th Street shows major scarping (6 to 8 feet high) with coquina boulders exposed.

Coquina rock with sand, looking north.

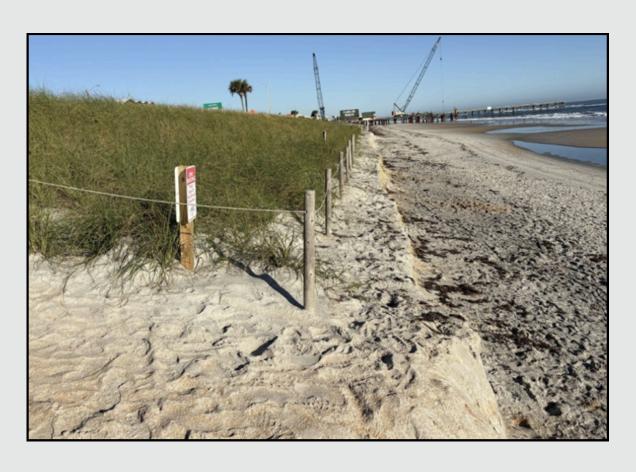
At South 8^{th} Street, the beach has been deflated and observed scarping of dune 2 - 3 feet high.

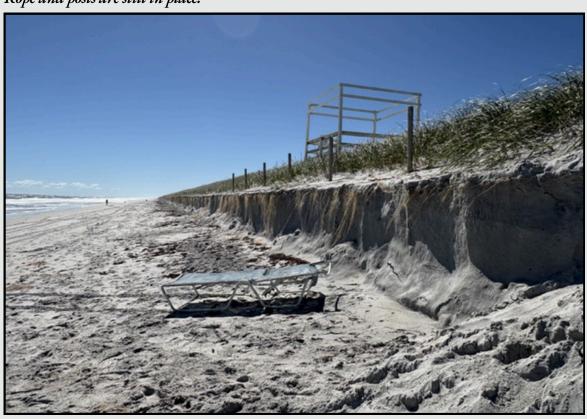
11th Street South across from the Ocean Club has difficult beach access with 4 to 5 foot scarp. Rope and posts are still in place.

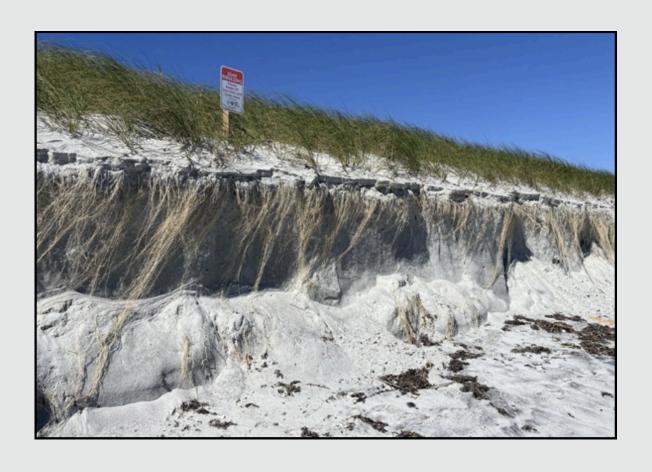
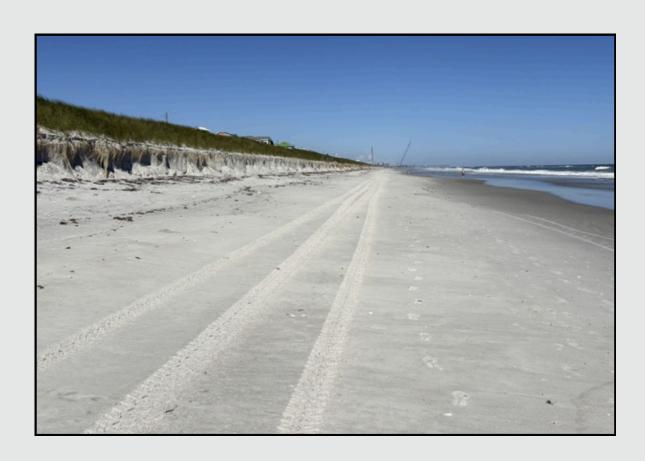
16th Street South access has significant scarping along the project for several blocks in each direction. Scarps are approximately 6 feet tall. Rope and posts are down and stacked at access. Difficulty climbing up access from beach. (Man shown for scale.)

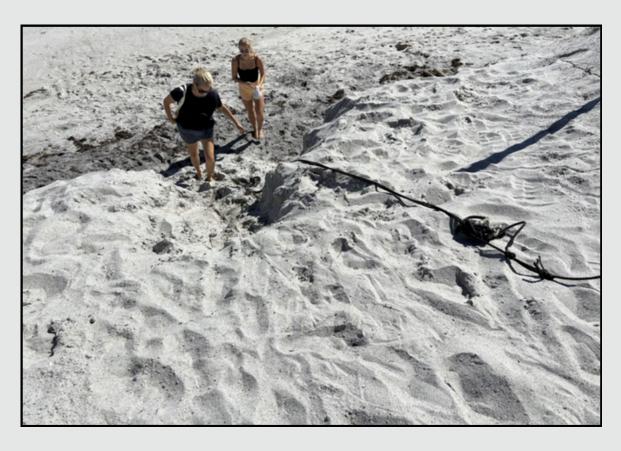
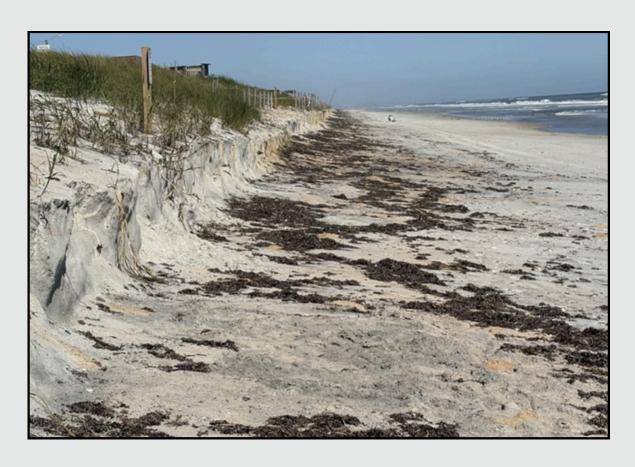
19th St South has significant scarping (4 to 5 feet high). Rope and posts down making beach access difficult.

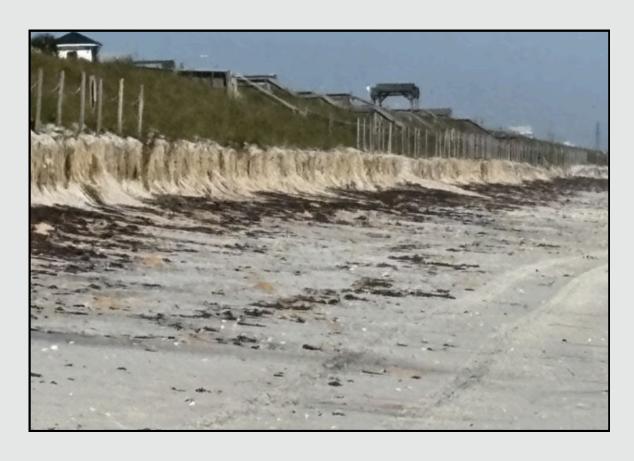
28^{th} Street South has 2 to 3 foot scarping in each direction.

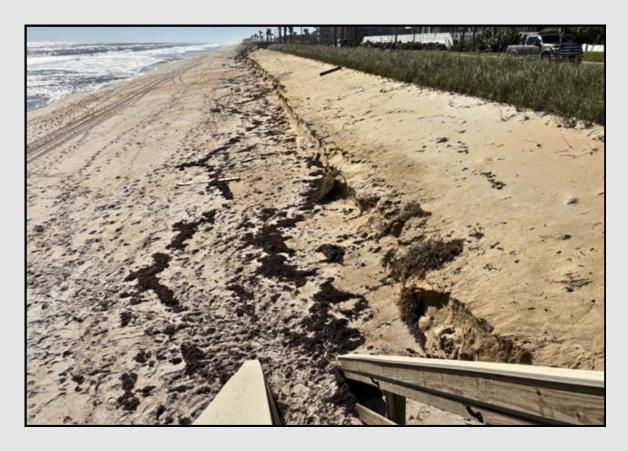
Secant Wall in southern Flagler County has a scarp height varied along the project from minimal scarping to upwards of 4 feet along dune.
