# Indoor Air Quality Investigative Report

**Sheriff's Department Bunnell Florida Investigation**  
ESi Project #: 63367F

Flagler County Sheriff's Department Operations Center  
901 East Moody Blvd.  
Bunnell, FL 32110

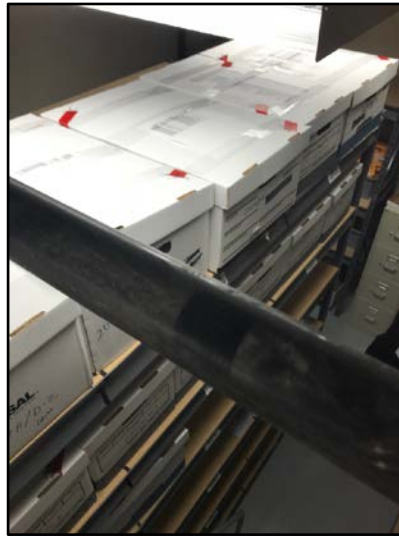
Sample 1. Room 138 Narcotics sample was collected from a sprinkler pipe near the ceiling that has probably not been cleaned for an extended period of time, perhaps since the building was first occupied. Photos in Figure 3 show photos of the location of the pipe and the dust accumulation on the pipe in the location where the sample was taken. The cleaned square on the pipe is the result of sampling and removing the accumulations from the pipe and collecting them on the sampling swab. Historically, these levels of dust in warehouse locations in Florida result in high Category B results. The result was MV 16 which is a Category A. This indicates that this room does not have a mold growth problem. The mold value would essentially pass the post remediation criteria. Nonetheless dust accumulation as heavy as observed on the pipes in the room should be part of a periodic cleaning as this room including the pipes above the shelves are part of the occupant breathing space when people walk in and out and if disturbed could lead to dust irritants being inhaled or coming into contact with skin and eyes. Wiping the hard surfaces with moist cloth or vacuuming would minimize the potential for exposures. This room has HVAC vent that provides conditioned air to it. It has no return back to the HVAC, it has a vent directly to the outside of the building exhausting any potential irritants from this room.

Figure 3. Room 138 Narcotics – dust accumulations on a water sprinkle pipe above the file shelves. Sample 1 location.

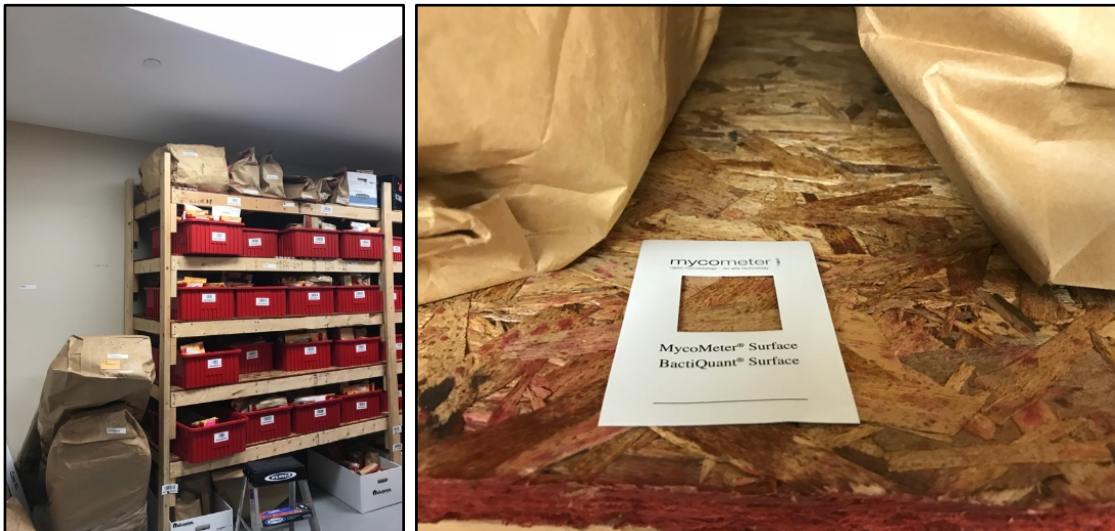
Figure 4. Room 139 bio storage.

Sample 2. Bio storage room top shelf. There were no visible accumulations of dust at this location and the result was MV 16 which is category A. The location is depicted in Figure 4.

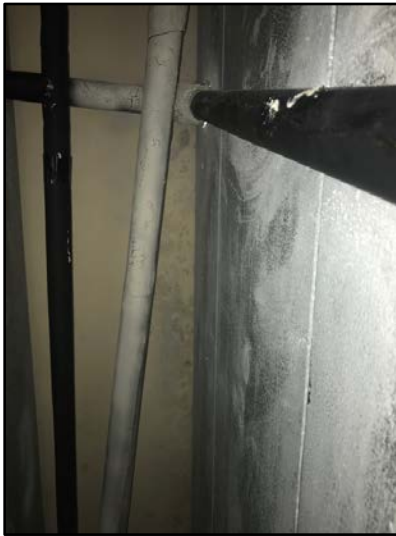
This room also houses the walk-in freezer and refrigerator. There was water on the floor from an apparent condensate leak or condensation issue and the wall behind and between the refrigeration units was damp and had some visible mold. The condition is shown in Figure 5. The test of this area is sample number 5 and returned MV of 399 Category B. This indicates that the mold was desiccated and not mobile and not spreading into the rest of the room. The leak needs to be fixed and the damaged drywall replaced. These activities are likely to generate dust and the area of repair should be isolated from the rest of the room to keep the dust contained.

Figure 5. Room 139 Bio storage; wall behind and between the refrigerator and freezer in need of repair.

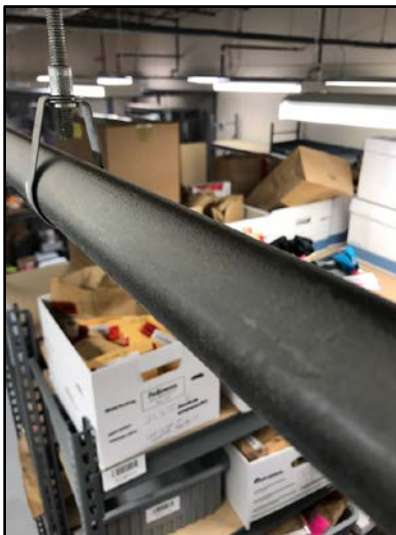
Sample 3 Room 137 evidence room on top of sprinkler pipe. The dust accumulations here were similar to the narcotics room next door. The MV was 47 indicative of accumulated dust but no evidence of Mold contamination. Figure 6 shows the dust on the pipe where the sample was taken from. Housecleaning and relative humidity management in these areas is likely to result in Category A, like in the adjacent rooms 138 and 139.

Figure 6 Dusty sprinkler pipe in evidence room # 137 where sample number 3 was taken.

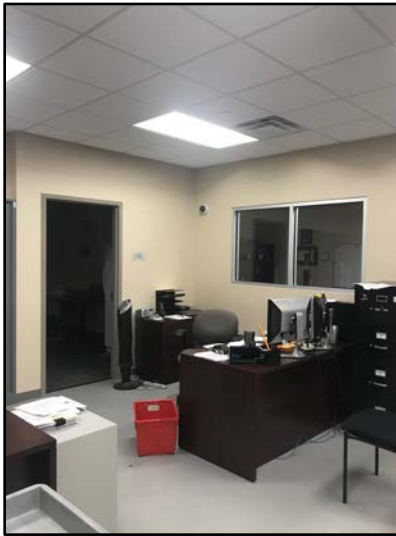
Sample 4 was taken from the top of the security camera in evidence office in room # 134. The MV was 36 – a low Category B indicating that there is not a mold problem in this room. Housekeeping and relative humidity management is likely to result in bringing this area of the building back into Category A. Figure 7 shows the location of the camera in the corner of the room where the dust accumulations were sampled.

Figure 7. Security camera in the corner of the room where the sample was taken.

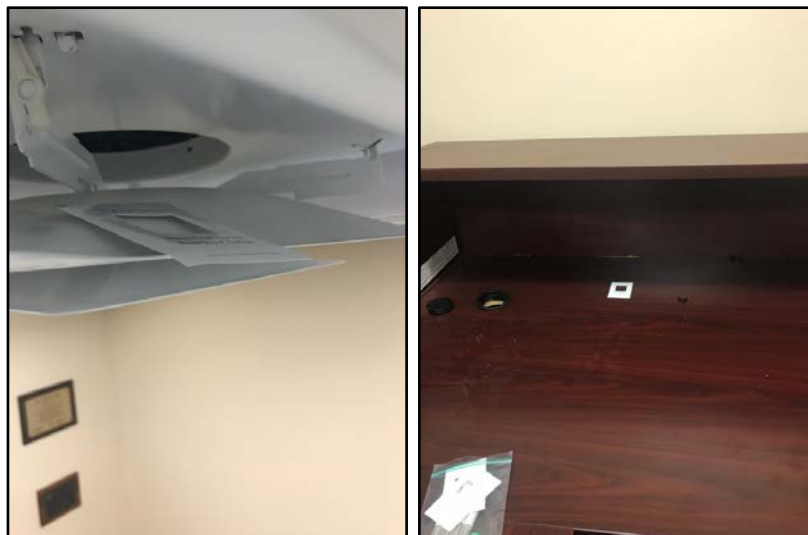
Samples 6 and 7 were taken in room 129A Supervisor's office and the dust accumulated on one of the desks in room 129 respectively. The sample from the supervisor's office was taken from the vent above the desk. Figure 8 shows the sampling locations. Both returned Category A. The MV count from both samples was 14 which is so low that it is considered Below Method Quantification Limit. This indicates that there is not any mold contamination in this part of the building. These rooms reportedly went through a mold remediation. The results indicated that the remedial efforts were successful. This room has not been in use for some time and the desk had significant dust accumulation including white specks that ESi found to originate from the tile used in the drop ceiling grid.

Figure 8. Sampling locations – Vent in room 129A(left) and dust on desktop in room 129(right)

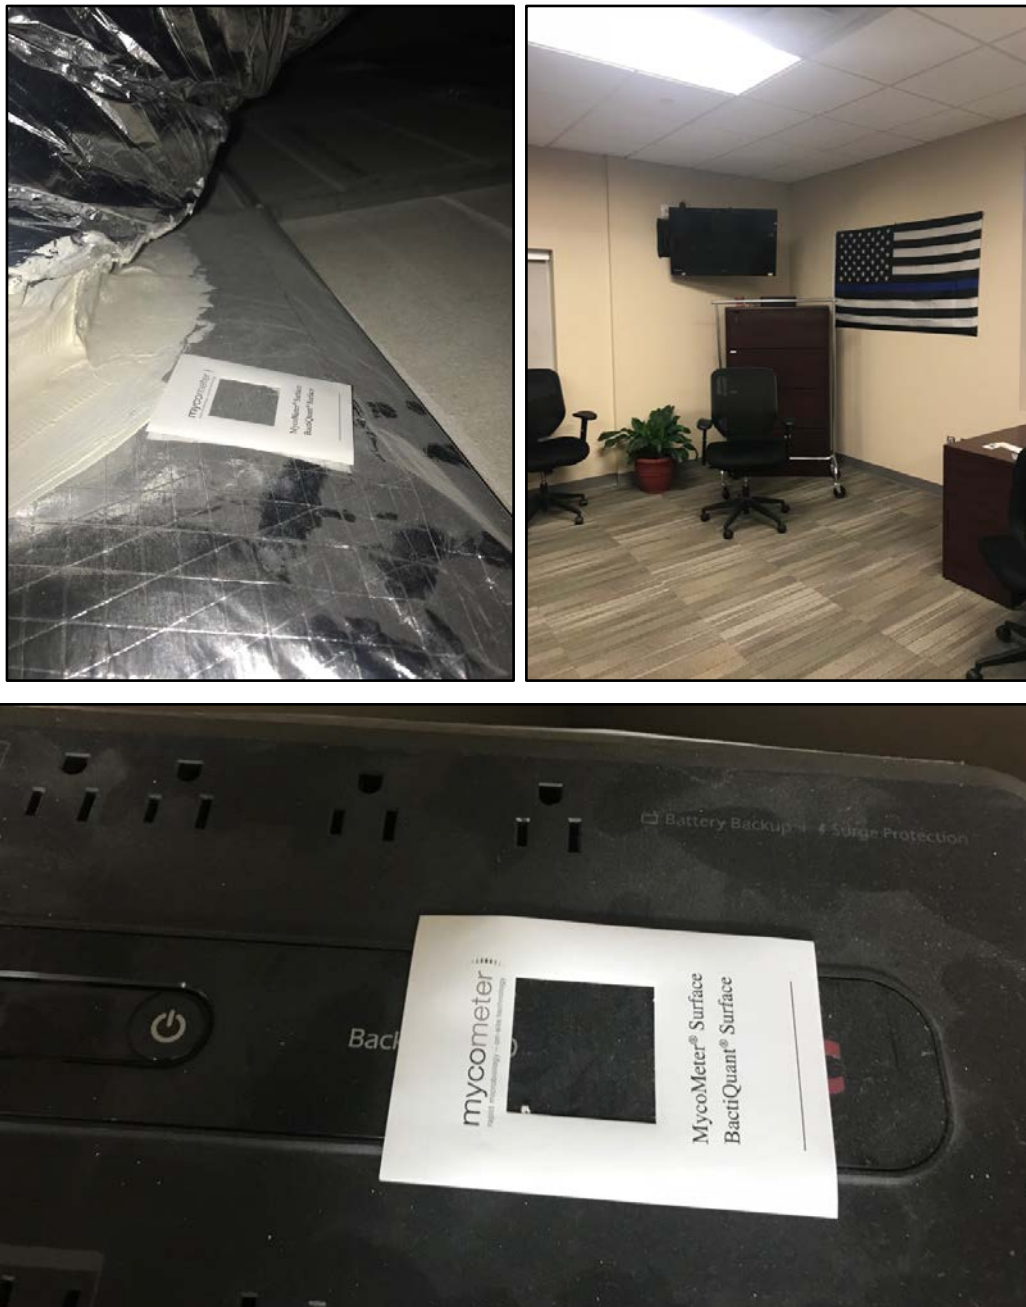
Samples 8 and 9 were collected in Records – room 103. Sample 8 was taken from dust above the drop ceiling grid. Sample 9 was taken from dust accumulation on battery backup/surge protector under the TV. The MV for sample 8 was 3 which is Category A and the mold level is considered below detection limit in

the area above the drop ceiling. The MV for sample 9 dust accumulations was 38 which is a Category B. The level in the room is higher than the area above the ceiling. This indicates that the mold in the room did not originate from the ceiling above but are from other sources. Housekeeping and relative humidity management is likely to result in bringing this area of the building back into Category A. Figure 9 shows the sampling locations.

Figure 9. Sampling location above the ceiling (upper left) and under the TV (upper right); close up of the sample location on battery backup (bottom).

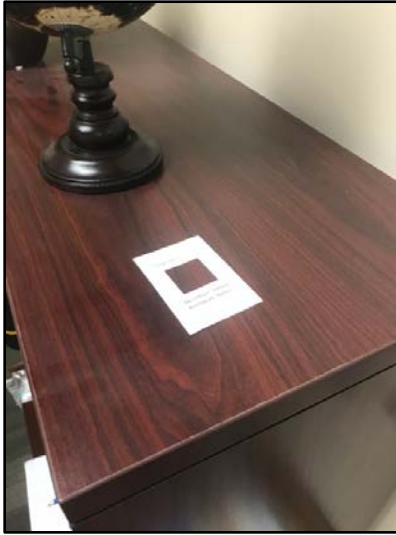
Figure10. Sampling location in room 152

Sample number 10 was collected from room 152 Commanders room. The temperature in the room was set at 69 degrees. The sample was taken from top of the bookshelf. The MV was 37 which is a low Category B. Housekeeping and relative humidity management is likely to result in bringing this area of the building back into Category A. Figure 10 shows the sampling location.

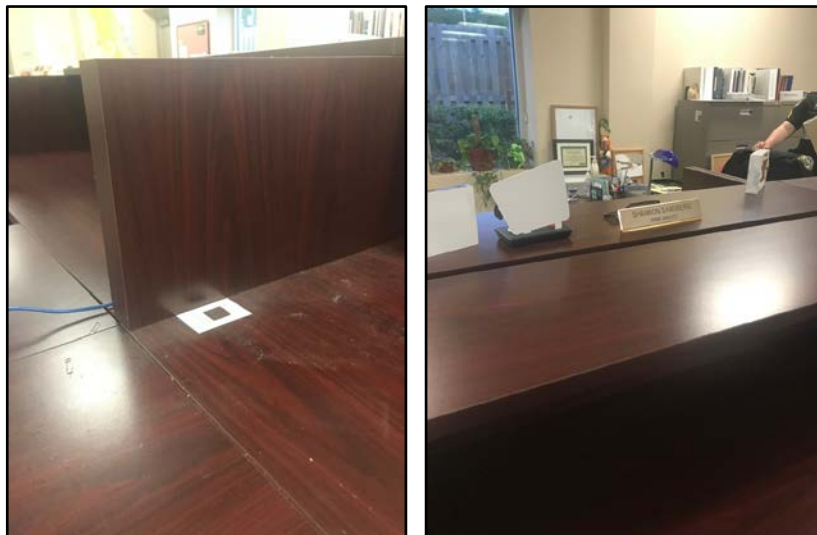
Samples 11 and 12 were taken in the investigations room 111; sample 11 from heavy accumulations on Costello's desk and sample 12 from Sandberg's desk. Figure 11 depicts the sampling locations.

The MV were 70 (Category B) and 11 (Category A) respectively. The results demonstrate the impact of heavy dust accumulations that tend to have more settled mold biomass than the smaller dust accumulations. Housekeeping and relative humidity management is likely to result in bringing this area of the building back into Category A.

Figure 11. Room 111 sampling locations (Costello left, Sandberg right)

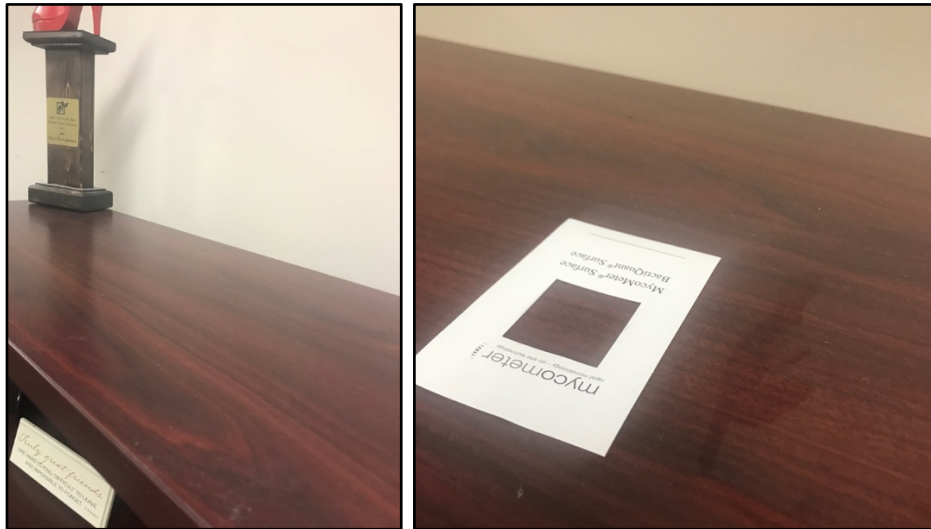
Figure 12. Sampling location in room 118

Sample 13 was taken from top of book shelf in Victim's services room 118. It returned MV 18 (Category A). The results indicate clean conditions with respect to mold. Sample location is depicted in figure 12.

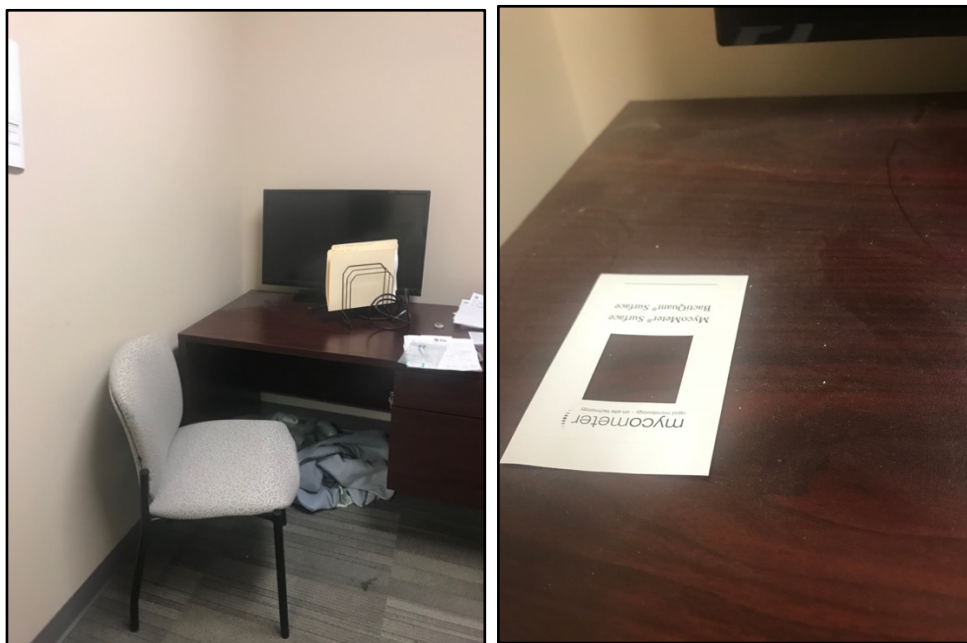
Figure 13. Monitor room # 126

Sample 14 was collected in room 126 Monitor room desk that had heavy dust accumulations on the corner portions of the desk away from the chair and behind the computer screen. The location is depicted in figure 13. The MV value was 45 (Category B). Housekeeping and relative humidity management is likely to result in bringing this area of the building back into Category A.

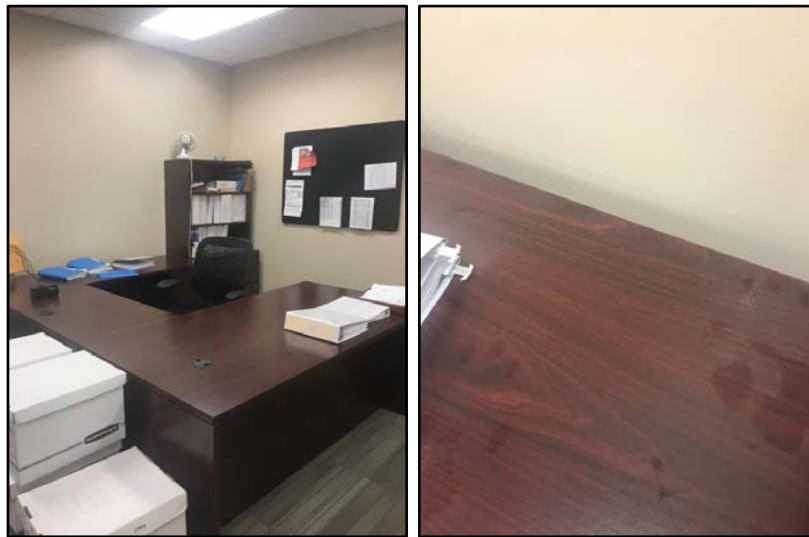
Figure 14. Sampling location from room 157.

Sample 15 was taken from Payroll Accounts payable room 157. The sample was collected in the vicinity of the accountant's desk. The location is depicted in Figure 14. MV value was 22 (Category A). The results indicate clean conditions with respect to mold. The righthand side of the figure has the dust with hand prints. This demonstrates the dermal pathway. Our hand and exposed skin are moist and will collect dust. Although the mold in this sample is low, sensitized individuals could experience adverse reaction to dust that they contact. The dust was most likely result of the recent evacuation but housekeeping during occupancy should minimize the level of dust accumulation that was noted in the building.

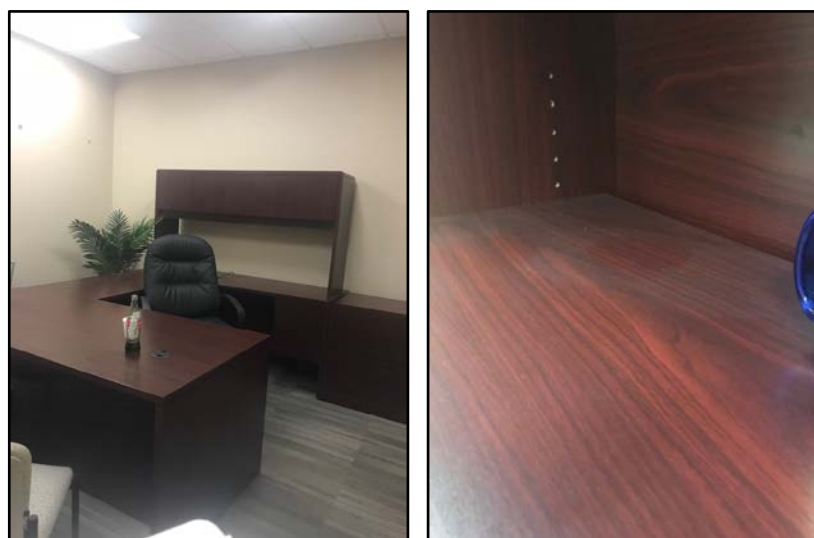
Figure 15 Room 172 sampling location.

Sample 16 was collected from room 172 Chief Paul Bovino bookshelf. MV value was 12 (category A). The results indicate clean conditions with respect to mold. The sampling location is depicted in Figure 15.

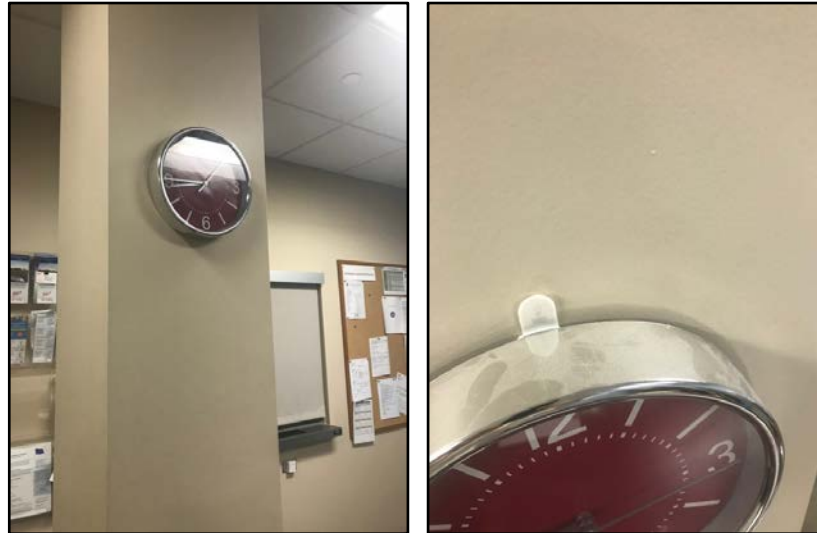
Figure 16. Sampling location in room 105 A

Sample 17 was collected from HR room 105A from the top of the clock. The MV was 59 which is a Category B. Housekeeping and relative humidity management is likely to result in bringing this area of the building back into Category A. Figure 16 shows the sampling location.

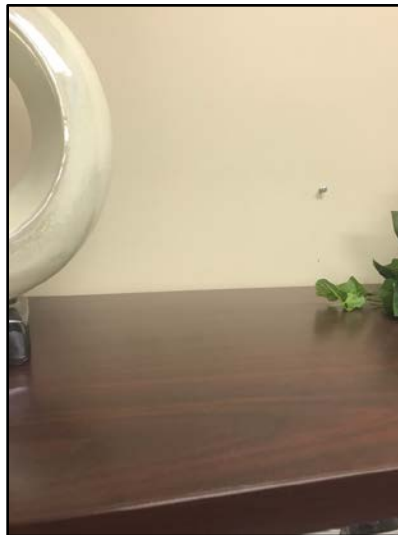
Figure 17. Sampling location in room 106

Sample 18 was collected from HR director room 106 top of the bookshelf. MV value was 16 (Category A). The results indicate clean conditions with respect to mold. The sampling location is depicted in figure 17.

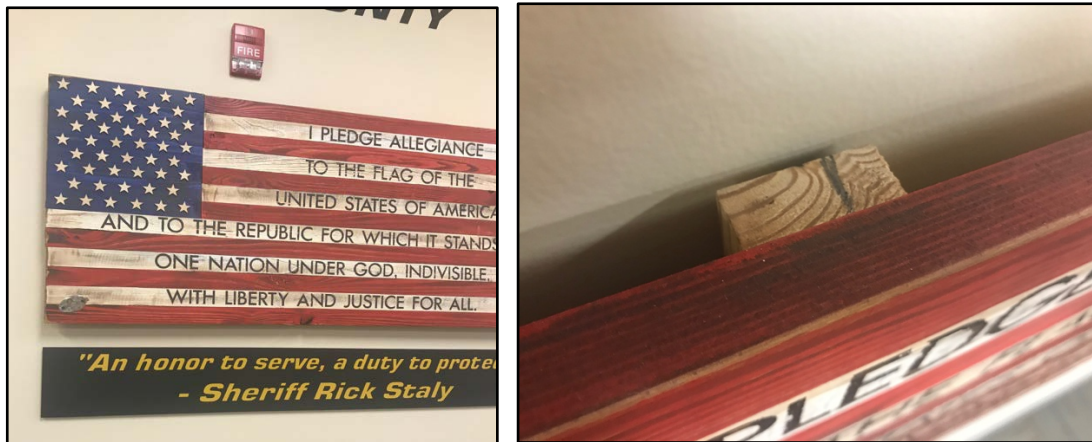
Figure 18. Sampling location in room # 146.

Sample 19 was collected from Muster/Training room # 146 from the top of the wooden flag. The MV was 61 which is a Category B. The sampling location was not particularly dusty, but the porous wood can provide mold food if excursions in relative humidity are above 60% and remain that way for sufficient length of time. This result indicates that the wood reached sufficient humidity to start to accumulate

above normal mold biomass. Housekeeping and relative humidity management is likely to result in bringing this area of the building back into Category A. Figure 18 shows the sampling location.

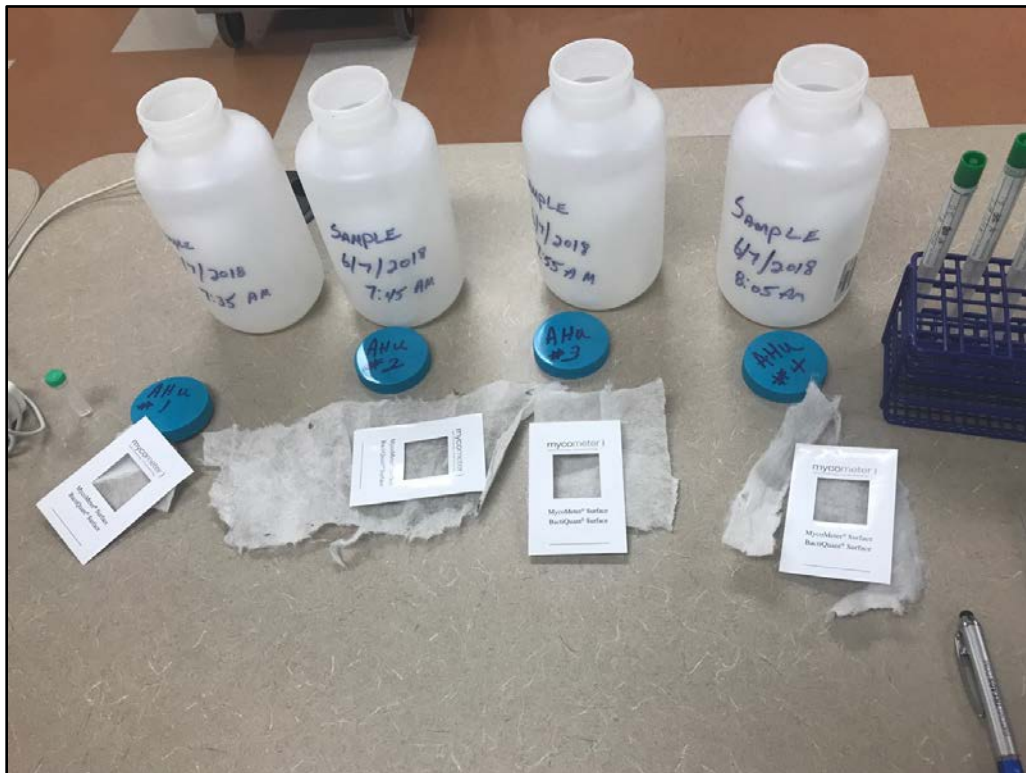
Figure 20. Air handler unit filter sampling.

In addition to sampling dusty areas of the rooms ESi requested that the air filters for all four air handlers be preserved. The air filter tests are important part of the investigation because all of the air that the employees are exposed to passes through these filters and the particulate matter that is left behind includes mold biomass. Figure 19 indicates which air handler is associated with which part of the building. The amount of the particulate matter and mold is representative of longer term exposure scenario (since the last time the filters were replaced). The filters that were in units AHU 1 through AHU 4 were installed on 5/17/18 and were removed 6/7/18. They collected airborne mold and particulate matter for 20 days. The results from AHU 1 was MV 182; AHU 2 was MV 12; AHU 3 was MV 57 and AHU 4 was 32. Figure 20 shows the sections of HVAC filter material that were sampled. The sample results from the HVAC return filters represent values of mold that have been airborne and flowed through air returns and represent the amount of mold in the air generally under the airflow and room exchange rates for those respective air handlers. The MV 182 sample result in AHU 1 relative to the results of the other 3 AHU being either A or very low Category B is elevated. The filter from AHU 1 also appeared to have more dust on it when compared to the others. This could either be poor humidity control in the area served by AHU 1 including outside ventilation from opening doors, or increased personnel activity stirring up more dust in that part of the building served by AHU 1. AHU 1 also has the largest fresh make-up air duct of the 4 AHUs. The fresh make-up air also passes through the filters. Although the MV is elevated when compared to the other AHUs it is well below category C and not indicative of mold growth issues and potential health threat. ESi requested Mechanical engineering assessment of the HVAC system. ESi noted that during the investigation the fresh make up air does not appear to be conditioned, treated or separately filtered and is upstream of the AHU filter location. ESi requested that the fresh make-up air be included in the mechanical engineering review as it could contribute to humidity variations and may provide a pathway for outdoor mold, dust and debris to be deposited on the individual filters.

Since the filter is located at the air handling unit, after the building returns and introduction of fresh make-up air, the tests are also useful in if there is mold growing in the return duct system in sufficient quantity to be airborne. When that happens the MV from the air filters typically range from MV 450 to several thousands. The results indicate that there is not a water, moisture or mold growth in return ducts.

Housekeeping and relative humidity management based on the results of the HVAC system engineering review is likely to result in reducing mold levels on the air return filters into category A.
