## **LOGAN DIVING & SALVAGE**

### **FLAGLER BEACH PIER POST INCIDENT SAFETY INSPECTION HURRICANE IRMA SEPTEMBER 15 - 17, 2017**

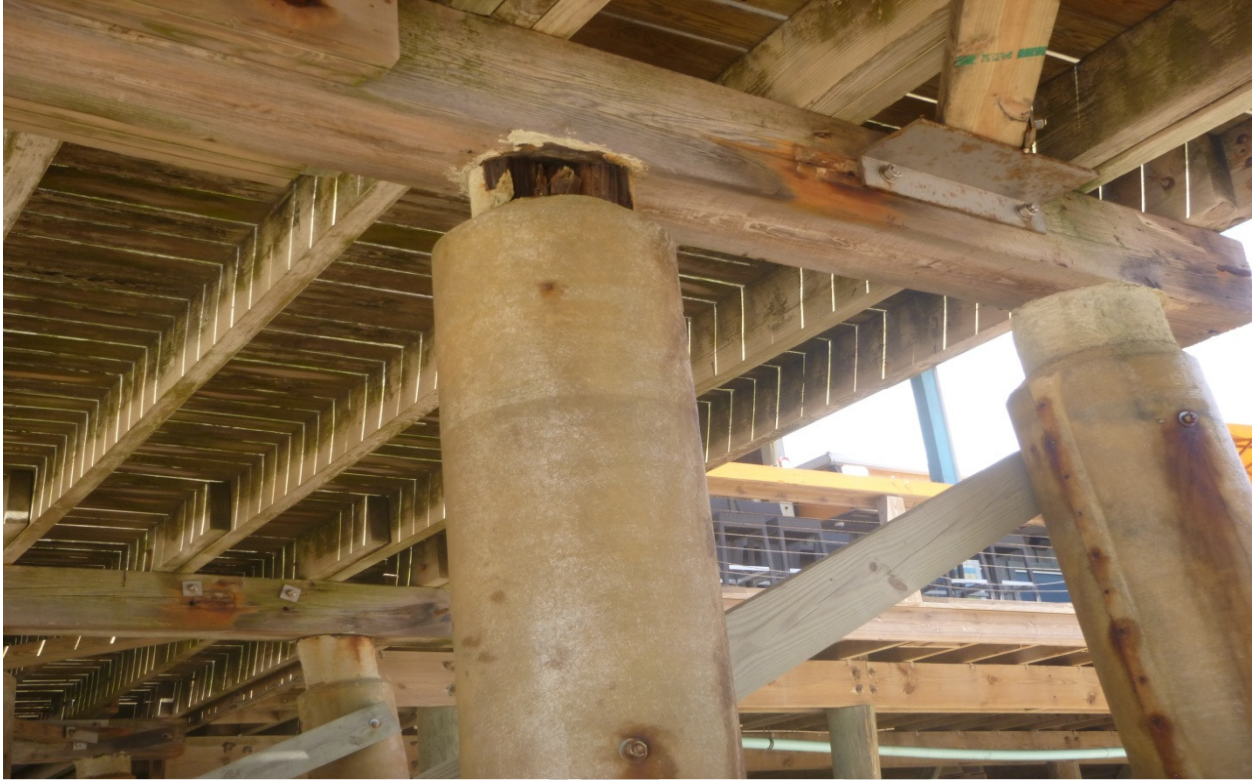
BENT 47 PILE D

EAST FACE VERTICAL DIAGONAL MISSING HARDWARE ON PILE D  
CAP IS 50% WASTED

- 1) REMOVE AND REPLACE ALL MISSING, FAILED, LOOSE, CRACKED CROSS BRACING.
- 2) REPAIR ALL SUSPENDED EPOXY PILE JACKET REPAIRS BY INSTALLING PILE JACKET EXTENSIONS FROM THE LOWER SUSPENDED ELEVATION INTO THE EXISTING GROUND LINE - 3'.
- 3) JACK, SHIM, AND LEVEL ALL LOOSE PILES THAT ARE NOT TOUCHING PILE CAPS AND CARRYING DECK LOAD.
- 4) REPLACE ALL FAILED OR MISSING HURRICANE STRAPS AND HARDWARE.
- 5) APPLY 2-PART EPOXY IN ALL UPPER ELEVATION PILE JACKETS GAPS. INJECT OR FORCE EPOXY INTO THE ANNULAR SPACE FOR PERMANENT REPAIR.
- 6) INSTALL 3/4" GALVANIZED THROUGH BOLTS WITH 3/4" GALVANIZED OGEE WASHERS ON THE ENDS OF ALL STRINGERS INTO THE CORRESPONDING STRINGER ENDS TO BETTER TIE THEM TOGETHER AT EACH BENT.

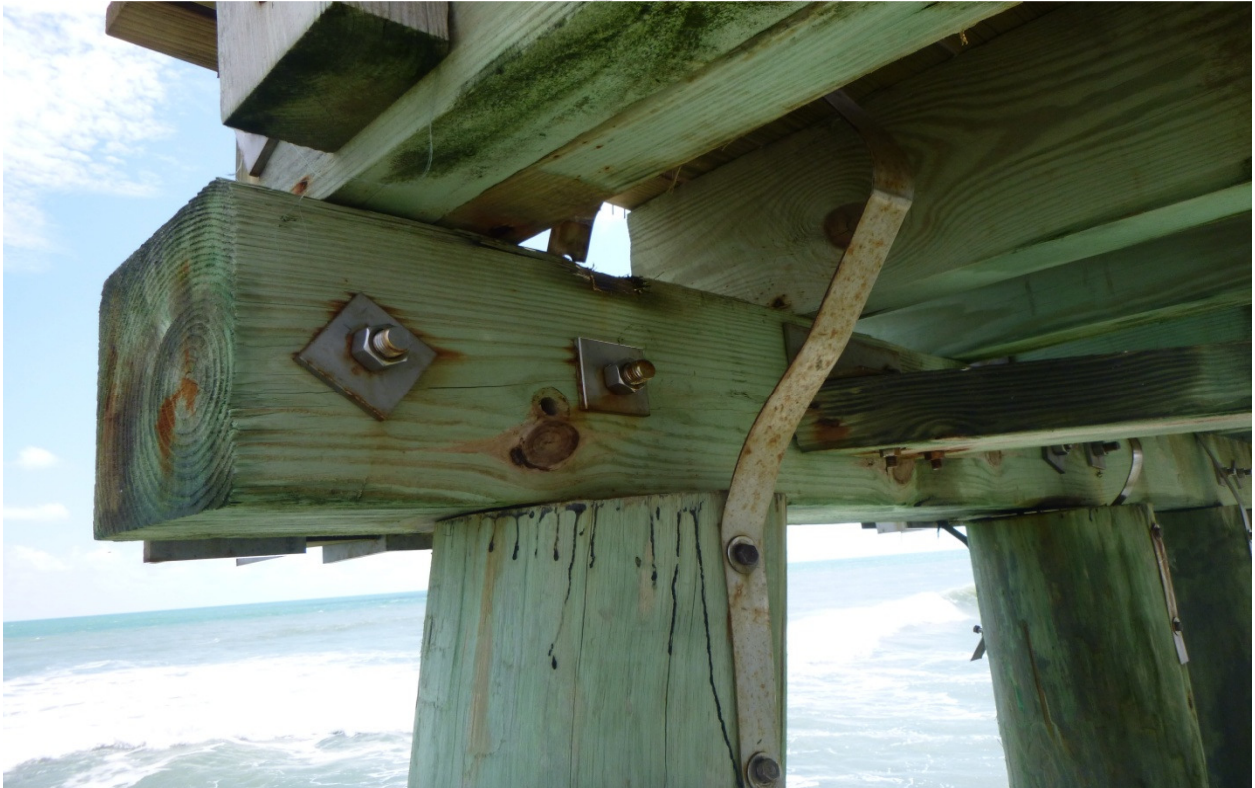
BENT 13 PILE

PILE C IS MOVING AND DOES NOT TOUCH CAP  
PILE E 90% PILE DOES NOT TOUCH CAP  
PILE B, G AND H 50% OF PILE DOES NOT TOUCH CAP  
SS STRAP ON PILE BAND C IS BROKEN  
PILE H HAS SUSPENDED JACKET

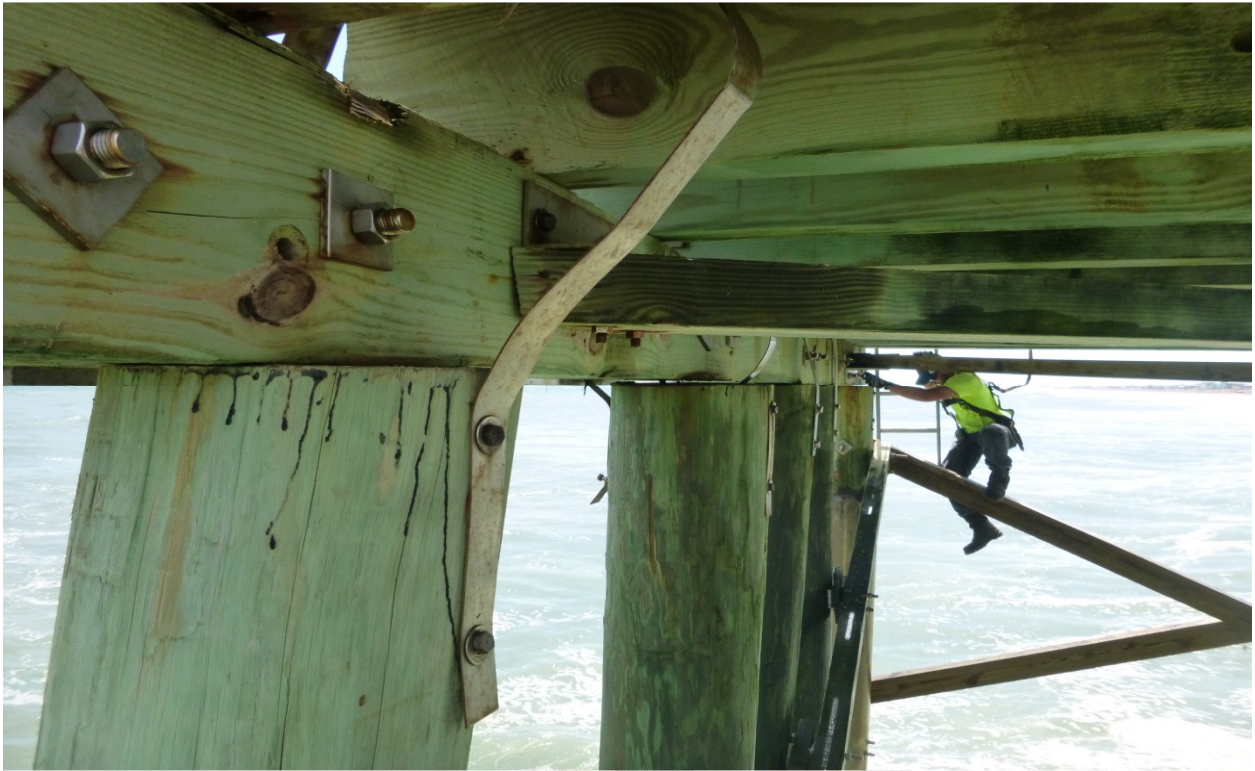
BENT 13 PILE C

ONE PILE WAS MOVING FREELY AT THE TOP (BENT 13 PILE C). A SECOND PILE WAS FOUND TO BE MOVING SLIGHTLY IN HEAVY SEAS (BENT 15 PILE D) (SEE ATTACHED PILE INSPECTION SHEETS).

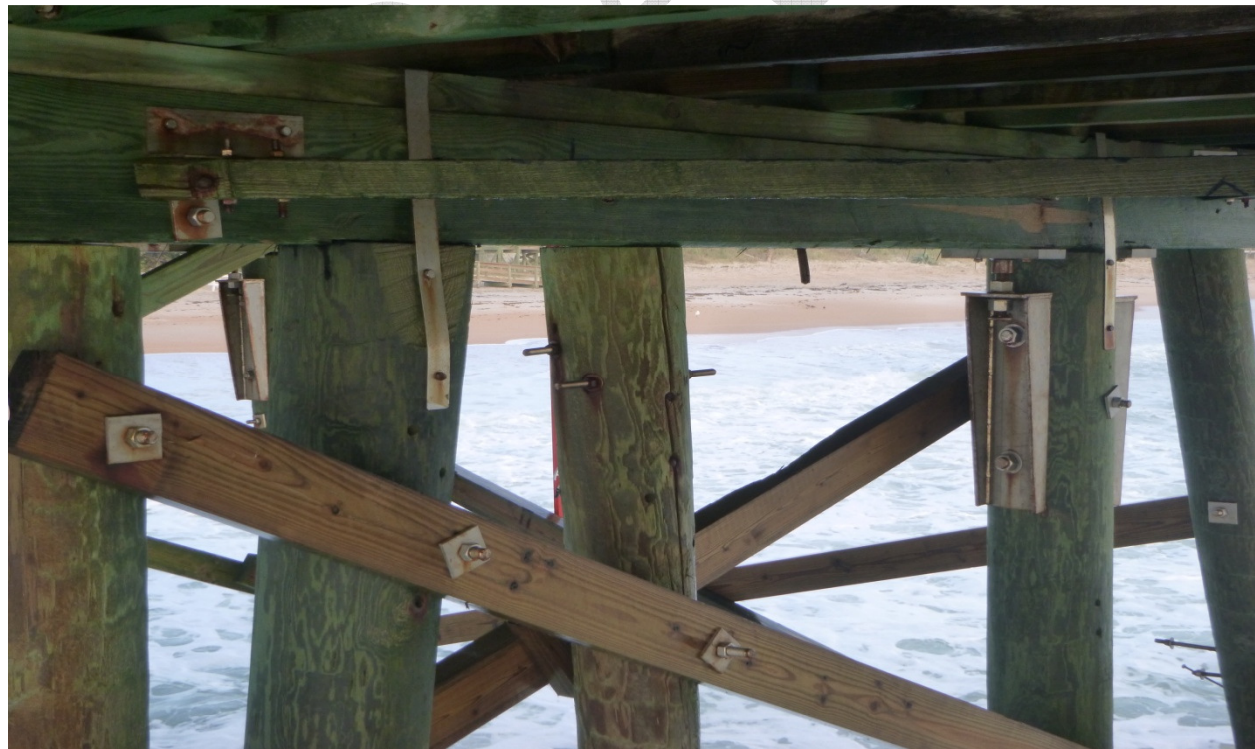
BENT 37 PILE E

PILE E 90% OF PILE NOT TOUCHING THE CAP  
PILE E IS 70% WASTED (TOP OF PILE SPLIT)  
PILE G 90% OF PILE NOT TOUCHING THE CAP

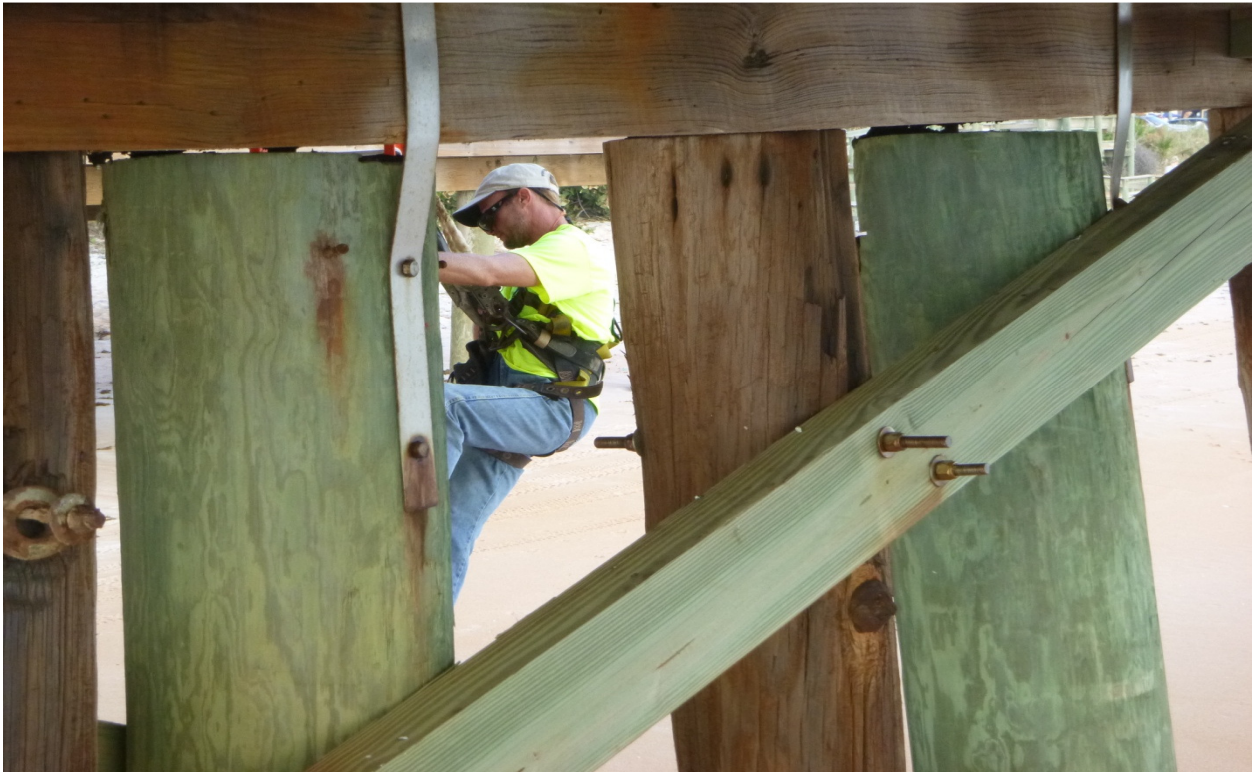
BENT 45 PILE C AND E

PILE C 100% OF PILE IS NOT TOUCHING THE CAP  
PILE C SS STRAP HAS NO HARDWARE  
PILE E 100% OF PILE IS NOT TOUCHING THE CAP  
PILES D AND B ARE 50% DETERIORATED  
PILE F IS 80% DETERIORATED  
HORIZONTAL X BRACE HARDWARE 60% WASTED  
CAP IS 50% WASTED

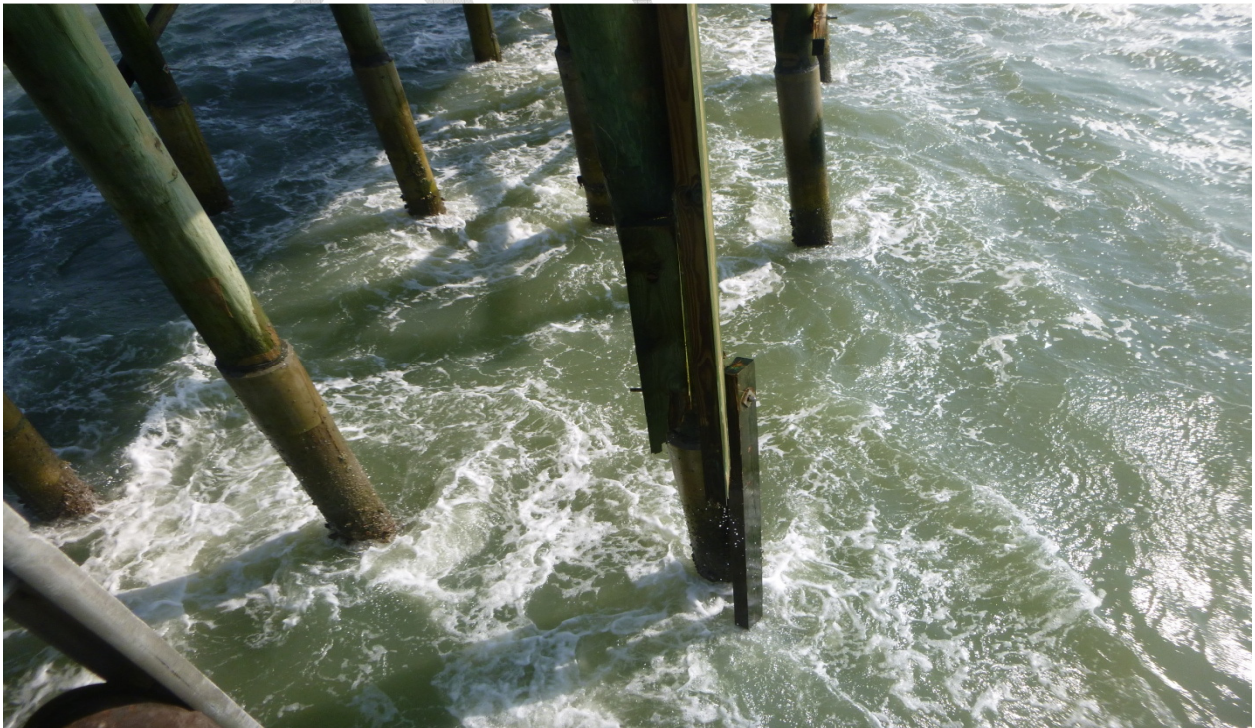
PILE F AND H 50% OF PILE DOES NOT TOUCH THE CAP  
THE WEST FACE VERTICAL DIAGONAL X BRACE BROKEN  
PILES B, D, F AND H HAVE SUSPENDED JACKETS

THE SOUTH FACE VERTICAL DIAGONAL X BRACE BROKEN  
PILES B, D, F AND H HAVE SUSPENDED JACKETS

BENT 17 TO 18 FAILED CROSS BRACING
