Evaluation of respiratory and other health concerns at a law enforcement office building with indoor environmental quality issues

HHE Report No. 2018-0157-3369

February 2020

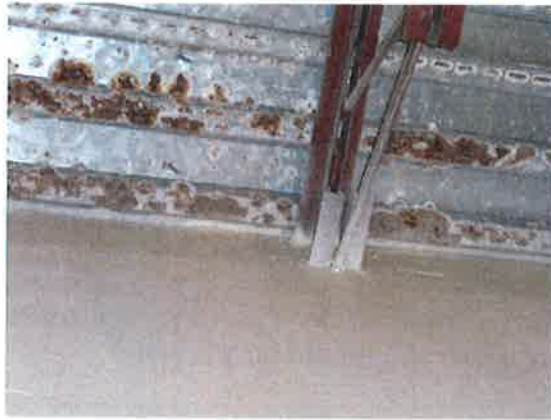
- We observed rust on the metal roof in the evidence room and room 129 (Figures 1 and 2).

Figure 1. Rust on ceiling in the evidence room. Photo by NIOSH.

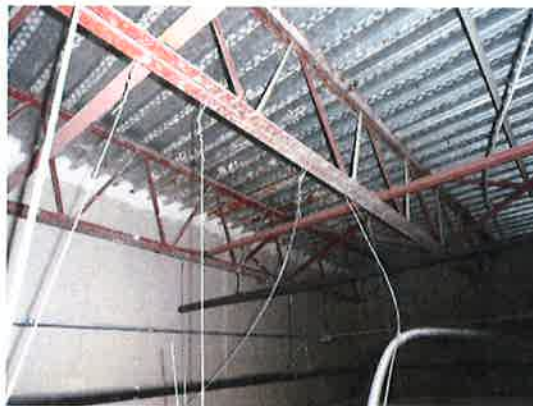
Figure 2. Rust on metal roof above the ceiling tiles in room 129. Photo by NIOSH.

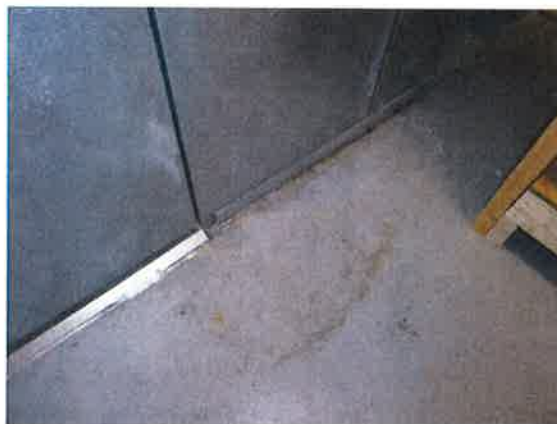
- We observed visible water damage/stains in front of the refrigerator and between the walk-in freezer and refrigerator in the evidence area (Figures 3 and 4).

Figure 3. Visible water damage/stains in front of the walk-in refrigerator in evidence area. Photo by NIOSH.

- Hidden moisture, mold, and bat droppings were found in wall cavities.
 - Mold was observed on the backside of drywall in a wall between the evidence refrigerator and freezer. Tape lift samples confirmed mold. Condensation on the coolant piping was causing mold growth on the drywall.

- Ensure dehumidifiers used to dry the evidence are cleaned and maintained regularly according to the manufacturer's recommendations.
 - Continue to work towards eliminating any condensation issues related to the walk-in refrigerator and freezer in the evidence room.

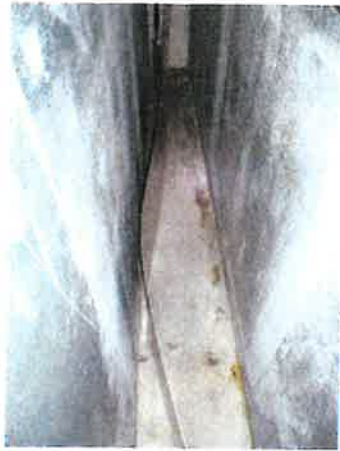
Figure 4. Visible water damage/stains between the walk-in freezer and refrigerator in the evidence area. Photo by NIOSH.

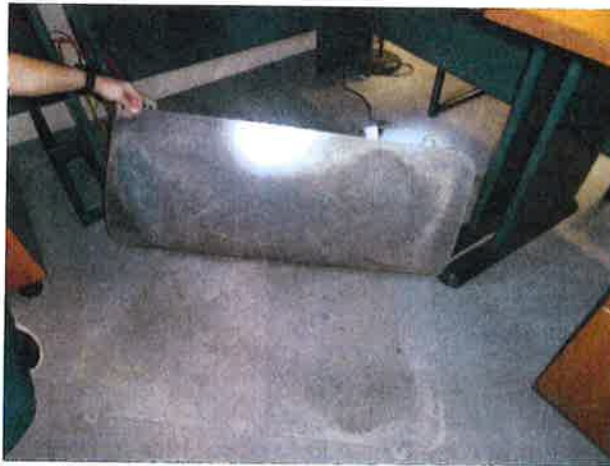
- We observed visible stains and a mold odor under a plastic mat on concrete floor (Figure 5).

Figure 5. Visible stains and mold odor under plastic mat on concrete floor in the evidence room. Photo by NIOSH.

- Visible mold was observed below a vinyl floor tile in the southeast common hallway.
 - A musty odor and visible mold were observed below a plastic floor mat on concrete in the Evidence Reception Room 134.

- The consultants noted that carpet tiles and adhesive created a vapor barrier at the top of the slab resulting in condensation and mold growth on the backside of the carpet tiles. They noted a similar issue was occurring on the backside of the vinyl flooring in the corridor and under plastic mats on concrete in the Evidence Reception Room.

- Remove mold and moisture-damaged flooring and any other damaged materials such as plastic floor mats and vinyl wall base.
- Remediate the mold on the concrete slab and old wood framing in the wall cavities according to the guidance below.

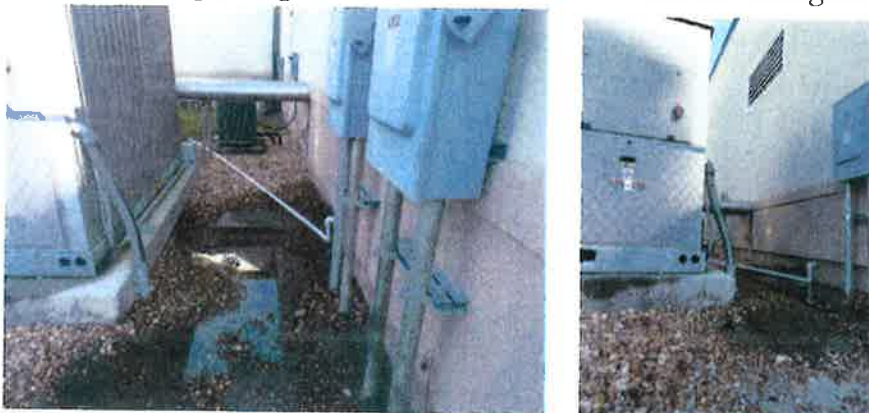
- We observed water pooling under the fresh air intake near the emergency generator (Figure 6).

Figure 6. Water pooling under fresh air intake near the emergency generator. Photos by NIOSH.

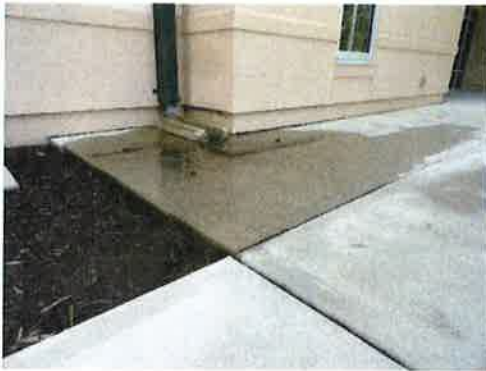
- We observed runoff from the roof accumulating at the foundation of the building allowing for potential water infiltration into the building. Water was pooling in mulch and against the building from some down spouts (Figures 7 and 8).

Figure 7. Water pooling in mulch and against building from downspout at front of building. Photo by NIOSH.

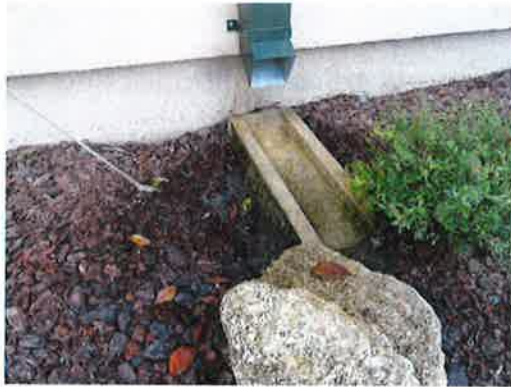
Figure 8. Water pooling in mulch and against building near outdoor patio space. Photo by NIOSH.

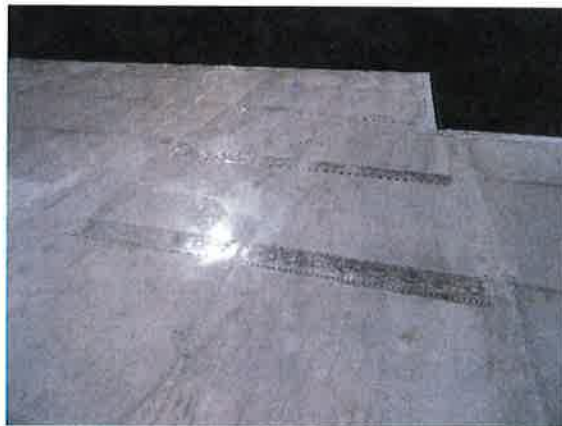
- We observed patches on the roof, indicating a possible mechanism for past water intrusion (Figure 9).

Figure 9. Patching on roof. Photo by NIOSH.

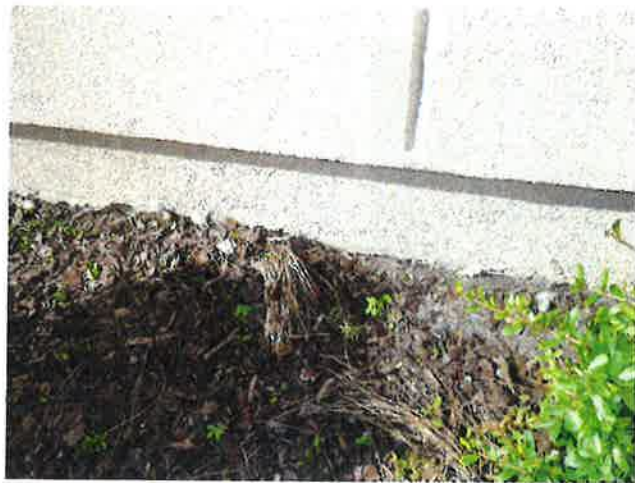
- We observed areas of exposed cement block at the base of the exterior wall, allowing for potential water infiltration into the building. (Figure 10).

Figure 10. Exposed cement block near the base of exterior wall. Photo by NIOSH.
