# Palm Coast Fire Station 22

Evaluation of Existing Fire Station 22

**SCHENKELSHULTZ**  
□ □ □ ARCHITECTURE □ □ □

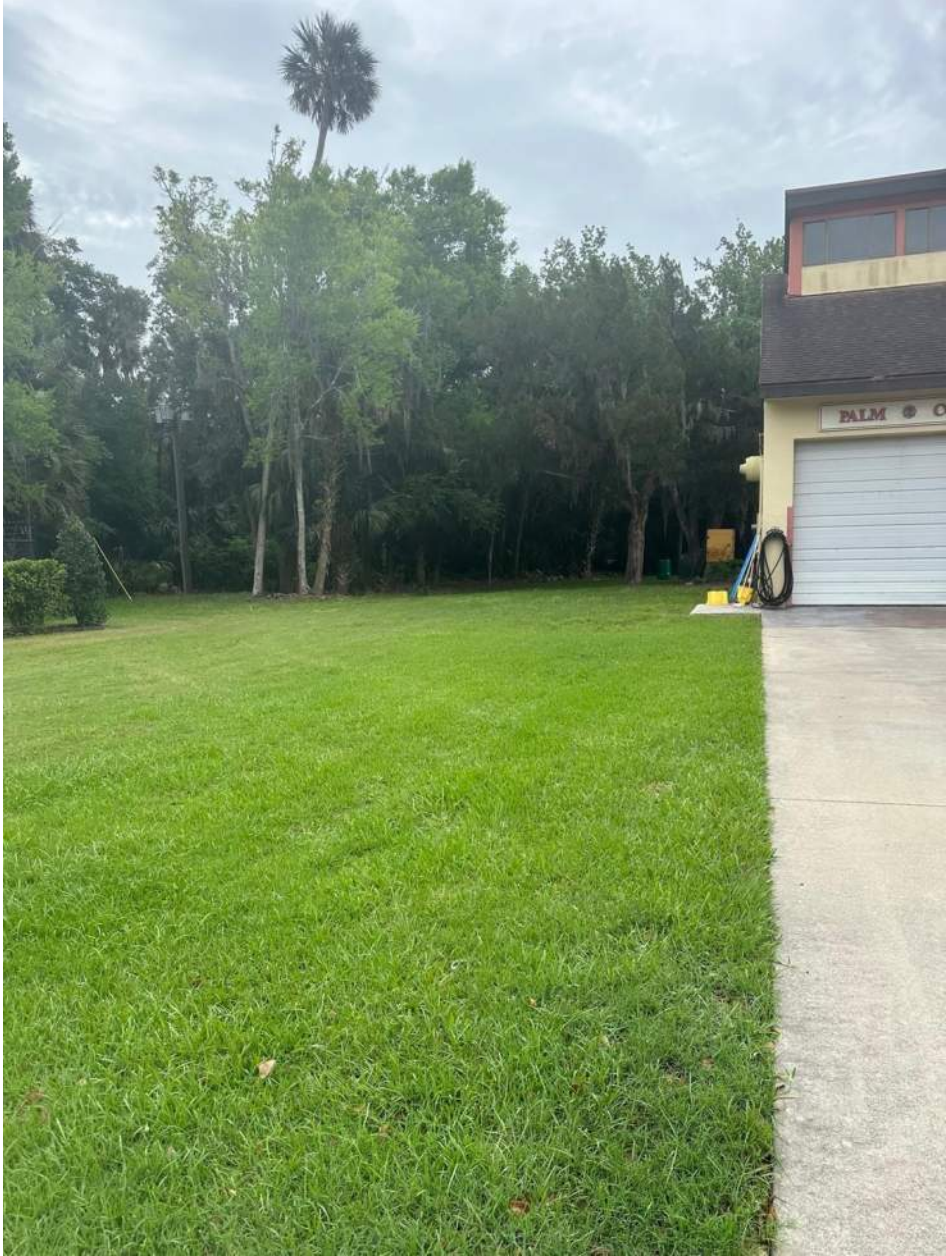
*East side of property undeveloped land*

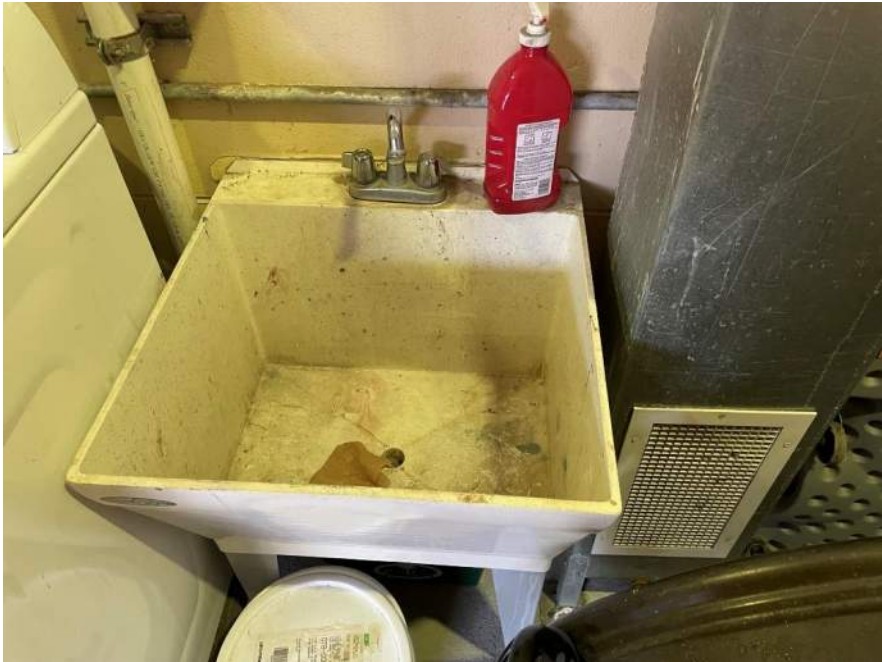
The Laundry tub (service sink) is in poor condition with rust and stain. The tub seems to have passed its useful life.

IMG\_4304: Laundry Tub (Service sink) rusted and stained.

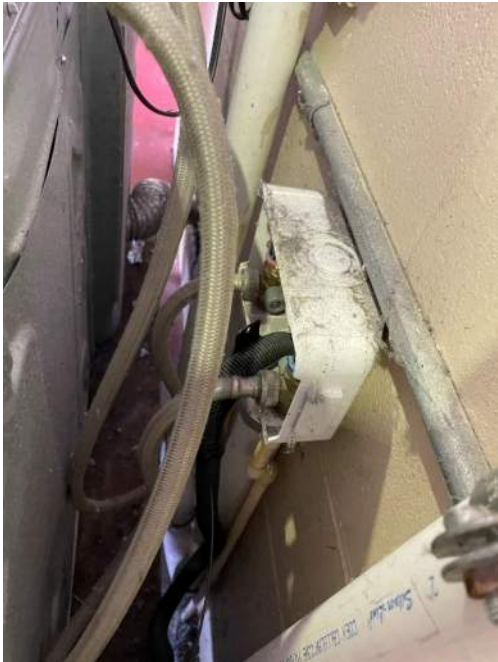
IMG\_4460: Wash Box is in poor condition

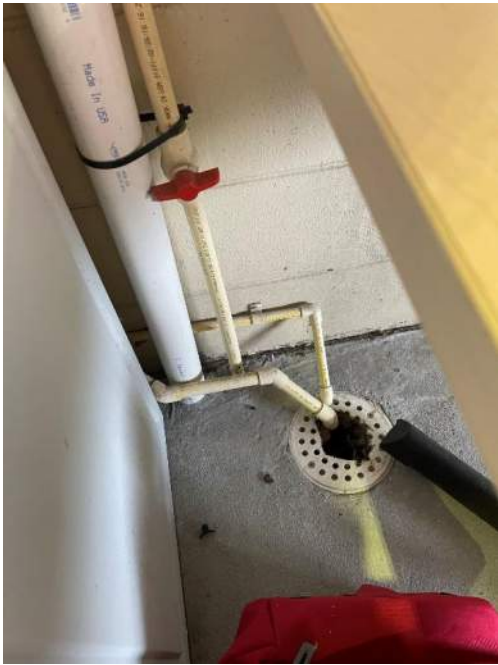
The floor drains in Apparatus bay are in poor condition and have passed their useful life expectancy.

IMG\_4467: Floor Drain needs replacement.

1. All Drains in apparatus bay need to be replaced.
2. Replace and properly install domestic water piping, heavily modified and improperly installed and added upon over the years.

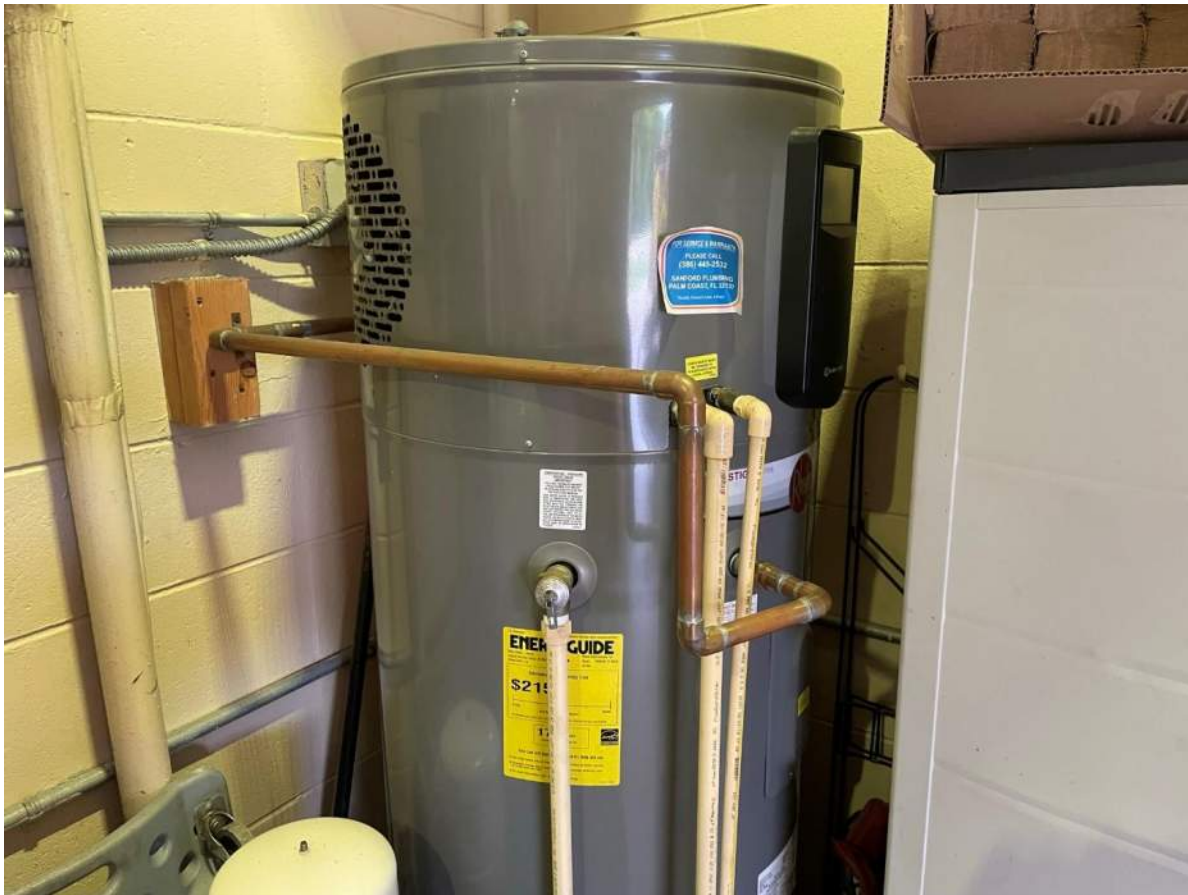
The existing water Heater appears to be in fair working condition.

IMG\_4305: Electric Water heater in fair working condition

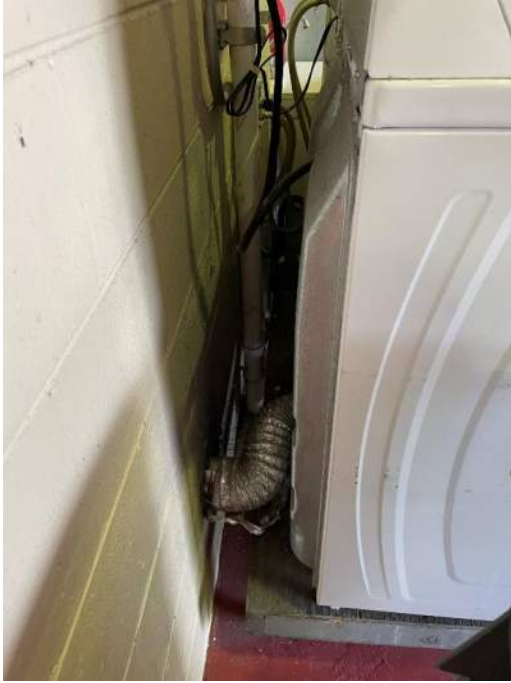
IMG\_4460: Laundry Wash box in poor condition

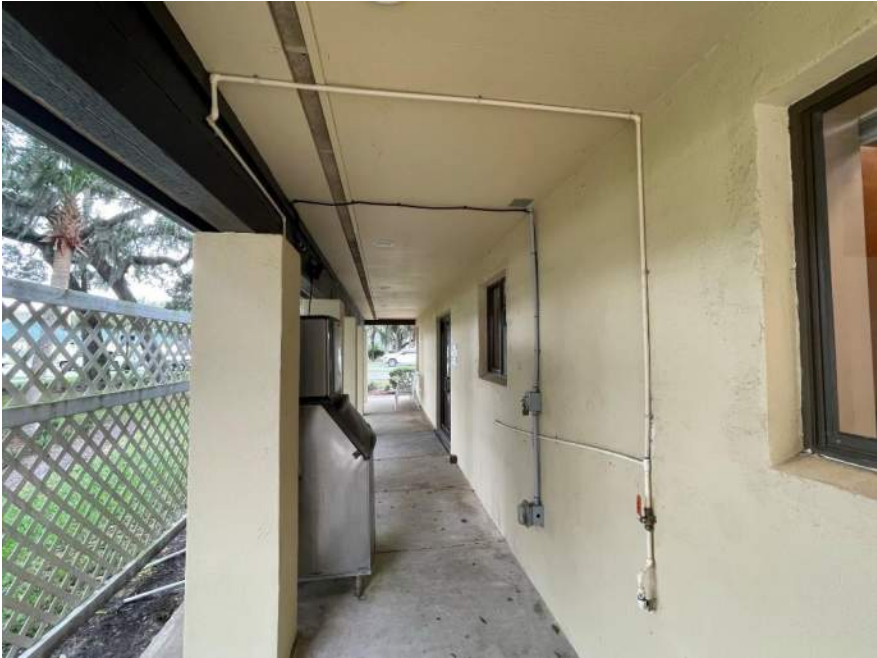
The above ground domestic water has been modified in some areas to accommodate for added equipment. These additions apparently have not been designed or engineered properly. Additional

IMG\_4342: Unprotected Domestic water piping for Icemaker subject to mechanical damage

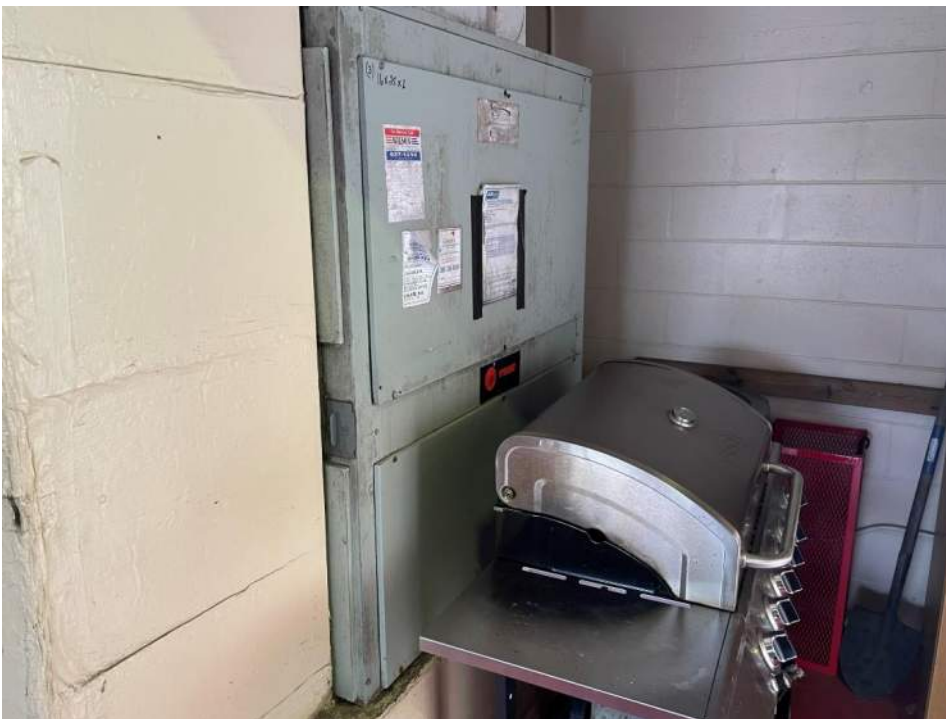
The air conditioning system serving the building consists of a single direct expansion (DX) split system. The Trane 7-1/2 ton system is estimated to have been installed in midyear 2016 making the equipment roughly 7 years old. The system appeared to be functioning properly at the time of the site verification. The air handling unit (AHU) is installed within the unconditioned apparatus bay. As a result, mildew and growth is visible on the exterior of the AHU housing. The housing on the condensing unit appeared to be in good condition, however some evidence of corrosion could be observed on the condenser coil. The typical useful service life for a DX air handling units is 15 to 20 years which leaves 8 to 10 years remaining. However, the proximity to the saltwater coast would greatly reduce the anticipated life expectancy for the AHU since it is installed within an unconditioned ventilated space. Similarly, the useful service life for the condensing unit is typically 8 to 12 years in this environment and would most likely require replacement in the near future. Another consideration for the air conditioning system is the pending refrigerant phase out where the R-410A the system utilizes will phased out in January of 2025. The planned replacement refrigerant for R-410A is a flammable material such as R-454B or R-32. When the condensing unit is required to be replaced within the next few years, the entire system will be required to be replaced including the air handling unit.

IMG\_4310: AHU showing visible mildew growth on the housing

3. Replace the entire HVAC system (AHU + Condensing unit)
4. Replace all HVAC distribution ducts and diffusers plus add additional zone controls.
  - a. Apparatus bay needs to be fully airconditioned space.

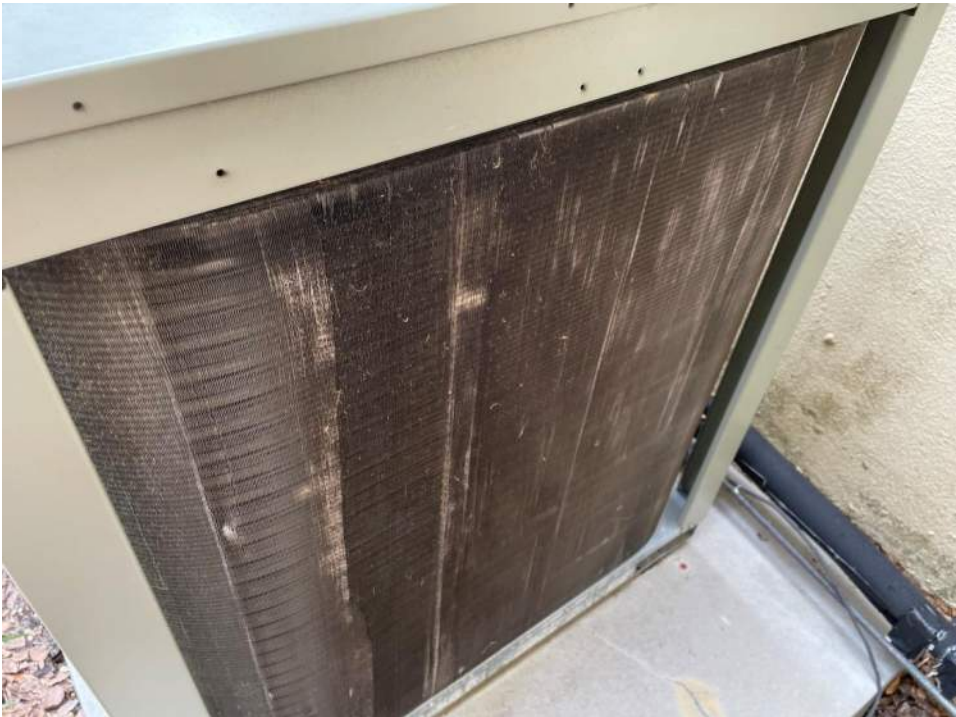
IMG\_4317: Corrosion visible on condensing unit coil

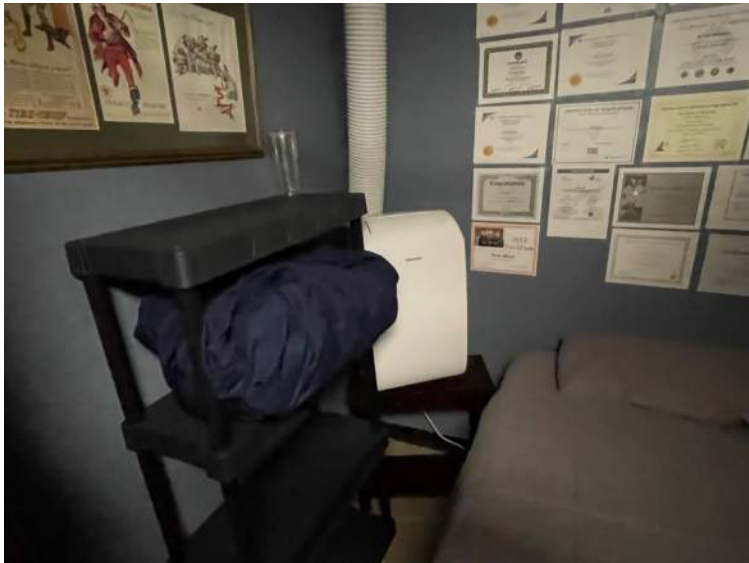
There is a supplemental portable air conditioning unit installed in the bunk room with the heat exhaust duct extending up through the ceiling into the attic space. It would be recommended to remove this unit and upgrade the central system to properly condition the building.

IMG\_4442: Supplemental portable ac unit in bunk

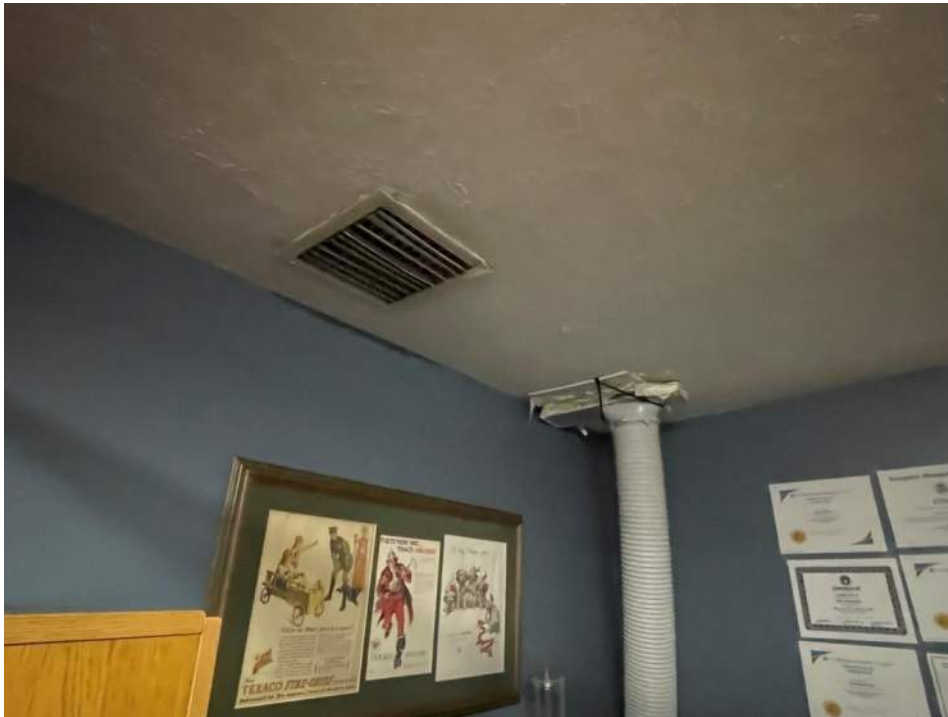
IMG\_4441: Heat discharge from portable unit extending through ceiling into attic

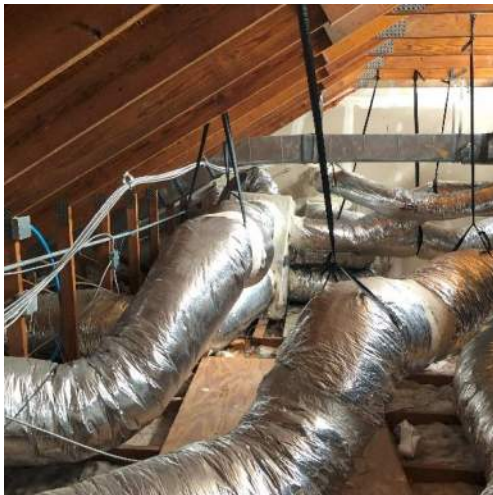
The duct distribution system consists of typical residential type layout using flexible ducts and small ductboard supply plenums. There were no visible failures in the duct system, however the installation would not be appropriate for a commercial application and it would be recommended to be replaced with a rigid supply and return duct system for building longevity. Depending on the type of use for the building in the future, it may be desirable to provide some sort of zone control to the various spaces.

IMG\_7885: Spaghetti flex duct distribution

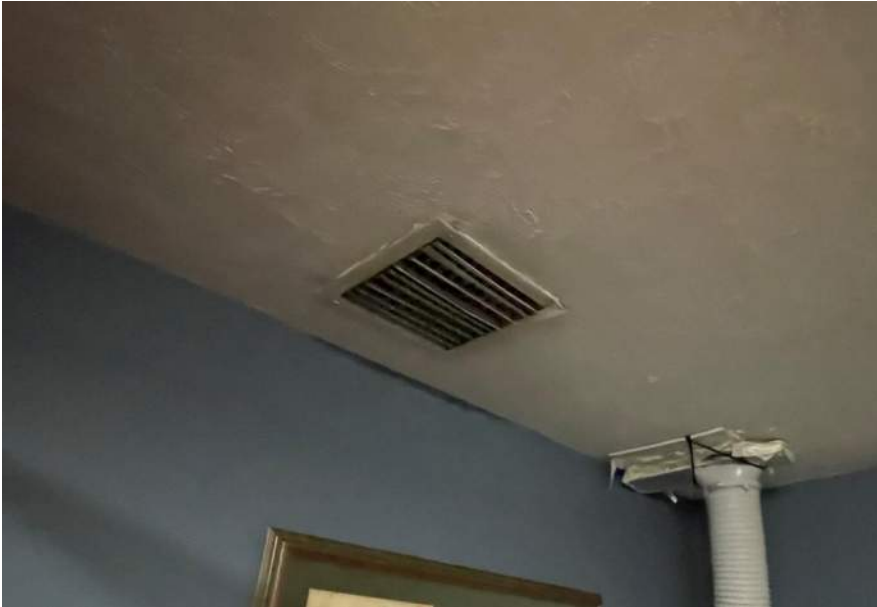
The air terminals throughout were in various conditions. Many had been replaced and others were clearly showing their age. It would be recommended to replace all air terminal units throughout if the building were to be reused or repurposed.

IMG\_4441: Damaged supply diffuser

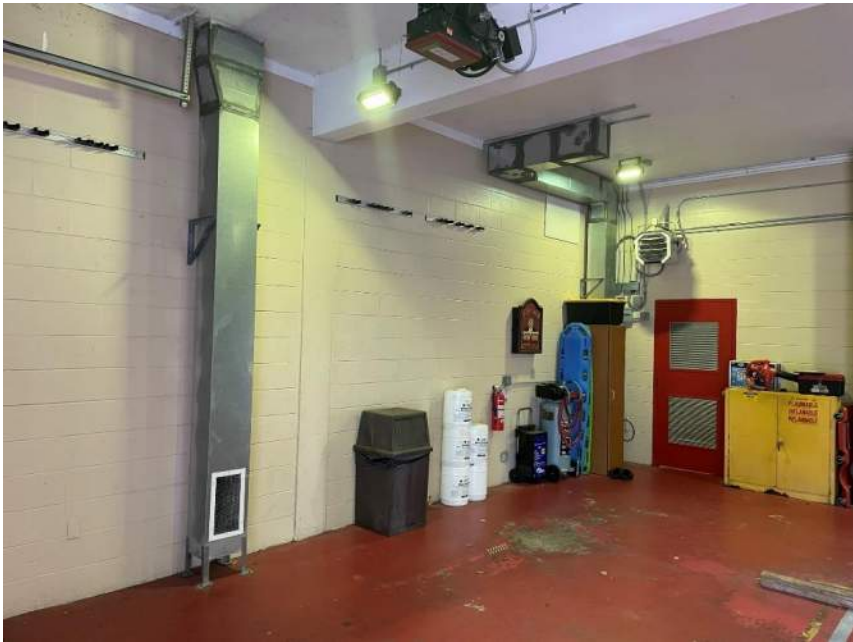
An exhaust system has been added since the original construction to include low air inlets. There are four vertical ducts extending down to the floor with grilles at the floor elevation. These are connected to an in-line fan in the attic which discharges to a louver on the east side of the apparatus bay. A louver installed in the clearstory window framing on the north side is ducted to the ceiling of the apparatus bay for make-up air. The fan and ductwork all appeared to be in good condition. The nameplate data off of the exhaust fan was not available to determine the equipment age. A visual inspection would estimate the fan would have roughly 10-15 years of useful service life remaining.

IMG\_4287: Vertical exhaust ducts extending down to floor in apparatus bay

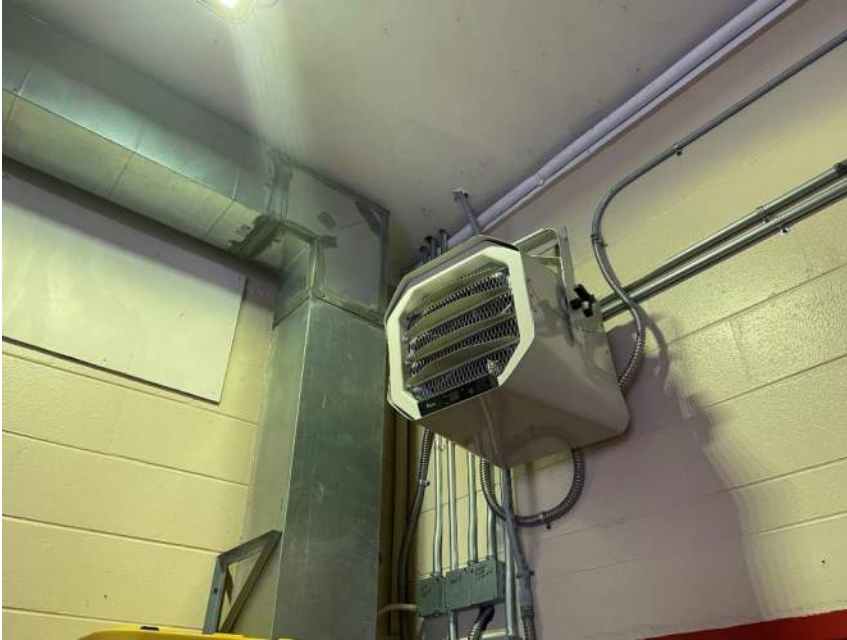
Two electric unit heaters were installed at some point in 2017. They appeared to be functional and in good condition. The anticipated useful service life for a unit heater is 13 years per the ASHRAE Equipment Life Expectancy Chart which would leave roughly 7 years.

IMG\_4292: Electric unit heater in the apparatus bay

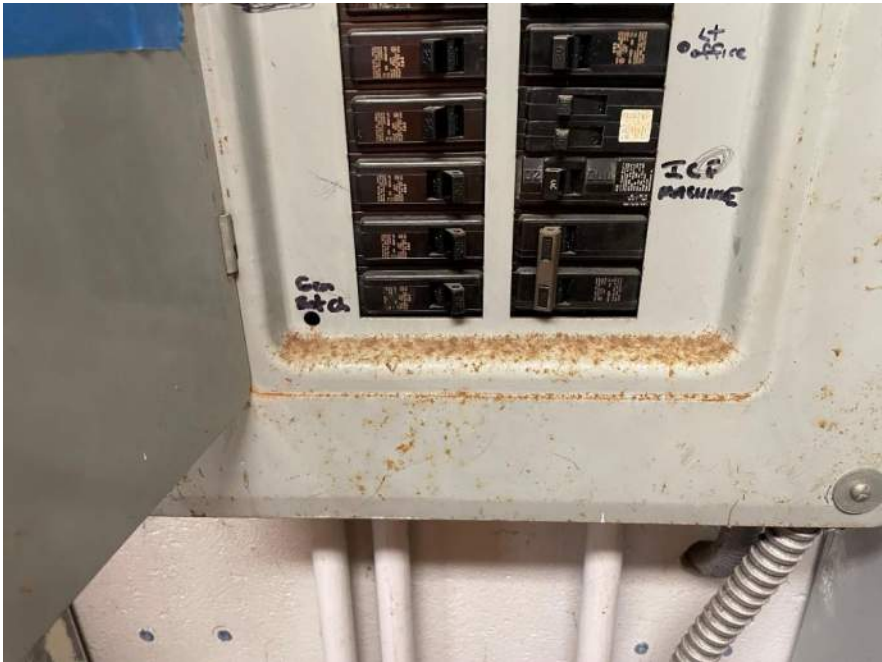
IMG\_4277: Rusting conditions on 45 year old panels

5. Replace all Electrical panels.
6. Replace generator and ATS (existing still have useful life but do not meet current code requirements and could be salvaged and repurposed elsewhere)
7. Replace all lights with LED technology lighting.
8. Replace all light switches with automatic occupancy sensors throughout.
9. Replace all Site lighting.
10. Replace all wiring and receptacles to meet current code requirements.
11. Add lightning protection system.

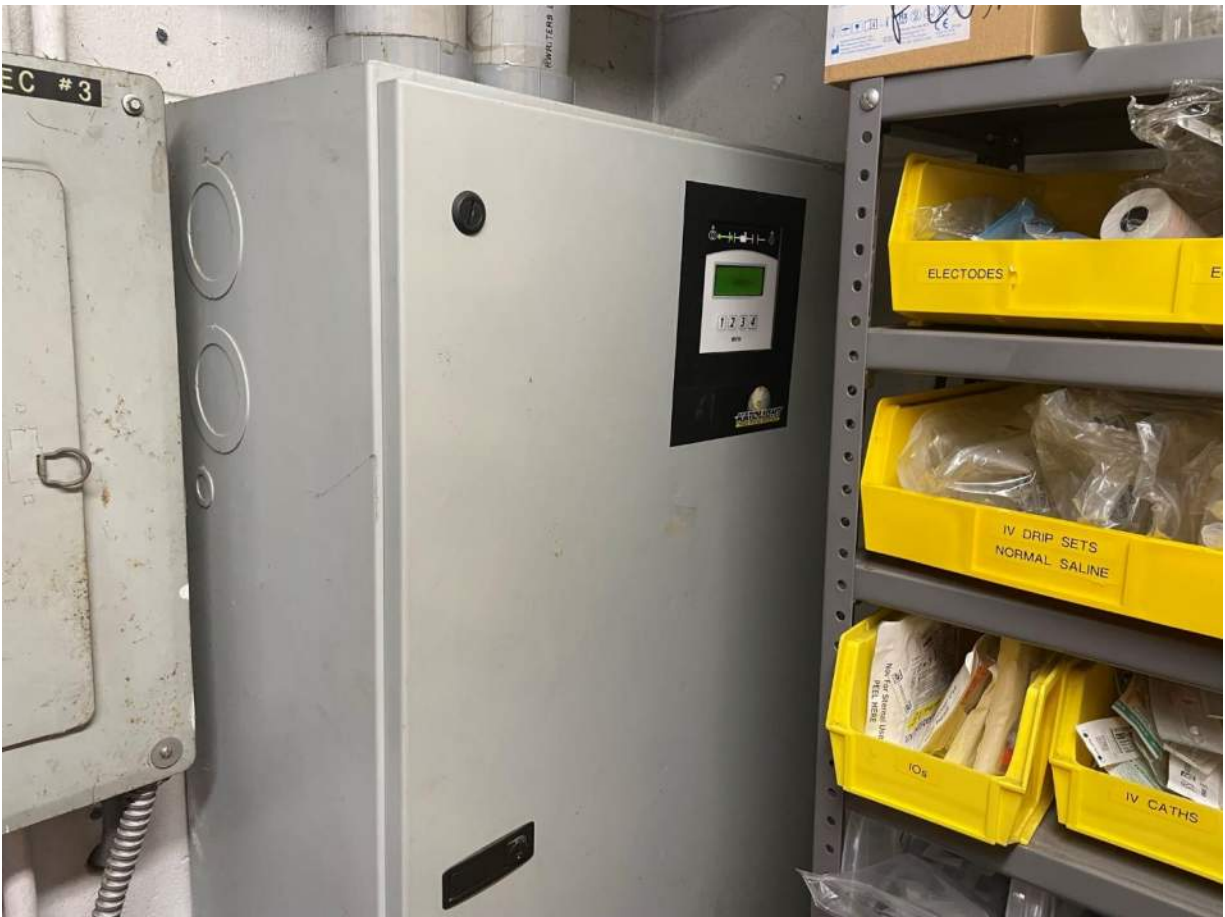
The generator system is fed from an Olympian(Caterpillar) 75kW diesel generator. It appears to have been installed in 2003. There is a Katolite Automatic Transfer Switch (ATS) located next to the MDP that provides generator power to a partial portion of the 400 amp service. The generator is rated for approximately 250 amps. This system does not meet the current code for Life Safety lighting. The generator appears to be in satisfactory condition and is approximately 20 years old. The generator and ATS should be salvaged for reuse. There were some 2 head emergency lights added to provide life safety emergency lighting.

IMG\_4279: ATS enclosure

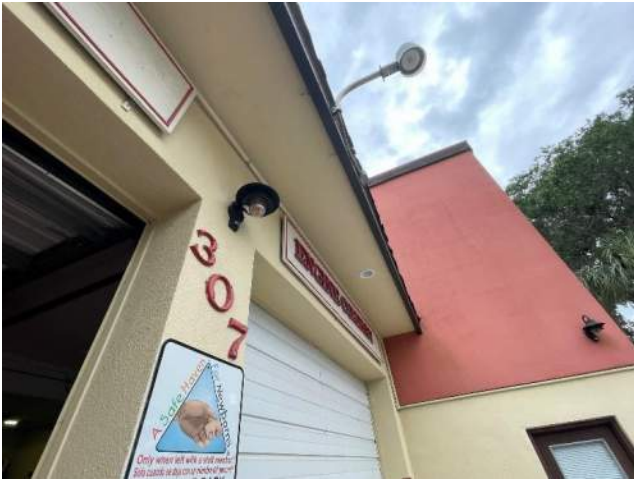
The site and parking area is illuminated with building mounted light fixtures and a pole mounted light fixture. These fixtures are of different varieties added at different stages of renovation. There is one steel pole site light and one wood pole site light. Recommend replacement of all.

IMG\_4332: Building mounted lights of various types

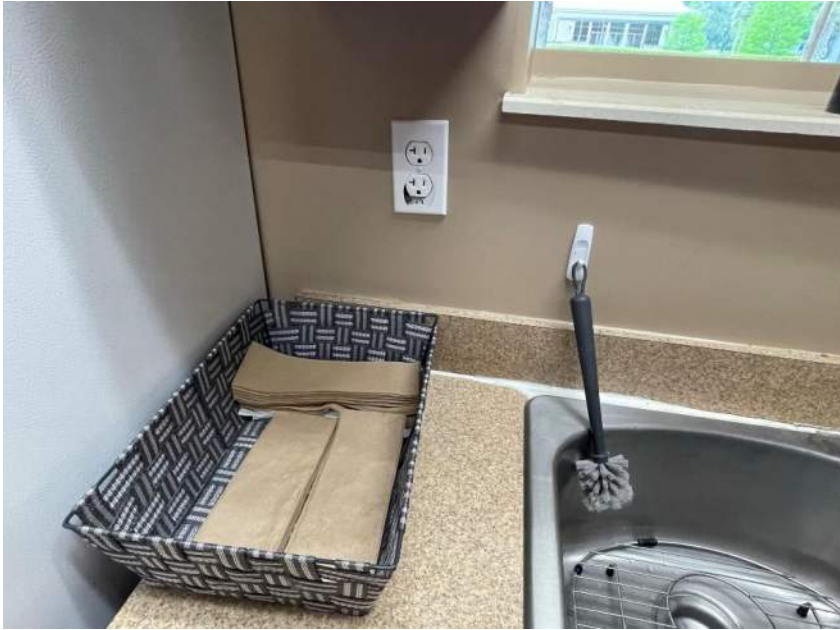
The wiring devices branch circuits were installed in the 1976 construction and are in poor condition. Many devices have been replaced but some faceplates are cracked/damaged. There may not be any ground conductors installed within these branch circuits which does not meet current code. There are not as many outlets installed in 1976 as are needed. There were many plugstrips being utilized. Within the Apparatus Bay, there were numerous outlets installed utilizing exposed surface conduit.

IMG\_4383: Cracked/damaged faceplate

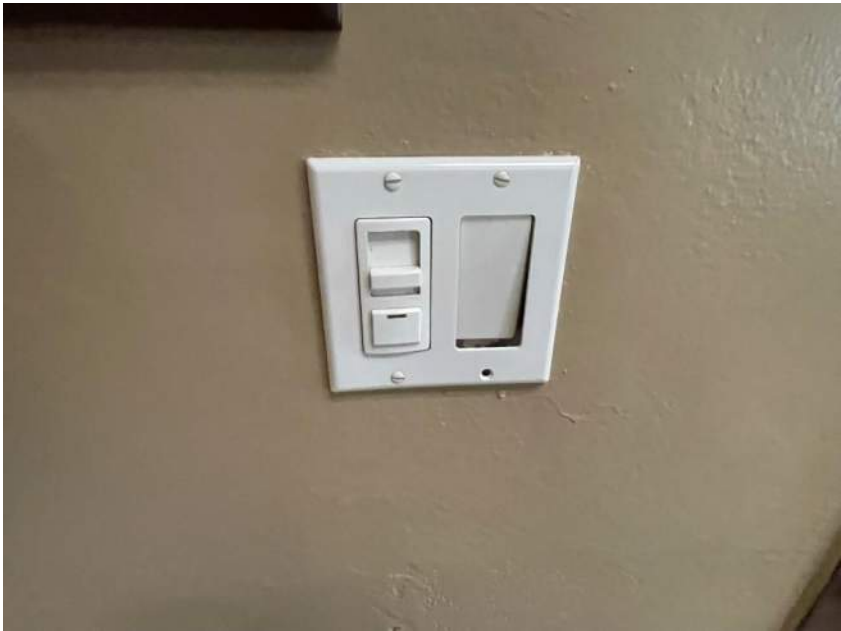
IMG\_4403: Cracked/damaged faceplate

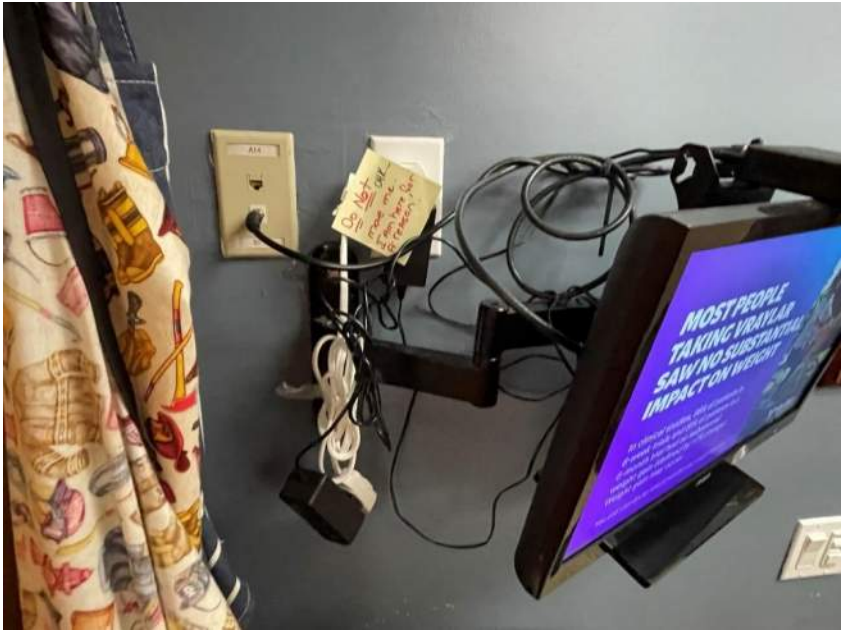
IMG\_4456: Not enough outlets in Lieutenant bunk

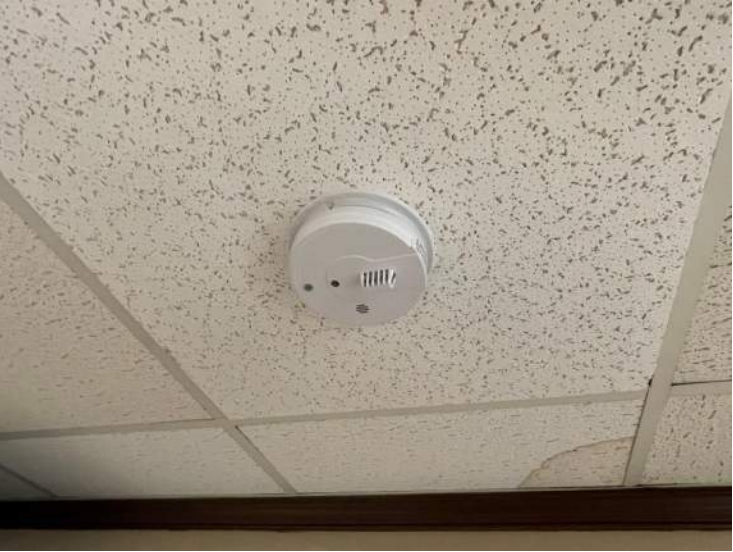
There is no fire alarm system installed within the building. However, there are stand alone smoke detectors installed within the building. A fire alarm system is strongly recommended.

IMG\_4380: Stand alone smoke detector in Dayroom

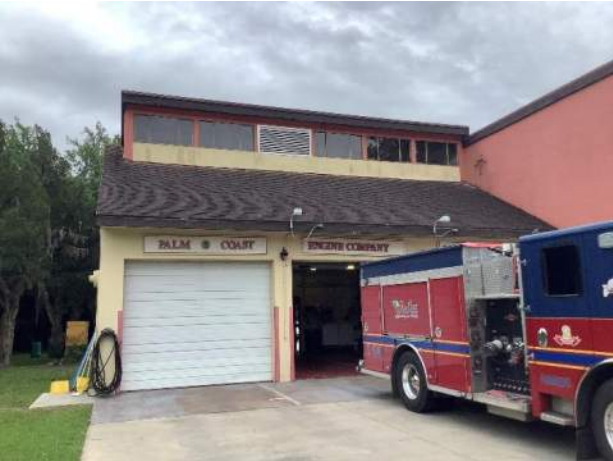
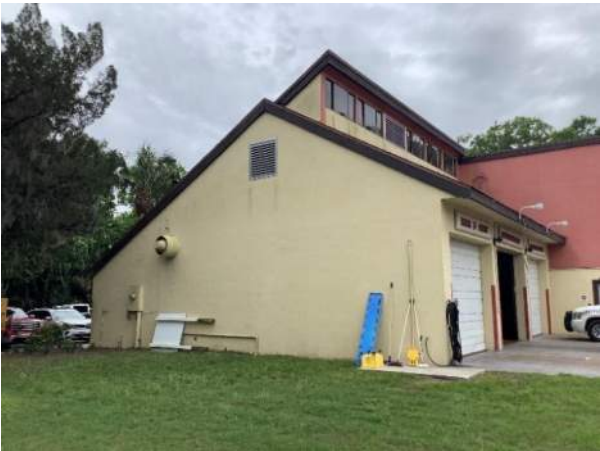
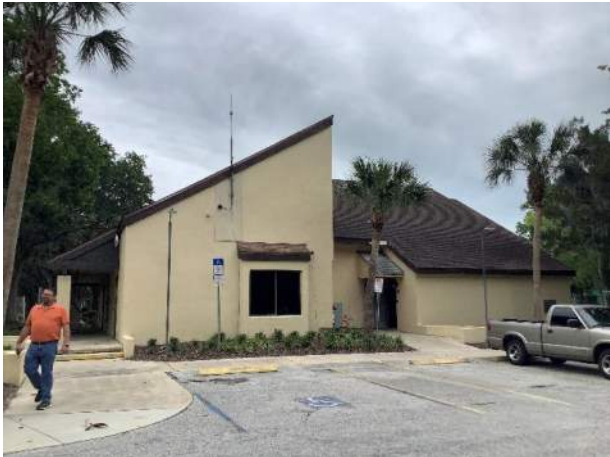
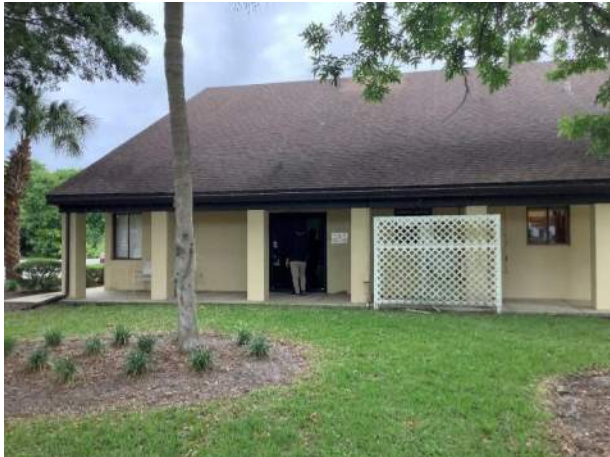
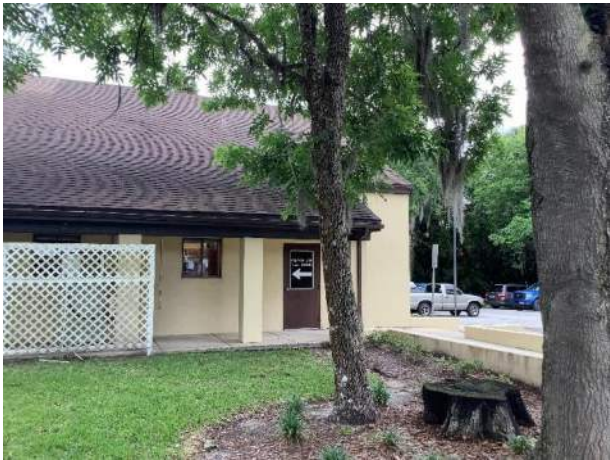
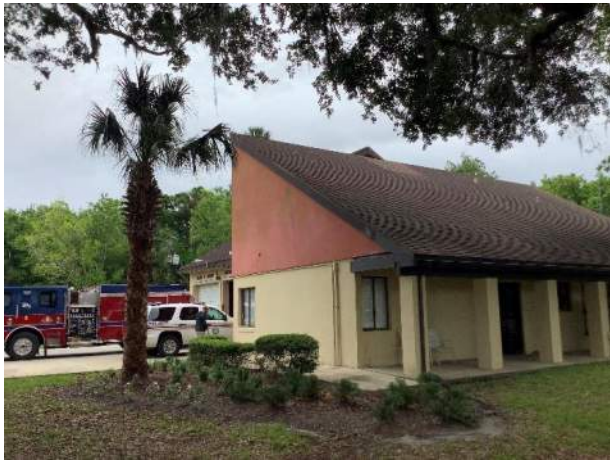
The photos above are of various location around the exterior of the building. In multiple locations there was noted cracking in the walls presumably from settlement over the years. This cracking was noticeable but appeared to be tight and unopened. Some repairs were evident in various location. See photos below.

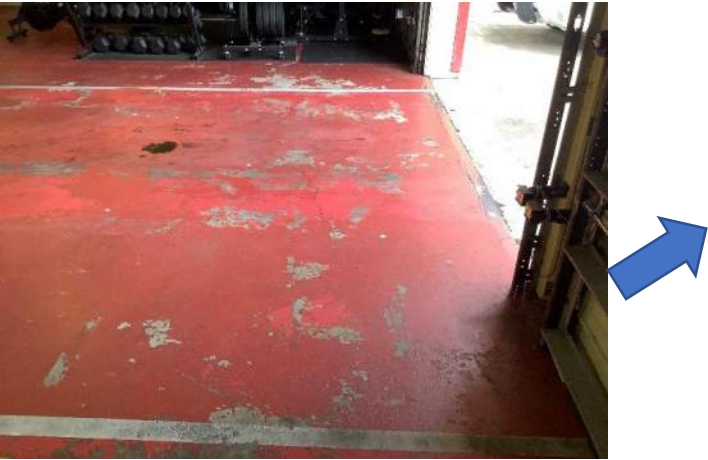
The interior truck bay floor had a singular longitudinal crack which ran from approximately middle of the first truck bay completely through the second truck bay and dissipated in the third truck bay area. This crack is most likely the result of fire engine weight localized on the edge of the bay floor slab at or near the doors. The crack is approximately 3'-0" inside the doors. The crack also appears to somewhat dated and may have occurred some time ago even as early as when the building was new.

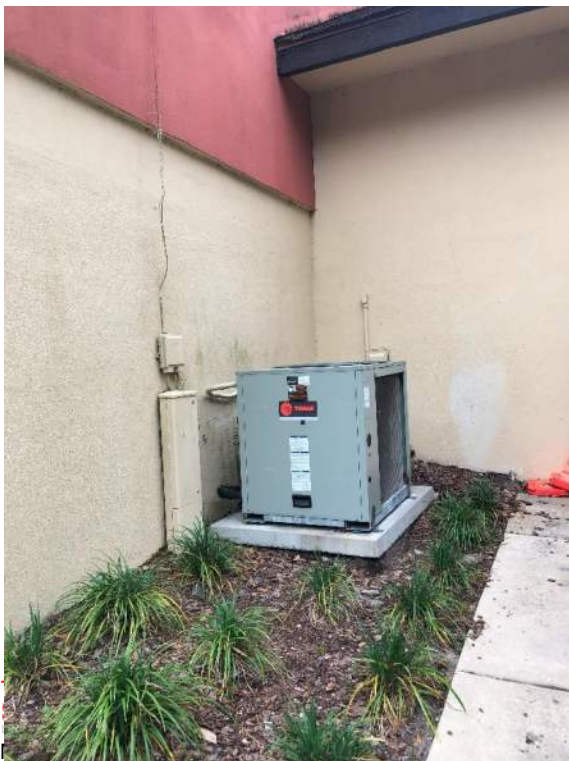
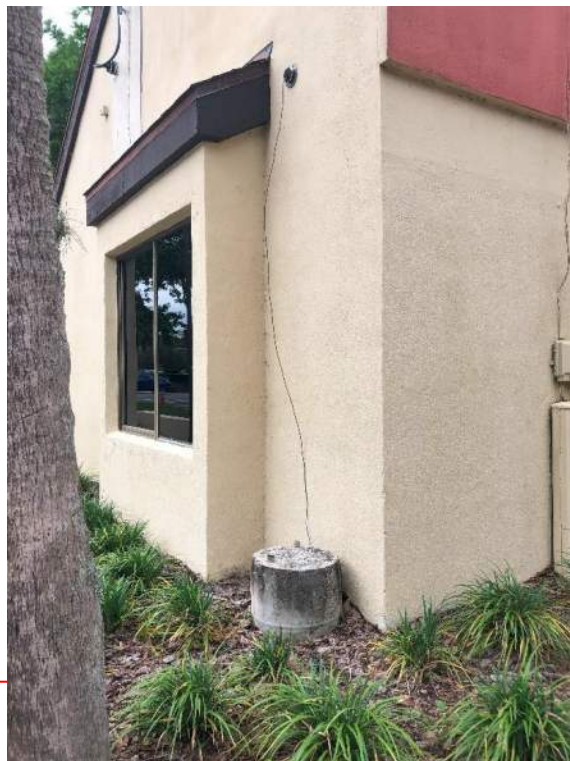
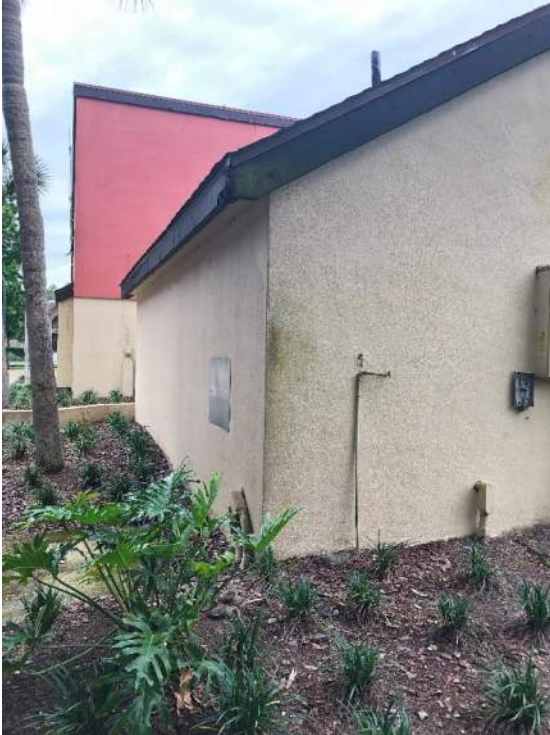
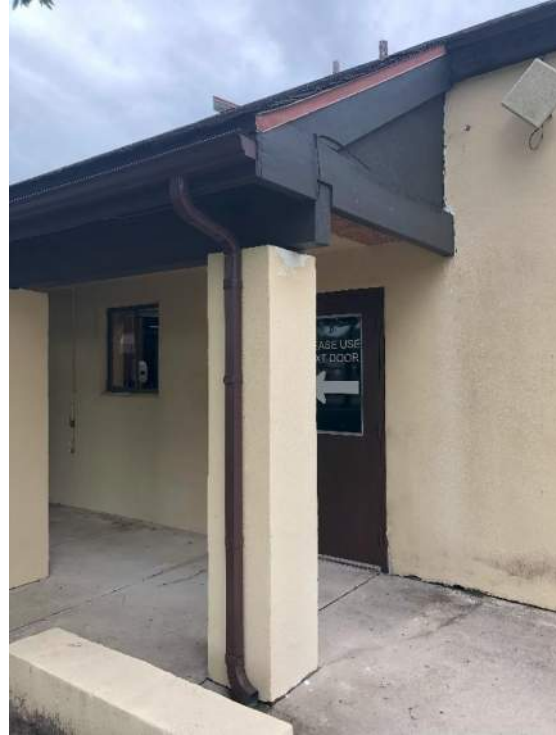
Please see the structural evaluation for the structural component of the exterior walls. The exterior cladding of the building is painted stucco finish over CMU (concrete masonry units). While not in major need for repair, the exterior cladding is in need of localized repairs and repainting, mostly due to water exposure, and seasonal cracking.

14. Repair Stucco on exterior
15. Repaint Exterior
16. Replace all windows and exterior storefront with insulated glazing systems
17. Replace Apparatus doors with storefront.
18. The roof needs to be replaced.
19. Exterior Soffits need to be repaired.
20. Repaint interior walls throughout.
21. Apparatus Bay floors need to be resurfaced and repaired.
22. All bathroom finishes need to be replaced.
23. Provide full insulation around apparatus bay (walls furred on inside, and ceiling or attic)

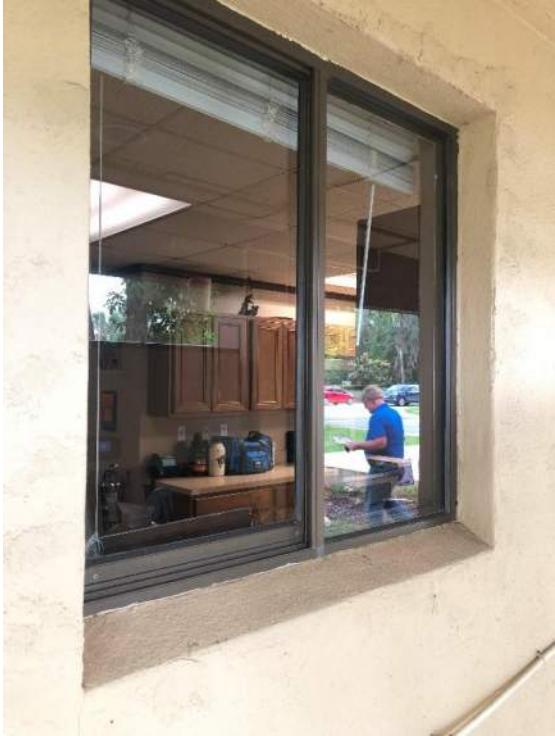
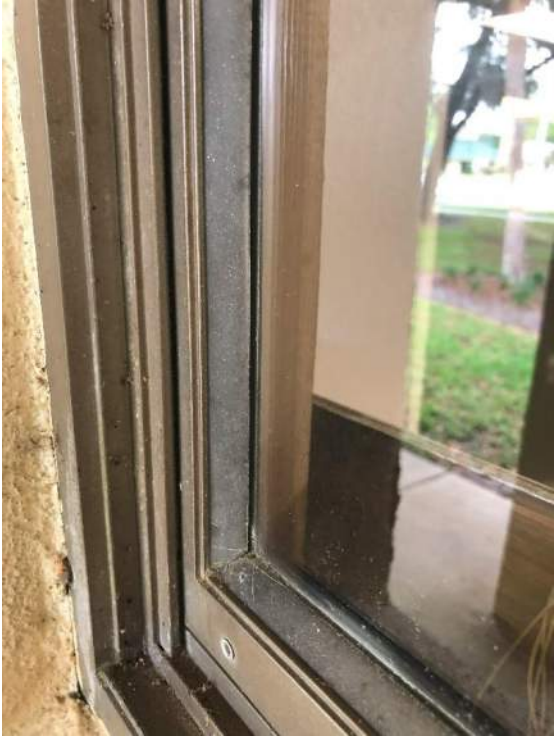
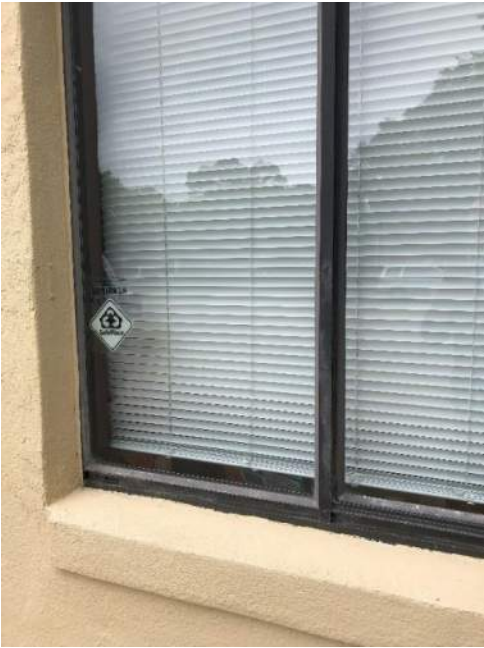
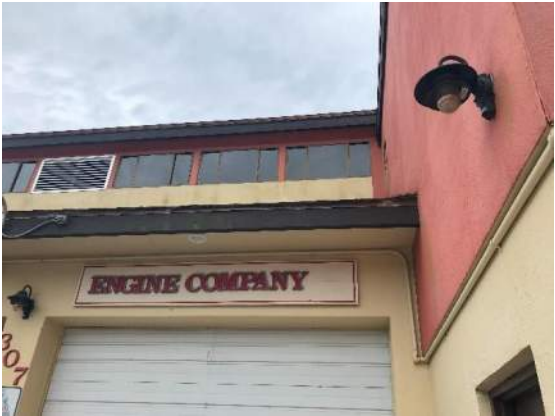
(Doors, Windows, Storefronts, louvers) while currently functional all exterior windows are single pane aluminum windows and as such are significantly more energy inefficient that windows/ storefront as per current code requirement. The recommendation of the architecture team is that all windows would need to be fully replaced with insulated window/ storefront systems.

Exterior doors are painted hollow metal doors with hollow metal frames. The condition of the doors is functional, no major issues were observed. The glazed exterior doors are single pane glass similar to the windows and would need to be replaced with more energy efficient glazed doors. The sectional overhead doors in the apparatus bays are in working order, although wear and tear as well as indentations are visible in several locations. Depending on proposed new use, sectional doors may have to be replaced with other doors or storefront windows as new use requires.

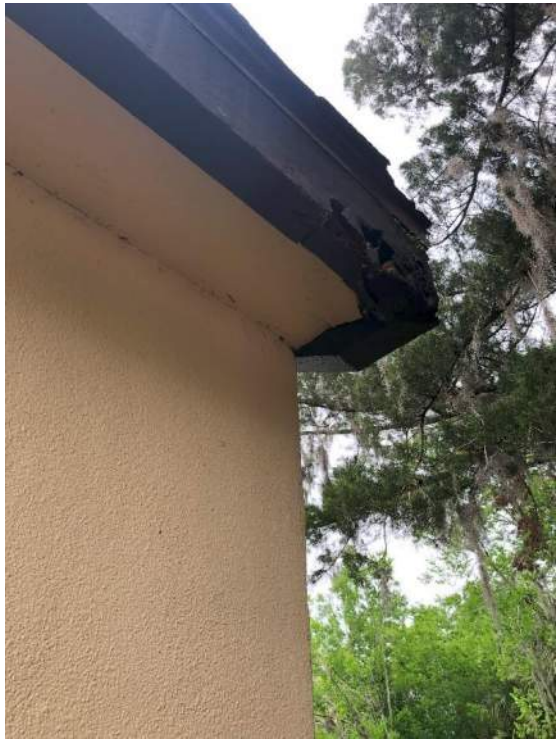
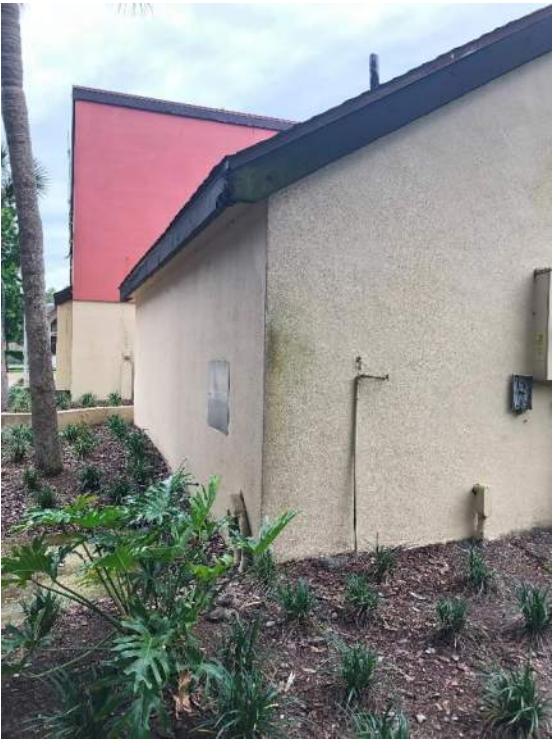
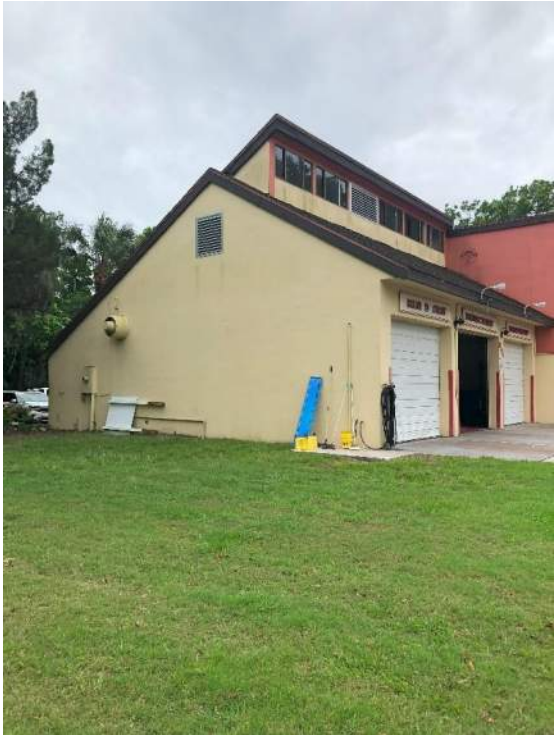
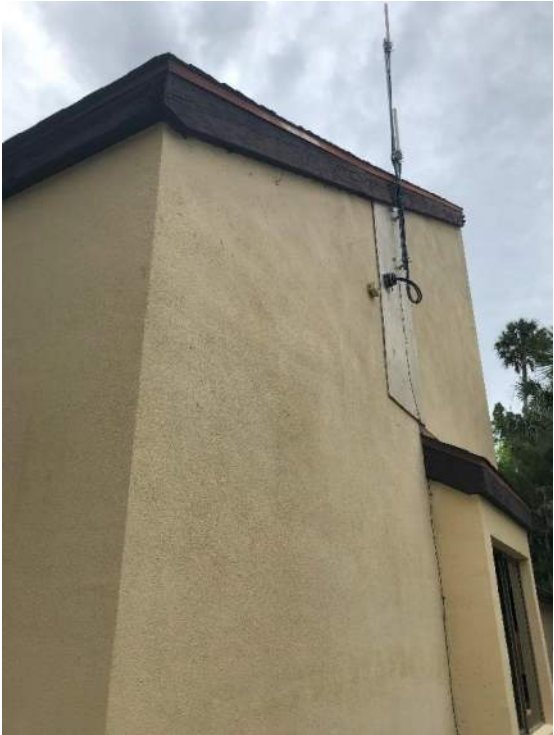
Please see structural evaluation for roof structure. The entire roofing system, and any openings and penetrations through the roof will need to be replaced. Fascia, and transition flashing between walls and roof need to be replaced as well.

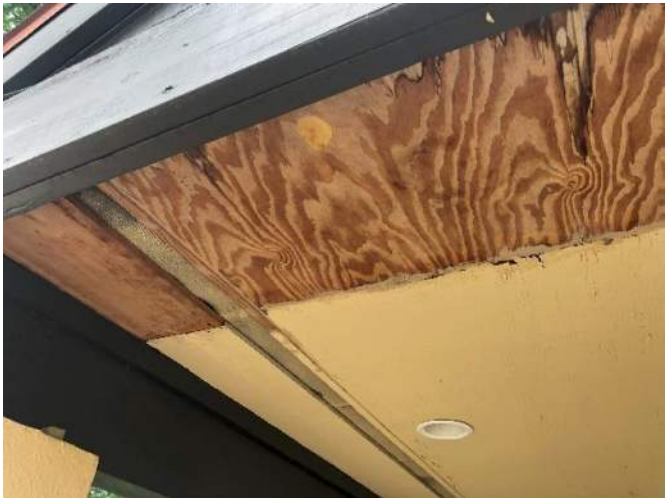
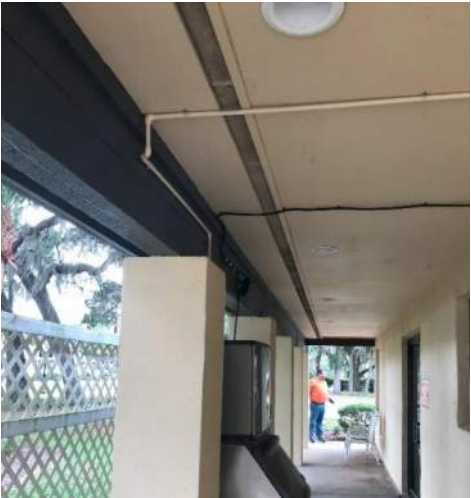
The exterior soffit appears to have been patch repaired at some point. The recommended action is to fully replace the entire exterior canopy soffit to minimize future water mitigation and damage.
