# Palm Coast Fire Station 22

Evaluation of Existing Fire Station 22

**SCHENKELSHULTZ**  
□ □ □ ARCHITECTURE □ □ □

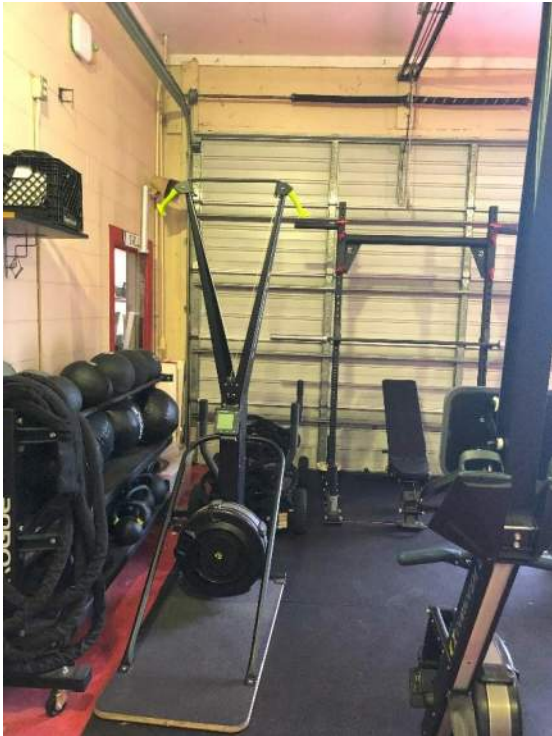
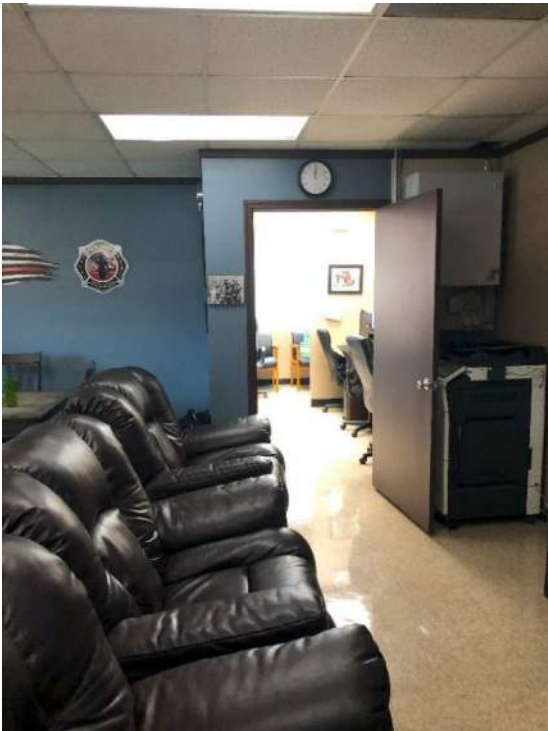
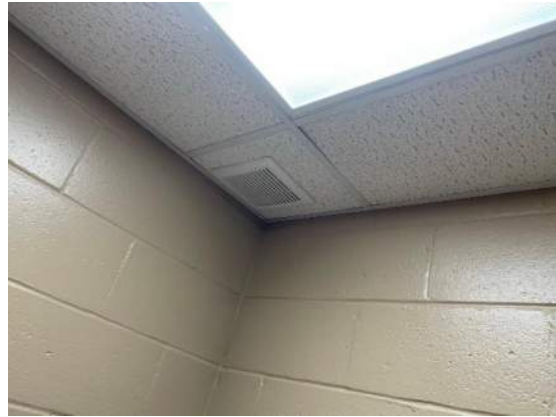
Apparatus bay and apparatus support/storage spaces accessible directly from the apparatus bay gypsum board (hard ceilings). The ceilings have numerous penetrations and attachments from the current use of the facility. Extensive wear and tear noticeable, several patched areas visible. Depending on anticipated future use, ceilings at minimum would need to be patched, repaired and painted, but preferably replaced.

Throughout the rest of the facility ceilings are mostly ACT (acoustical ceiling tile) in generally good condition, with some tiles with more extensive cracking and discoloration. Hard ceilings in bunk spaces and portion of the restrooms is in good condition as well. ACT in restrooms would need to be replaced with hard ceiling.

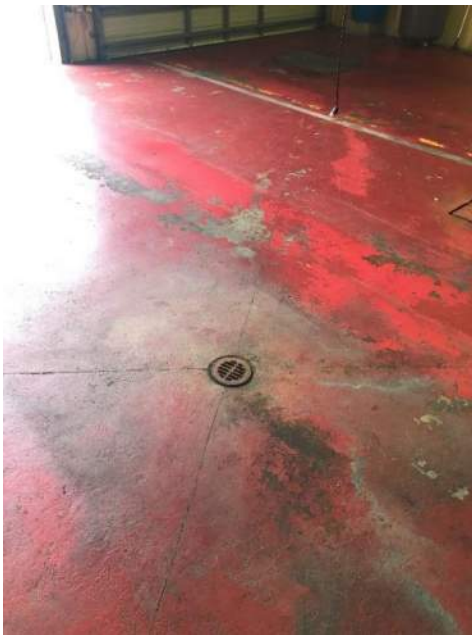
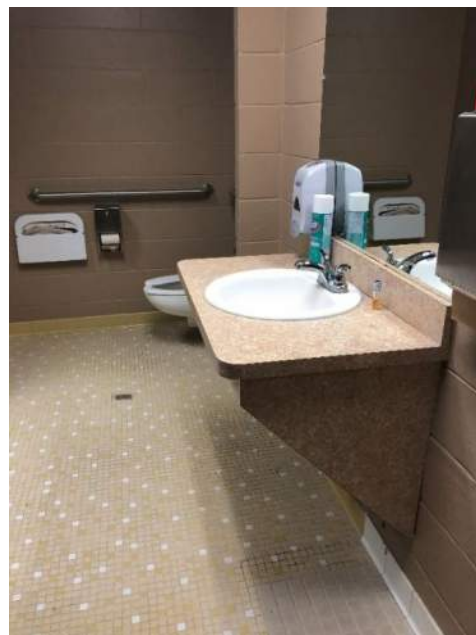
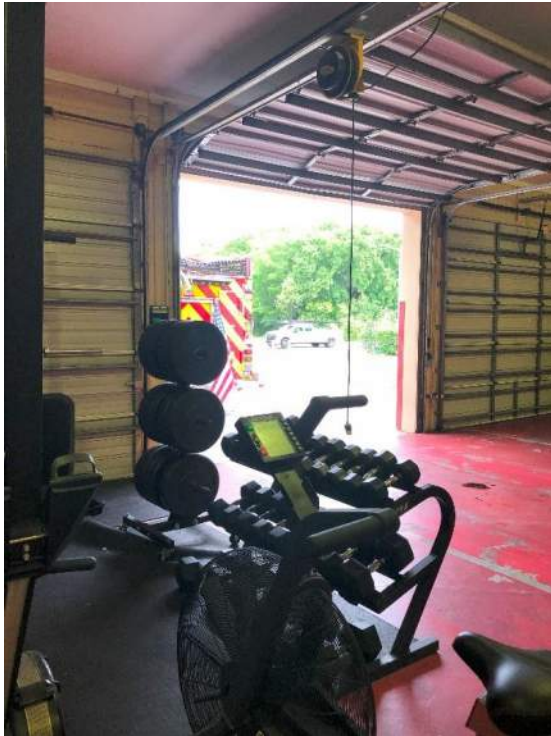
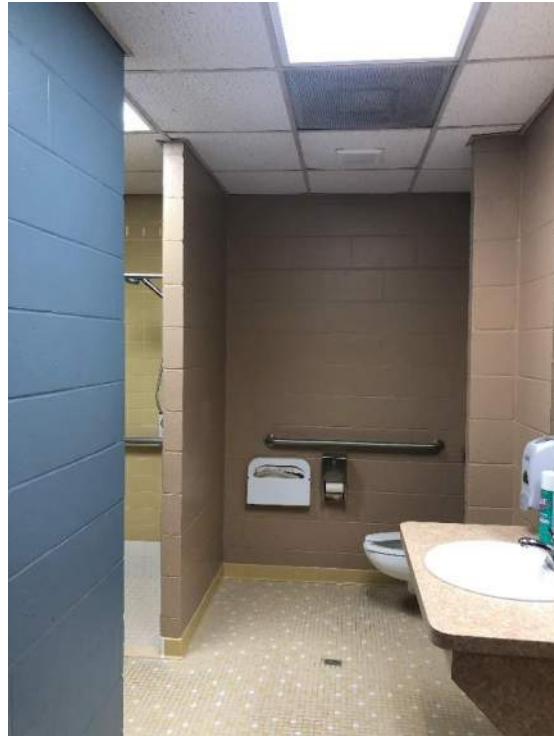
Apparatus bay floors are painted concrete floors. Due to the age of the facility and the use as a fire station, extensive discoloration and oil spills are present in the floor. Any other future use of the space other than a garage/ storage usage would require floor remediation by clean up, and surface refinishing.

The rest of the facility features VCT (vinyl composite tile) flooring in generally good condition. The restrooms/ showers have tile floors which although functional would need to be replaced. At several locations, patched repaired not matching tiles are visible.

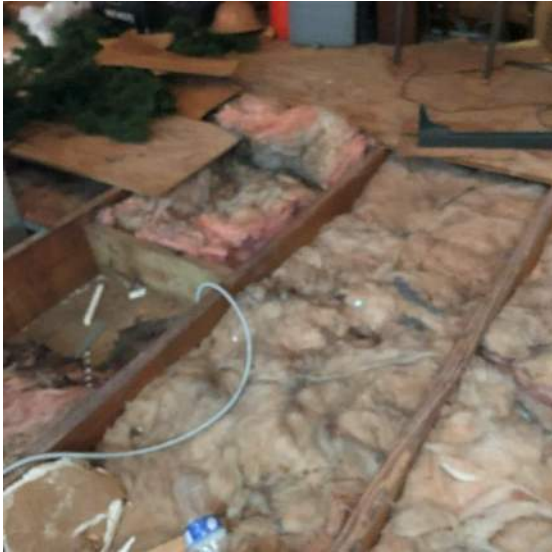
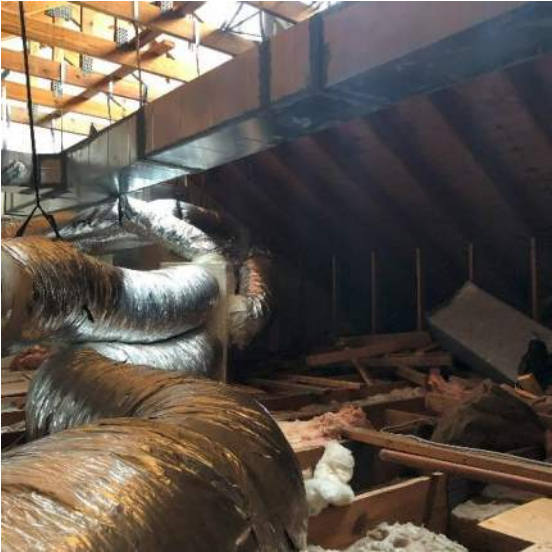
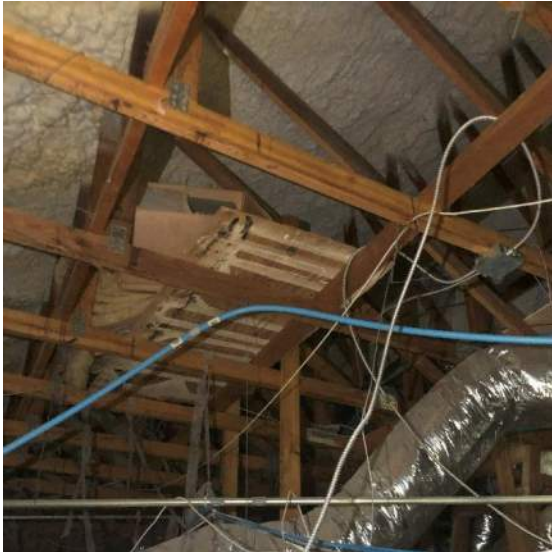
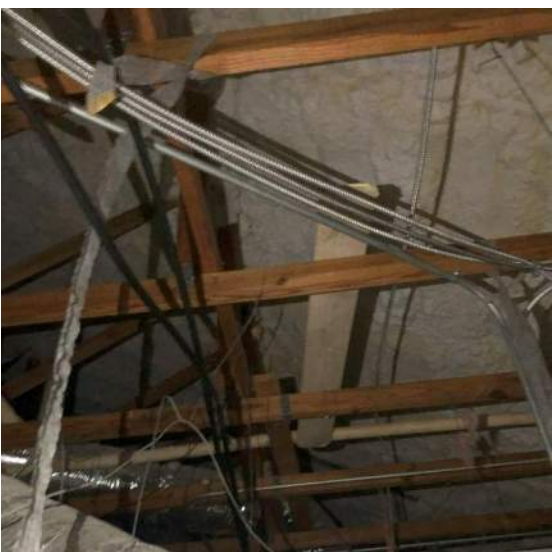
The design team was able to observe the roof and attic insulation only since it was readily visible. The roof in the apparatus bay does not show any insulation on the underdeck. There is loose batt insulation over the apparatus bay ceiling. Only a portion of the apparatus has attic insulation over the ceiling, the rest is exposed framing and gypsum board. Depending on future uses of space additional insulation may be required. The roof over the day spaces/ admin appears to have spray foam insulation under the roof deck in the attic space.
