Condition Assessment Old Flagler Hospital, Flagler County

CONFORMING REPORT

DJ Project #02218.02

July 26, 2013

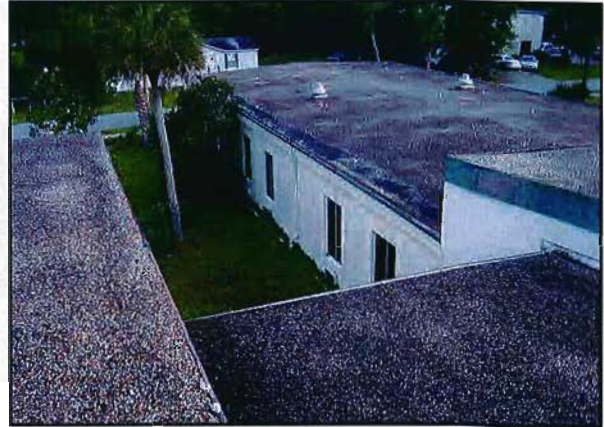
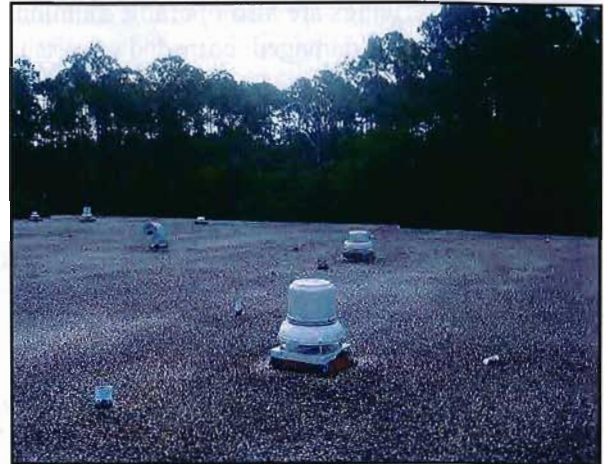
The existing roof is a gravel-ballasted asphalt roof membrane over lightweight insulating concrete poured over a vented deck with polystyrene for the slopes. **R & R Industries** of Daytona Beach inspected the roof on June 12, 2013 and found that the lightweight “seemed in fairly good condition and seemed durable enough to hold fasteners...”. Pending a pull-test, **R & R** felt that a **GAF Drill Teklocking** impact nail should provide plenty of holding power against uplift. The roof shows numerous areas of distress although there appear to be few areas of active water penetration below. The existing roof has numerous roof curbs with mechanical equipment (fans and vents) sitting on them and most of these are no longer water-tight. The existing flashing, gravel-stops and gutters are deteriorated and pulling away from roof substrate.

We found little evidence of complete roofing failures, but due to its age and condition, we recommend that the entire existing roofed-area be replaced with a new system prior to commencing any interior remodeling. Most of the existing roof penetrations will no longer be necessary, but there may be additional, new penetrations to accommodate a new user/group. There are several re-roofing and budget options offered:

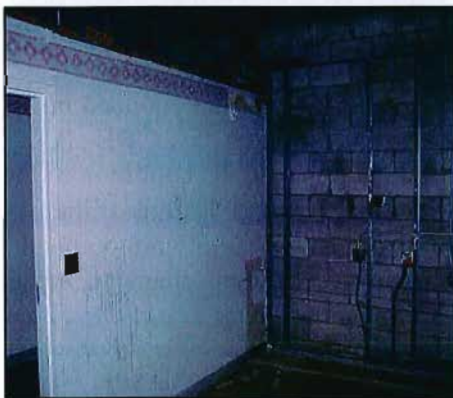
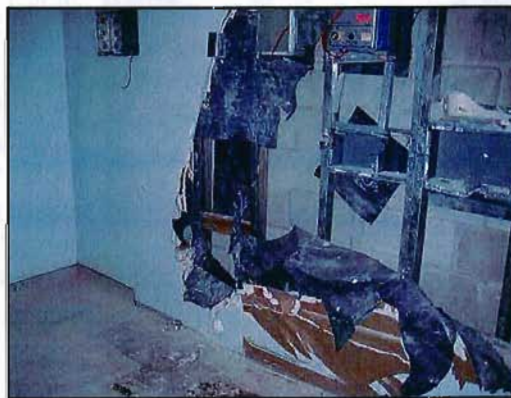
Interior wall finishes (wall-coverings) on the exterior perimeter walls have been removed from the building in many places. Some interior surfaces of exterior walls were surfaced with GWB applied directly to the CMU. Most floor coverings have also been removed, but there are existing areas of carpet and ceramic or quarry tile.

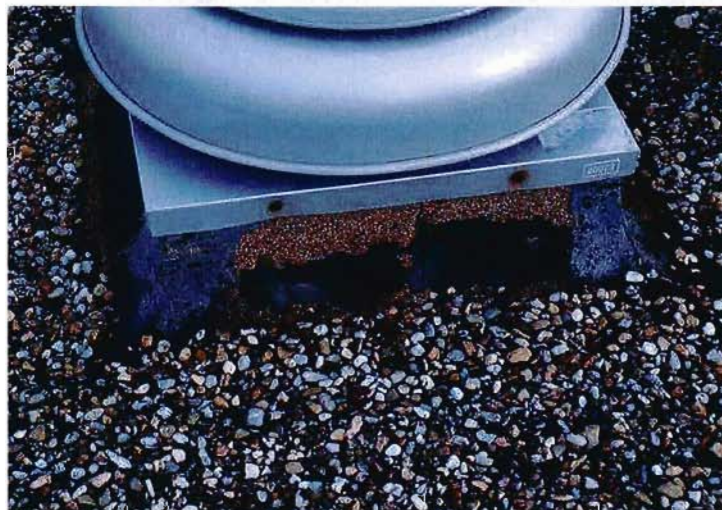
The facility is a 56,800 sq. ft. single story building with a gable roof at a 1/2:12 slope. The ridge line of the facility is off center from the centerline of the building by approximately 35'-0". The main facility has an approximate eave height of 13'-8". The east area of the facility branches into four (4) separate wings with an approximate eave height of 11'-8". The rooftop is a bituminous gravel layer, and according to the report by **Gibraltar**, underneath is 2" lightweight insulating concrete and 2" rigid insulation supported by a 24 gauge galvanized ventilated steel deck.

Built-Up Roof with Ballast

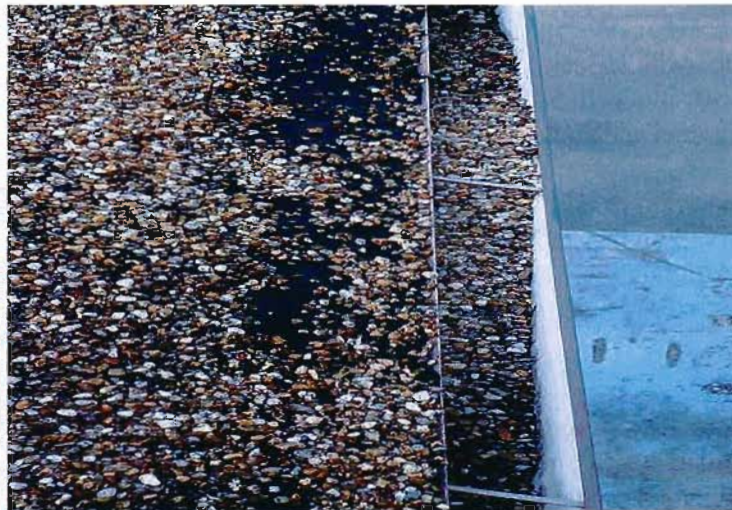
A gutter system was utilized around the perimeter of the roof edge. The deterioration of the bituminous gravel membrane resulted in buildup of gravel in the gutters.

Gutter Filled with Gravel from Roof Membrane

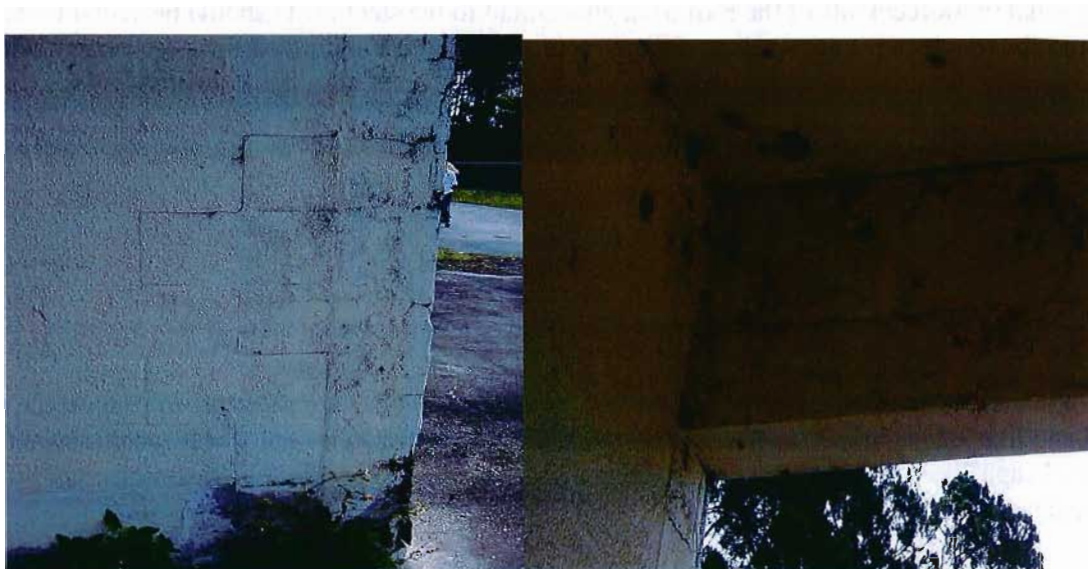
The exterior concrete masonry walls are 8” thick and are finished with an exterior insulation finishing system (EIFS). Slight damage to the surface finish was observed but appears to be cosmetic. There are openings in the CMU walls for wall-mounted air conditioning units throughout the facility. Currently, some openings still support air conditioning units while others are boarded with plywood. Windows around the facility are mostly broken; some are covered with plywood. What appears to be settlement cracking is observed on the southwest CMU walls of the facility as well as in the concrete beam of the canopy structure over the doctor’s parking lot.

Settlement Cracking in CMU Wall and Concrete Beam

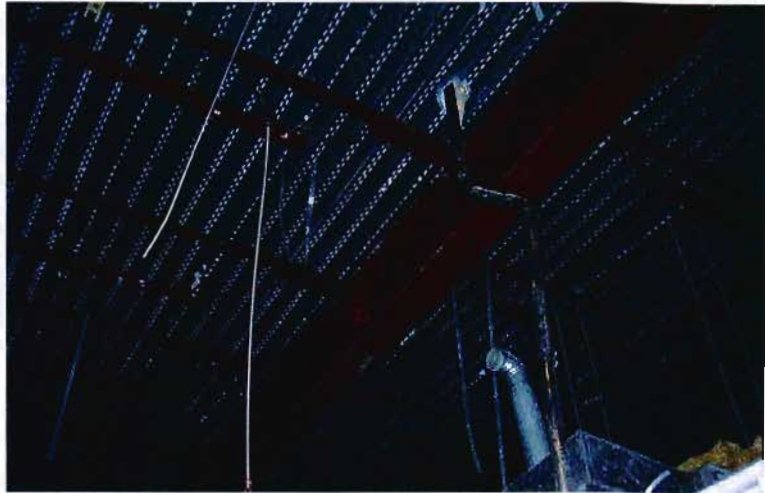
The existing roof deck is observed to be 1.5" Type B ventilated deck. The report by **Gibraltar** indicates that the roof deck is 24 gauge. The attachment of the roof deck to the steel joists did not appear to be typical of current standards and practices. CDE could not verify or qualify the deck attachment to the steel joists. Therefore, CDE is not able to render an opinion regarding its adequacy in accordance with current building standards and wind load requirements.

Steel Decking and Joist attached to Steel Beams

Additional reinforcements of the roof deck attachment to the steel joists should be added to insure that the roof deck can support the roof diaphragm shear that is anticipated from the current wind load requirements. Discussion for reinforcing the roof deck attachment to the steel joists is included in Part 6 of the report.

Though not required, it is recommended that additional reinforcements of the roof deck attachment to the steel joists be added to insure that the roof deck can support the roof diaphragm shear that is anticipated from the current wind load requirements.

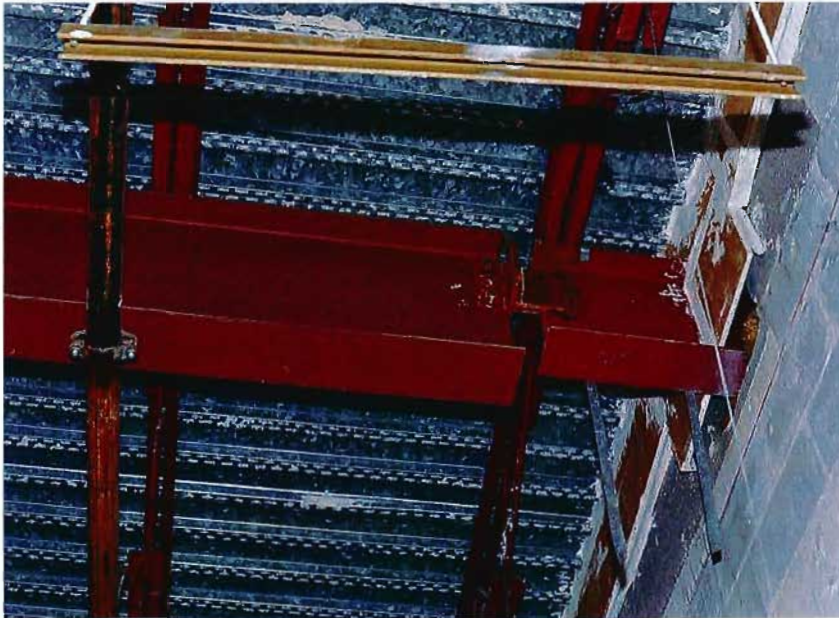
Beam Splice Connection of Dissimilar Beams

in the photo above. It was observed that no bottom flange bracing is provided. The bracing is required to reduce the unbraced length of the bottom compression flange of the steel beam due to wind uplift loads.

It is required that new L2x2x1/4 angle bracing from the bottom flange of the steel beams to the top chord of the steel joists for roof wind uplift support, as shown in the following figure:

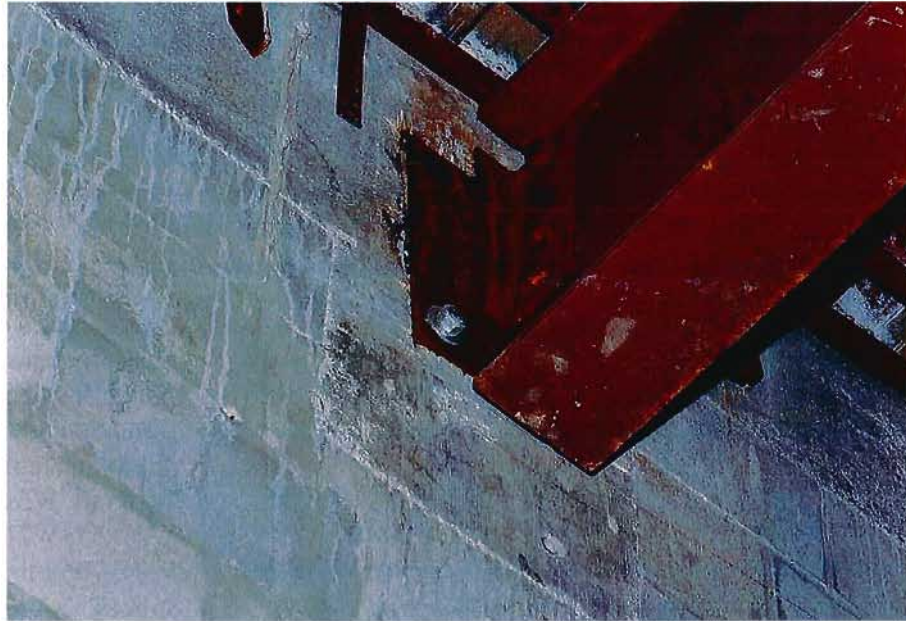
The interior steel columns are 6" diameter steel pipe columns while the concrete columns within the load-bearing masonry walls (exterior and interior) are approximately 8" x 16". Rebar reinforcements of the concrete columns are unknown. The ends of the wide flange steel beams are connected to the interior faces of the concrete columns. The existing steel and concrete columns are assumed to be adequate to support the roof dead and live loads summarized in Section 3.1 of this report. The findings discussed in the report by **Gibraltar** also confirm the adequacy of the existing column framing.

Wide Flange Beam Connection to a Concrete Column

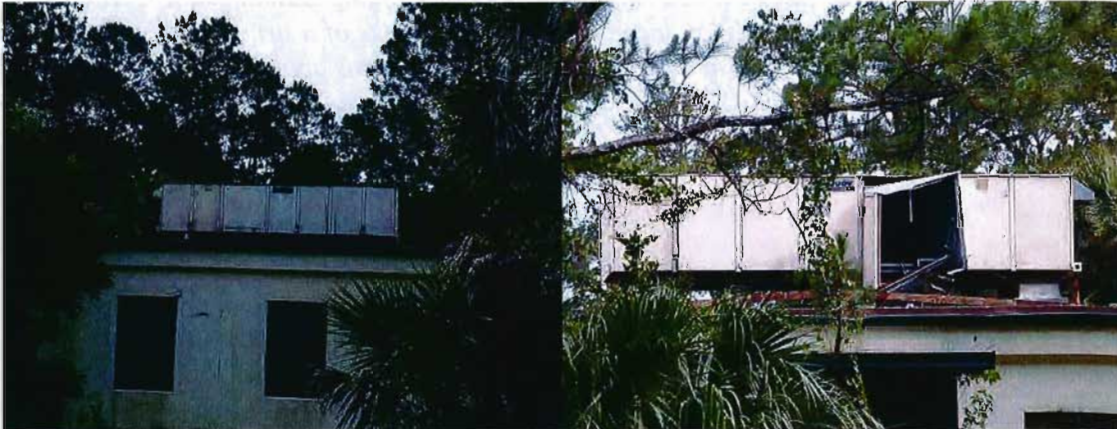
The mechanical systems that remains includes a rooftop packaged air conditioner by McQuay that appears to be past its useful reliable life. It is located above the northeast patient room wing.

McQuay Rooftop Packaged Unit

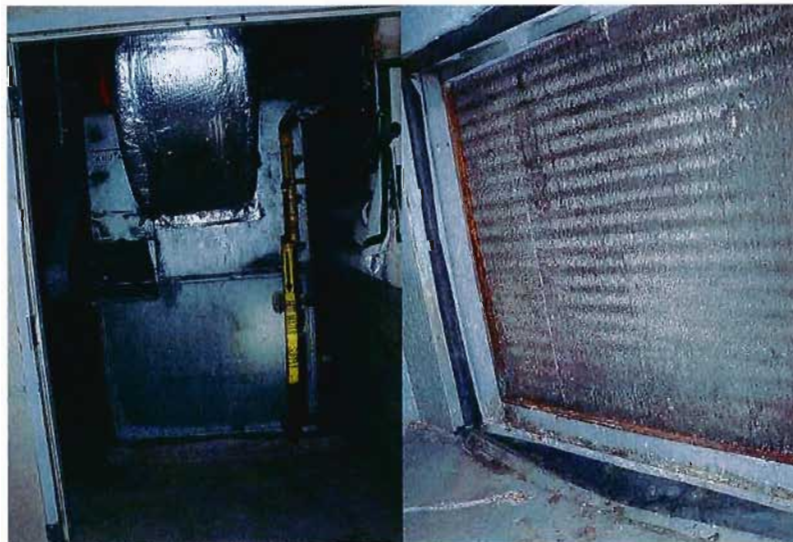
The existing AHU motors have been removed and the cabinets are in poor condition. They are single wall and the mechanical room unit floor has corroded past the ability of repair.

Typical AHU and Coil

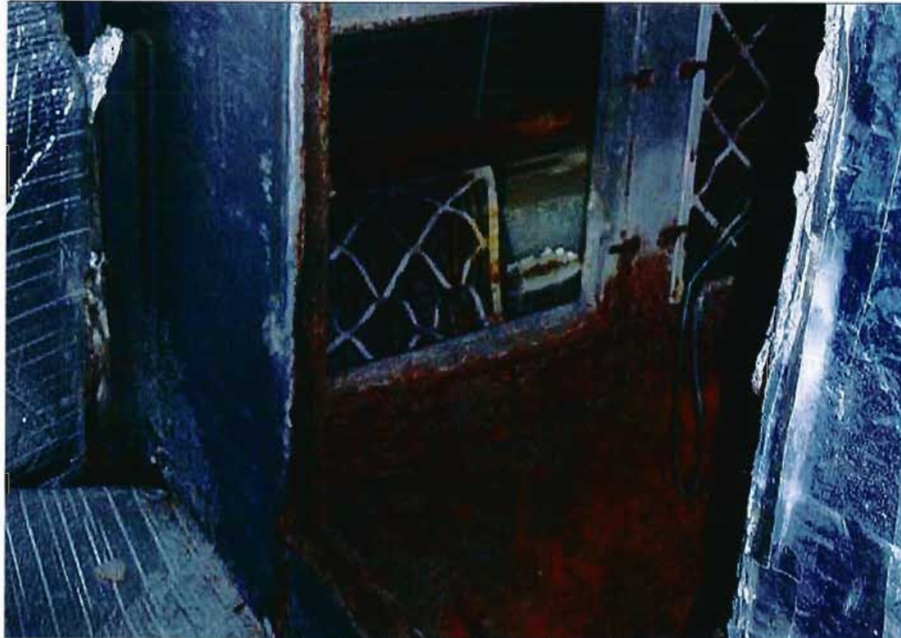
Photo 1 – AHU Interior in Mechanical Room

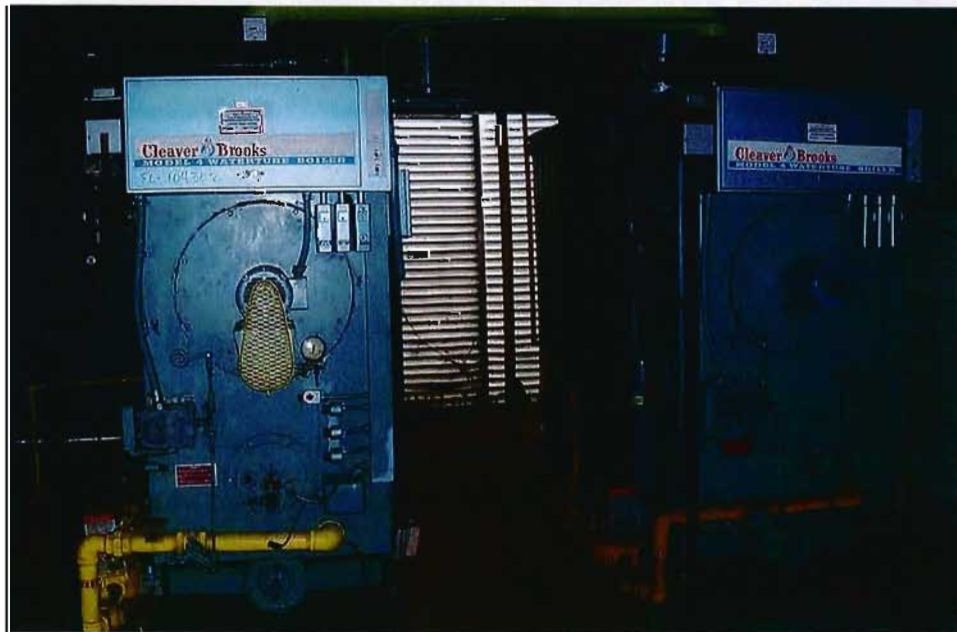
The boilers appear to be near operational; however none of the pumps are operational. Some pumps (and all pump motors) have been removed. The remaining pumps show signs of corrosion.

Existing Boilers

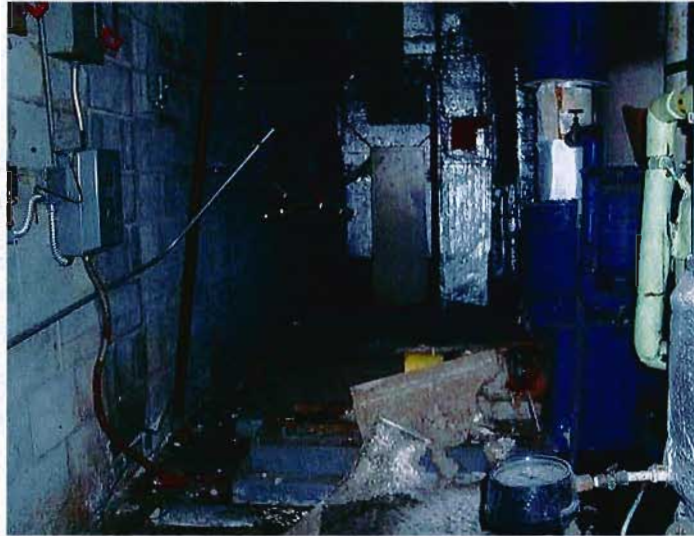
Missing Chilled Water Pumps

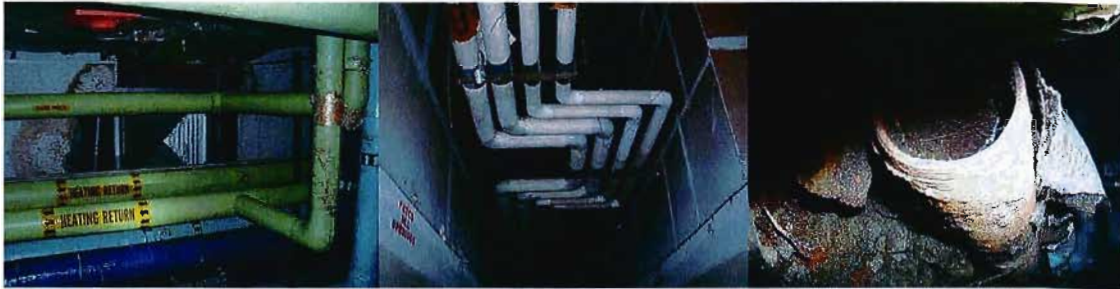
There is insulated carbon steel piping feeding into the existing mechanical rooms. The piping is in poor condition due to interior corrosion at this time.

Typical Insulation and Pipe Conditions

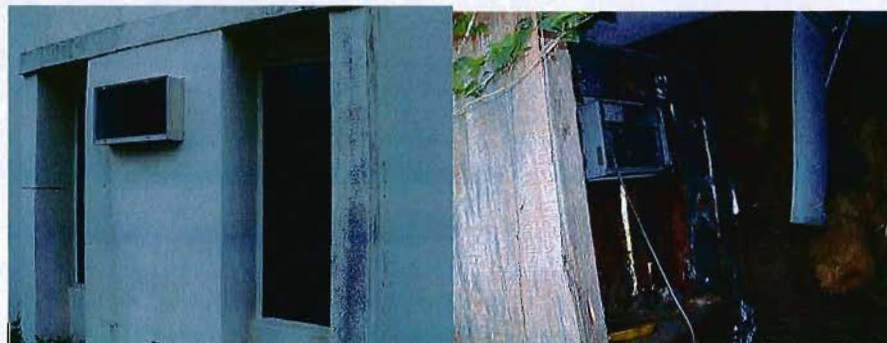
The PTAC units that have not been removed are beyond their useful life. None of the equipment was operational during the site visit.

Condition of PTAC Units

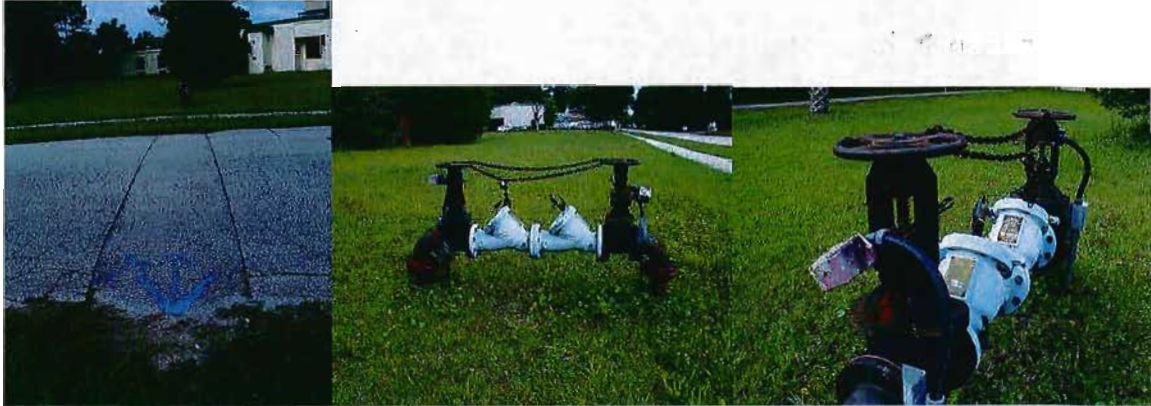
The water service to the building was through a 4" line feeding from the west end of the building. It appeared to need corrosion control performed on it but otherwise appeared operational. This line also fed the fire suppression system in 1/4 of the patient wings. Generally the building is not sprinkled other than a few specific areas that appeared to have been renovated near the end of the facilities use. There is a fire department connection on the East and West ends of the building.

Potable Water Entrance

Plumbing will require new fixtures to be tied into existing waste vent and water lines. The water meter and backflow preventer should be tested and possibly replaced if found lacking. The waste lines will need to be cleaned out to the closest manhole outside the building. New restrooms will be provided and regardless of the location will require the floor to be removed to tie into existing waste lines. Abandoned waste lines should be filled and capped to prevent future issues.

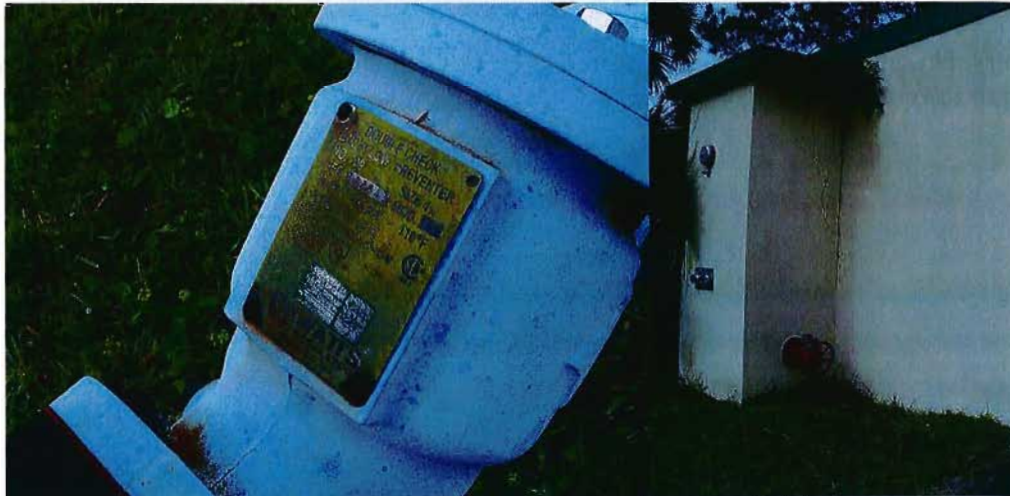
Potable Water Check Valve (left) FDC and Entrance (right)

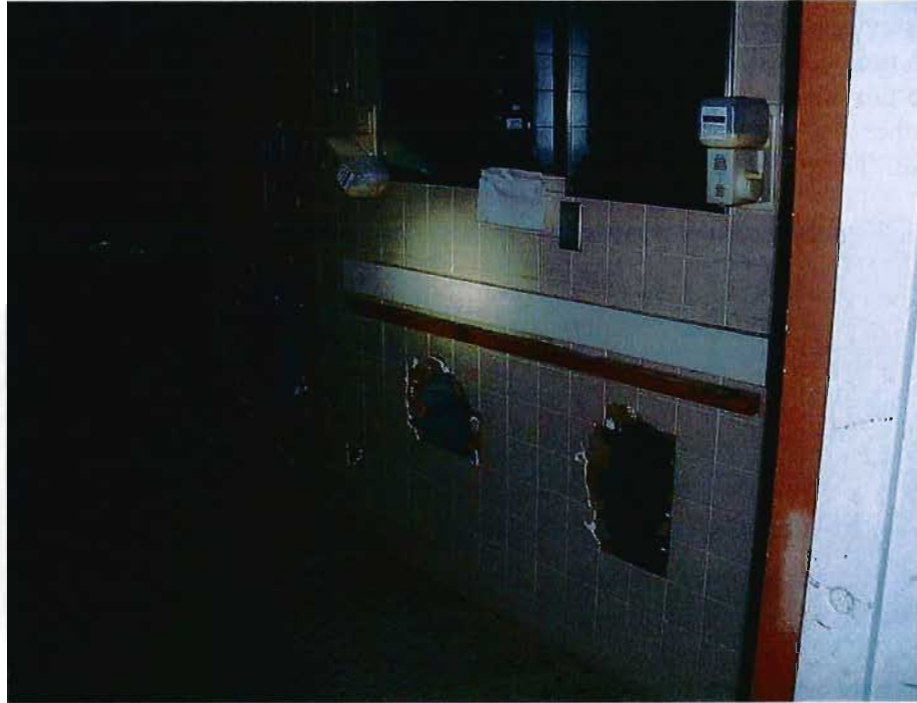
Plumbing fixtures have been vandalized to access plumbing piping in the building so that it could be salvaged. Most, if not all, of the copper has been removed, destructively damaging waste and vent piping in the process in addition to wet walls and fixtures.

Typical Plumbing Conditions

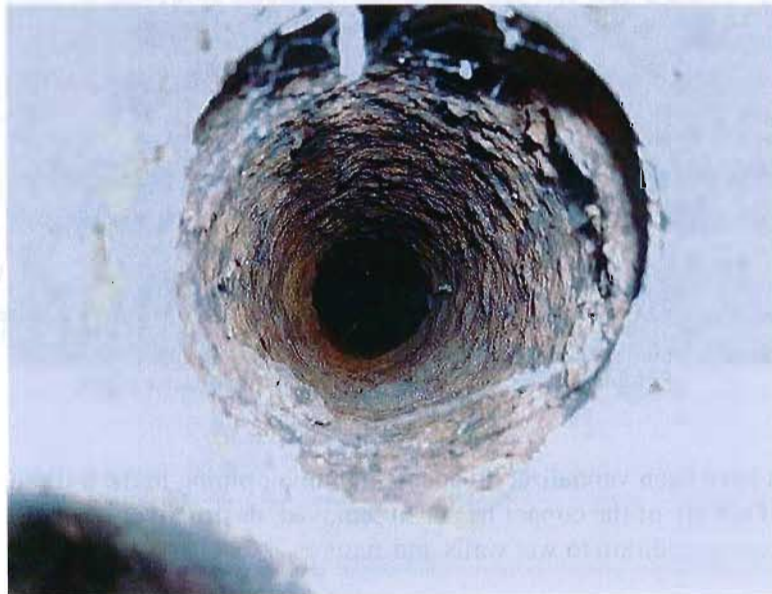
All observable sanitary sewer lines appeared to be clogged with debris and floor drain traps were clogged or have dried.

Typical Floor Drain

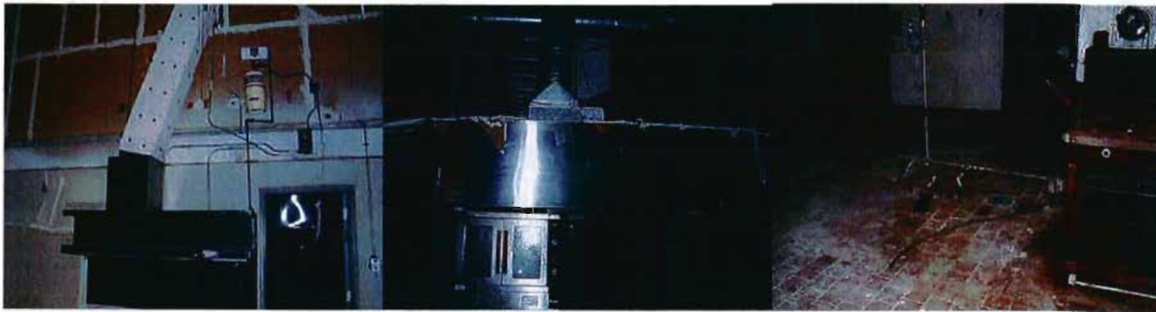
There were kitchen hoods on site that appeared to be in fair condition. The roof top fans however were not in good condition and at the end of their useful life. The kitchen equipment in the building

was corroded past renovation. One **Ansul** fire suppression hood system appeared to be pressurized. The larger system has been discharged.

Kitchen Equipment

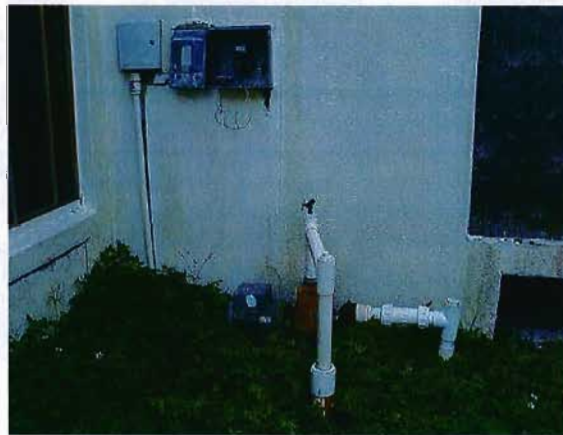
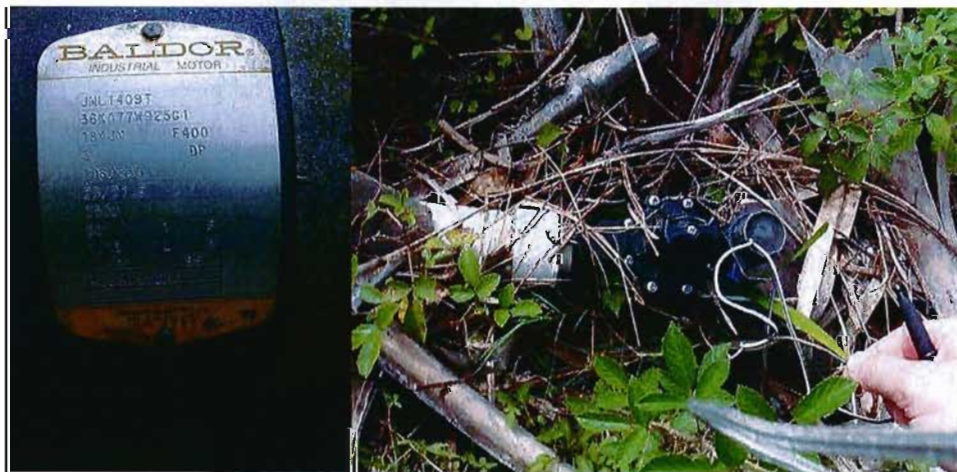
The sprinkler pump appeared to be near the end of its useful life; the electrical had been stripped feeding the pump along with the wiring to zone control valves. One valve appeared new but it was not indicative of the system and was not connected to a controller.

Irrigation Pump and Typical Zone Control Valve

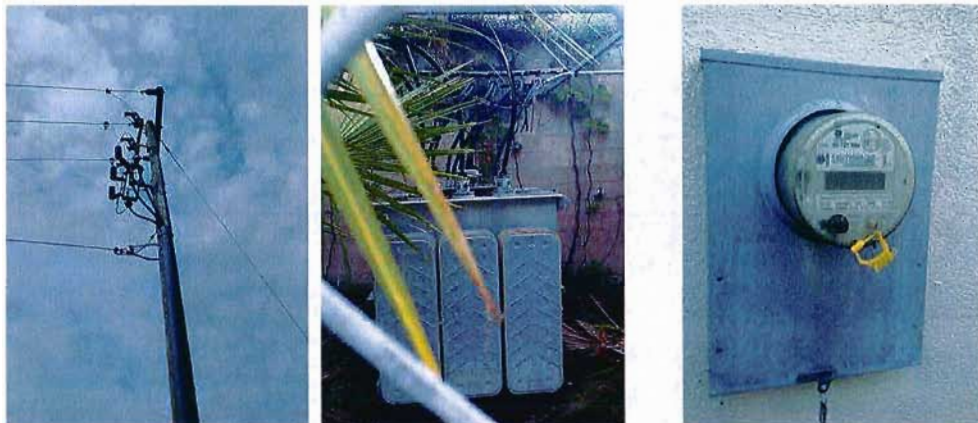
- The building still has a medium voltage drop from the power company (FPL) that terminates in a 700KVA pad-mounted sub-station type transformer located in an enclosed yard. The primary cables and secondary cables are still active.

FPL Service

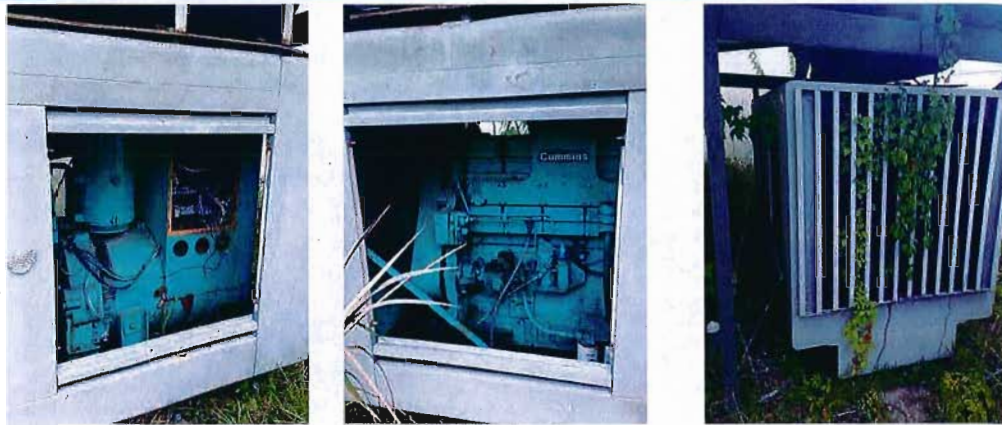
- The building had a 300 kW diesel fueled emergency generator. Most of the electrical components of the generator have been vandalized and/or removed. The remaining engine and enclosure have deteriorated, apparently due to weather and non-use.

Existing Generators

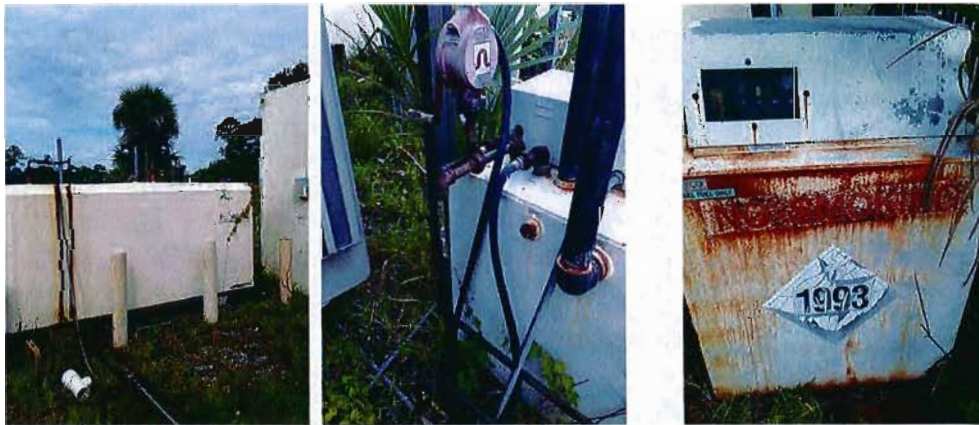
- The emergency generator was fueled from a ground mounted 2,000 gal. Convault tank and a fuel pump. Both the tank and pump have deteriorated, apparently due to weather and non-use.

Generator Fuel Tank and Pump

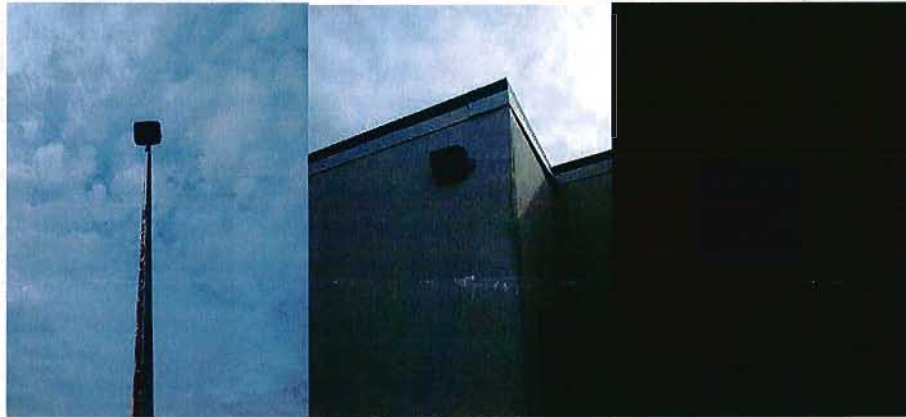
- The parking lot of the facility has only about four (4) pole mounted lights, these appear deteriorated and the cables have been removed. The building also has lighting mounted on the exterior walls which is also deteriorated.

Exterior Lighting

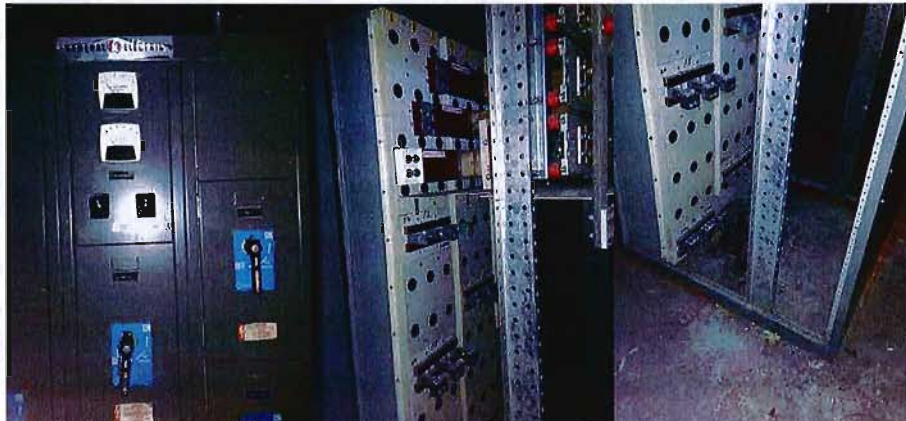
- The building had a 277/480V, 3-phase, 4000 amps service via a floor mounted switchboard located in the main mechanical/electrical room of the facility. This switchboard has been vandalized and most of its major components removed. What remains of this is outdated equipment.

Main Distribution Switchboard

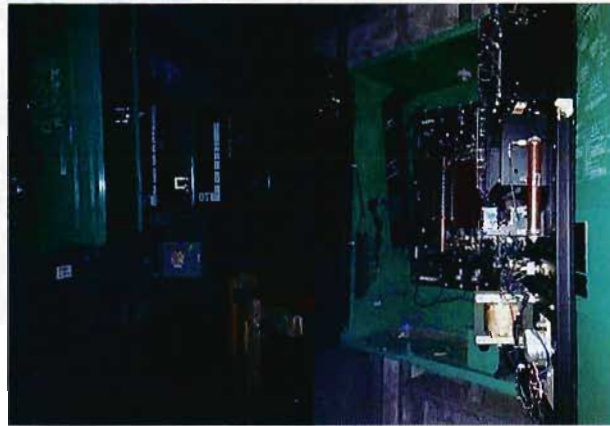
- The building had four (4) automatic transfer switches for the critical and emergency loads commonly found in a hospital building. These transfer switches have been vandalized and most of its major components removed. What remains of these is outdated equipment.

Transfer Switches

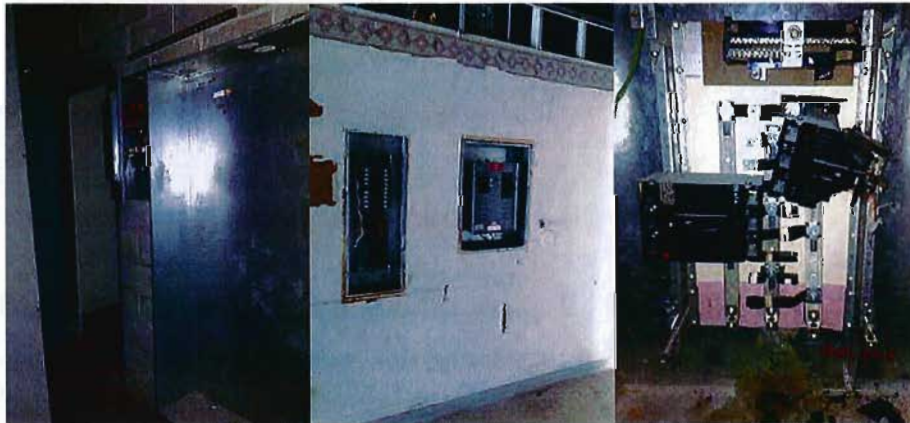
- Most of the building's sub-panelboards were located throughout the facility at strategic locations to serve the different areas. As with most other equipment, these have been vandalized and most of its major components removed. Very little remains of all these sub-panelboards, and the remains are outdated and unusable.

Sub-panelboards

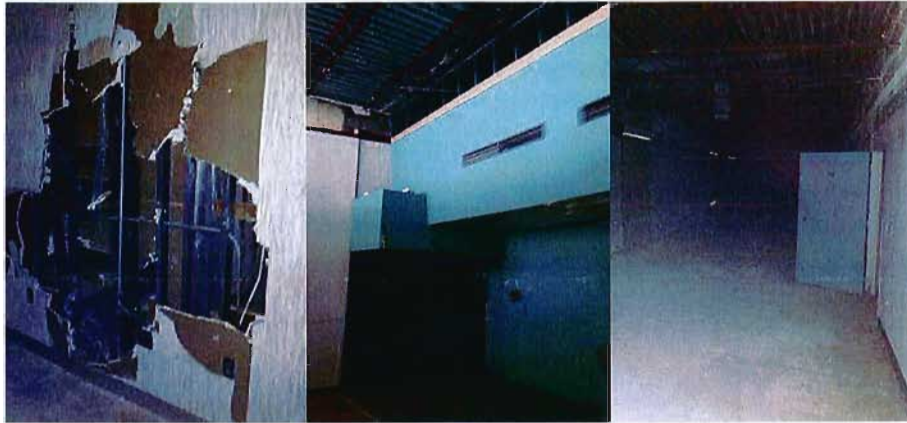
- The majority of the interior wiring has been removed. Most of the interior wiring devices such as receptacles, switches, etc. have also been removed or vandalized. The rooms in the four bedroom wings do not have any devices on them.

Interior Wiring and Devices

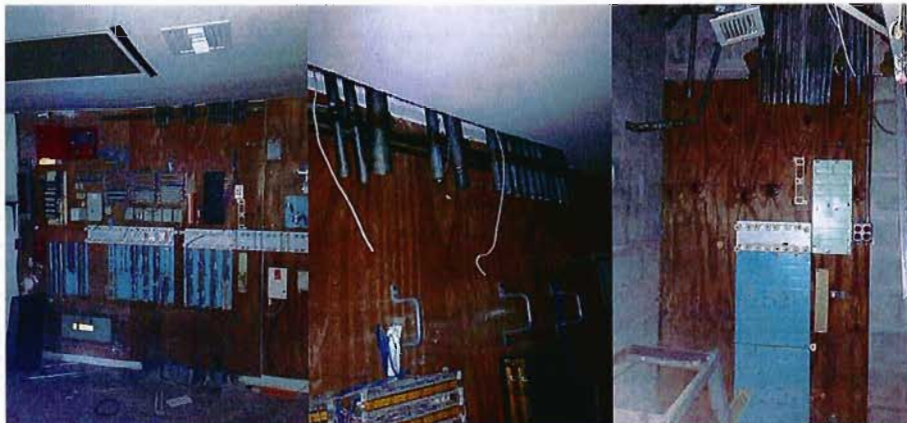
- The building had a main telephone/data room which brought in the provider's incoming services. The room has plywood backboards and the components that remain are mounted to these. Similarly to other systems, the majority of the cabling has been removed, and the devices that remain are vandalized and/or outdated.

Existing Telephone and Data

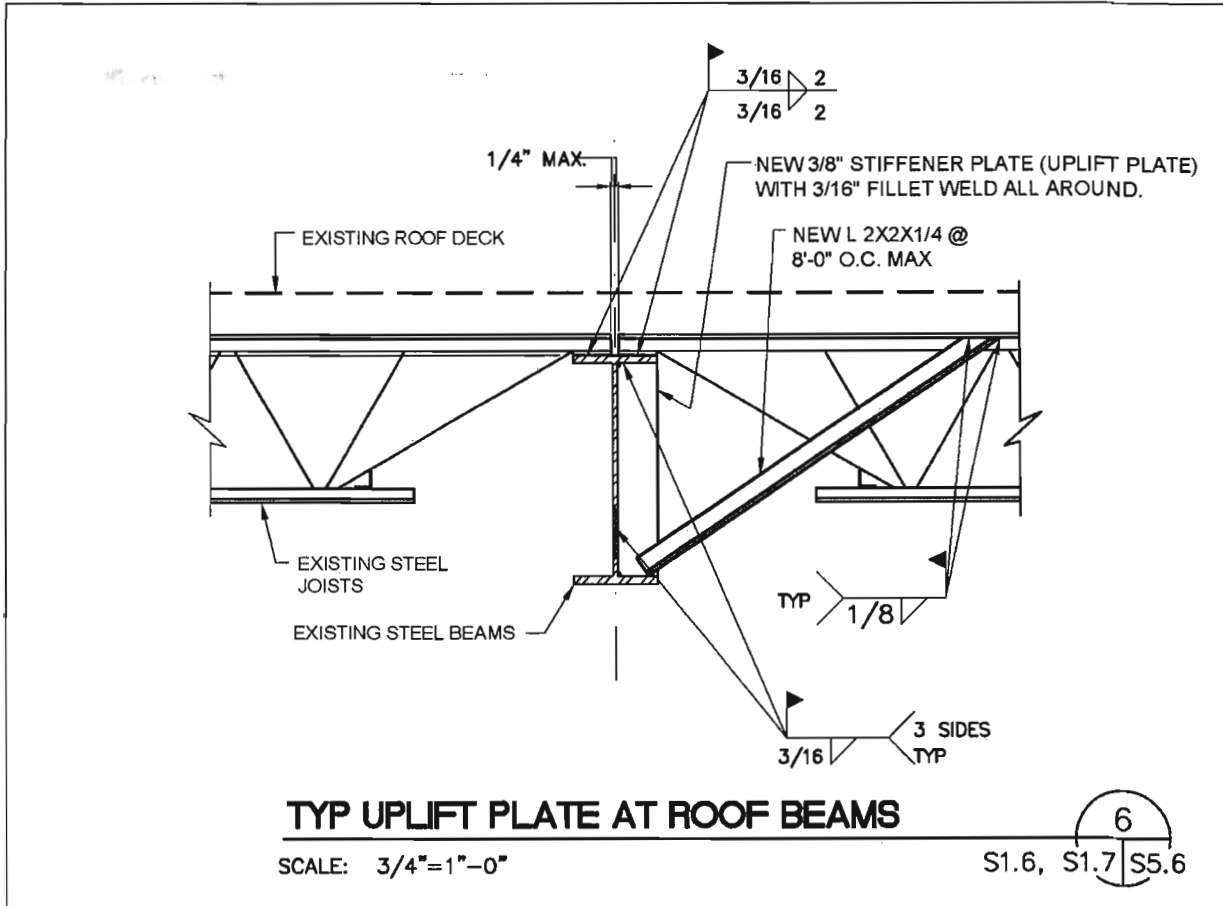
Typical Uplift Plate at Roof Beams Detail

The lack of vertical reinforcement within the perimeter masonry walls reduces the masonry walls’ capacity to resist lateral loads due to C&C wind pressures. Roof uplift due to wind load subjects the bottom flange of the steel beams to compressive stress. The lack of bottom flange bracing reduces the steel beams’ capacity to support the compressive stresses due to roof wind uplift and may cause the steel beams to buckle if overstressed.
