NATIONAL TRANSPORTATION SAFETY BOARD

AIR TRAFFIC CONTROL GROUP FACTUAL REPORT

ERA13FA105

Location: Palm Coast, Florida
Date/Time: Friday, January 4, 2013, 1413 eastern standard time (EST)¹
Friday, January 4, 2013, 1913 Coordinated Universal Time (UTC)²
Airplane: N375B, a Beech H35 Bonanza

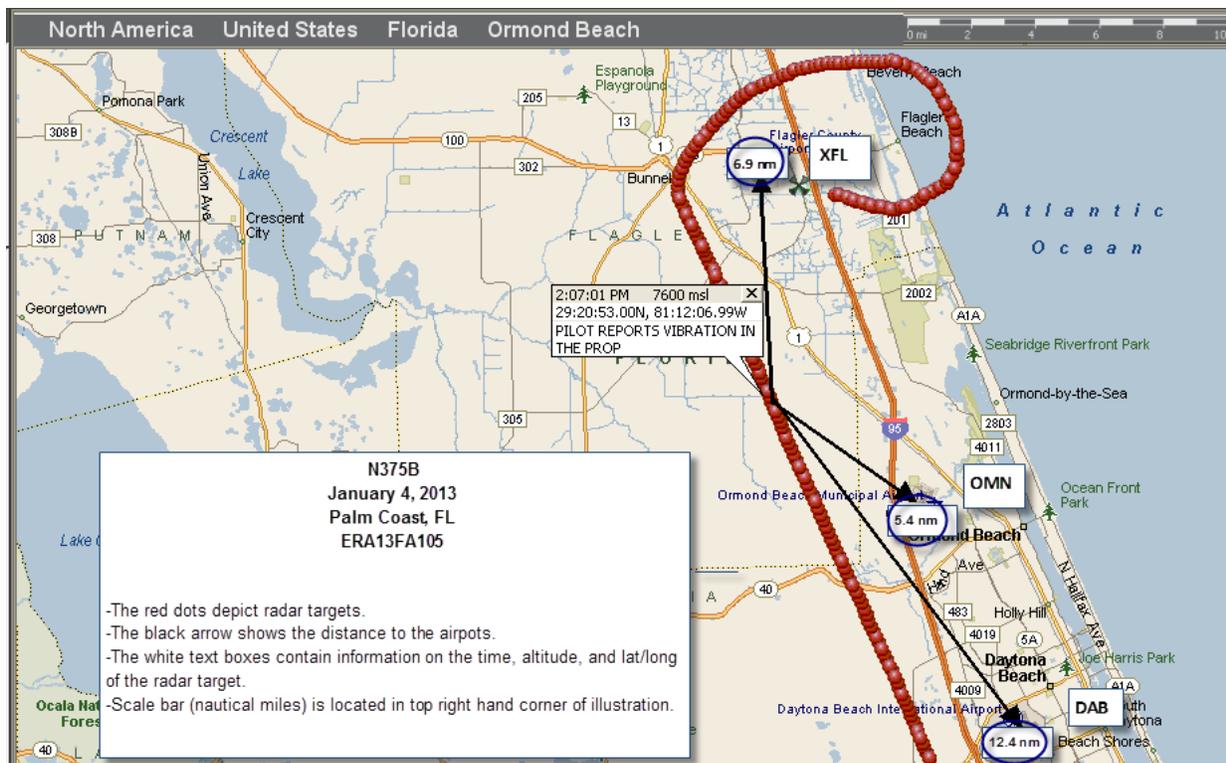
Figure 1. Location of the closest airports to N375B when the pilot reported a vibration.

According to the approach controller, Ormond Beach airport, which was located approximately 6 miles to the southeast of the airplane's position, was considered briefly, however, because runway 8/26 was closed for construction and there had been a strong tailwind for runway 17, that airport was not an option.

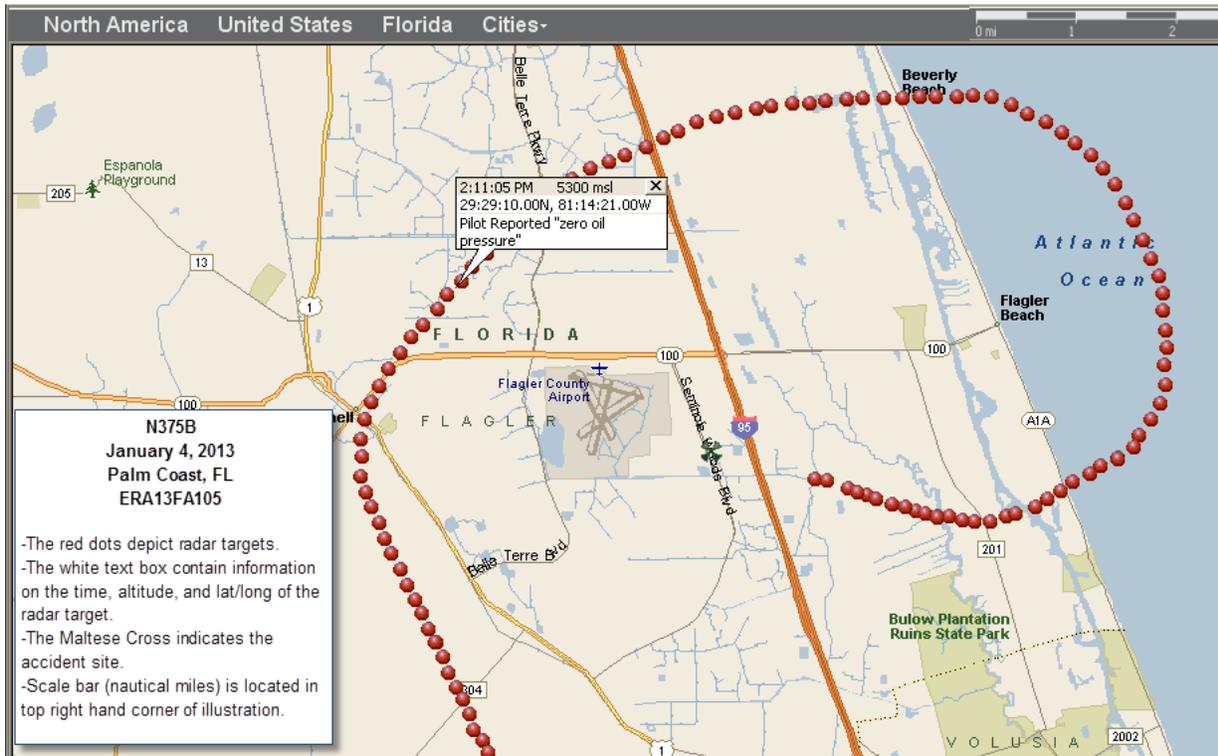
At 1411:06, N375B reported, “...we got zero oil pressure, but we’ve got cool cylinder head temperature.” The arrival controller acknowledged the pilot’s transmission and instructed the

Figure 2. The position of the airplane when the pilot reported, "zero oil pressure."

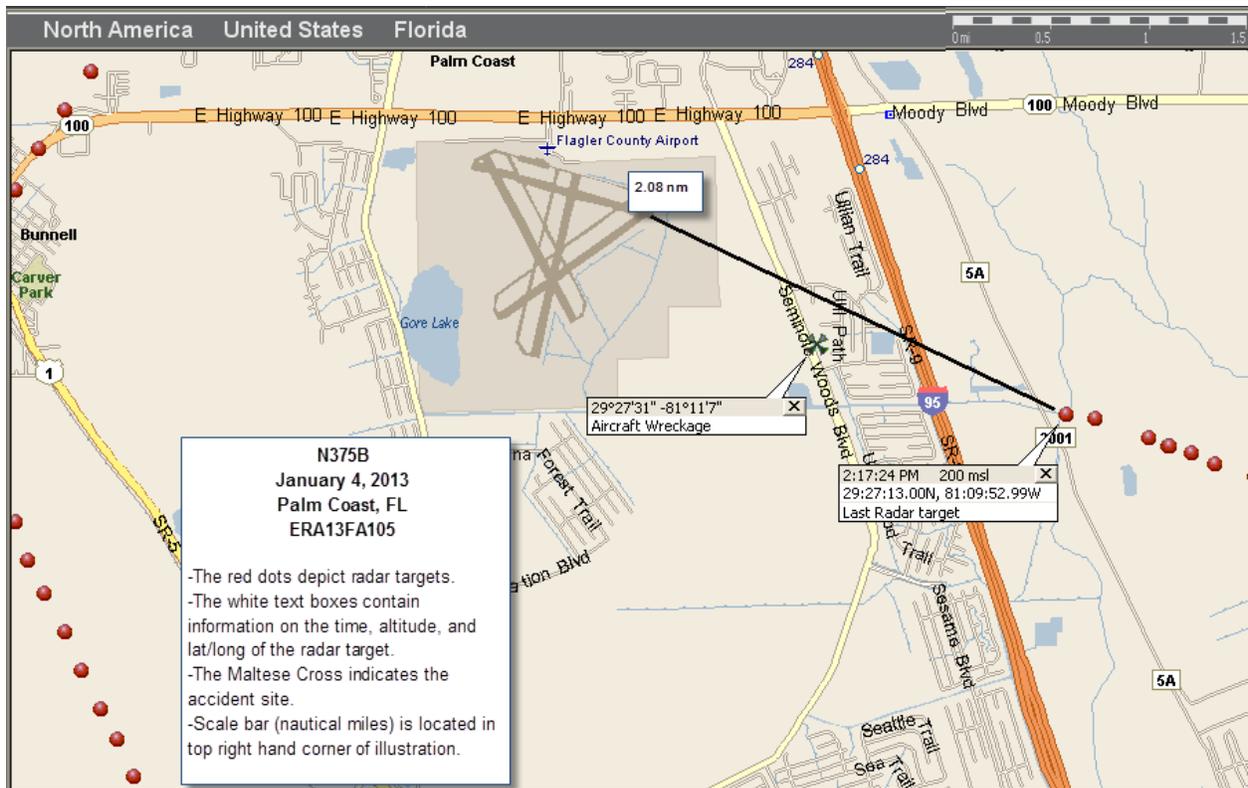
At 1418:55, the Flagler tower controller called the arrival controller and informed him that N375B did not make it. Figure 3 depicts the last radar target and the location of the accident site.

Figure 3. The location of the wreckage and the radar data indicating the last radar target observed.
