October 21, 2022

Re: Fishing Pier-Post Hurricane Ian Assessment Supplement
 FEMA Disaster Declaration DR-4673-FL
 Temporary Pier Closure
 Mott MacDonald Project No. 502100947

**FLAGLER BEACH PIER
POST INCIDENT SAFETY INSPECTION
HURRICANE IAN
OCTOBER 6 - 12, 2022**

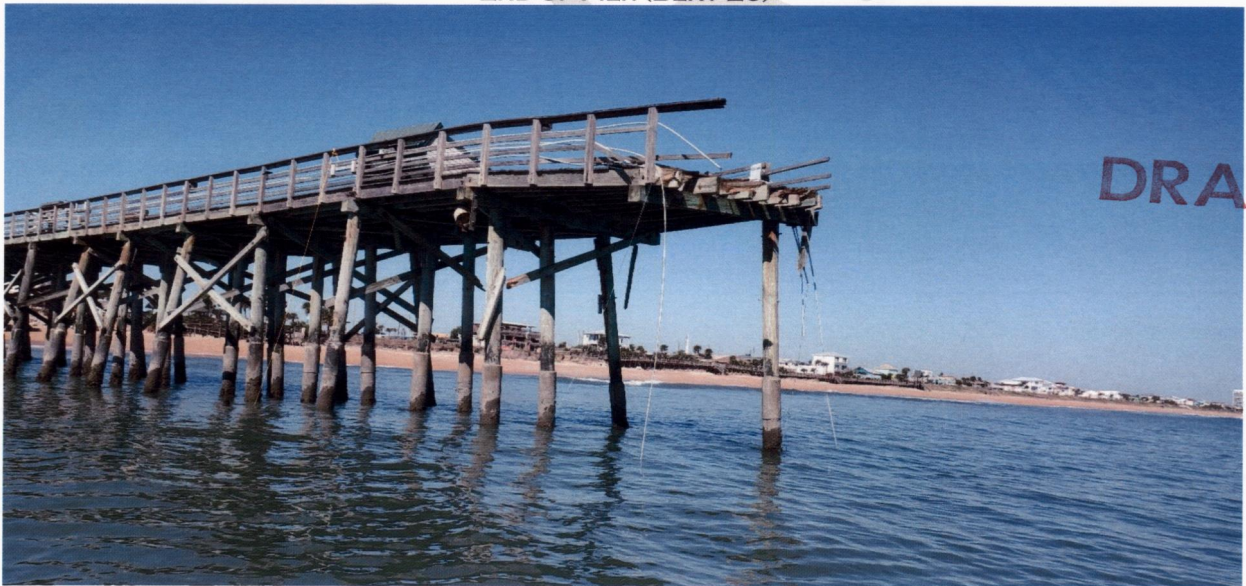
END OF PIER (BENT 20)

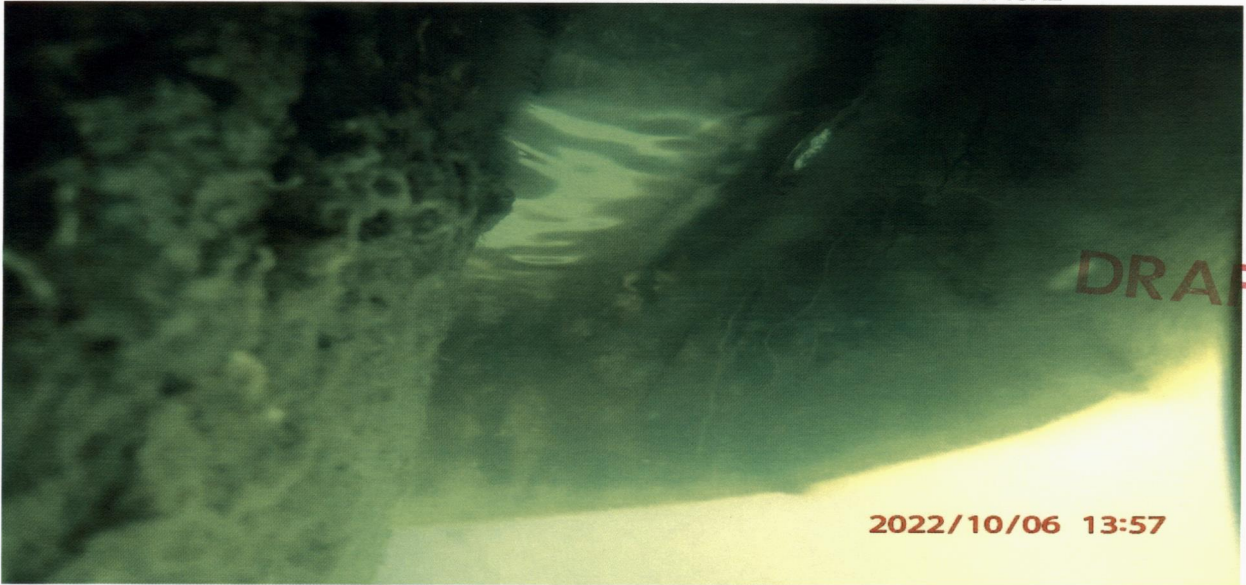
52 PILES HAVE EXCESSIVE SCOUR RESULTING IN SUSPENDED PILE JACKETS. PREVIOUSLY BURIED SECTIONS OF PILING NOW ARE EXPOSED AND UNPROTECTED AGAINST MARINE BORERS. ALL SUSPENDED PILE JACKETS HAVE CEMENT FILL MISSING IN ANNULUS VOID FROM THE BOTTOM UP FOR 6" TO 8".

ANNULUS VOID FROM BOTTOM OF SUSPENDED PILE JACKETS — TYPICAL

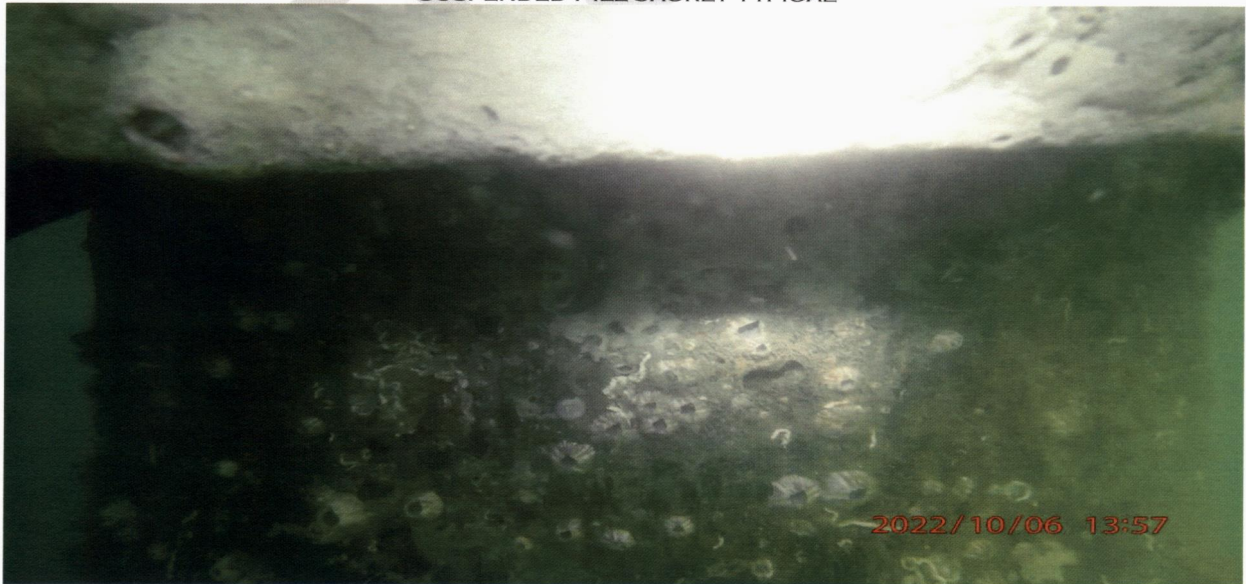
HEAVY SEAS AND CURRENTS EXPERIENCED DURING THE HURRICANE HAVE SCOURED OUT THE GROUND LINE, EXPOSING AND SUSPENDING PAST PILE JACKET REPAIRS FROM 0' TO -7' COMPARED TO POST IRMA GL ELEVATIONS (SEE ATTACHED PILE INSPECTION SHEET).

SUSPENDED PILE JACKET-TYPICAL

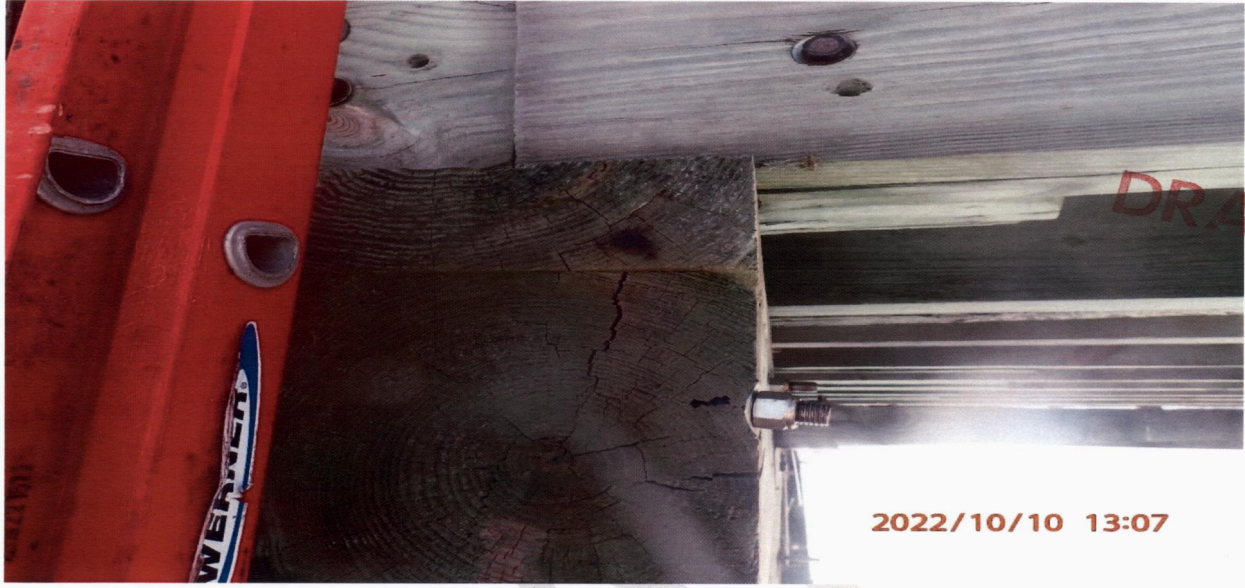
4'x12" SHIM ON TOP OF CAP – TYPICAL

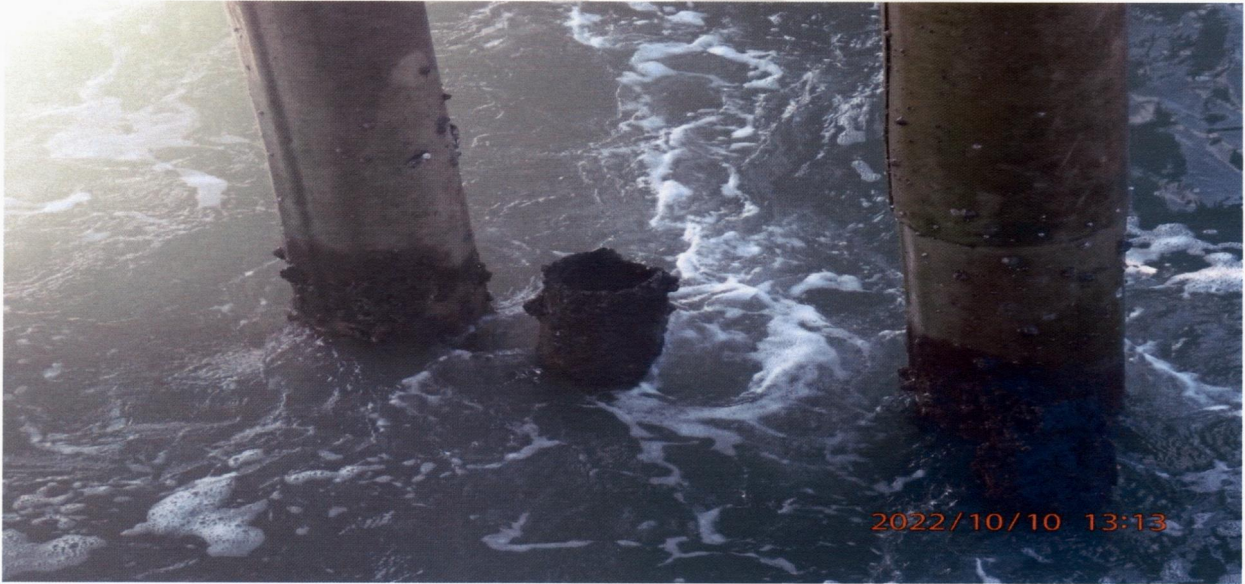
AFTER SCANNING, DIVERS LOCATED AND INSPECTED THE PILES FOR REFERENCE. DIVERS NOTED ALL THE PILES THAT WERE FOUND WERE APPROXIMATELY 3'-4' ABOVE THE GROUNDLINE. THEY NOTED HOLLOW CENTERS WITH HEAVY HARD MARINE GROWTH INSIDE AND OUT. DIVERS SET 2 BUOYS ON THE MOST EASTERN EXPOSE PILE STUBS, ONE ON THE NORTH AND ONE ON THE SOUTH.

EXPOSED HOLLOWED PILE STUB ABOVE GL – TYPICAL

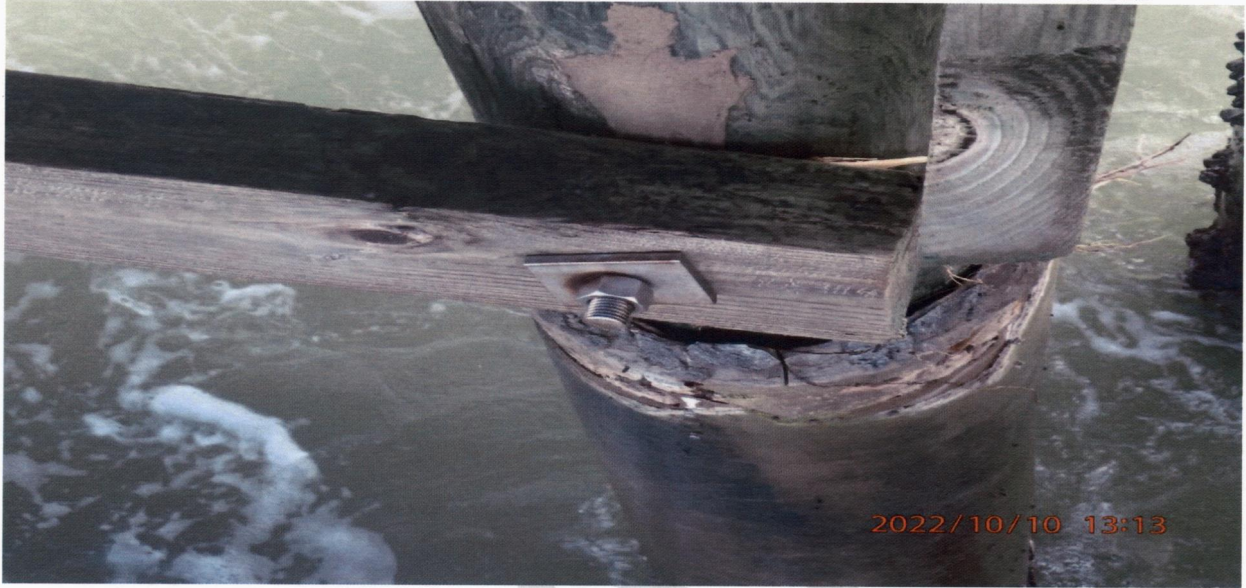
STAINLESS STEEL MOUNTING HARDWARE – TYPICAL , NOTE PILE TOPPING DISPLACED

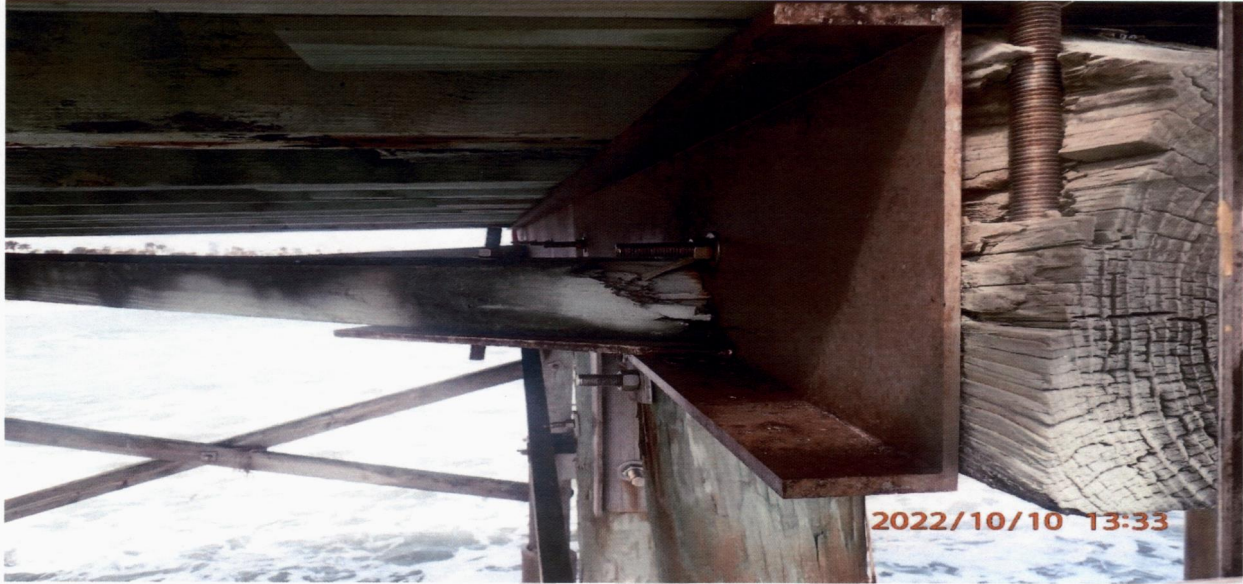
BENT 39 CAP REPAIR WESTSIDE

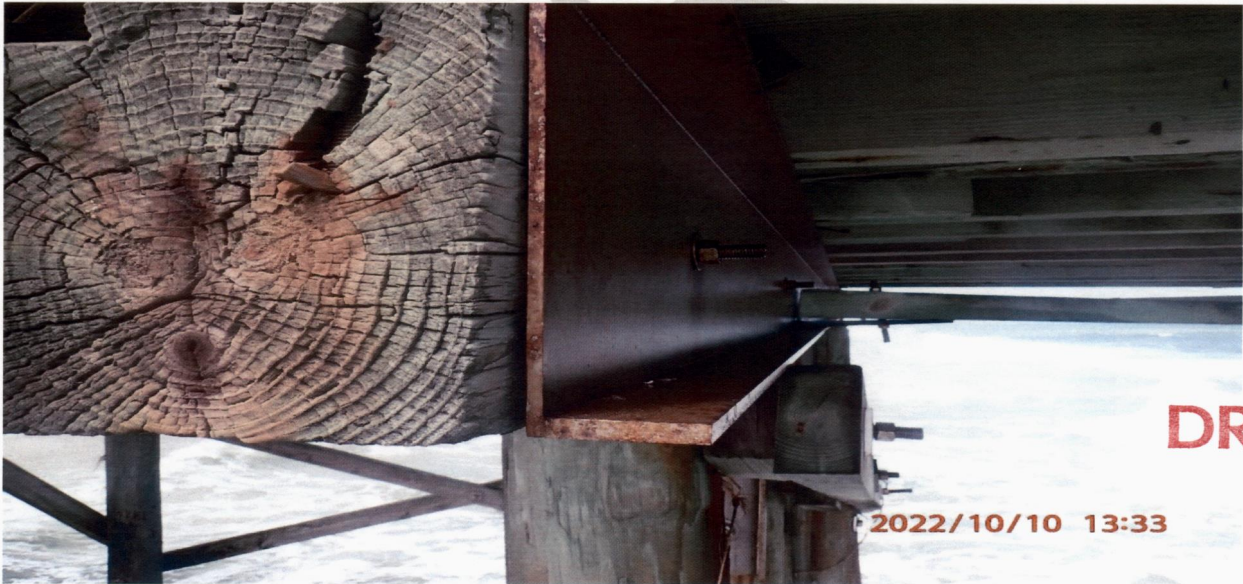
BENT 39 CAP REPAIR EASTSIDE

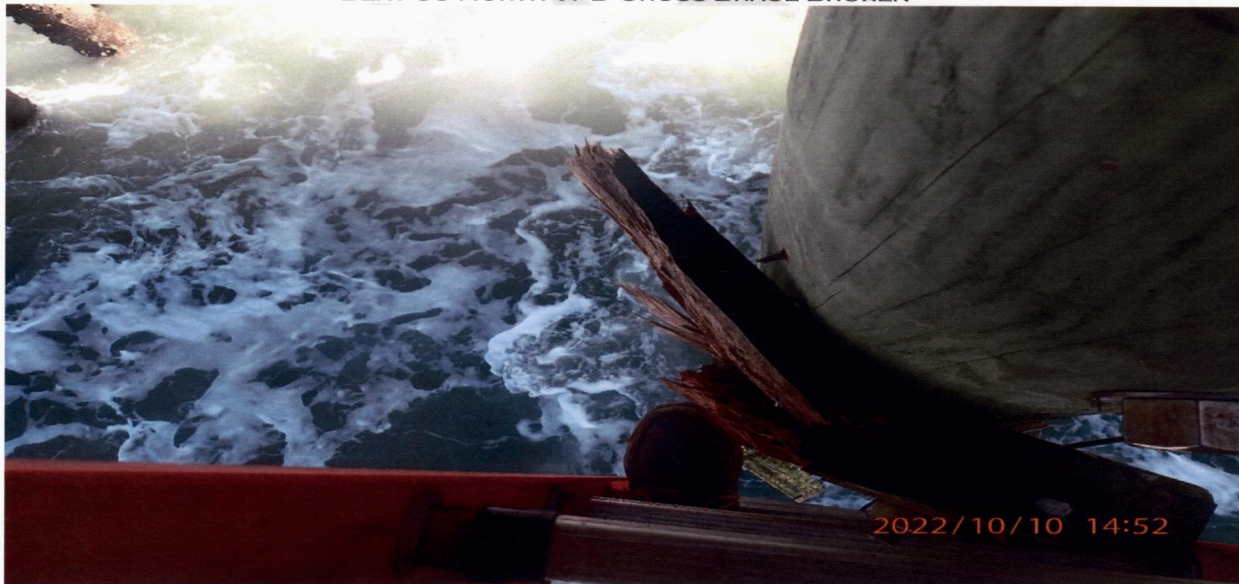
BENT 38 NORTH V/D CROSS BRACE BROKEN

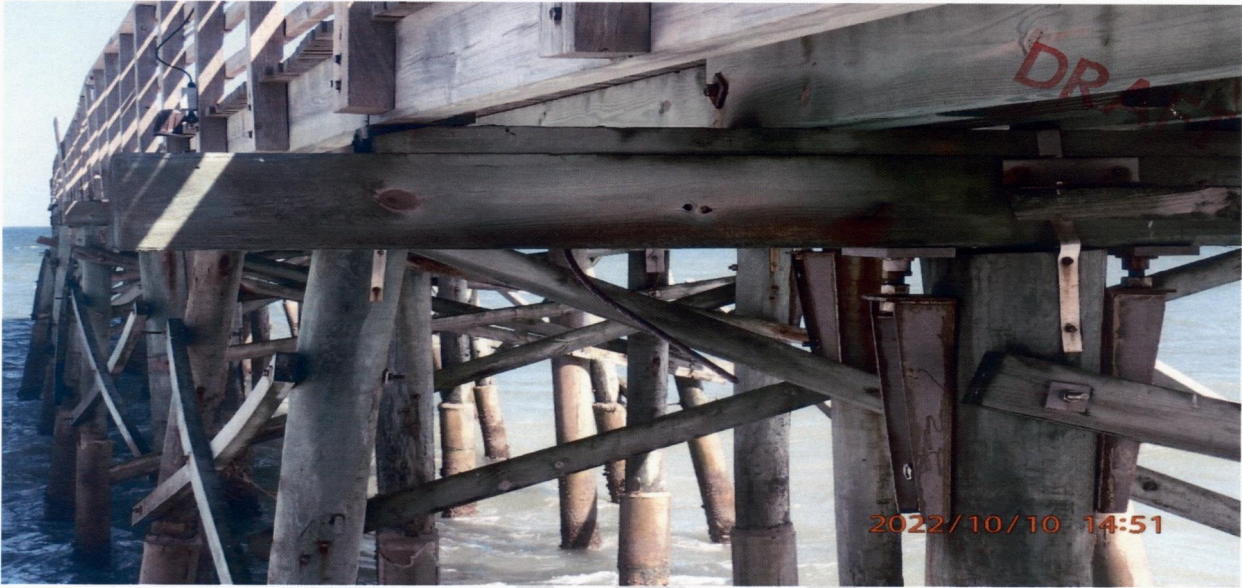
MAJORITY OF THE MISSING OR FAILED SUBSTRUCTURE MEMBERS ARE BETWEEN BENTS 26 AND 38. NORTH PILES 'B' ON BENTS 26 AND 37 ARE MISSING, VISIBLE HARDWARE IN PREVIOUS LOCATION FOUND UNDER CAP BEAM (SEE PHOTOS BELOW). SEVERAL VERTICAL DIAGONAL AND HORIZONTAL CROSS BRACING WERE ALSO FOUND MISSING/BROKEN (SEE ATTACHED PILE INSPECTION SHEETS).

BENT 37 PILE B MISSING

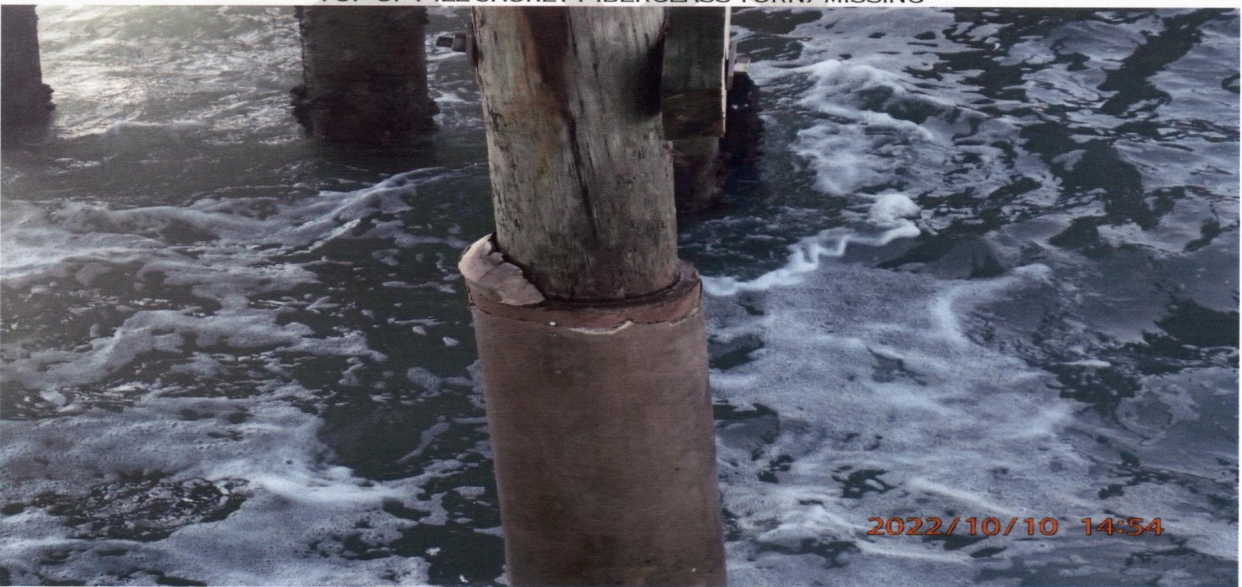
THE MAJORITY OF TOP EPOXY SEALS ON EVERY PILE JACKET ARE BROKEN/ CRACKED/ MISSING/ FAILED, LEAVING AN ANNULAR SPACE OF TRAPPED SEAWATER.

TOP EPOXY SEALS ON EVERY PILE JACKET ARE BROKEN/ CRACKED/ MISSING/ FAILED — TYPICAL TOP OF PILE JACKET FIBERGLASS TORN/MISSING

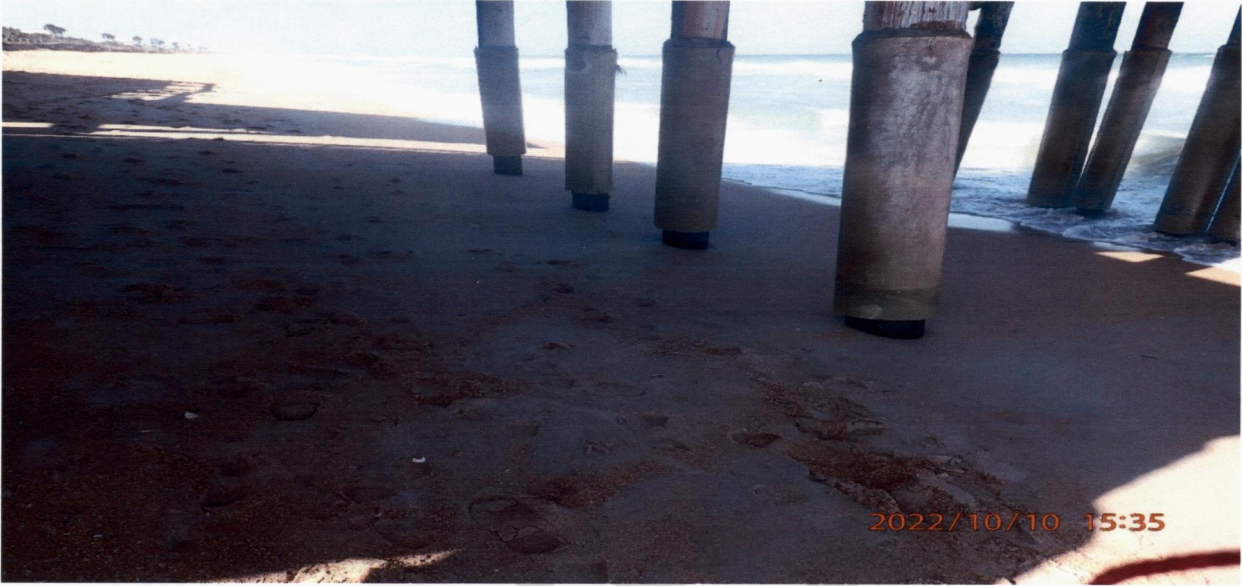
SUSPENDED PILE JACKETS — TYPICAL

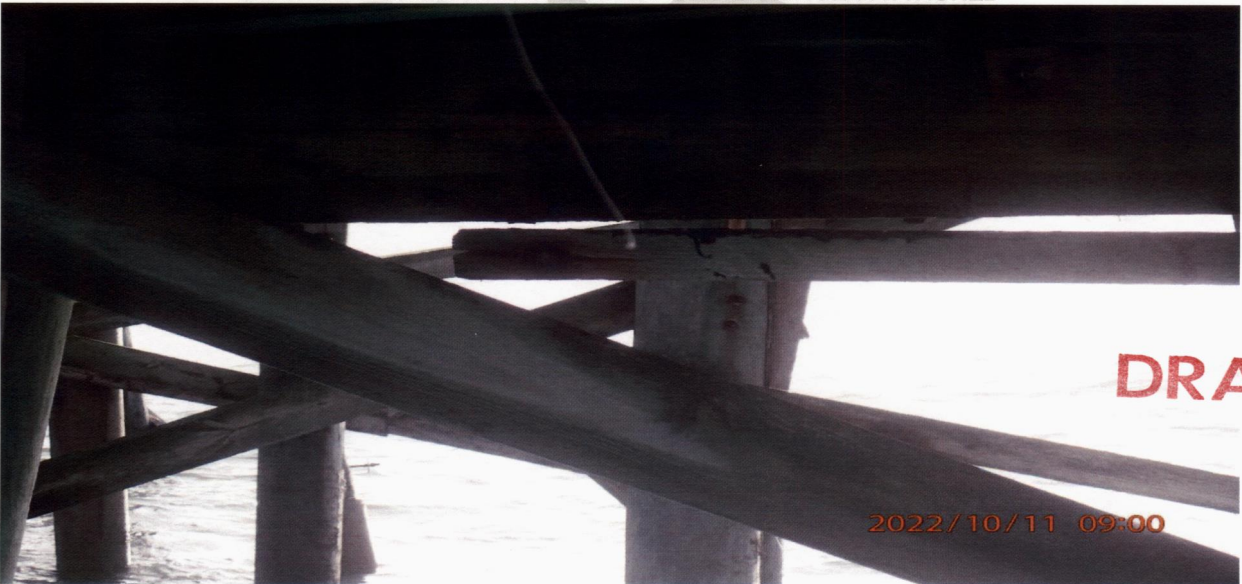
BENT 37 HORIZONTAL CROSS BRACE NO LONGER ATTACHED

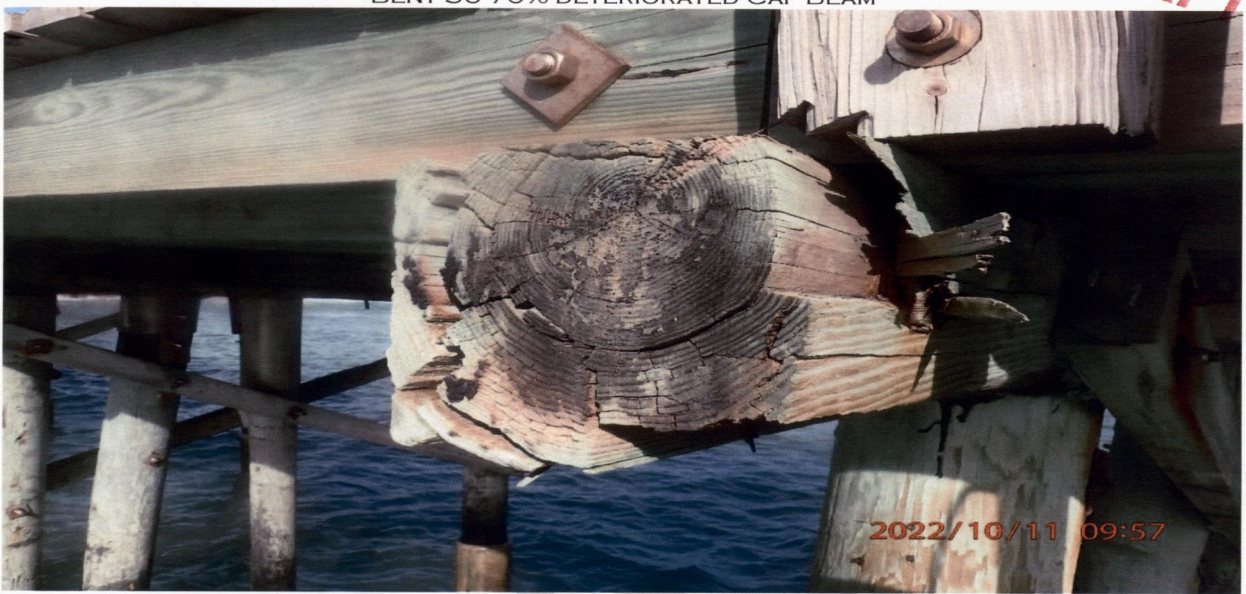
BENT 36 70% DETERIORATED CAP BEAM

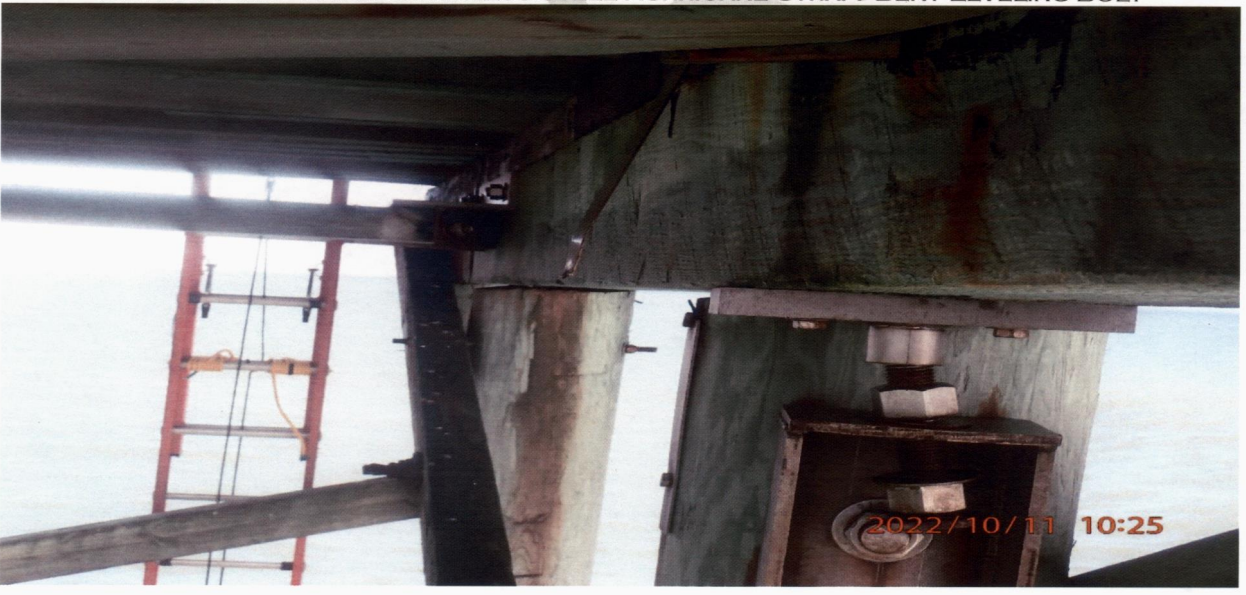
BENT 35 PILE F FAILED STAINLESS STEEL HURRICANE STRAP/BENT LEVELING BOLT

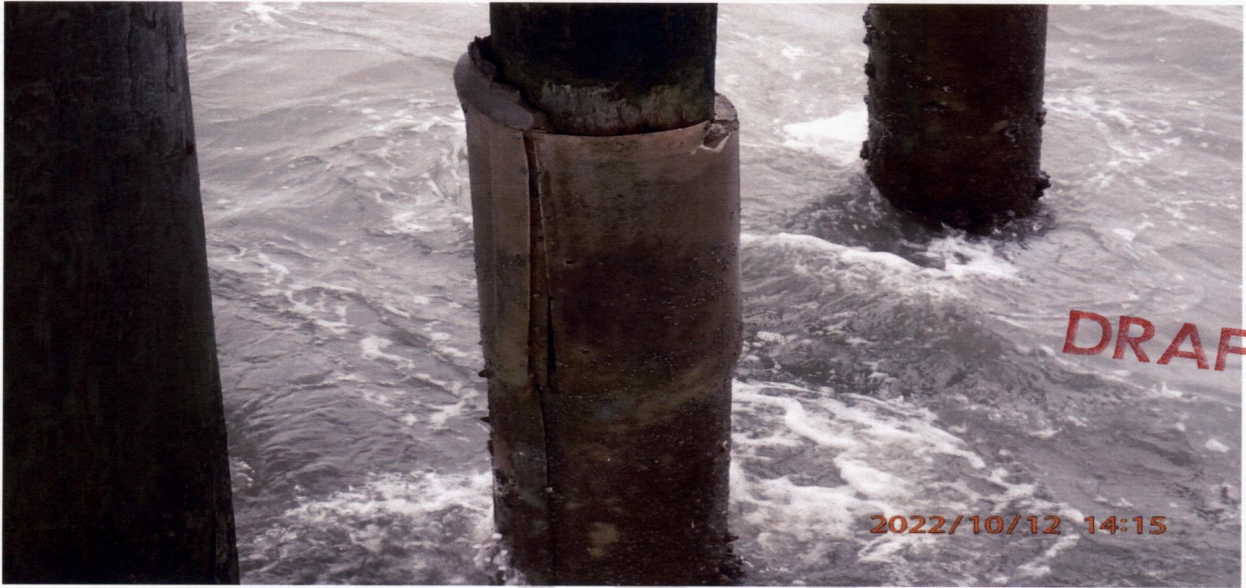
BENT 23 PILE D UPPER SECTION OF PILE JACKET SEAM SEPARATION

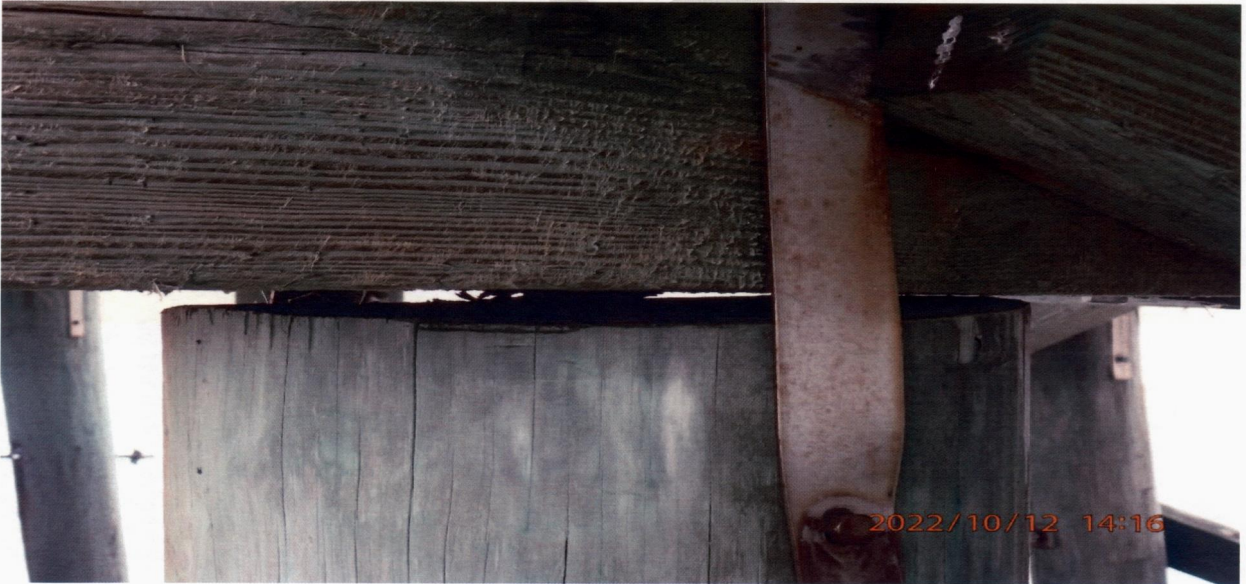
23 PILES WERE FOUND TO HAVE GREATER THAN 50% OF THE PILE NOT TOUCHING THE CAP BEAM, 13 OF THOSE 23 PILES HAVE 100% OF THE PILE NOT TOUCHING THE CAP BEAM. 13 PILES ARE PROVIDING NO SUPPORT TO THE CAPS, STRINGERS, AND DECK (SEE ATTACHED PILE INSPECTION SHEETS).

PILE 100% NOT TOUCHING THE CAP – TYPICAL

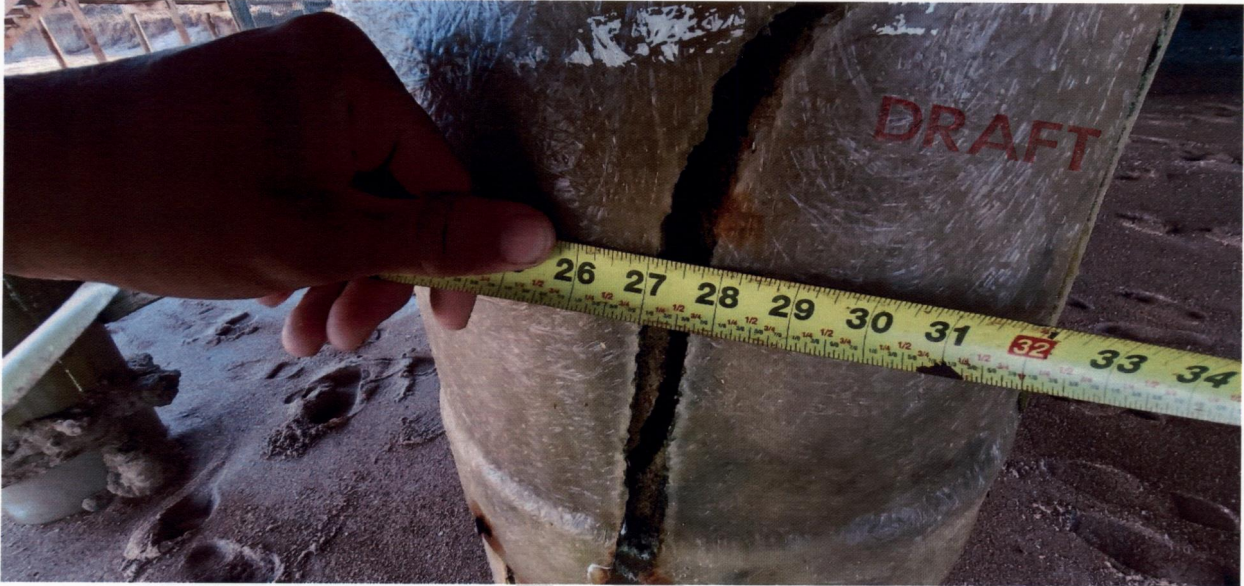
BENT 49 PILE F 5'x3" DEEP CRACK ~ 2'+ GROUT CRACK LENGTH

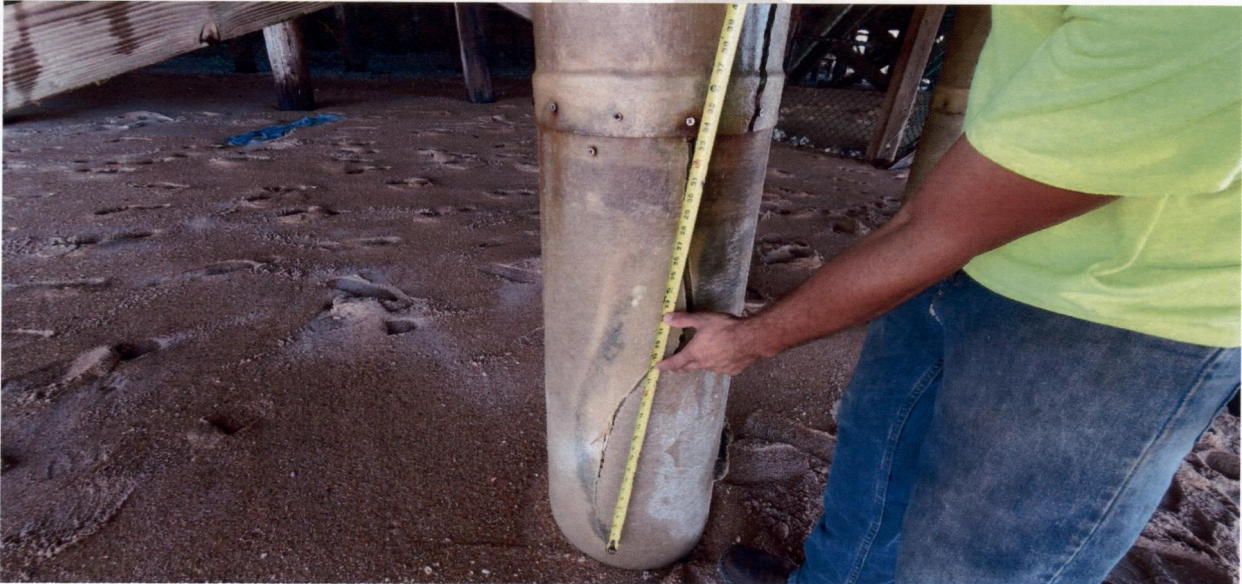
BENT 49 PILE F 5'x3" DEEP CRACK

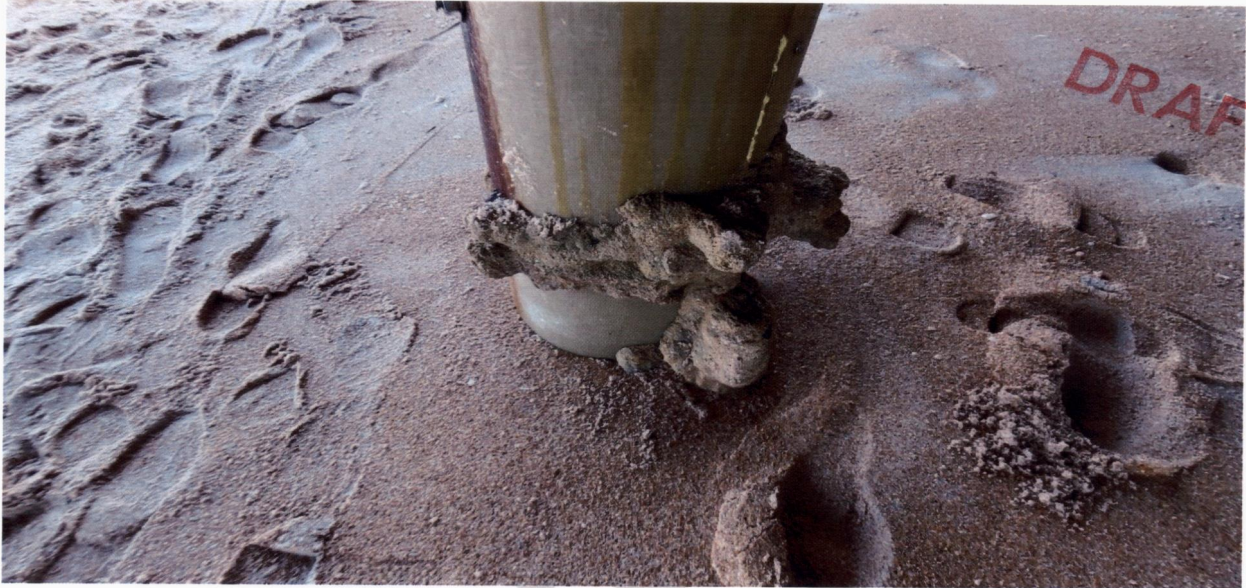
BENT 49 PILE H OVER POUR
