STORMWATER

Presented to Palm Coast City Council July 26, 2011

Infrastructure Inventory for Stormwater Drainage System

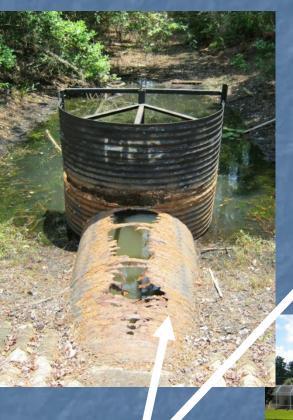
L-1 Structure Structural Rate = 6

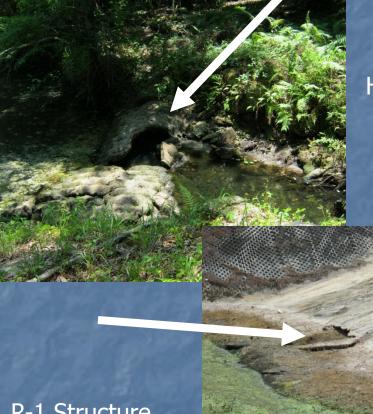
M-2 Structure Mulberry Creek Hazard Rating = 1

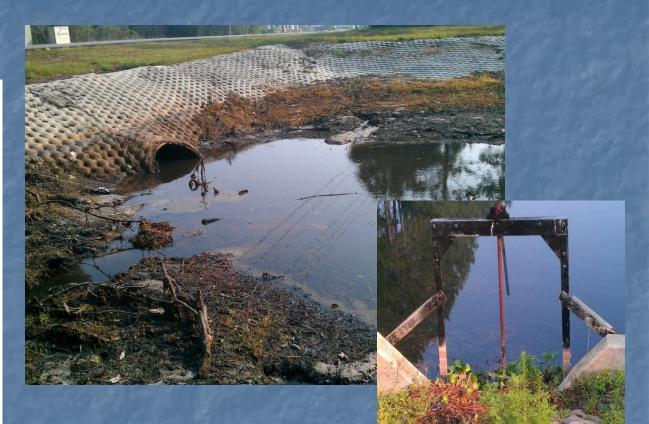
BT-2 Structure – Total Rating = 11 Bird of Paradise Drive on Bellaire Waterway Deterioration is Underwater

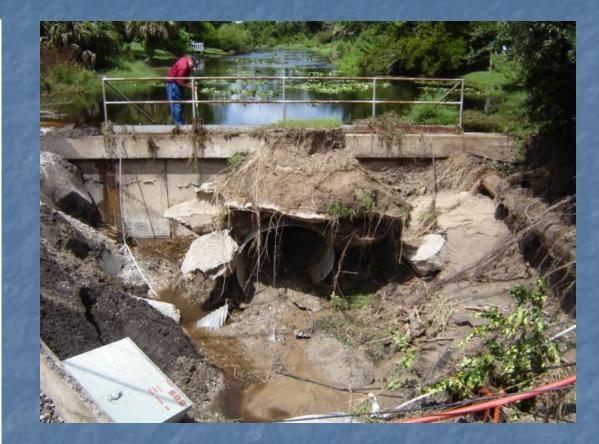
Emergency – Florida Park Drive June 2010 Cost \$666,244
