# Supplemental Moisture Intrusion and IAQ Report

Flagler County Sheriff's Operations Building  
901 E. Moody Blvd.

October 28, 2019

Terracon Project No. F9196079

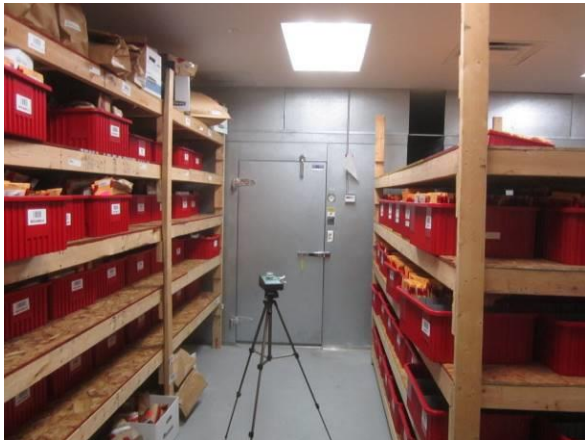
No elevated mold spores were identified in the follow-up air sample collected from the evidence cooler room after the mold removal activities were performed. No further evaluation is recommended in this area.

**Photo #1** Air sampling in the evidence cooler room.

- No further evaluation of the localized area of removed mold or air testing is recommended in the Cold Storage/Freezer Evidence Room.
- Contract with a Florida licensed mold abatement firm to clean and sanitize approximately 55 linear feet of old wood framing within the upper enclosed wall cavity behind the wall finishes from the southwest corner of the building and east to approximately 12 feet into the Main Evidence Storage room. The work should be performed in accordance with the EPA guidance document "Mold Remediation in Schools and Commercial Buildings (EPA 402-K-01-001)".

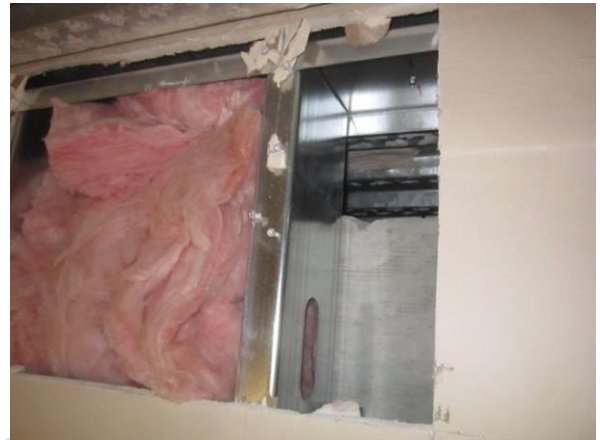
No old wood or old insulation was observed at three of the test cuts within the east and south center wall of the Main Evidence Storage Room or within the west end of the hallway with entrances to evidence rooms.

**Photo #2** Typical view of new fiberglass and metal studs in upper wall cavity cuts in the southeast east portion of the evidence storage room.

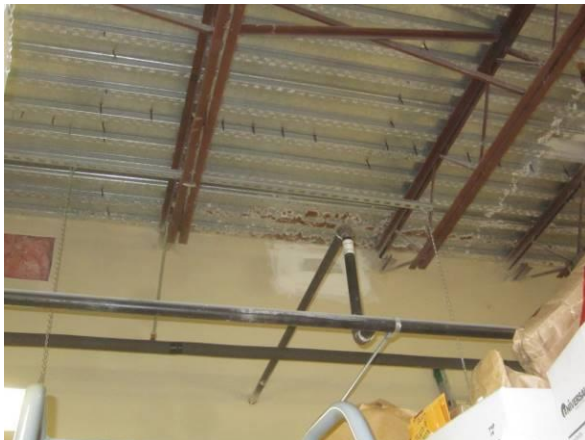
**Photo #3** Corrosion on metal roof deck within the southwest portion of the evidence storage room.

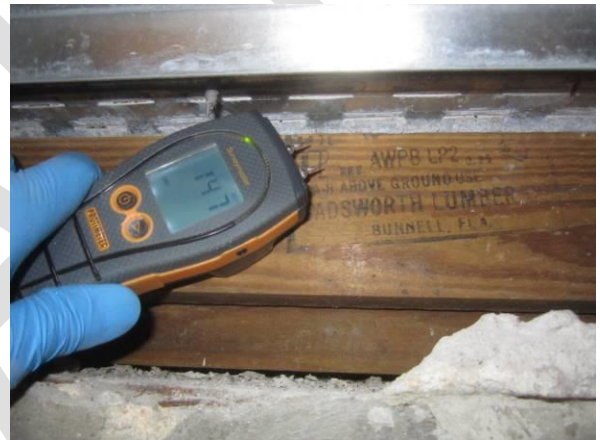
Old wood was observed within an upper wall cut within the southwest corner of the Main Evidence Room and within an upper wall cut along the south side of the Narcotics Evidence Storage Room, which adjoins the Main Evidence Storage Room to the west.

**Photo #4** Dry moisture measurement in old wood framing blocking at top of concrete wall in southwest corner of the evidence storage room.

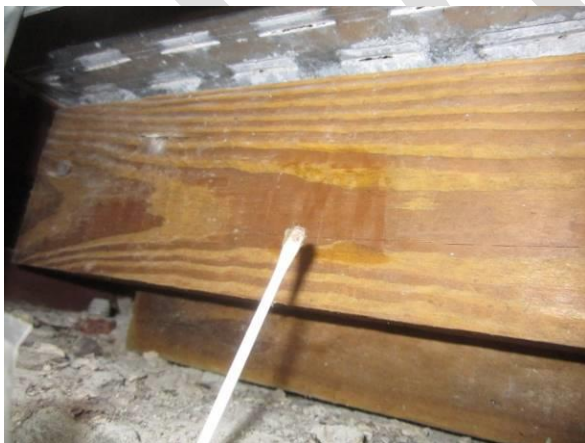
**Photo #5** Swab testing on old wood in old wood in southwest upper wall cavity of Evidence Storage.

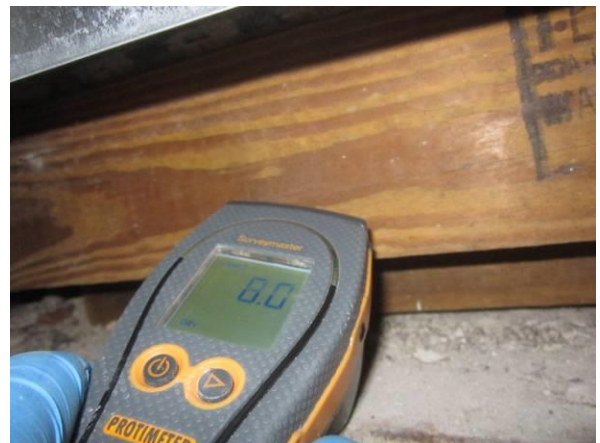
**Photo #6** Dry moisture measurement in old wood in southwest upper wall cavity of Evidence Storage.

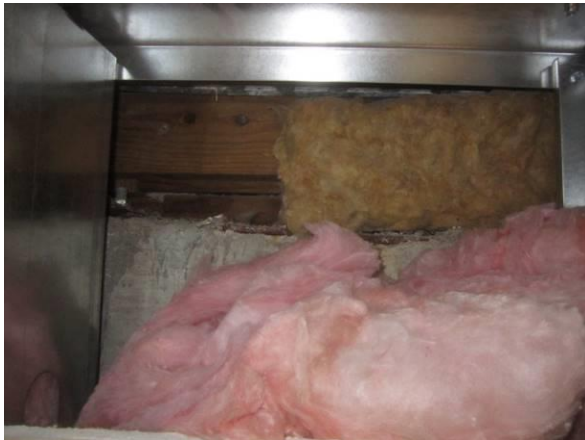
Old yellow insulation was also observed within the Narcotics Evidence Storage Room test cut and in three upper enclosed wall cavities behind the wall finishes along the south wall in Training Room 129. Some staining was observed on the old wood (blocking between the top of the concrete perimeter wall and roof deck); however, the wood felt solid and dry with moisture meter pins and exhibited no obvious visible mold or musty odors. The lower wall test cut through drywall within the southeast corner of Training Room 129 was identified to be from a metal stud wall added in front of the south concrete wall.

**Photo #7** Old wood and insulation along upper south wall in Narcotics Storage.

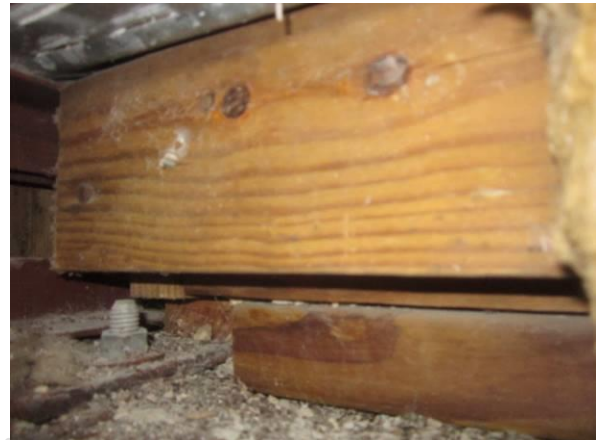
**Photo #8** Close up of old wood blocking on South upper wall in Narcotics Storage.

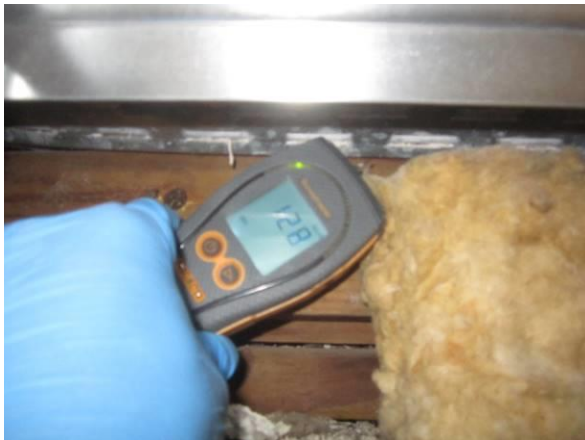
**Photo #9** Dry moisture measurement on old wood on upper wall in Narcotics Storage

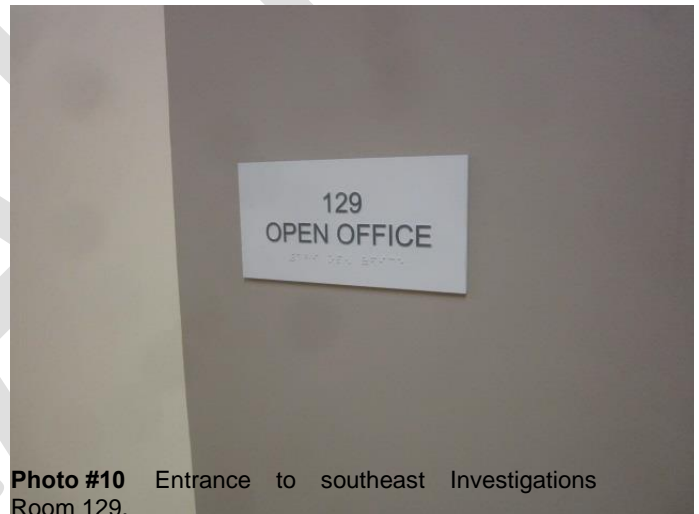
**Photo #10** Entrance to southeast Investigations Room 129.

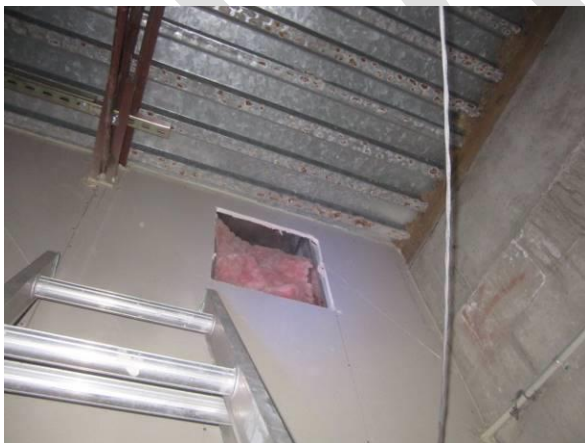
**Photo #11** Upper wall cut at southwest corner of Room 129.

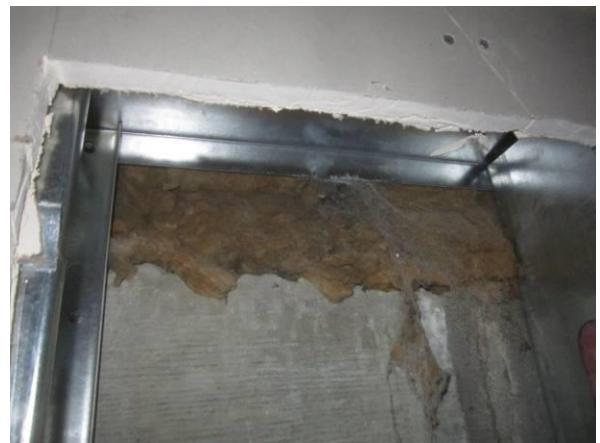
**Photo #12** Old fiberglass on top of concrete upper wall in southwest corner of Room 129.

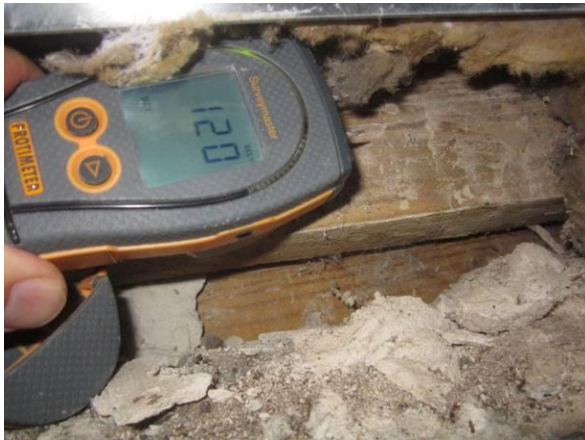
Old wood that exhibited some staining was identified within the upper enclosed wall cavity behind the wall finishes along the south wall in the evidence rooms and southeast Training Room 129. Moderate to high counts of non-viable mold were identified in several tape samples from the old wood. Low viable fungal counts were identified in the Narcotics Evidence Storage room. An elevated fungal count was identified on old wood where bat droppings were identified in the southeast corner of Training Room 129. The old wood appeared solid and exhibited dry moisture measurements.

**Photo #13** Dry moisture measurement in old wood on upper southwest wall in Room 129.

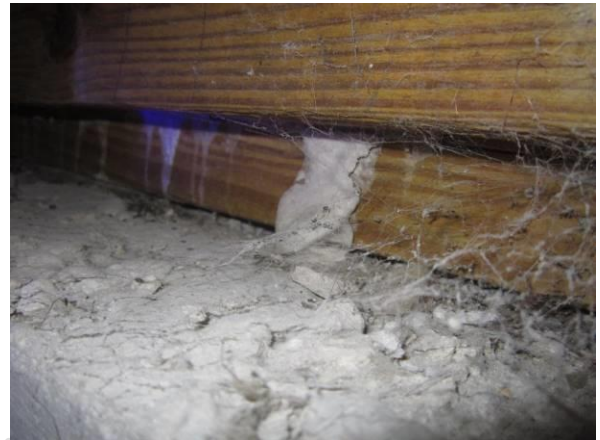
**Photo #14** View of old wood on upper south center wall in Room 129.

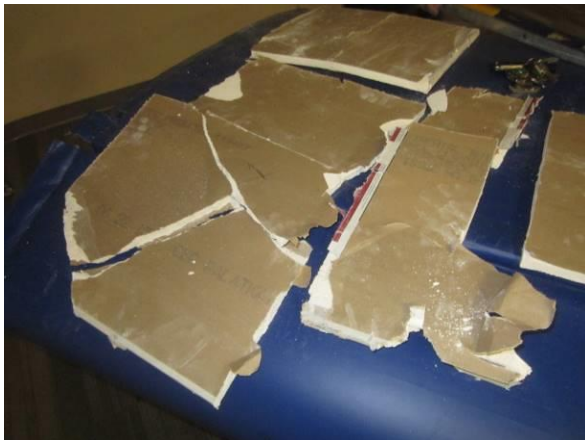
**Photo #15** No visible mold growth on back of drywall at cut locations in Room 129.

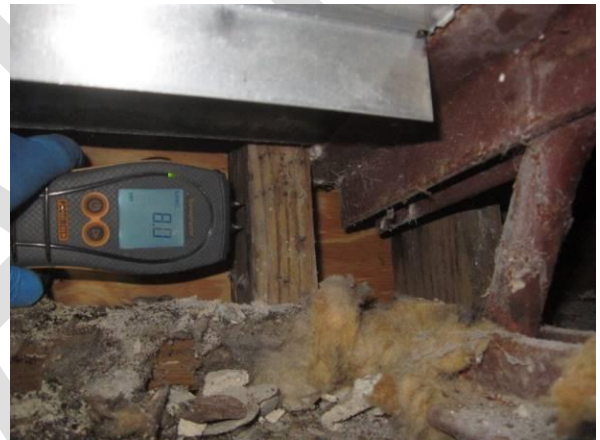
- SE Training Room 129 – Four test cuts. In addition, an approximate 4' x 1' test cut (2 cuts combined into one) was made at the bottom of the SE corner wall below the location of bat droppings observed in the upper enclosed wall cavity behind the wall finishes.

**Photo #16** Dry moisture measurement in old wood by bat droppings at southwest corner of Room 129.

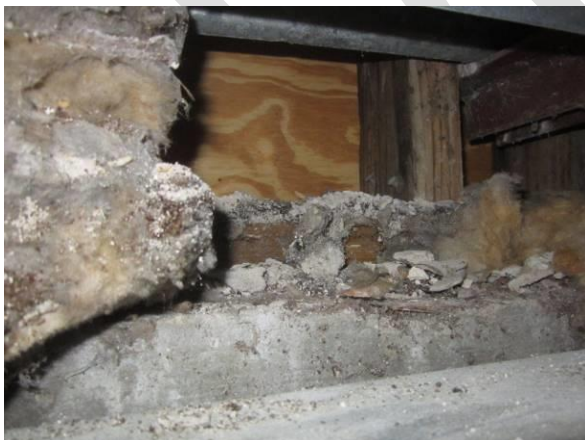
**Photo #17** Bat guano at top of concrete wall in southeast corner of Room 129.

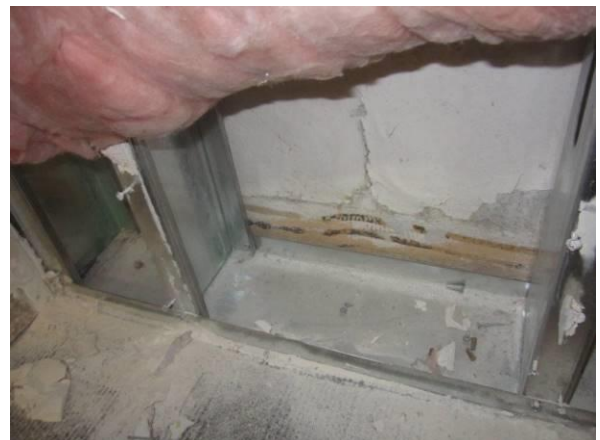
**Photo #18** Concrete wall behind recently built-out gypsum wall at base of southeast wall in Room 129.

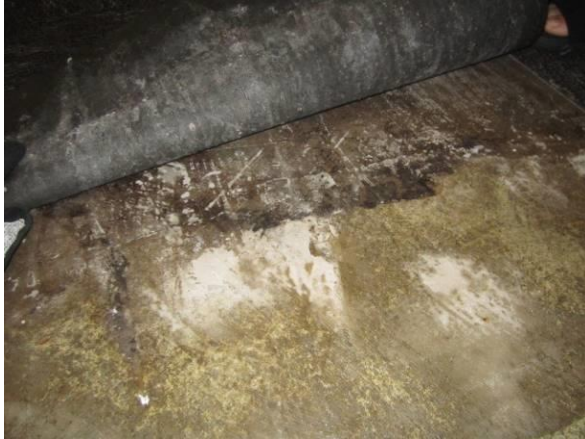
1. Sheriff's Office Room 178 – musty odor and suspect visible growth (SVG) below recently replaced dark carpet square.
2. Room 175 – No moisture, odors or SVG below older gray carpet square.
3. Room 168 – Moist glue, musty odor and SVG below carpet square.

**Photo #19** Visible mold below carpet square by entrance to the Sheriff's Office Room 178.

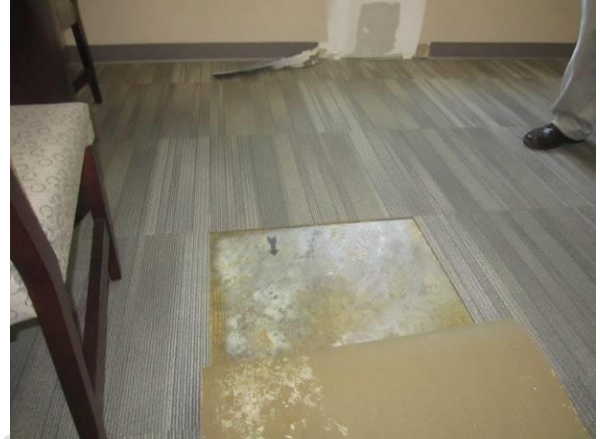
**Photo #20** No moisture or mold issues identified below carpet square in Room 175.

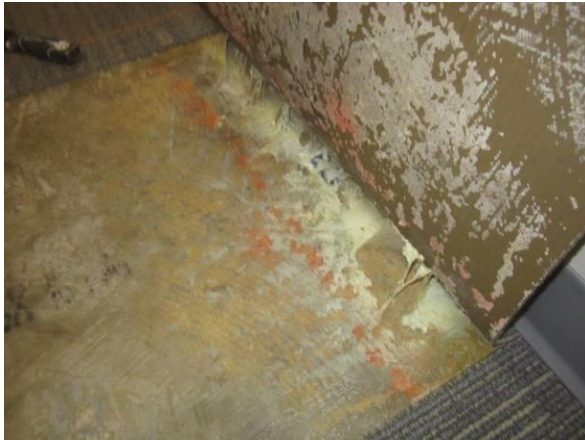
**Photo #21** Moisture and mold below carpet square in Room 168.

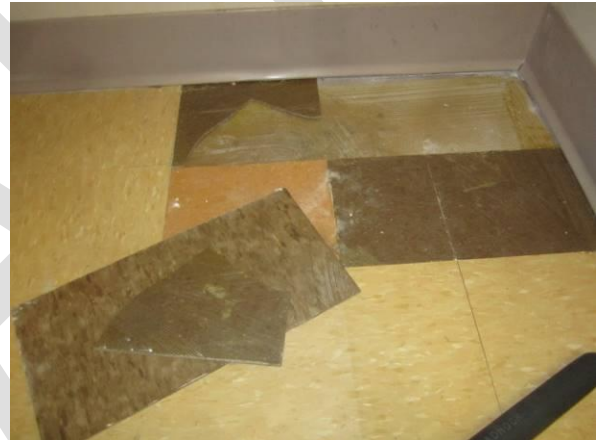
4. Room 166 – Musty odor and SVG below carpet square.
5. Hall at Drinking Fountain by Restrooms – SVG below bottom vinyl floor tile layer.
6. Room 161 – Rust staining and slight musty odor below carpet square.

**Photo #22** Visible mold below bottom floor tile layer by drinking fountain in west hallway by restrooms.

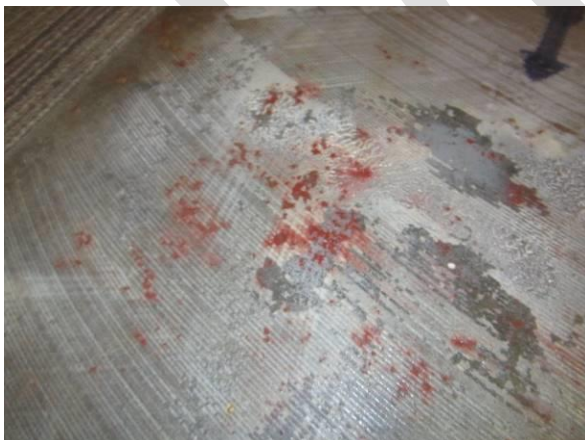
7. Room 165 – Wet glue, red staining and slight musty odor below carpet square.
8. Room 146 – Wet glue and musty odor below carpet square.
9. Hall by Room 156 – Mold staining and musty odor between vinyl floor tile layers.

**Photo #23** Wet glue, red staining and musty odor below carpet square in Room 165.

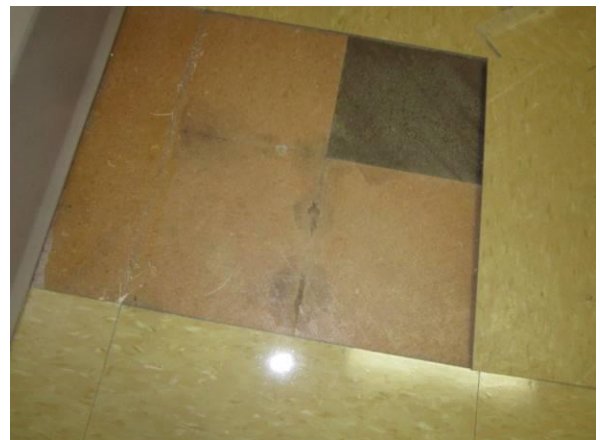
**Photo #24** Visible mold and musty odor between floor tile layers in east hallway by Room 156.

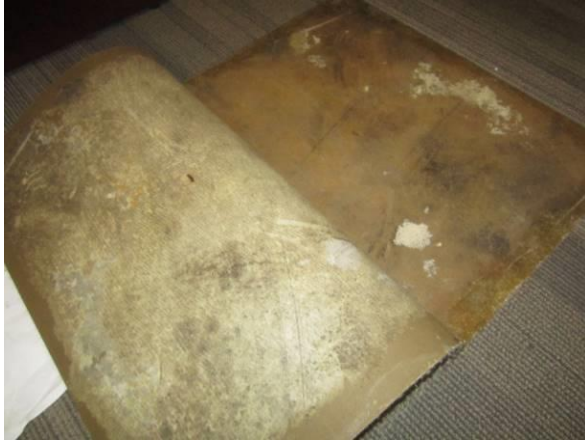
10. Room 111 – Wet glue, musty odor and SVG below carpet square.
11. Room 118 – Wet glue, musty odor and SVG below carpet square.
12. Room 124 – No moisture, odors or SVG below older gray carpet.

**Photo #25** Musty and moldy below carpet square in Victims Services Room 118.

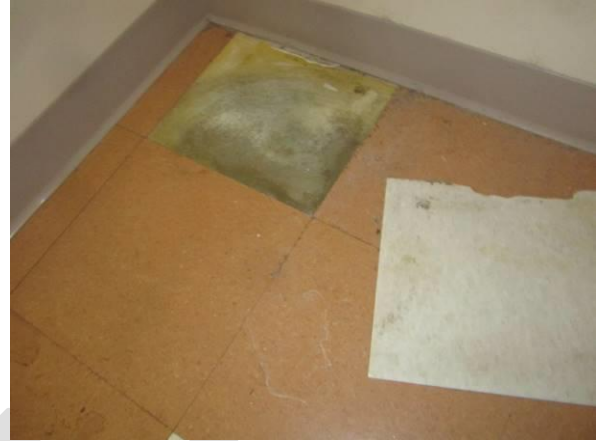
**Photo #26** Mold below floor tile in Room 127.

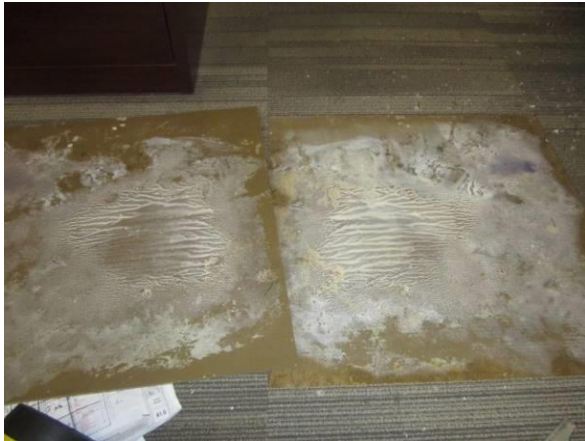
18. Room 133A – No moisture, odor of SVG below newer black/white carpet square
19. Room 103 – Wet glue, musty odor and SVG below carpet square
20. Room 105A – Musty odor and SVG below carpet square.

**Photo #27** Wet carpet glue in Room 103.

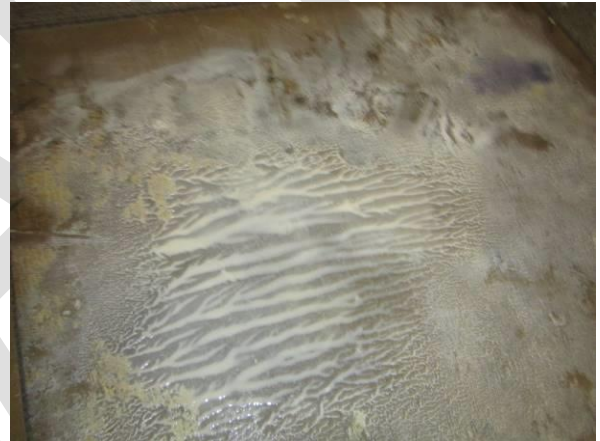
**Photo #28** Close up of wet carpet glue in Room 103.

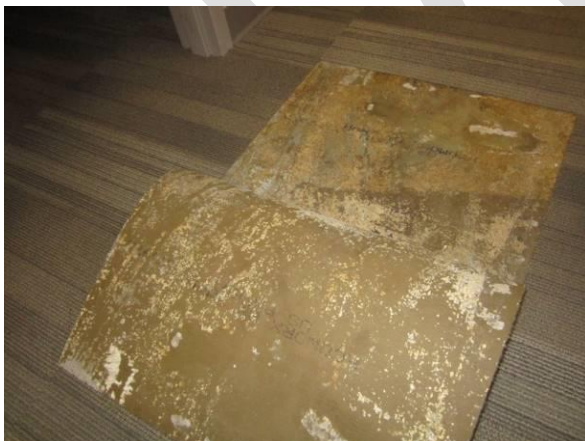
**Photo #29** Musty odor and mold below carpet square in Room 105A.

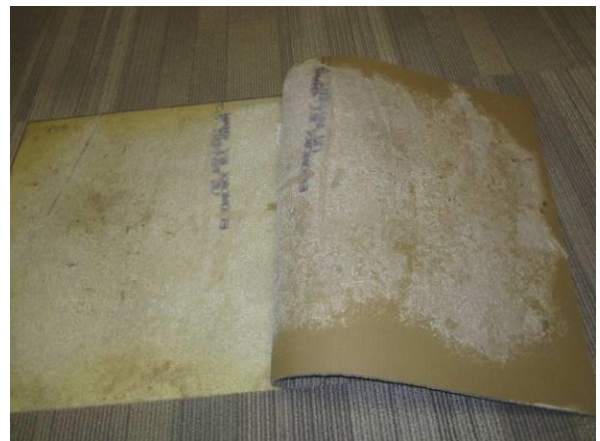
21. Room 150 – Moist glue, musty odor and some SVG below newer carpet square with white glue.

**Photo #30** Wet carpet glue below carpet square in IT Room 150.

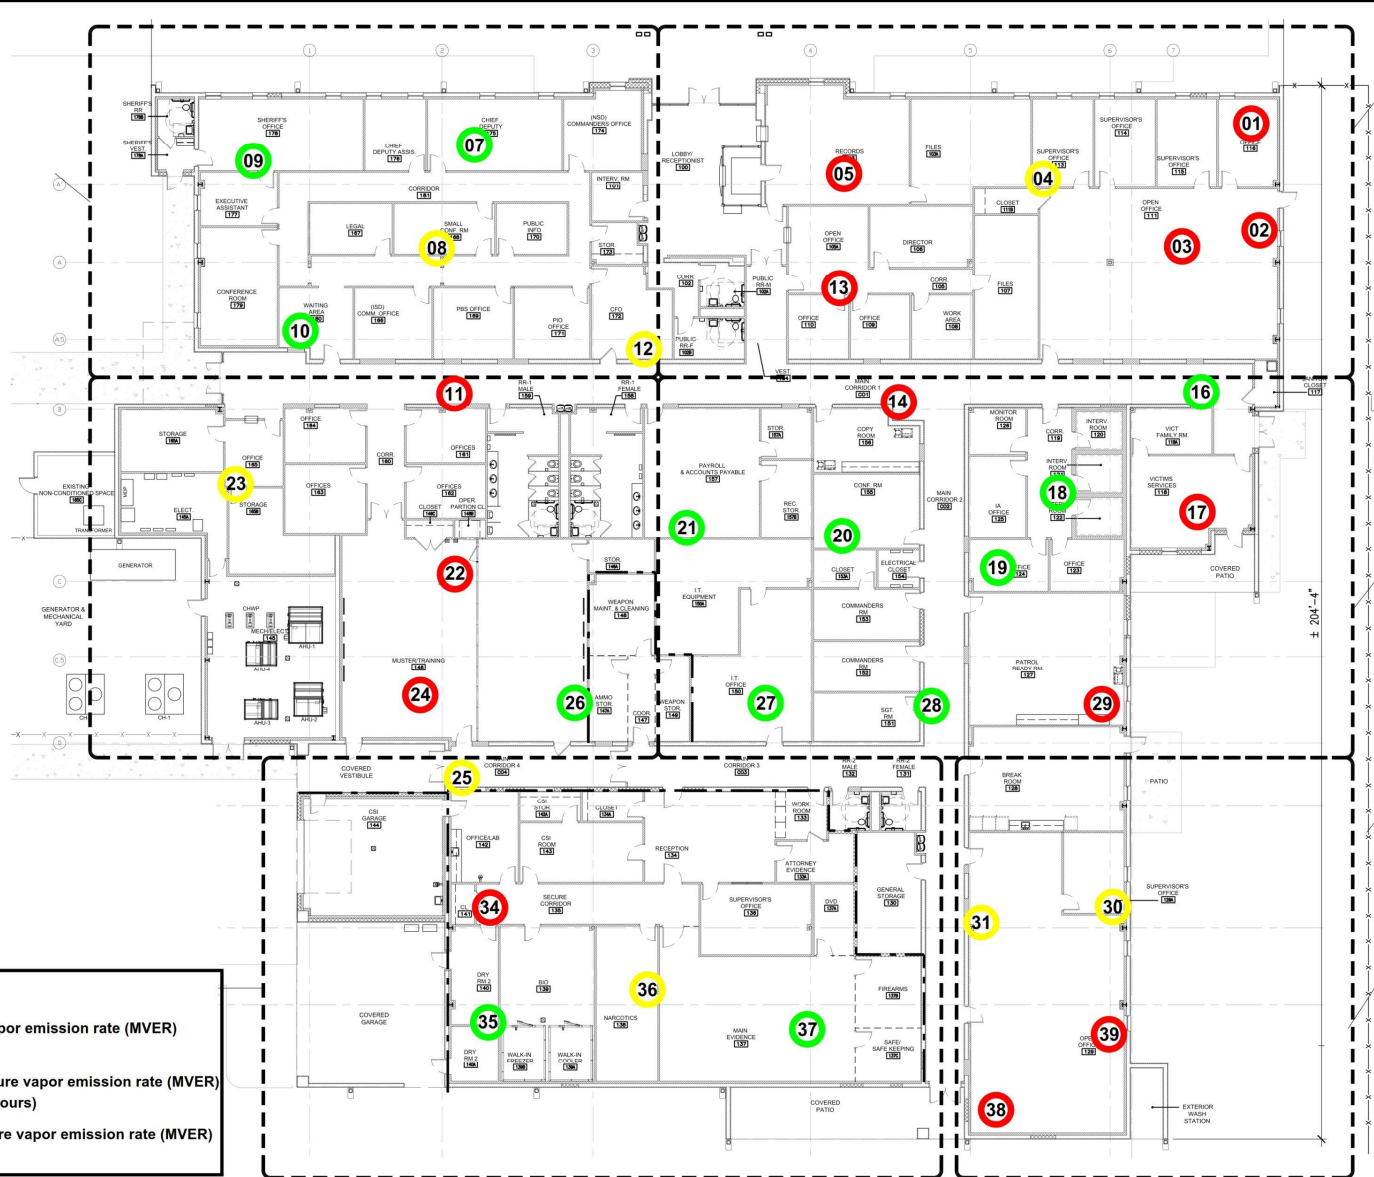
**TESTING LOCATION PLAN**  
Moisture Vapor Transmission and Relative Humidity Measurements  
Flagler County Sheriff's Operations Building  
901 East Moody Boulevard  
Bunnell, Florida

- Fourteen of the 35 measurement results indicate moisture emission rates exceeding generally accepted maximum values for floor covering installation (greater than 5.0 MVER).
- Eight of the 35 measurement results indicate moisture emission rates with the potential to exceed generally accepted maximum values for floor covering installation (between 3.0 and 5.0 MVER).
- Thirteen of the 35 measurement results indicate moisture emission rates below generally accepted maximum values for floor covering installation (less than 3.0 MVER).

The test results indicate that an elevated moisture condition exists in certain areas of the concrete slab. Based on a comparison of our visual observations during our initial and follow-up IAQ evaluation and this floor slab moisture testing, it appears that the elevated moisture condition is improving, most likely due to the perimeter exterior drainage improvements recently performed. These drainage improvements appear to have addressed the source of the moisture saturating the slab. The floor slab will continue to dry to the interior, except where impermeable floor coverings inhibit the flow of water vapor to the interior conditioned space.

- Retain a qualified leak detection firm to evaluate slab conditions at the building's restrooms and at concrete test locations 11, 22 and 24 to evaluate the possible source of the elevated slab moisture in these areas.
