## ASBESTOS-CONTAINING MATERIALS SURVEY

Commercial Building  
14 Palm Harbor Village Way  
Palm Coast, Florida

UES Project No. 0940.1800120.0000

Report Date: September 13, 2018

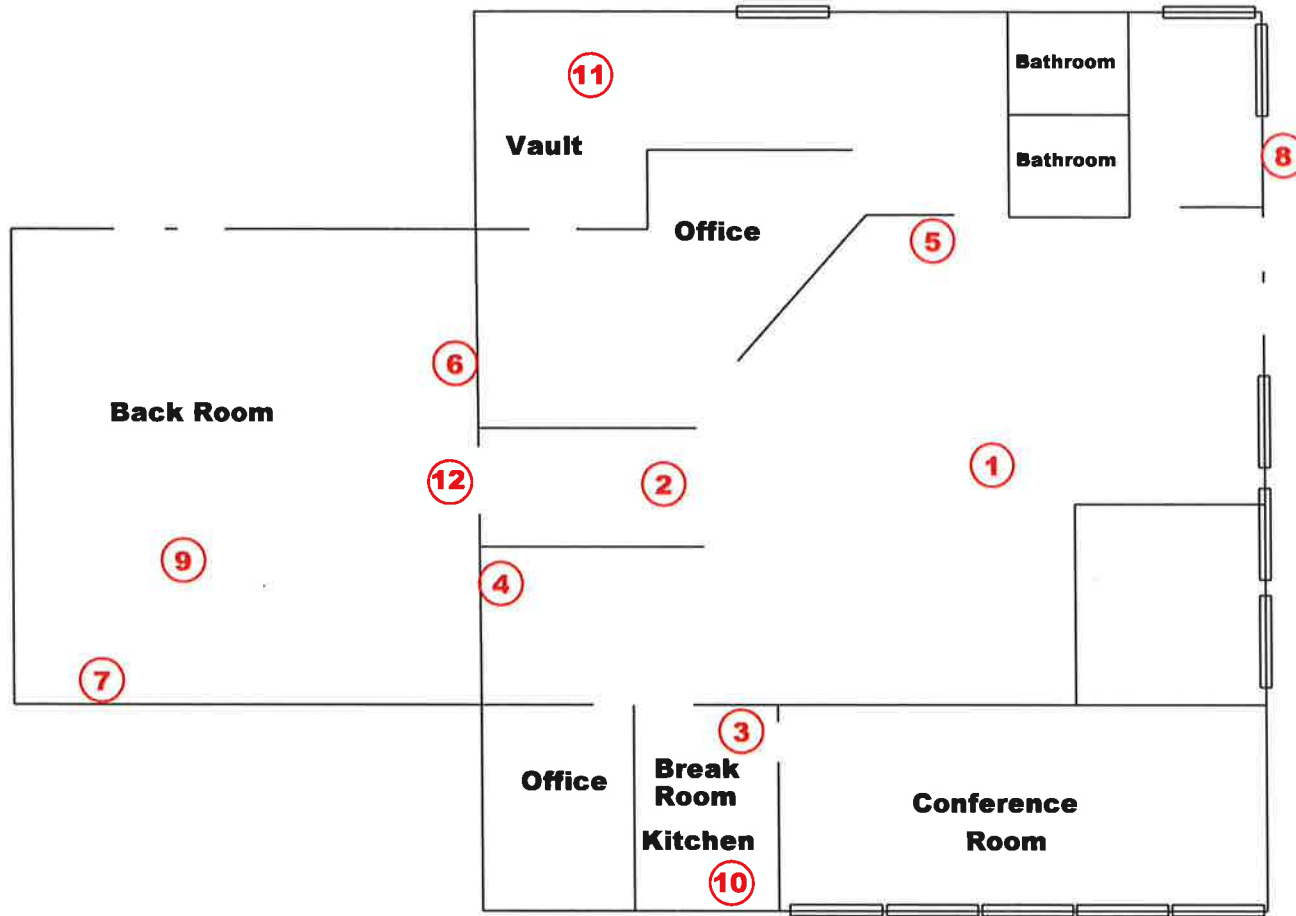
**ASBESTOS SAMPLE LOCATION PLAN**

Based on UES' review of the available building system information and visual survey of the subject building, [8] homogeneous materials were identified at the subject building commonly suspected of containing asbestos. The homogeneous materials consisted of suspended ceiling tiles, wallboard and joint compound, window caulking, floor tile and wall texture material. A map illustrating the sample locations is included in **Appendix A** of this report.

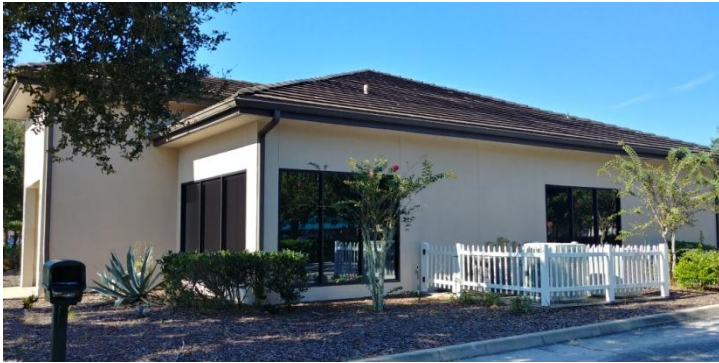
1. Subject property view from north-east Corner looking south.

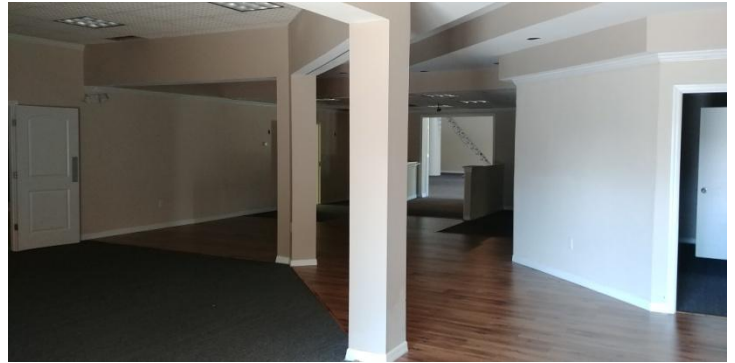
2. Lobby inside main entrance.

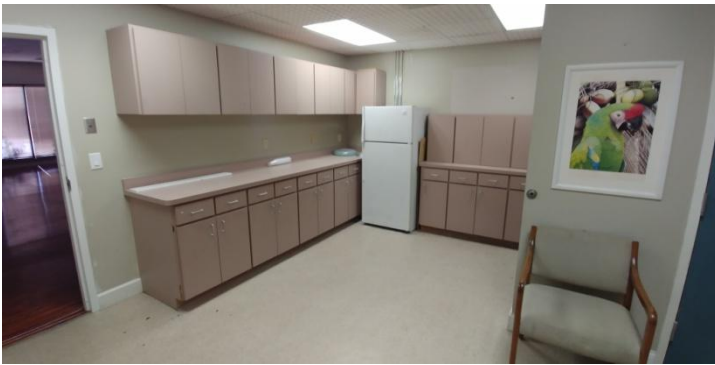
3. Break room/kitchen floor tile that was sampled.

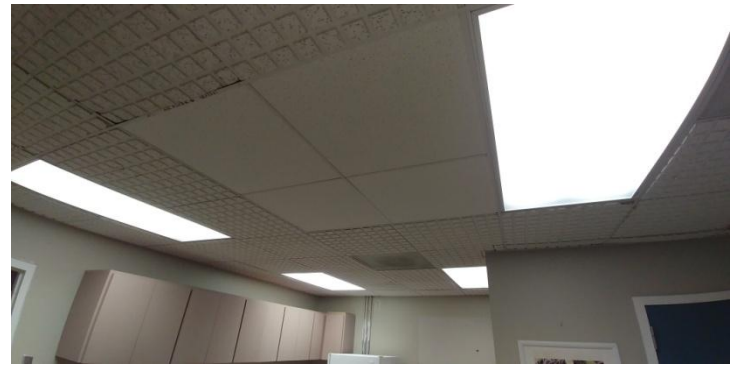
4. Two different types of ceiling tile were sampled in the break room/kitchen.

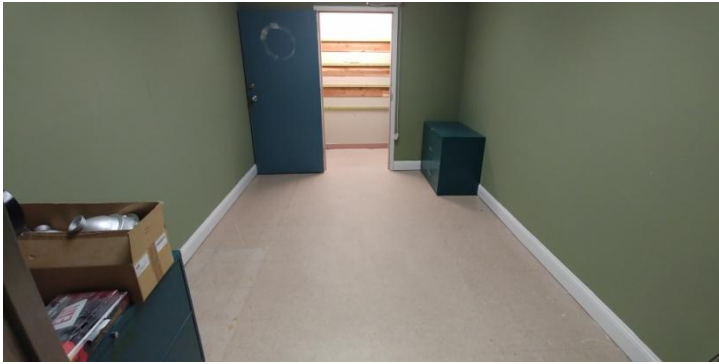
5. Vault interior floor tiles sampled.

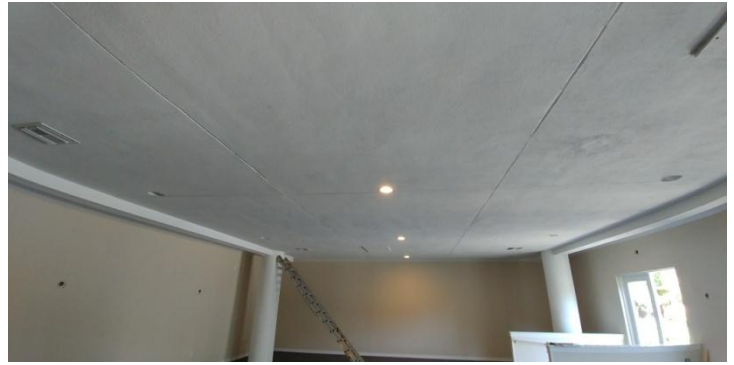
6. Roof texturing inside back room sampled.

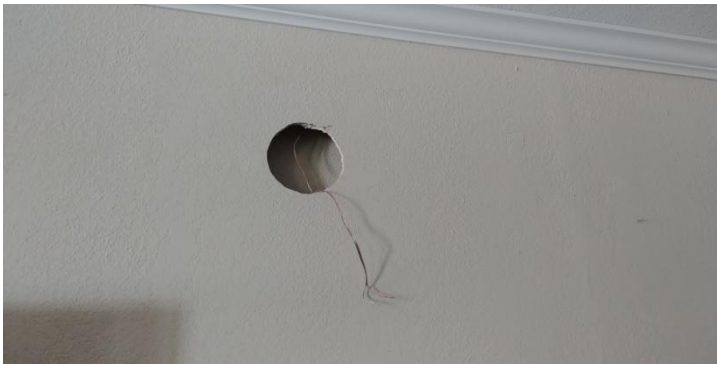
7. Drywall/Joint Compound in back room sampled.

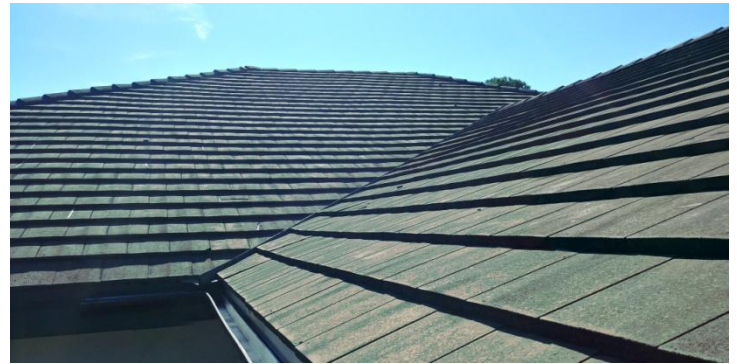
HAS #6 and #8 were both less than 10 sq.ft. Roofing tiles were newer cement tiles and were not sampled due to possibility of damaging roof.

8. Cement roof tiles were not sampled.

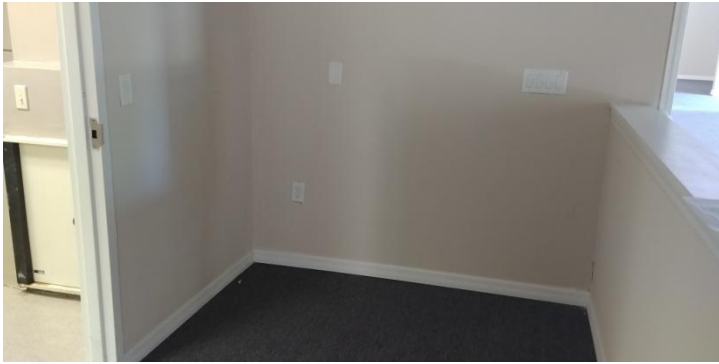
9. Joint compound/drywall sampled inside main lobby.

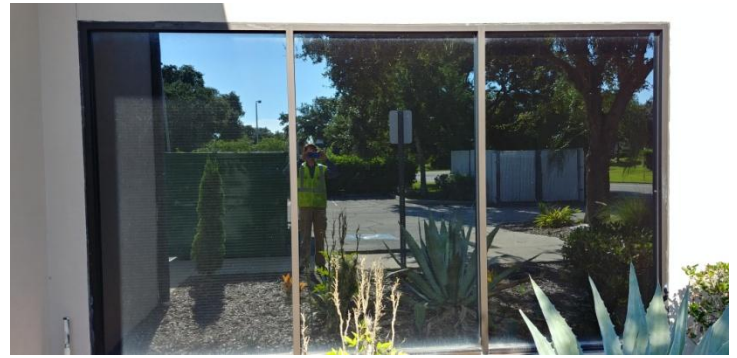
Four percent (4%) Chrysotile Asbestos was found in the black exterior window caulking. No asbestos was detected in any of the other samples obtained from the building.

HSA	Material Description	Location	%/Type Asbestos	Estimated Quantity	NESHAPS Category
5	<b>Black Exterior Window Caulking</b>	<b>Exterior Windows</b>	<b>4% Chrysotile</b>	<b>100 linear feet.</b>	<b>Category 1 Non-Friable</b>

10. Example of windows where caulk sample was collected.

Any material identified as non-friable ACM must be treated as friable ACM when the material is about to become friable as a result of activities performed within the buildings. Prior to renovation or demolition, Universal strongly recommends you meet with the controlling agencies and discuss the specific requirements for disposition of the asbestos containing materials identified in this report. State licensing and OSHA-related requirements would be applicable and should be strictly complied with during the demolition process.
