# UNIVERSAL ENGINEERING SCIENCES

RE: Property Condition Assessment Report – Former Sears Building  
4888 Palm Coast Pkwy NW, Palm Coast, Flagler County, FL  
UES Project No. 0415.1800110.0000  
UES Report No. 161543

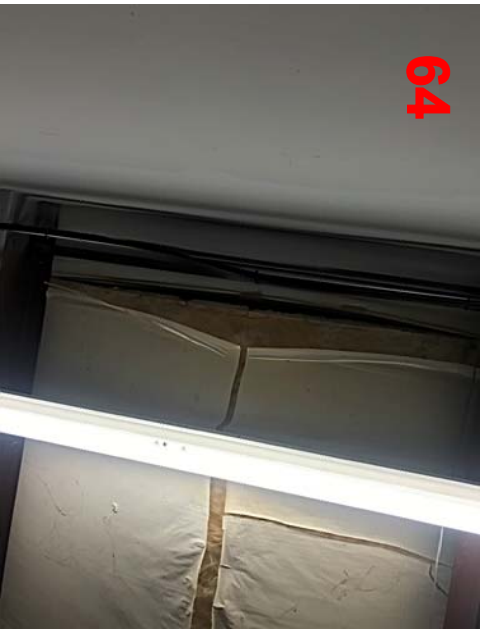
64

Insulation shows signs of physical damage and repairs are needed as shown in photos 55, 56, 57, 59, 60, 61, 62, 63, 64, 67.

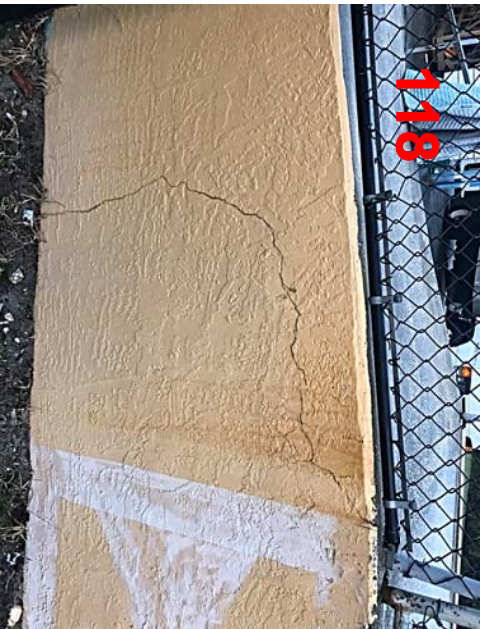
118

Secure storage areas are present in the rear of the structure as well as a loading dock area. The loading dock has sustained physical damage from vehicular traffic as shown in photos 4, 7, 118, 119, 120, 122, 123, 125, 126.
