# Building Envelope & Indoor Air Evaluation Report

Flagler County Sheriff's Operations Building  
901 E. Moody Blvd.  
Bunnell, FL

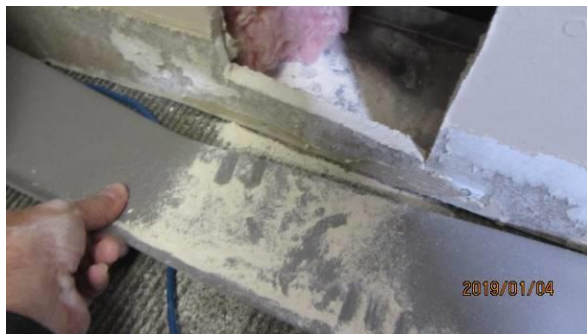
**Photo #3** Low wall cut in Investigations Room. No moisture or evidence of mold in cavity or backside of vinyl base.

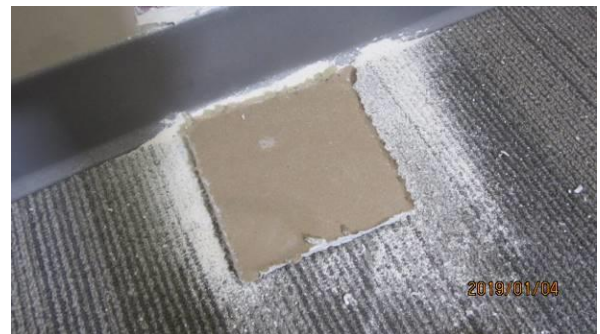
**Photo #4** Typical low wall cut. Backside of gypsum drywall dry and free of any staining or mold.

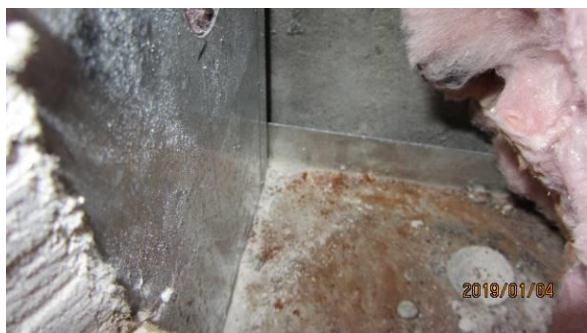
**Photo #5** View of stud cavity in low wall cut at northwest quadrant. Some light corrosion noted in the track; no moisture evident.

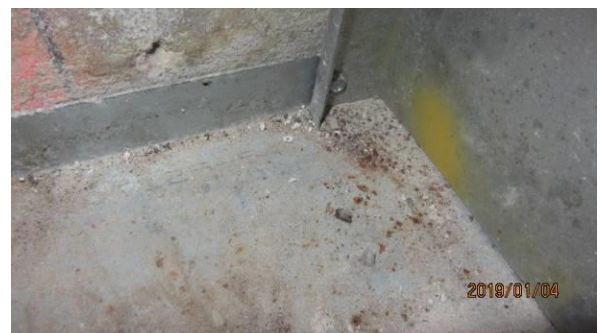
**Photo #6** View of stud cavity in low wall cut at northeast quadrant. Some light corrosion noted in the track; no moisture evident.

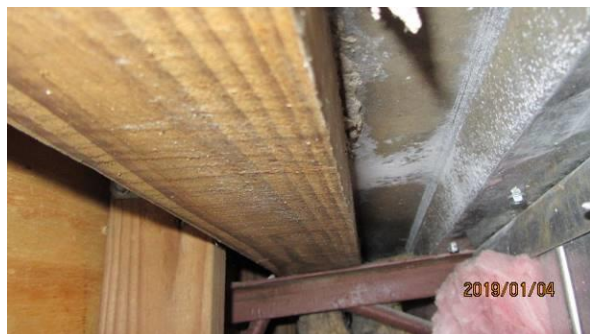
**Photo #7** Cut at top of the wall in northwest quadrant. All wood blocking and framing dry and in good condition.

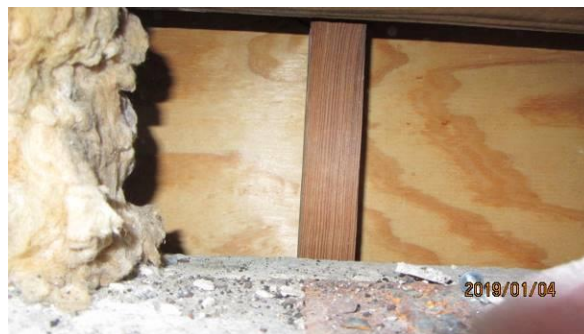
**Photo #8** View of same cut. Some debris noted on top of the CMU wall; possibly rodent or bat droppings.

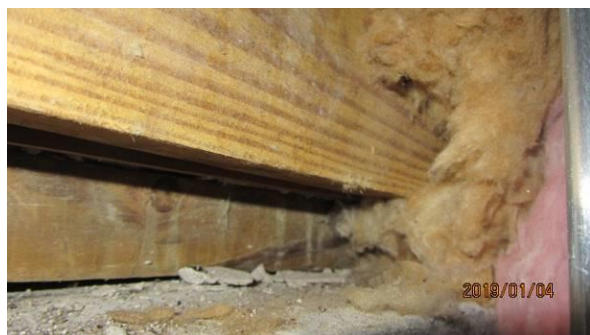
**Photo #9** Cut at top of wall in Main Evidence room. Old insulation (yellow) and new insulation (pink) are noted. Recessed wood is original; dry, good condition.

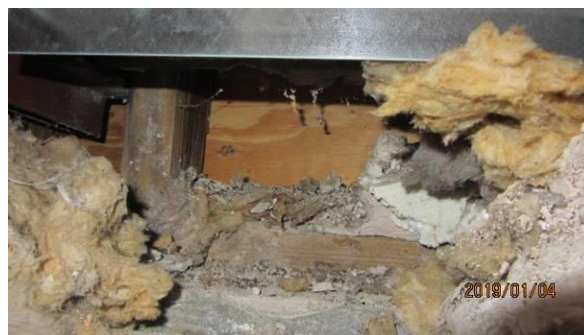
**Photo #10** Cut at top of south wall, Training Room. Old wood dry and in good condition. Various types of debris on top of CMU, with possible bat droppings.

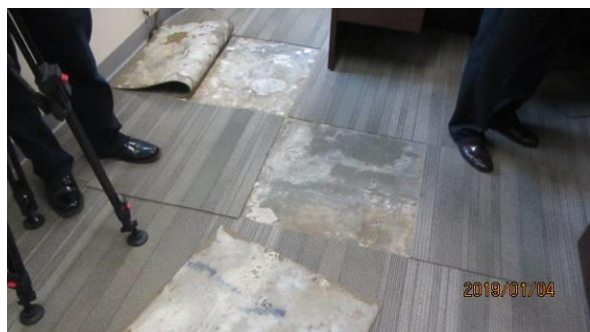
**Photo #11** Carpet tiles removed adjacent to east wall in Investigations Room. Evidence of moisture and mold on backside of carpet tiles.

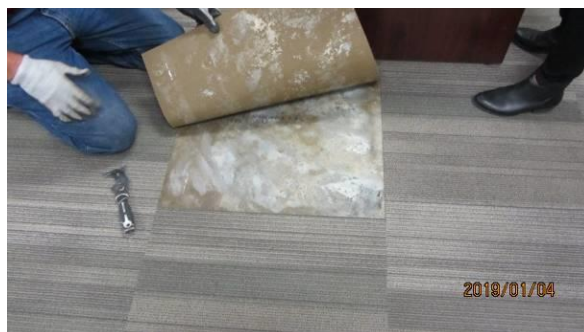
**Photo #12** Carpet tile removed at location away from outside wall, same room. Evidence of moisture on slab.

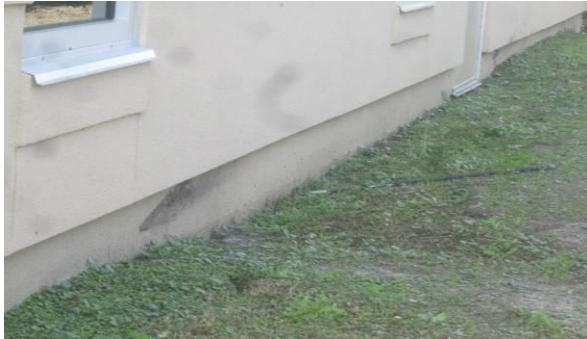
**Photo #13** Low drainage areas along east exterior.

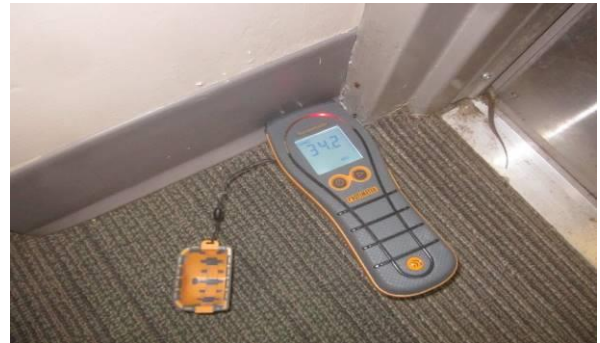
**Photo #22** High moisture at base of drywall by the northeast exit in the Investigations Room.

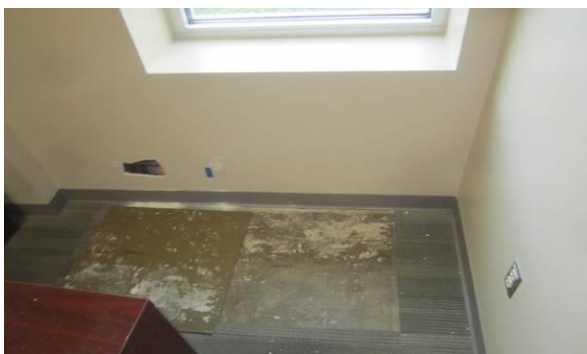
**Photo #23** Visible mold and musty odor below carpet square in Investigations Room 129 (Tape Sample T10).

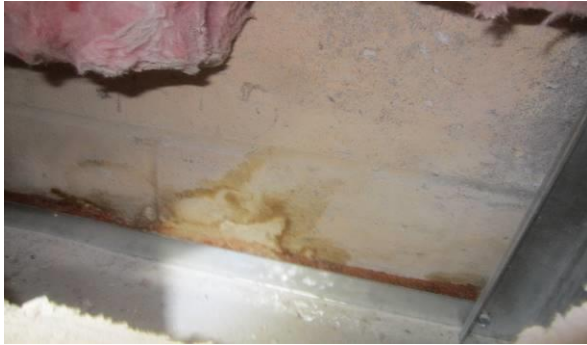
**Photo #25** Water stain on Evidence Room block wall.

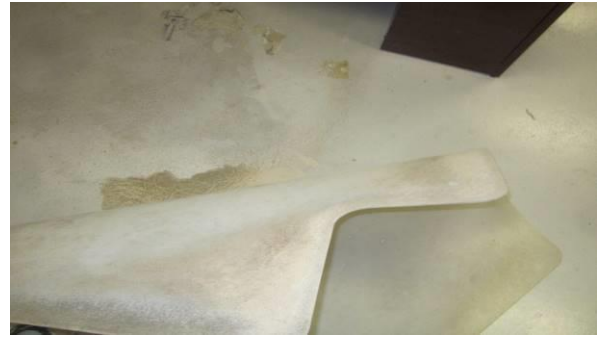
**Photo #26** Visible mold and musty odor identified on underside of plastic floor mat on concrete floor in the Evidence Room (Tape Sample T12).
