# **Belle Terre Park**

## **Facility Assessment and Recommendations**

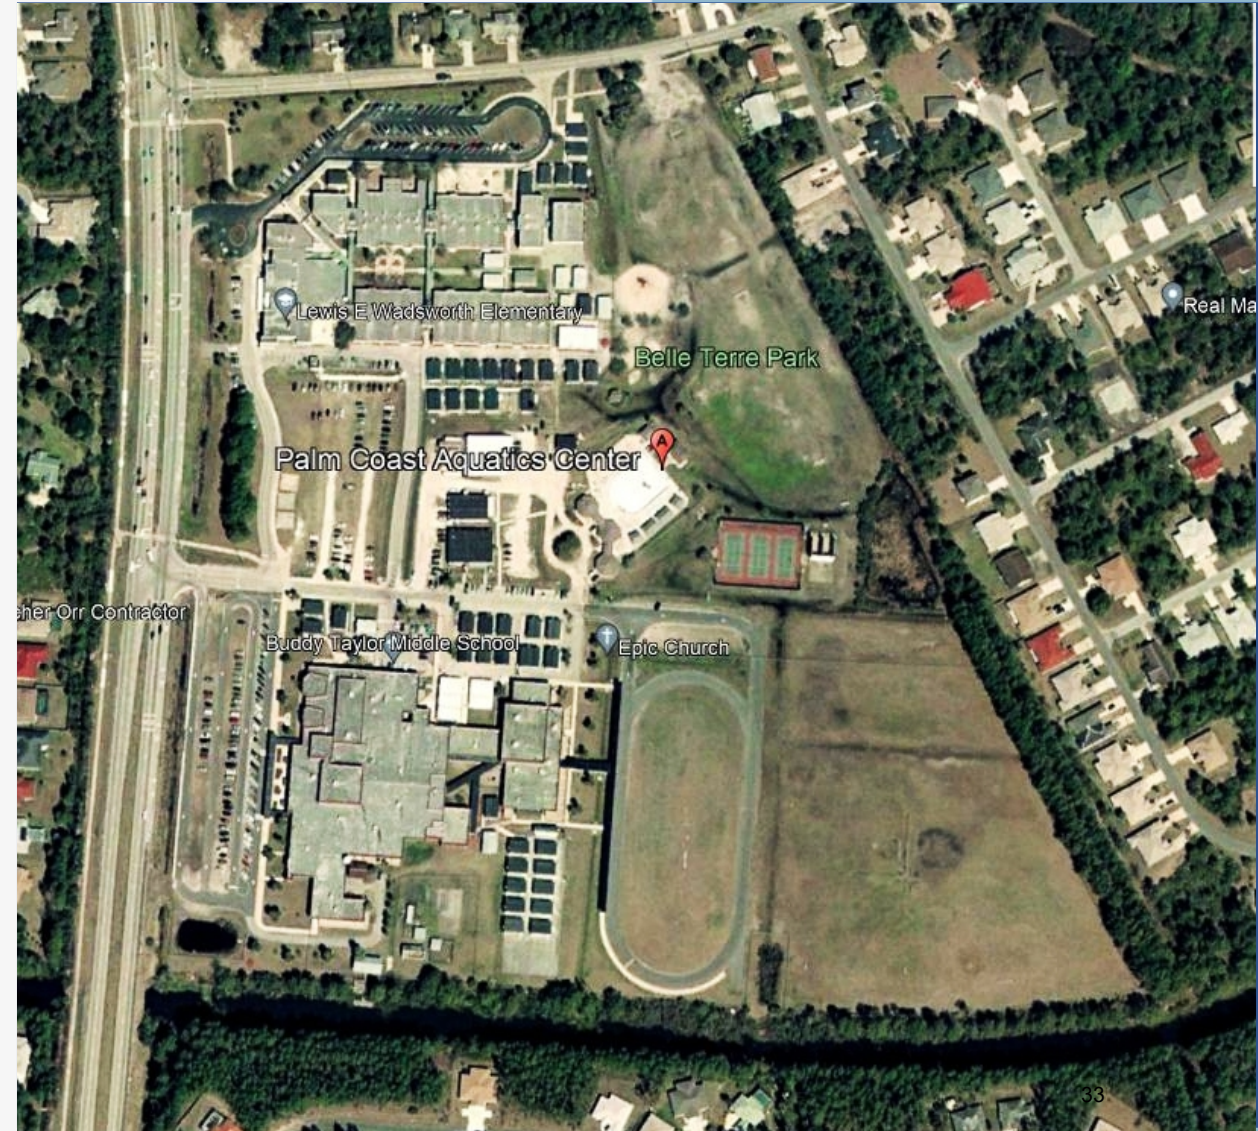
## Original Concept (2006 View)

- Middle School Amenity
- Shared direct access from Belle Terre Parkway
- Connected park setting
- Parking independent of bus route

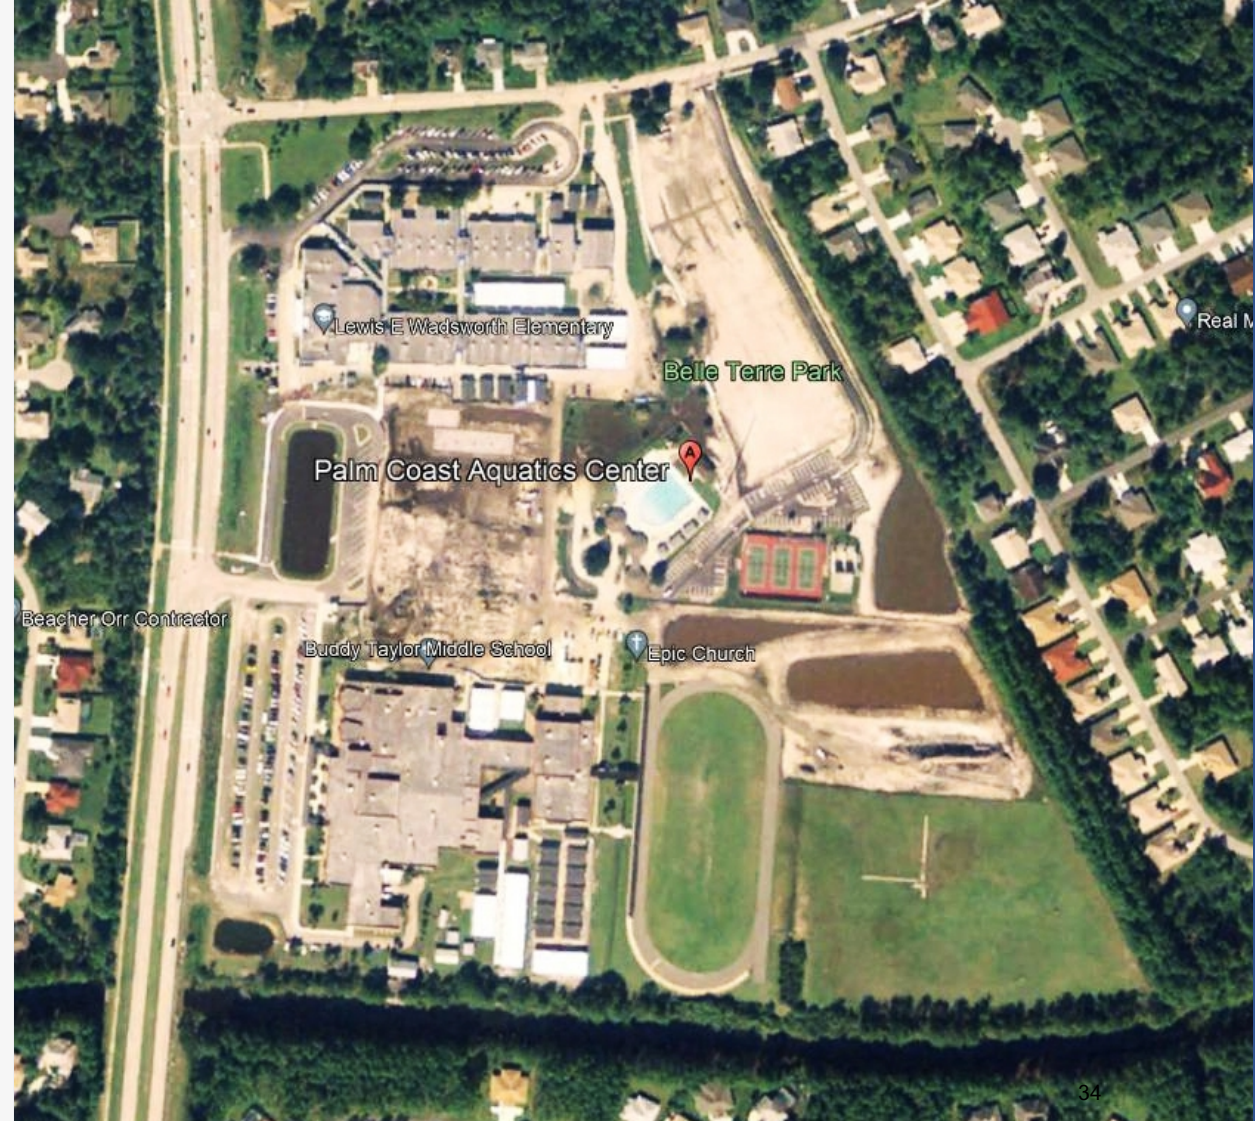
## Middle school expansion (2007)

- New building location
- Add detention areas
- Revise traffic pattern
- Eliminate direct connection to Belle Terre Pkwy

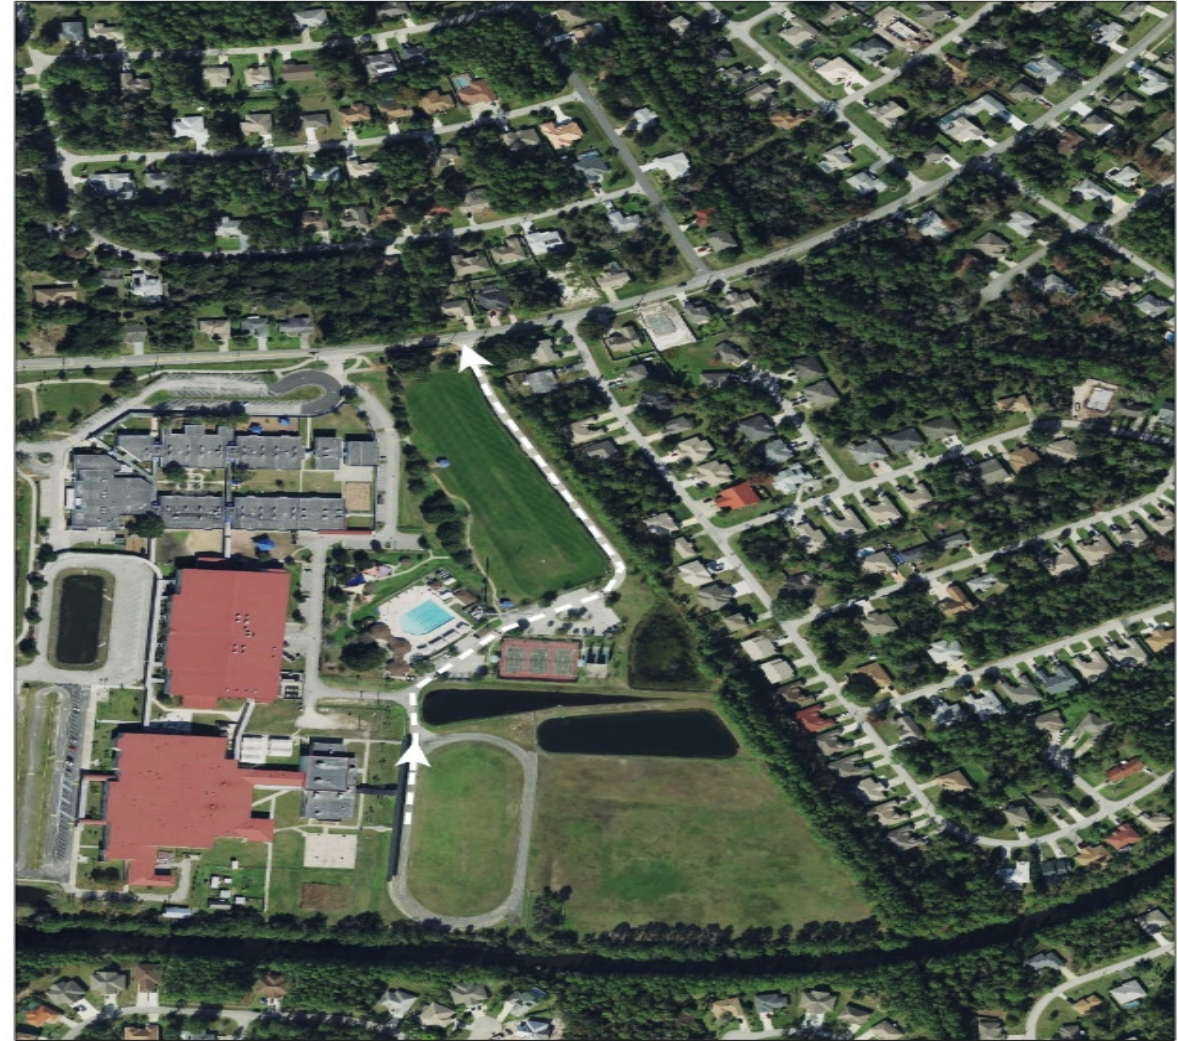
# Buddy Taylor Bus Route

- During the school year the bus traffic occurs from 7am-7:30am and 1-2pm
- Traffic goes through the parking lot for the pool and its surrounding amenities

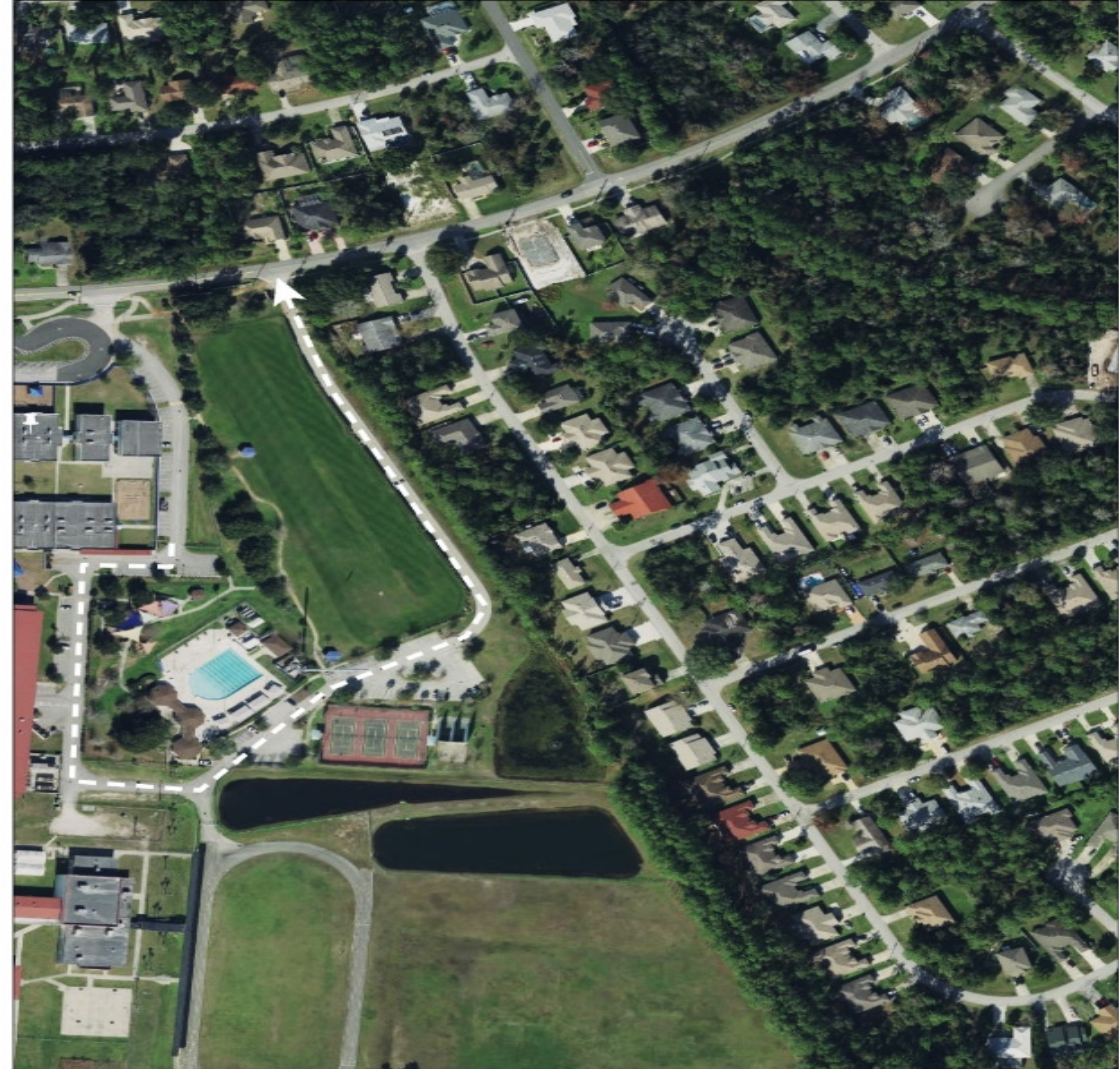
# Wadsworth Pick-up Line

- During the school year traffic begins at 8:30am-9am for drop and 3:30pm-4pm for pick up
- Traffic goes through the parking lot for the pool and it's surrounding amenities.

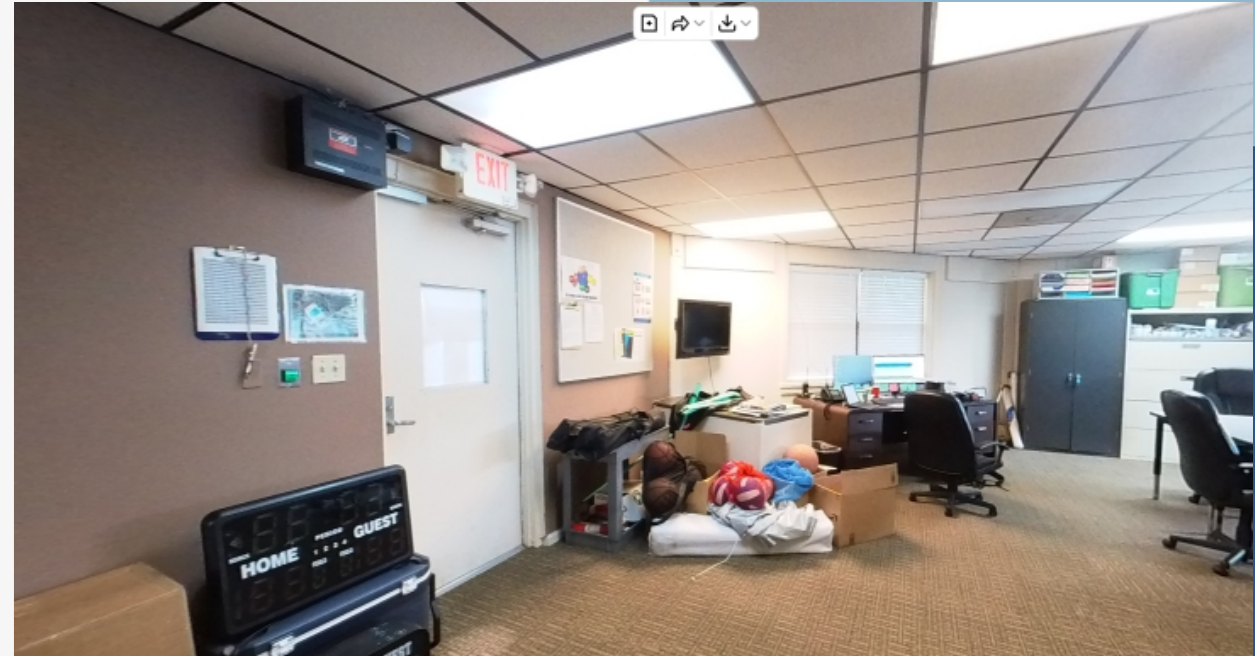
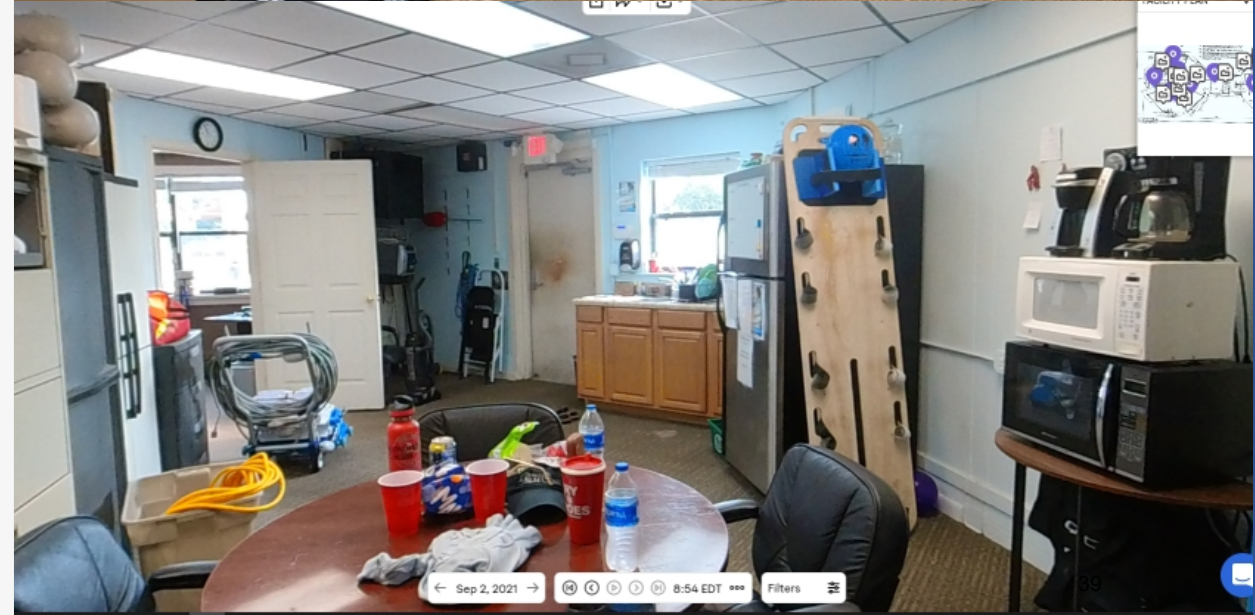
## Admin Building

- Current Condition
  - Building shows signs of distress
  - Building in current configuration insufficient to serve staff and guests
  - Fire safety and prevention items are missing
  - Limited air condition provided for staff cool down
- Suitability for continued use
  - Building greatly deficient in condition, size and location; any extensive remodeling is likely to trigger the need for structure upgrade
- Recommendation
  - Building to be demolished and replaced with a new building
- Value
  - None

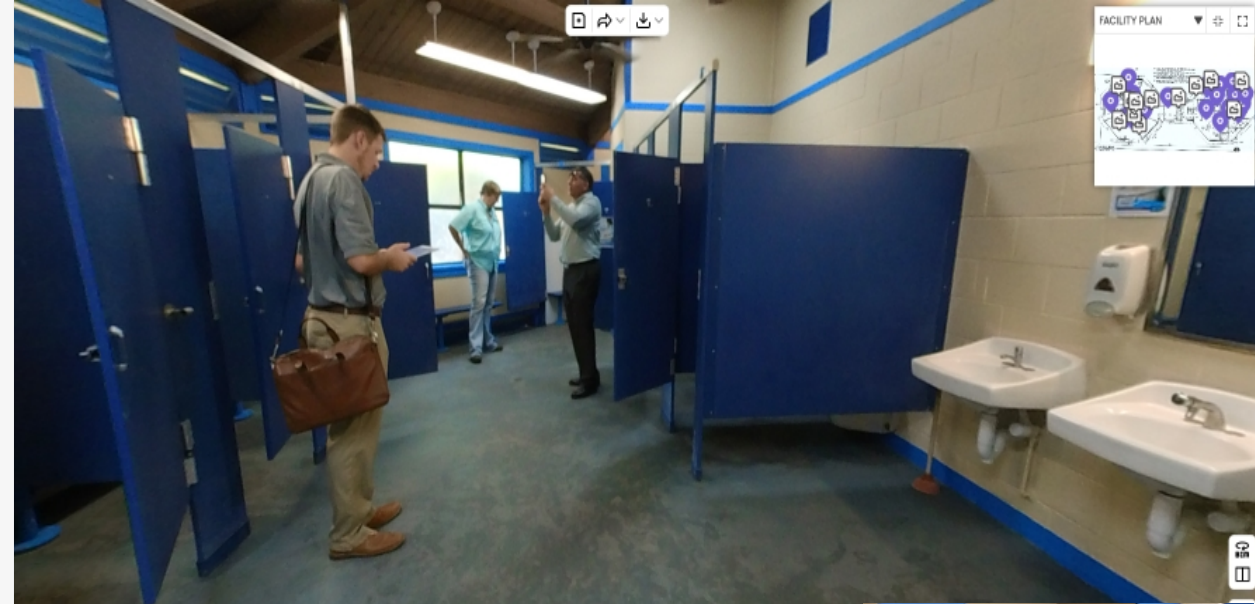
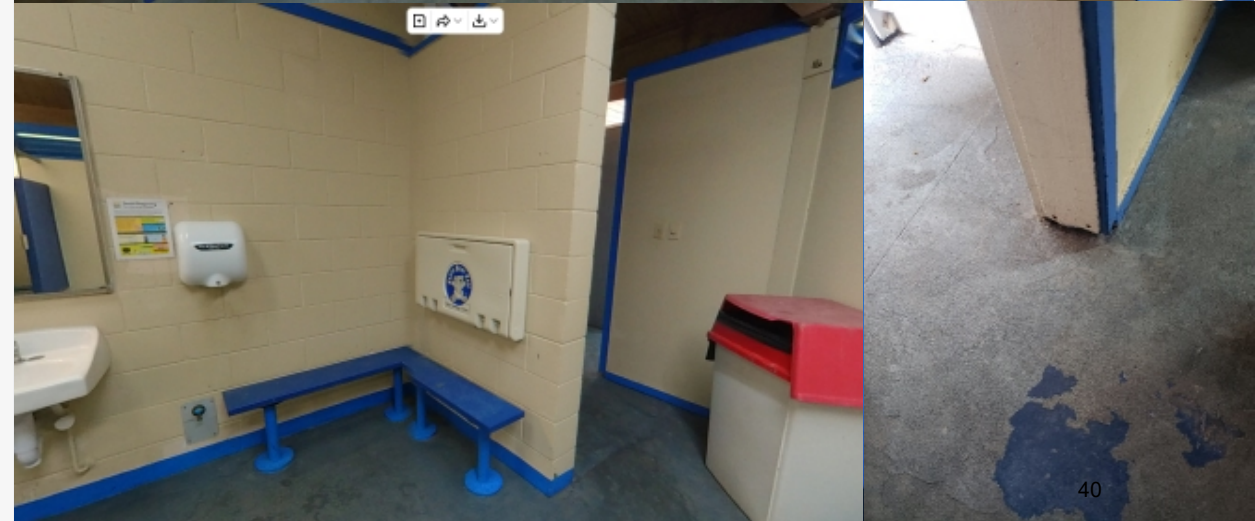
## Locker Rooms

- Current Condition
  - Building shows signs of distress; resting beam connections
  - Plumbing fixture and partitions need upgrade
  - Fire safety and prevention items are missing
  - Accessible features are missing
- Suitability for continued use
  - Building greatly deficient
  - Accessibility upgrades are needed
  - Any extensive remodeling is likely to trigger the need for structure upgrade
- Recommendation
  - Building to be demolished and replaced with a new building
- Value
  - None

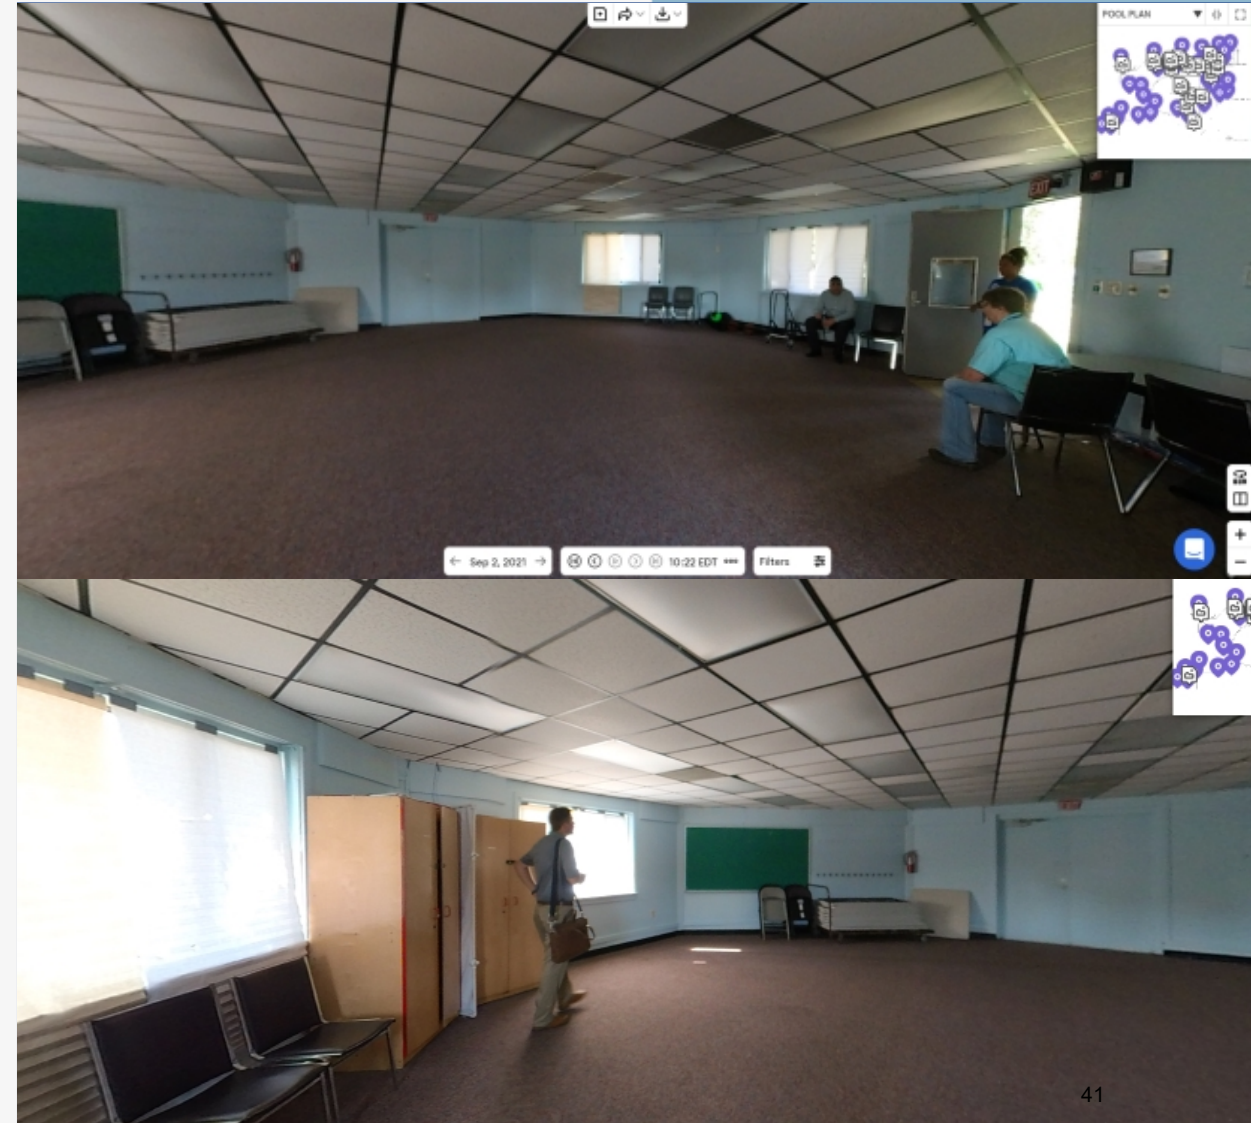
## Multi-purpose Room

- Current Condition
  - Building shows signs of distress
  - Exterior toilet is in distress
  - Fire safety and prevention items are missing
  - Accessible features are missing
- Suitability for continued use
  - Building greatly deficient in condition
  - Any extensive remodeling is likely to trigger the need for structure upgrade
- Recommendation
  - Building to be demolished and replaced with a new building
- Value
  - None

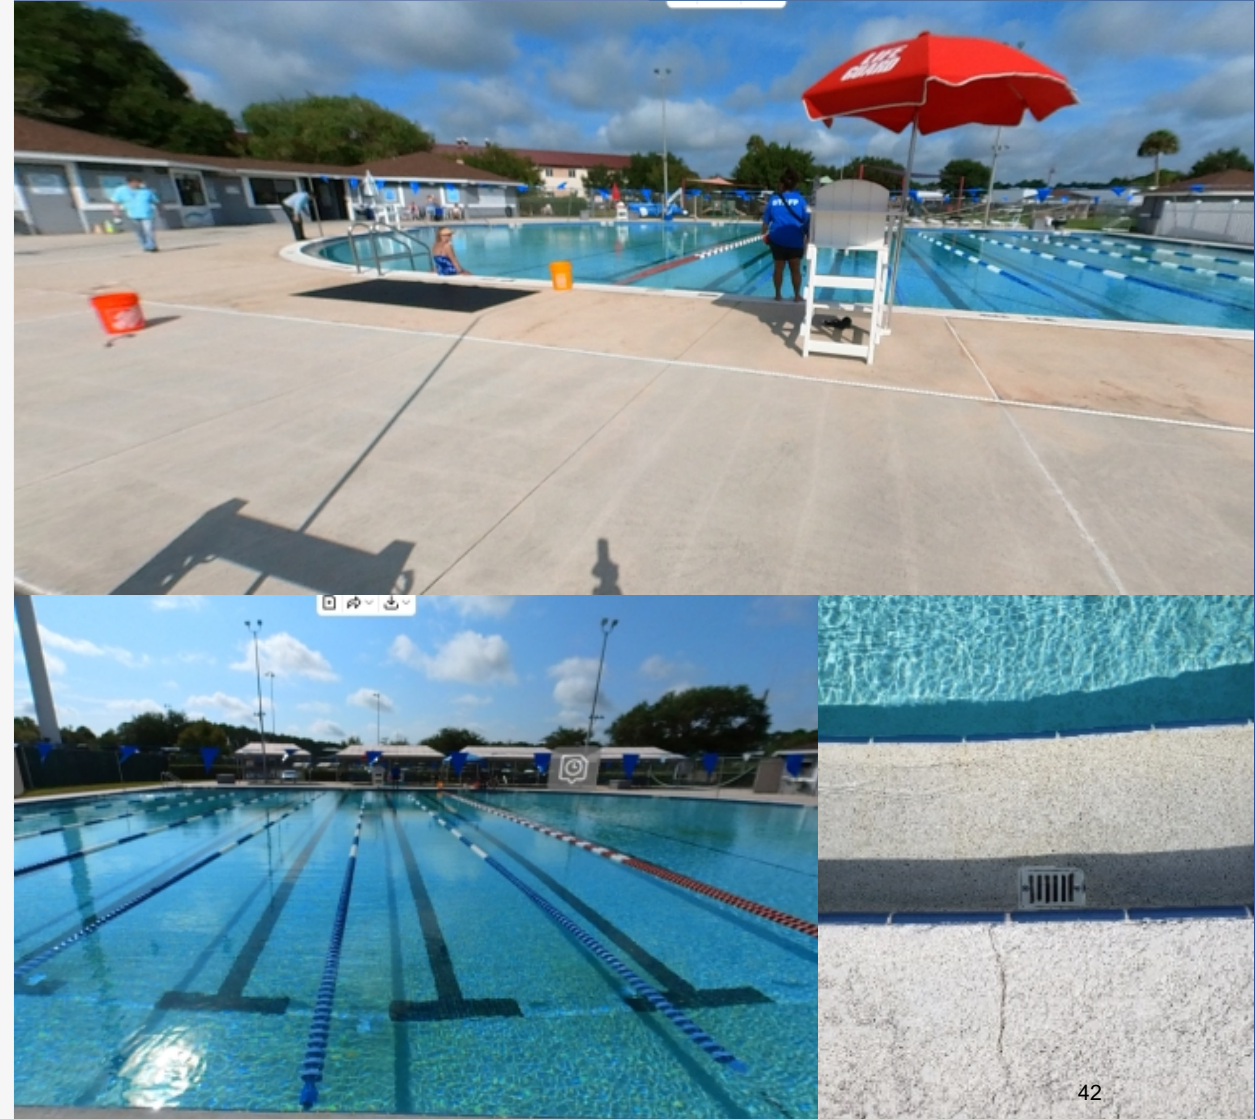
## Pool

- Current Condition
  - Pool is 38 years old and showing sign of aging
  - Pool shell shows cracking in finish
  - Pool coping experience cracking
  - Pool deck is a patchwork of different concrete pours
  - Pool is not suitable for sanctioned lap swimming
  - Pool does not have any features to attract kids
- Suitability for continued use
  - Pool design is dated, not comparable to current design trend and citizens' expectations
- Recommendation
  - Study the viability of aquatics for this neighborhood park
- Value
  - Pool is suitable as a learn-to-swim pool

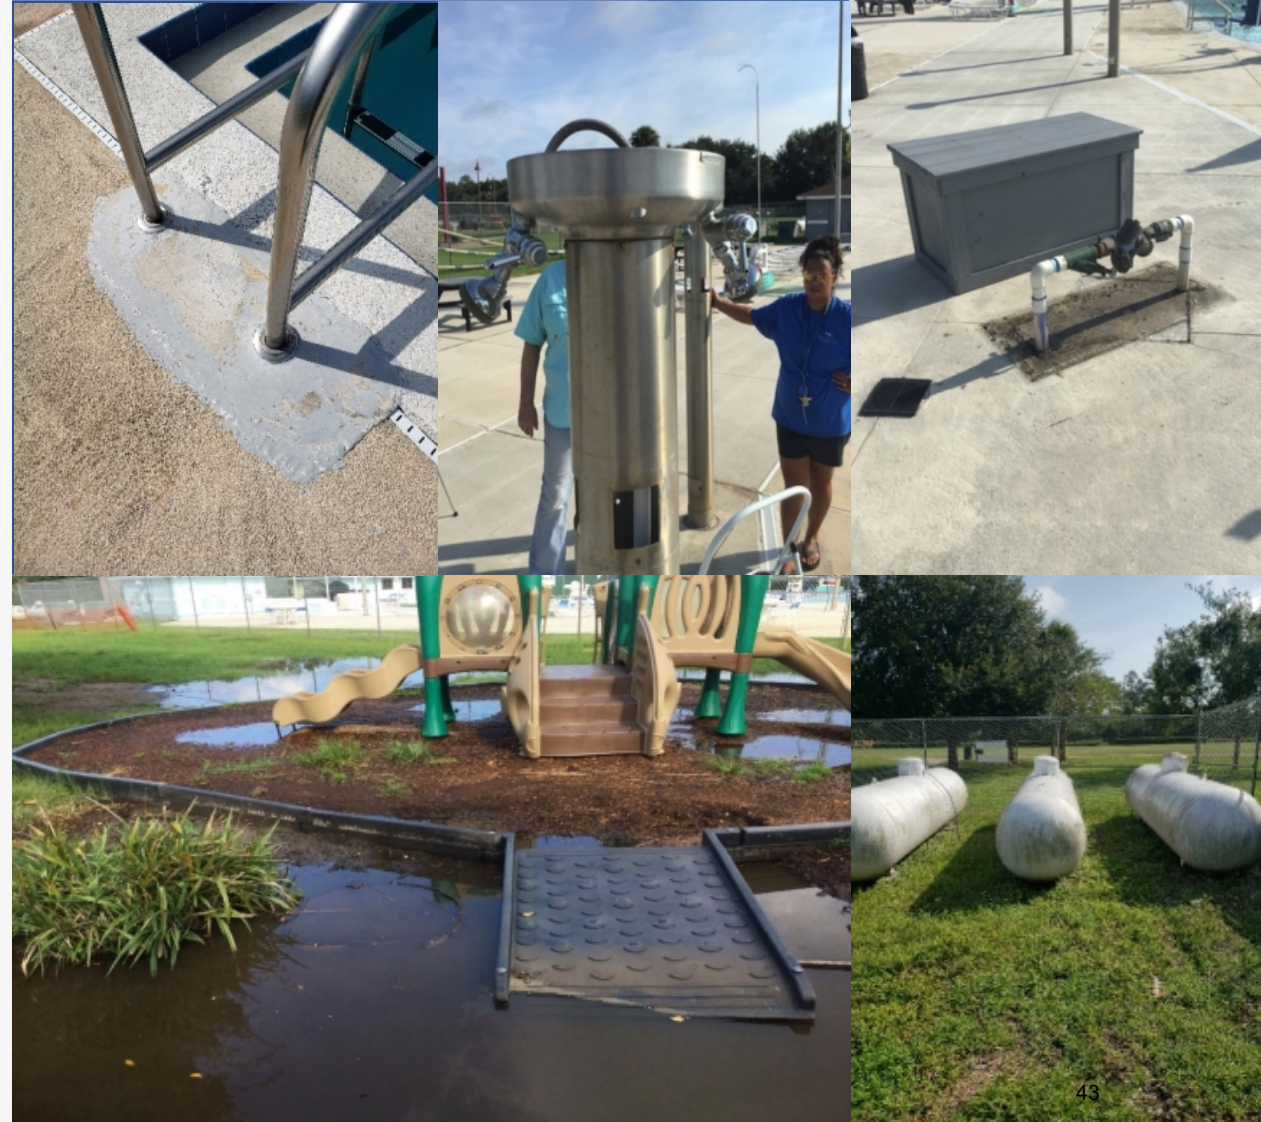
## Pool Equipment

- Current Condition
  - Pool equipment recently upgraded and in good condition
  - Pool filter backwash is not connected to storm drainage; floods playground once or twice a week
  - Under pool ground water relieve system not functional
  - Gas tank needs maintenance
- Suitability for continued use
  - Equipment will serve the pool in its current configuration but needs to be replaced if pool size changes
- Recommendation
  - TBD to follow pool recommendation
- Value
  - Could serve current pool for remaining life span (7-10 years)

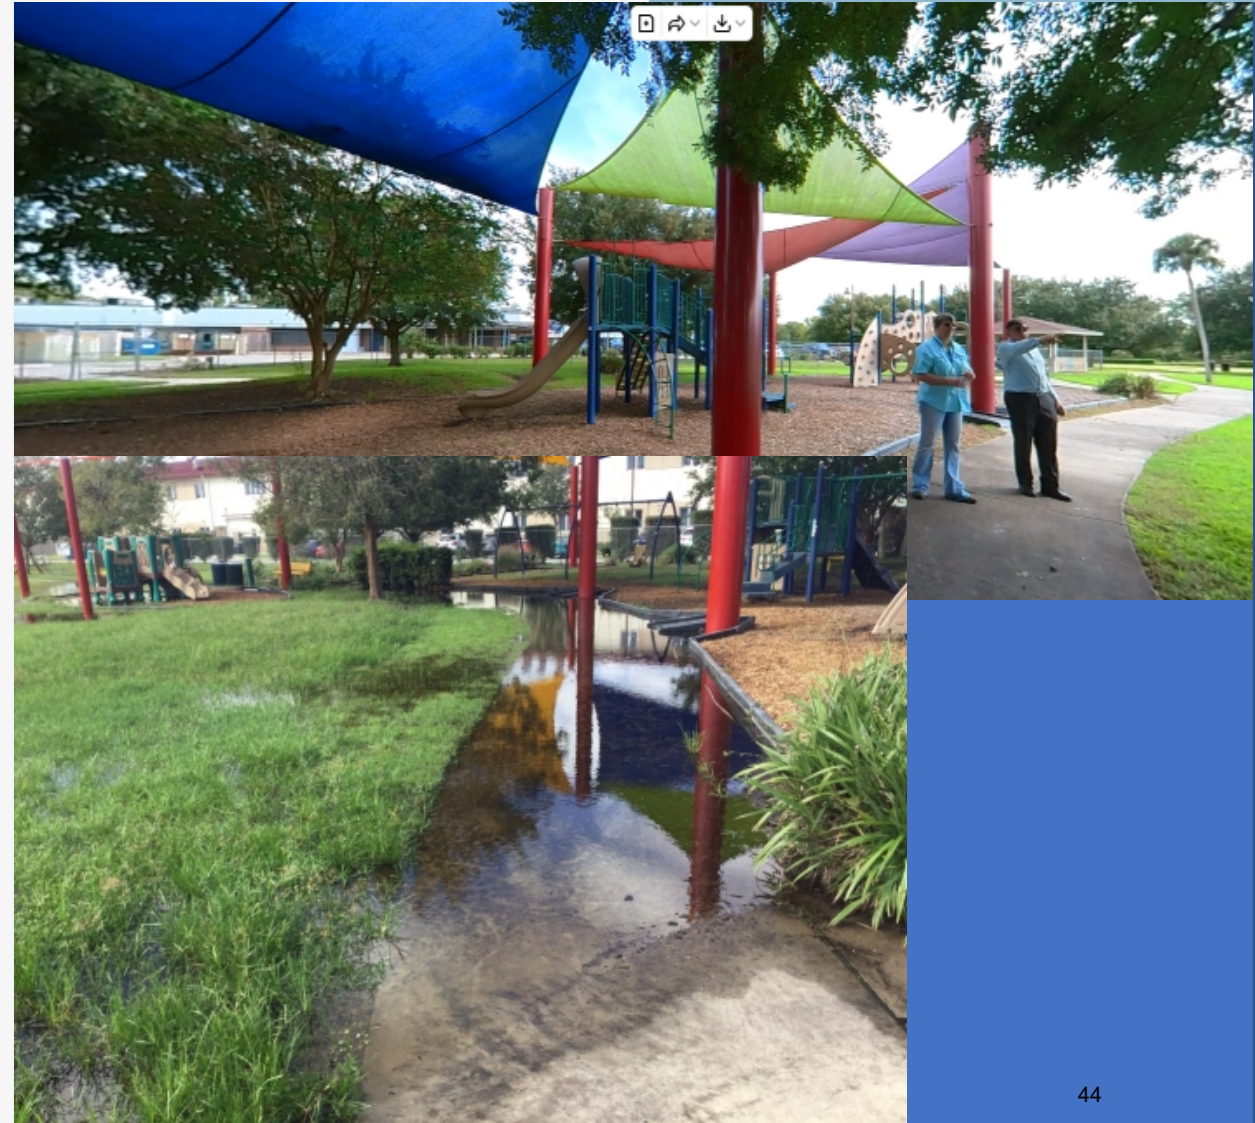
## Playground

- Current Condition
  - Long walk from parking area
  - Play structure hidden from view
  - New construction as of 2018 in good condition
  - Area floods once or twice a week due to pool backwash
  - Too far from public toilets
- Suitability for continued use
  - Playground suitable for continued use, except when flooded
  - Could benefit from resolving the flooding issue
  - Could benefit from easier access
- Recommendation
  - Provide drainage route for back wash
- Value
  - Could serve neighborhood for remaining life span

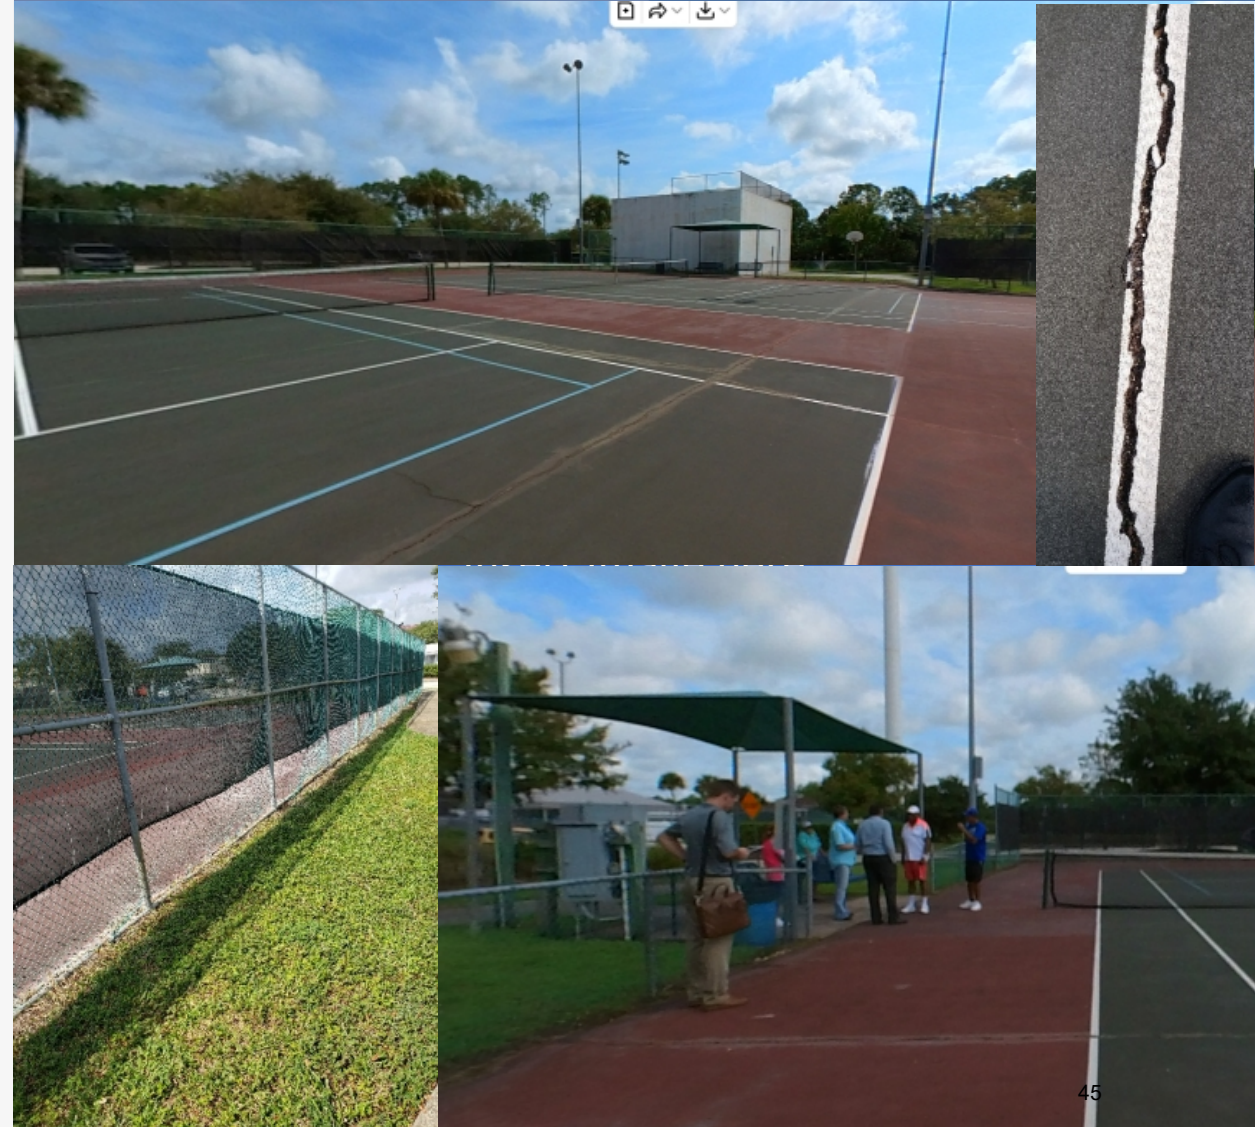
## Tennis Courts

- Current Condition
  - Courts substrate and surface are greatly deficient
  - Courts fences are deteriorated
  - Courts nets and posts are deteriorated
  - Courts lighting are inefficient and in poor condition
- Suitability for continued use
  - Courts are not usable in current condition
- Recommendation
  - Courts to be demolished and replaced
- Value
  - None

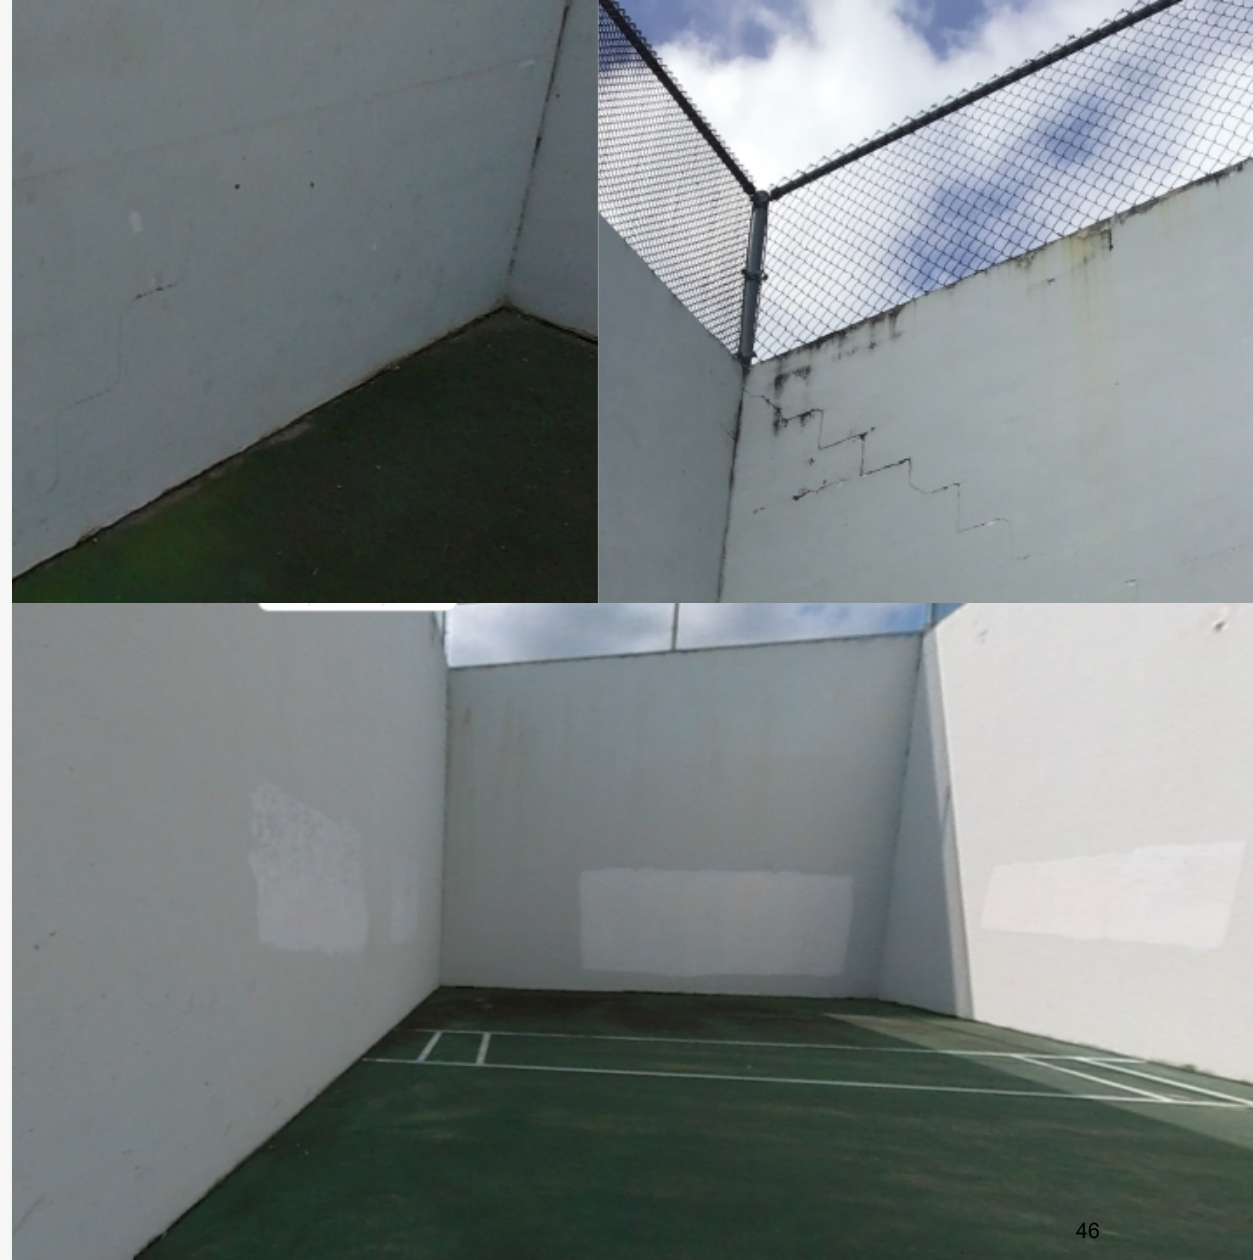
## Racquetball Courts

- Current Condition
  - Courts substrate and surface are deficient
  - Courts structural walls showing cracks
  - Access to courts is not ideal
- Suitability for continued use
  - Sport experiencing low usage for decades
  - Courts is not usable in current condition
  - Social game with no social space
- Recommendation
  - Courts to be demolished and replaced with amenity with greater use
- Value
  - None
