**FLAGLER COUNTY BOARD OF COUNTY COMMISSIONERS  
WORKSHOP/ AGENDA ITEM # 4**

**SUBJECT:** Consideration of an Agreement for the Purchase of the Former Hospital at 901 E. Moody Boulevard in the Amount of \$1,230,000.

**Report of the Building  
Construction/Renovation  
Study for Flagler County**

**Summary Appraisal Report  
of**

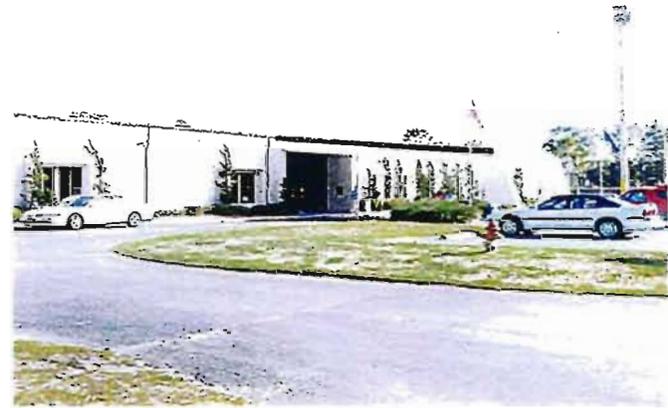
*Front entrance to Hospital*

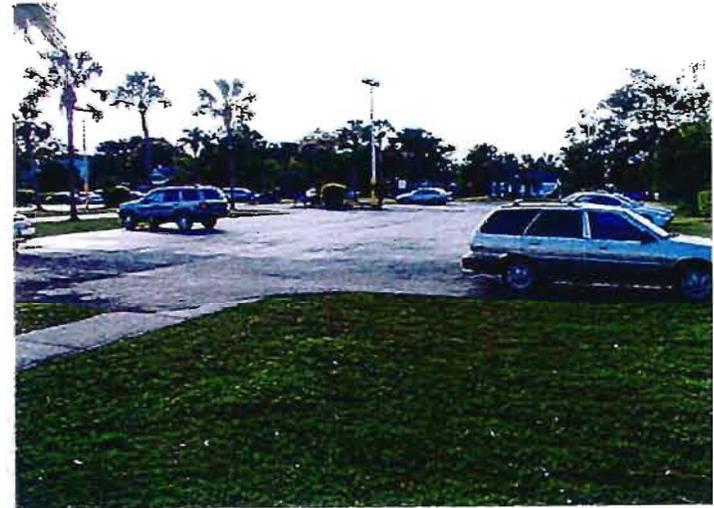
Hospital parking lot

Our firm visited the site on March 22, 2002, and performed a cursory review. The site is in generally good condition. Groundcover, landscaping and trees have been well maintained. We observed a functional sprinkler system currently used by the hospital in the front area of the facility. The aesthetics and functionality of the parking lot could be improved by resurfacing and restriping.

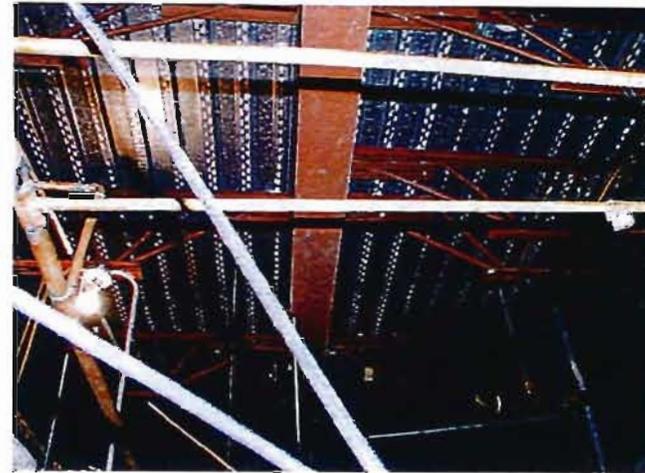
*Existing roof structure*

In summary, our cursory structural analysis revealed no deficiencies, except for the lack of concrete masonry unit vertical wall reinforcing and the lack of bottom flange bracing of the structural steel beams of the roof. The loads used in the preparation of the structural construction documents appear to be appropriate, and the structural member sizes specified are adequate to support the imposed loads.

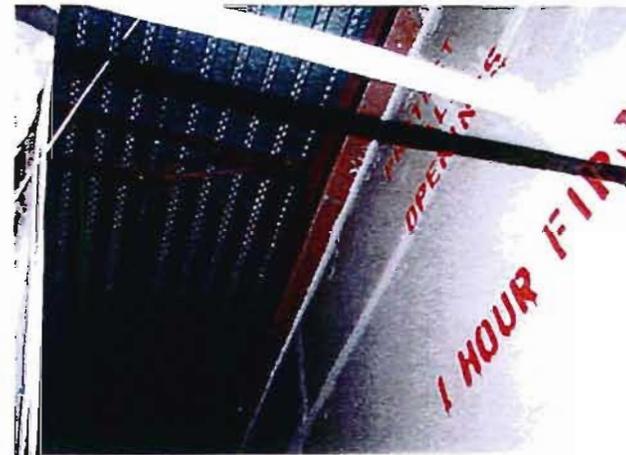
*Existing rated wall*

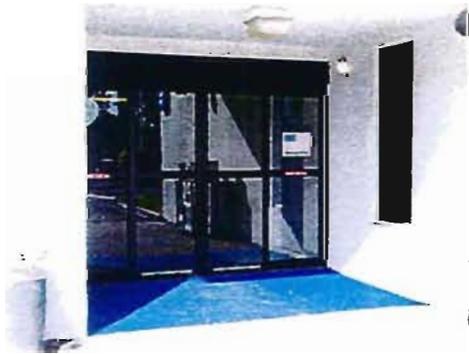
- o The glass and window frame system is in good condition.
- o The operable windows are all functional; however, some require minor adjustments for smoother operation.
- o All entry doors and hardware are functional.
- o All hollow metal doors show signs of use. All hollow metal doors and frames should be sanded and repainted.
- o All aluminum storefront doors and frames are functional and in good condition.
- o The exterior walls are covered with an EIFS (exterior insulation and finish system). Overall this system is in good condition. There are a number of areas at ground level that have been penetrated with mowing equipment, which should be patched and repaired.

*Hospital building exterior*

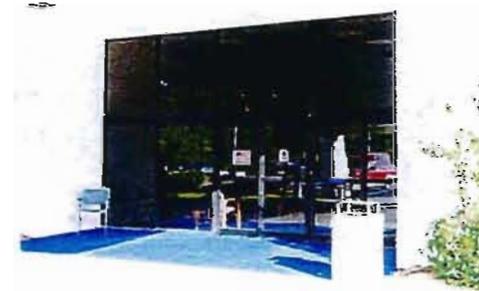
- o The roof is an approximately 2/12 pitch. The roof is a modified bitumen with a gutter system tied into subsurface drainage. The roof is in very good condition with no sign of leaks. (See Exhibit “A”, roofing contractor’s report.)

*Hospital building exterior*

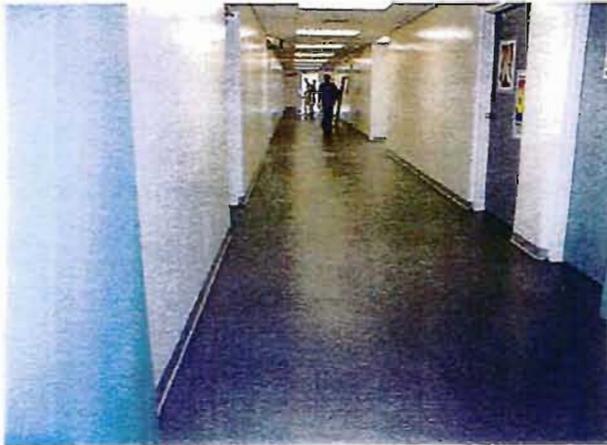
- 1) Carpet
  - a) The carpet in some areas appears to be relatively new, and may only require steam cleaning.
  - b) There are several areas of old/worn carpet that should be replaced.
- 2) Doors
  - a) All interior doors and hardware are functional.
  - b) All interior doors are plastic laminate, show signs of use and need repair.

*Corridor*

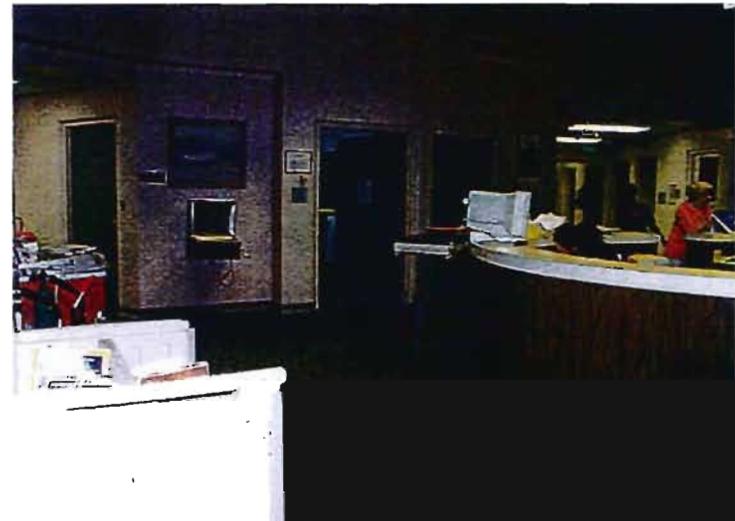
- 3) Walls
  - a) All interior walls are in good condition with only minor patchwork required before painting.
  - b) Painting in many areas shows sign of wear. The building should be painted throughout.
  - c) In the administration area, the walls are metal stud with drywall or metal stud with paneling. The paneling is dark in color, which decreases the lighting level. Paneling should be replaced upon renovation of the building.
  - d) The scope of our study did not include research on evidence of lead.

*Nurses' Station*

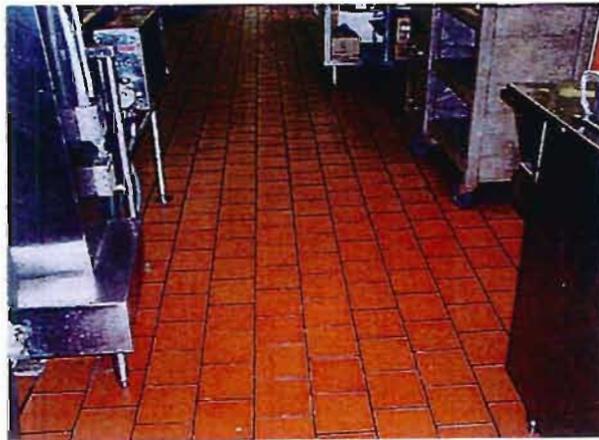
- a) The ceiling is a 2 x 4, lay-in acoustical grid system. All ceiling tiles are in place.
- b) Ceiling grid and tiles are old and discolored throughout the building. Ceiling tiles have been replaced in many areas and do not match. Ceiling grid and tile should be replaced upon renovation of the building.
- c) In the kitchen area, the floor is quarry tile and is in good condition. The ceiling is a plastered ceiling with several water-damaged areas that have been patched.

*Kitchen floor*

The kitchen ceiling should be removed and replaced with an acoustical grid system.

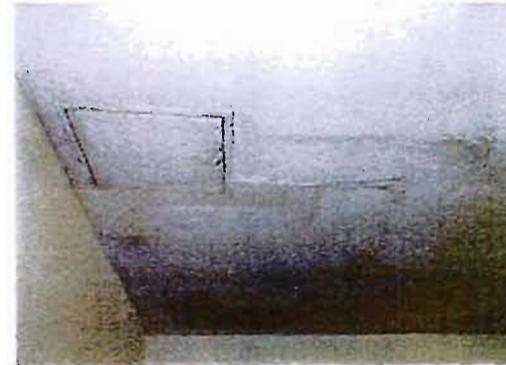
*Water stains on ceiling*

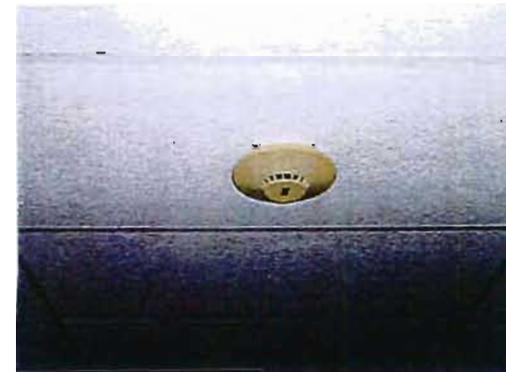
*Smoke detector*

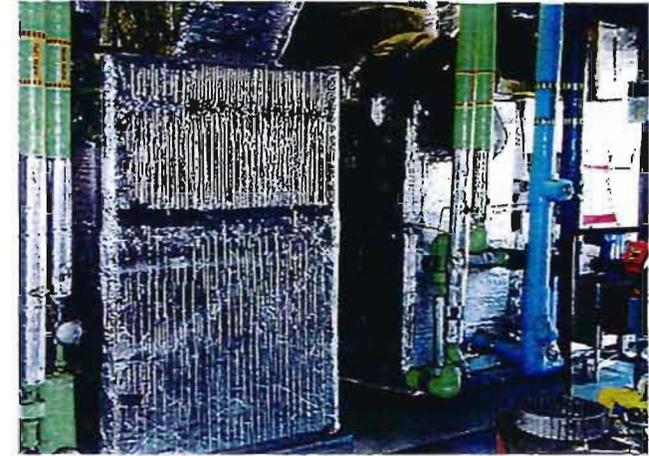
The common areas and administrative areas of the existing hospital facility are mechanically cooled by two air-cooled water chillers piped in parallel and located on the ground outside the central plant. From the manufacturer's nameplate data, each chiller has an approximate capacity of 100 tons. Chilled water from the two chillers is circulated by way of a single, constant-speed chilled water pump to several central station air handling units located throughout the building. Each air-handling unit is equipped with a three-way chilled water valve with bypass. Supply air is distributed from the central station air handling units through externally insulated sheet metal ductwork to ceiling and sidewall air terminal devices. The patient rooms are heated and cooled by packaged terminal air conditioners with electric resistance heat located in the exterior walls. However, the packaged terminal units have been removed and a packaged rooftop direct-expansion cooling unit has been added to serve Wing C. According to hospital facilities maintenance staff, all packaged terminal air conditioners were replaced approximately one year ago.

*Mechanical equipment*

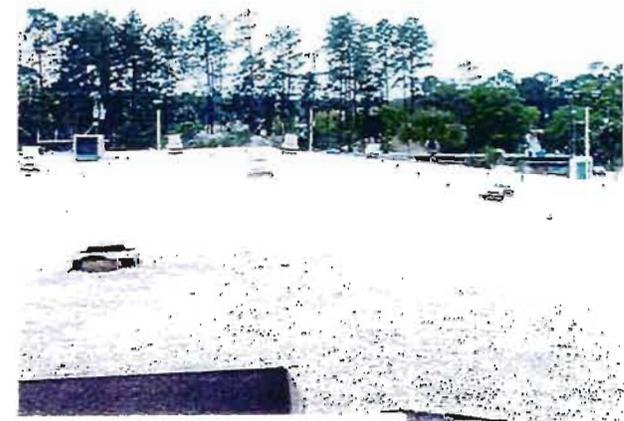
*Rooftop exhaust fans*

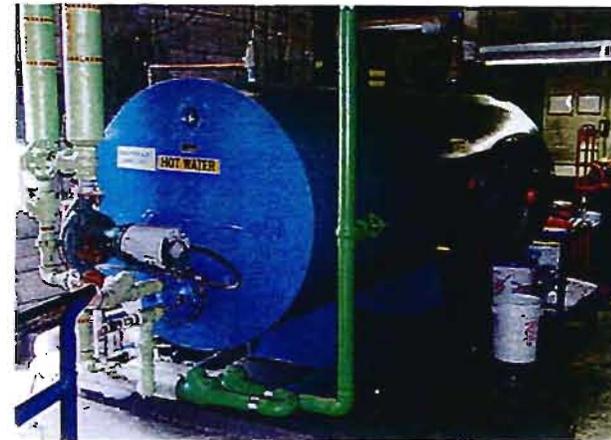
*Hot water tank*

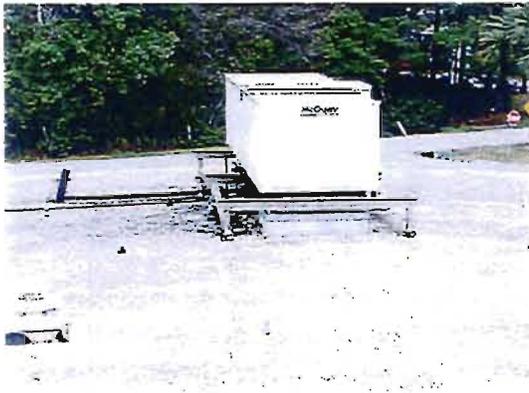
In summary, the existing mechanical systems appear to be in good condition, with the few exceptions mentioned above. According to the facilities maintenance staff, a comprehensive equipment maintenance program has been implemented over the last six months. It is highly recommended that this maintenance program be continued.

*Roof AHU*

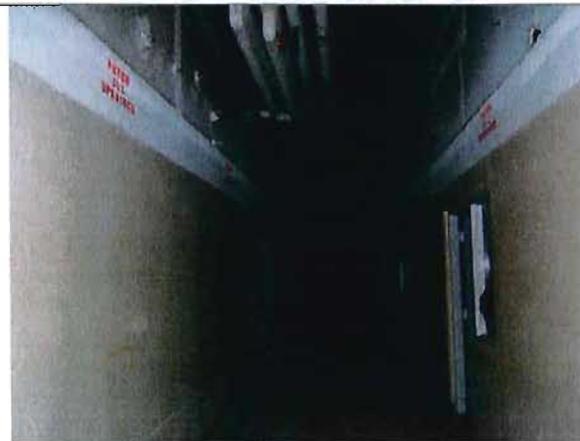
Interior Corridor Near Former Emergency Department; Typical Shell Condition.

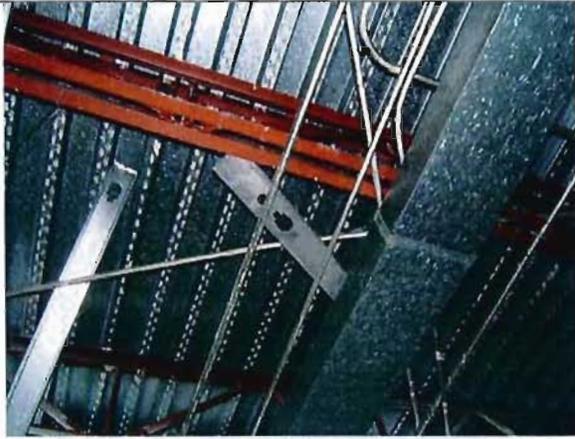
Roof Structure With Steel Trusses And Metal Decking.

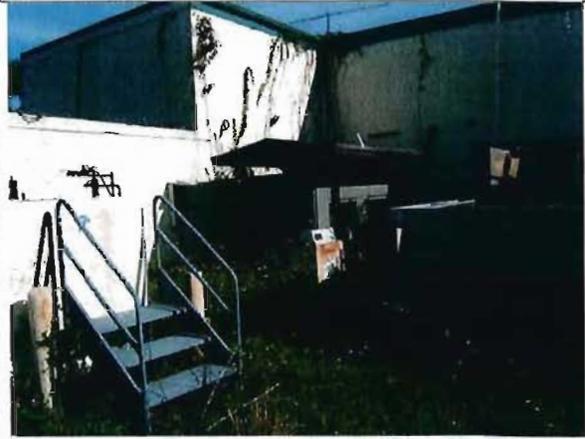
Emergency Generator In The Background; Concrete-Vaulted Fuel Storage Tank To The Left.
