**FLAGLER PIER RESTAURANT
COST ESTIMATE FOR REPAIRS**

Prepared for Ray Barshay

Pier Restaurant Assessment:

**FLAGLER BEACH PIER RESTAURANT COMPLEX
STRUCTURAL INVESTIGATION FEBRUARY 2010**

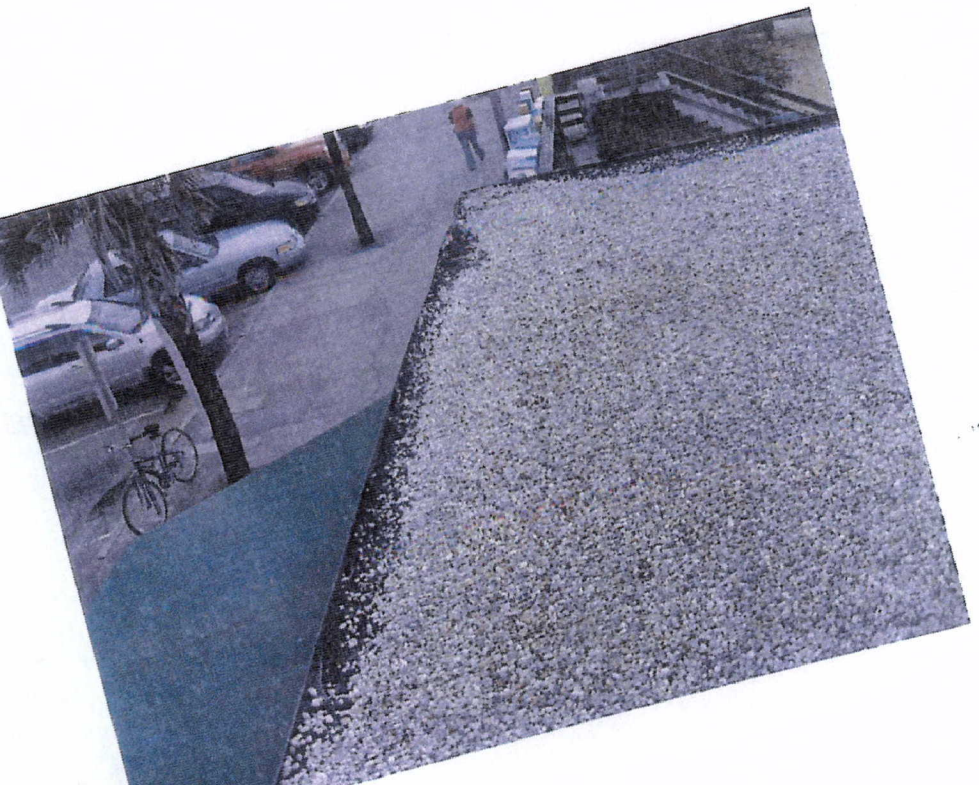
IBIT 3

- a. Some areas of the dining area of the roof deck were not level and had ponding issues (Refer to Exhibits 1 and 2)) following recent rain. Over time, water standing on a roof surface will damage roof coatings and roofing materials. Standing water eventually leads to roof leaks, damage to roof and deck materials, and damage inside the structure. No visible leaks were noted during our visit but proactive measures should be taken to repair ponding at low areas to avoid future damage.
- b. Several bare spots were noted and should be repaired. (Refer to Exhibits 3 and 4)

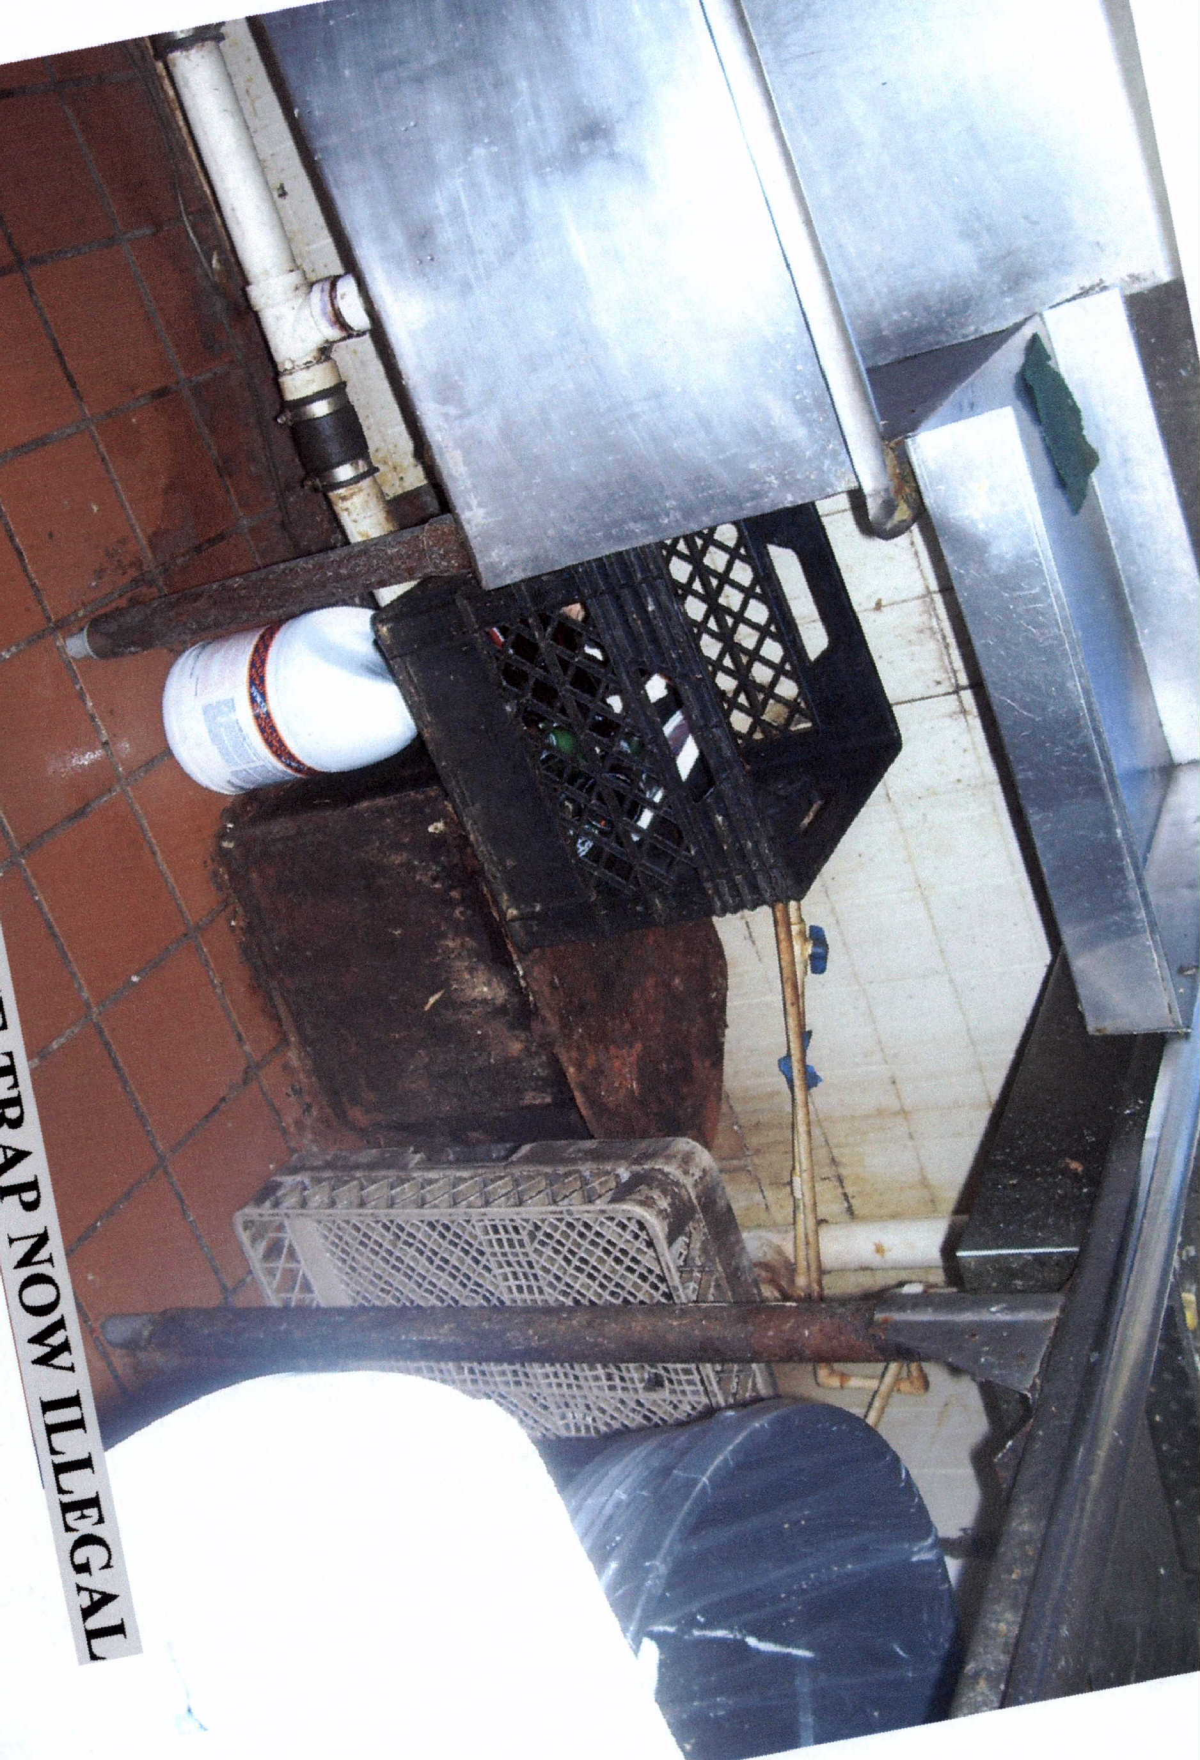
FLOOR DRAIN LEAKING

TRAP NOW ILLEGAL
