# Palm Coast Fire Station 22

Evaluation of Existing Fire Station 22

**SCHENKELSHULTZ**  
□ □ □ ARCHITECTURE □ □ □

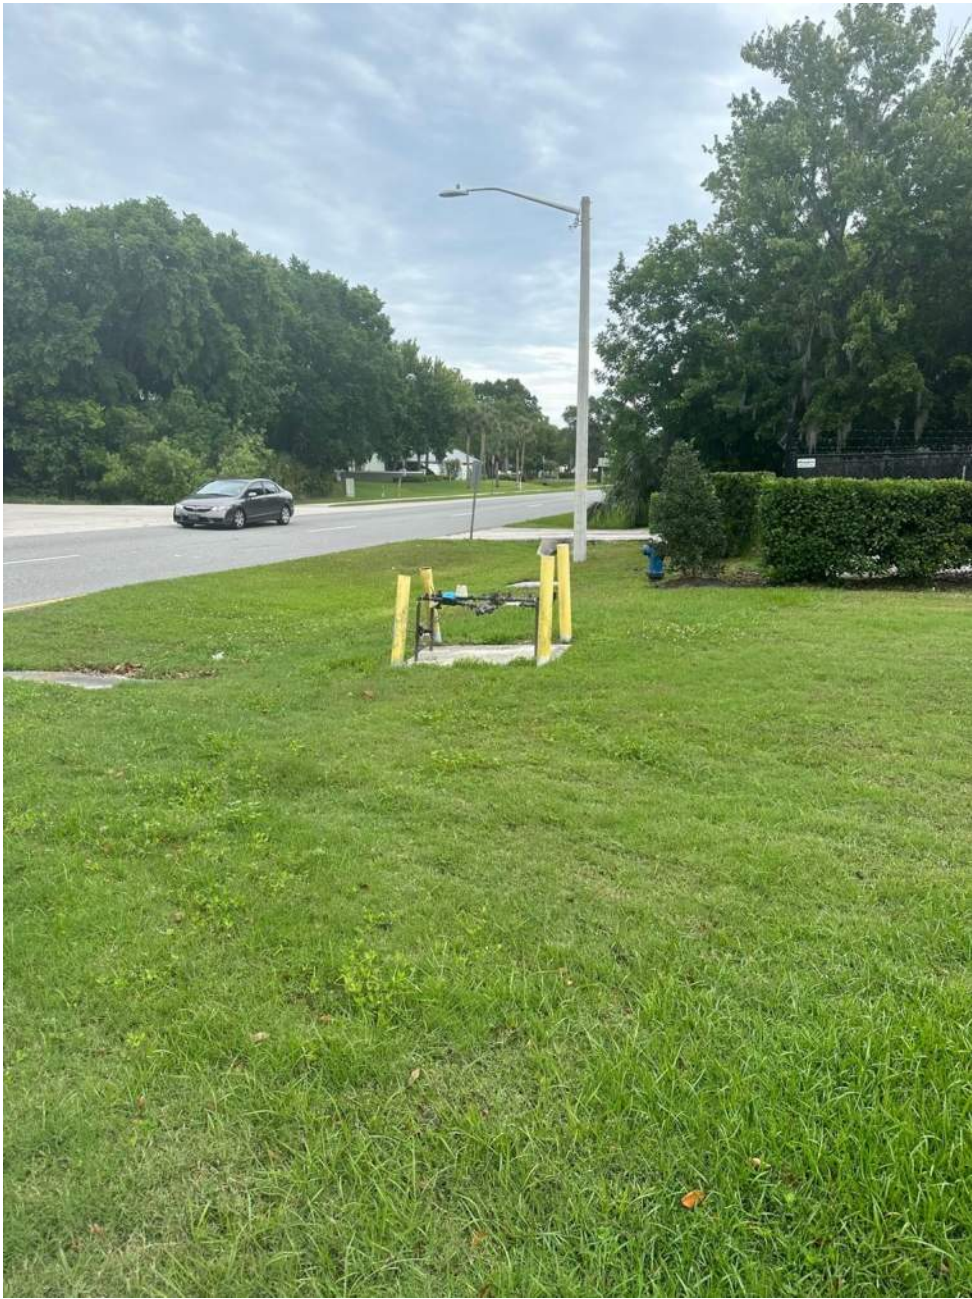
*Stormwater swale north and east property boundary Palm Coast Pkwy NE*

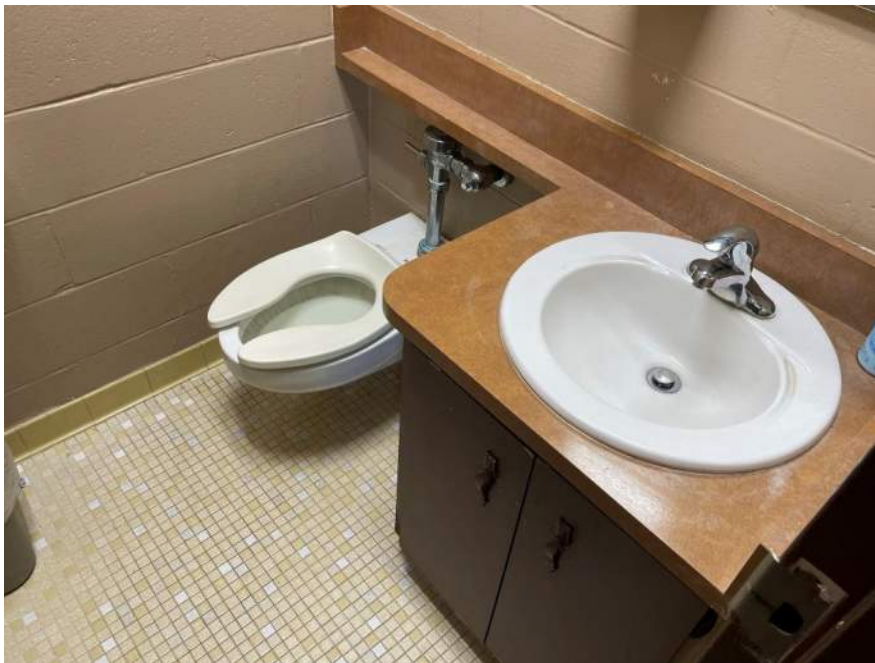
The plumbing fixtures in the bathrooms appear to be in fair condition. The typical useful service life for toilet fixtures is 15 to 20 years which appears to leave this building with 5 to 10 more useful years.

IMG\_4354: Toilet and Lavatory

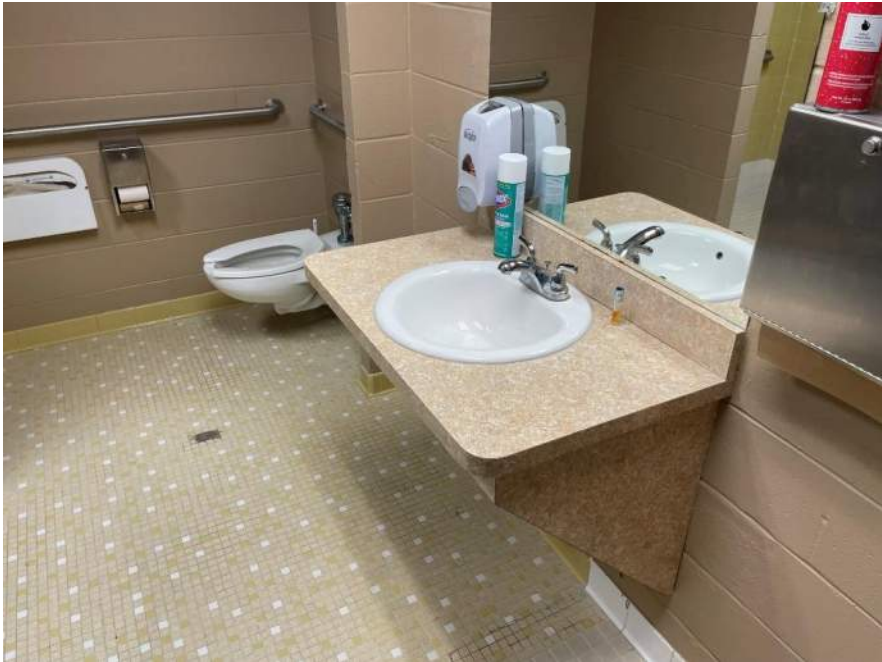
IMG\_4359: ADA Bathroom

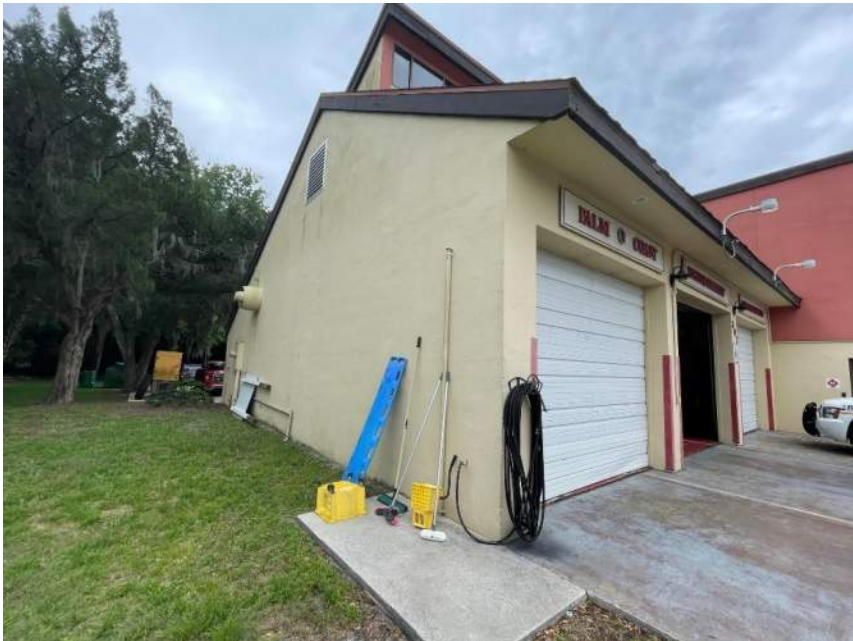
An exhaust system has been added since the original construction to include low air inlets. There are four vertical ducts extending down to the floor with grilles at the floor elevation. These are connected to an in-line fan in the attic which discharges to a louver on the east side of the apparatus bay. A louver installed in the clearstory window framing on the north side is ducted to the ceiling of the apparatus bay for make-up air. The fan and ductwork all appeared to be in good condition. The nameplate data off of the exhaust fan was not available to determine the equipment age. A visual inspection would estimate the fan would have roughly 10-15 years of useful service life remaining.

IMG\_7886: Apparatus bay exhaust fan discharging to louver in east wall

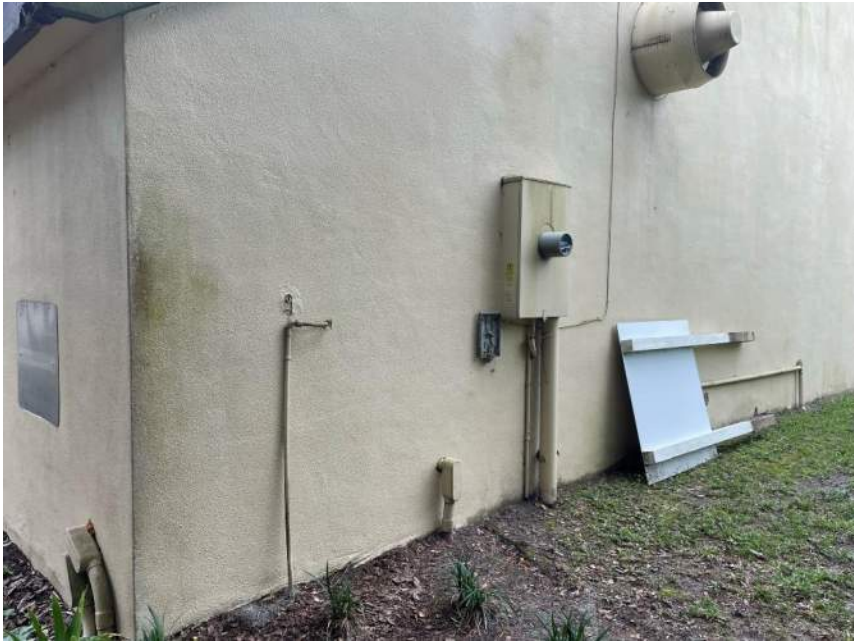
IMG\_0766: Exhaust louver on east wall and make-up air louvers in clearstory window

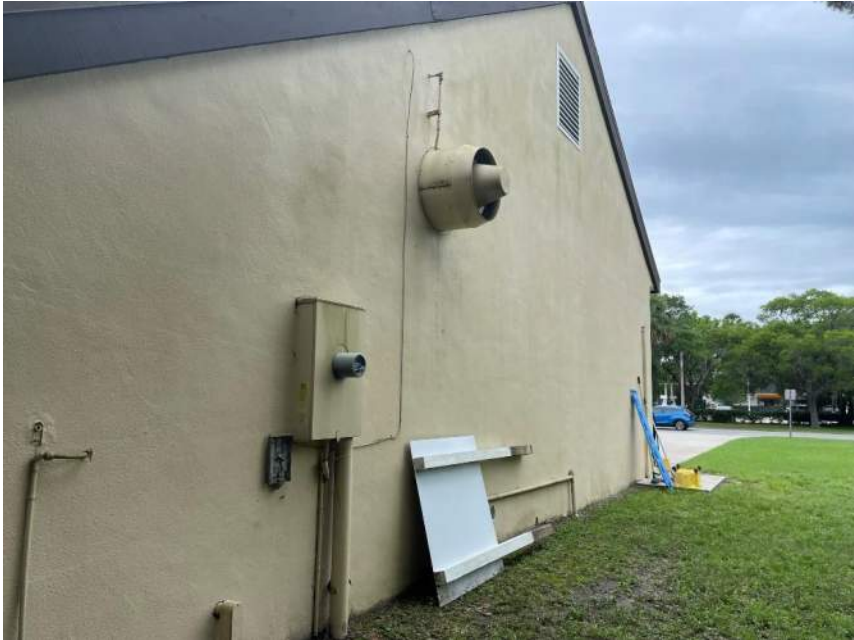
There is an abandoned wall mounted fan on the east wall of the apparatus bay that should be removed.

IMG\_4326: Abandoned fan on east wall

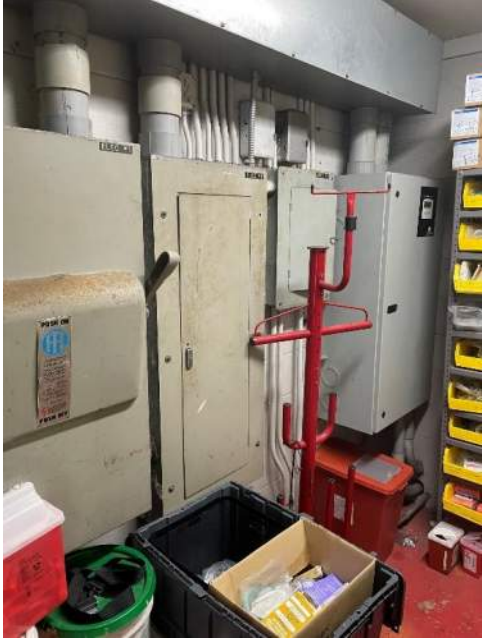
The Fire Station 22 Building was constructed in 1976. The electrical service is 120/208 volt, 3 phase. A 400 amp disconnect switch is located within the electrical room along with the Main Distribution Panel (MDP) and branch circuit Panel A. These panels, manufactured by ITE are over 45 years old and have reached their useful life span.

IMG\_4262: Electrical room main disconnect, MDP, Panel A and ATS

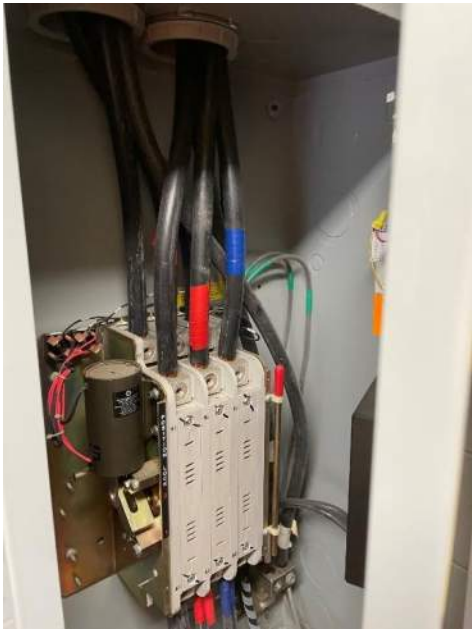
IMG\_4281: ATS interior

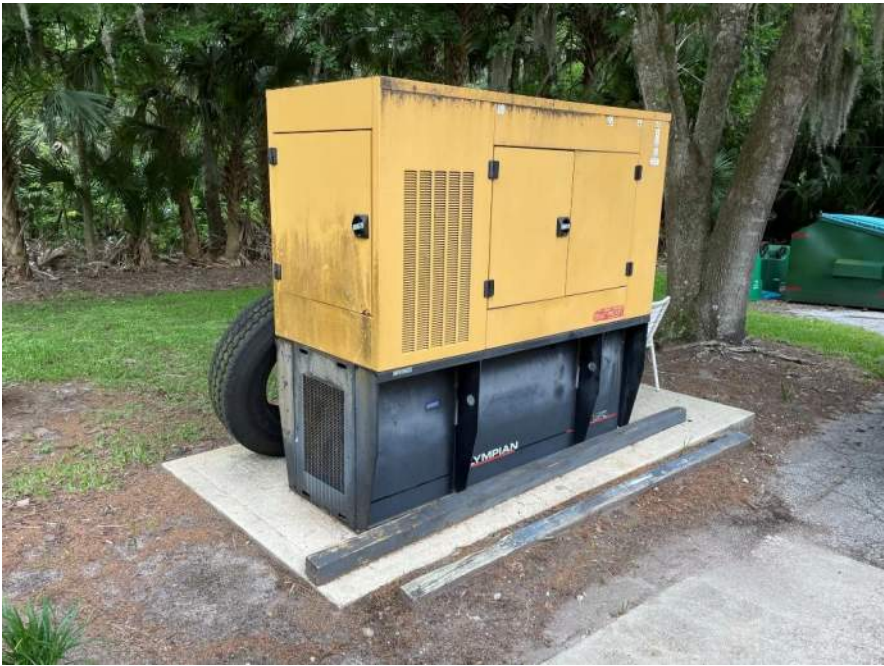
IMG\_4323: Generator and diesel fuel tank

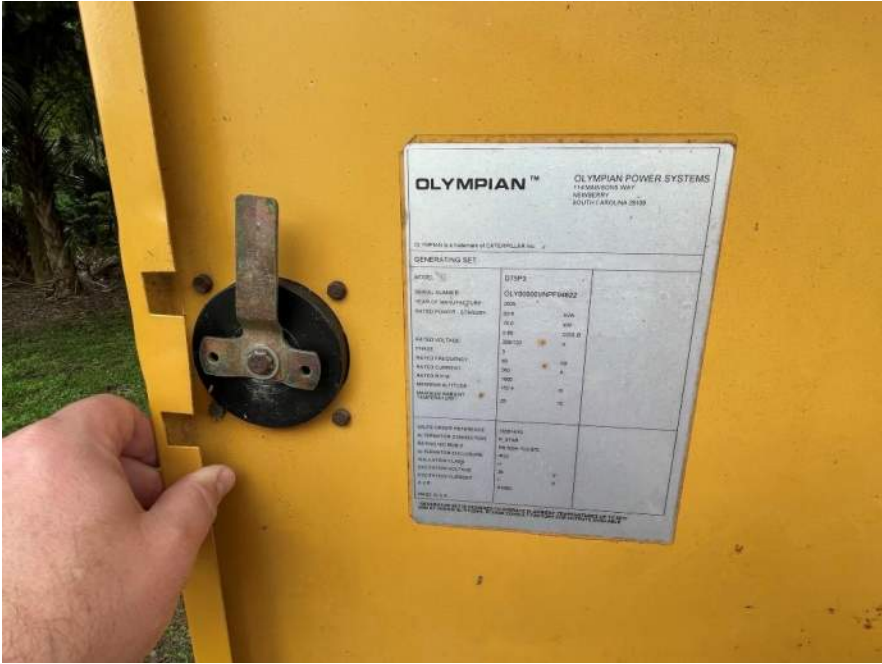
IMG\_4416: Generator nameplate

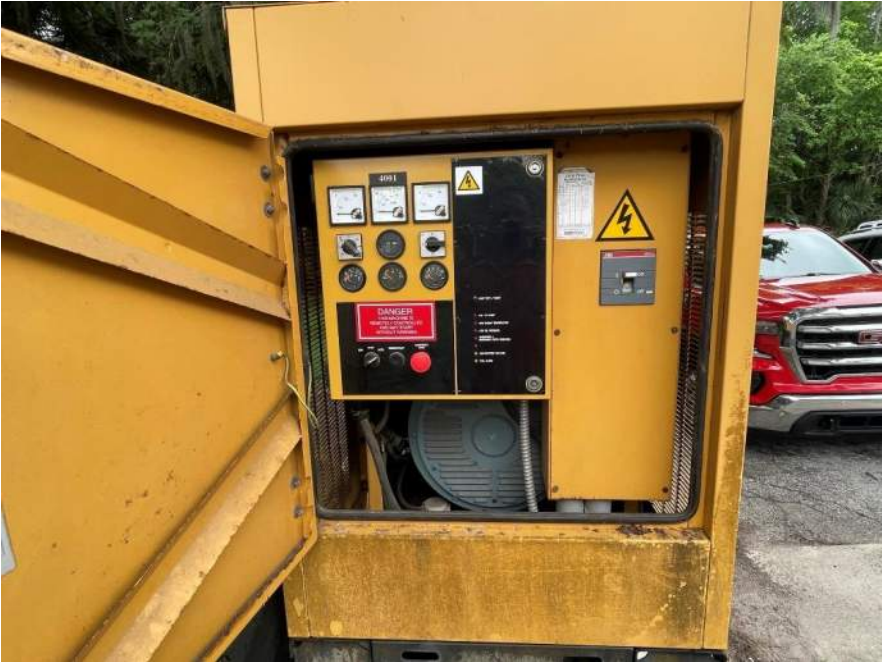
IMG\_4418: Generator control panel

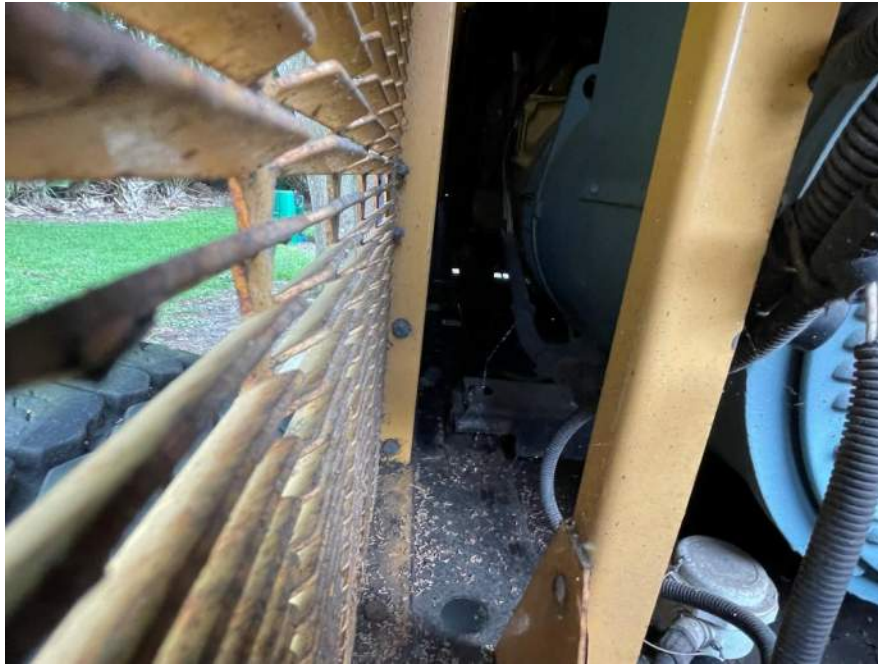
IMG\_4420: Generator interior

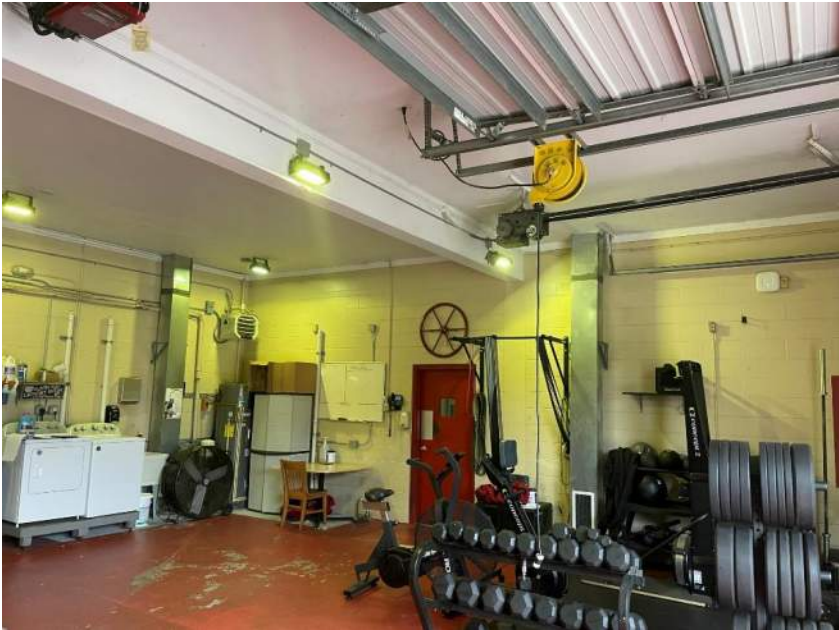
IMG\_4288: Apparatus Bay LED floodlights

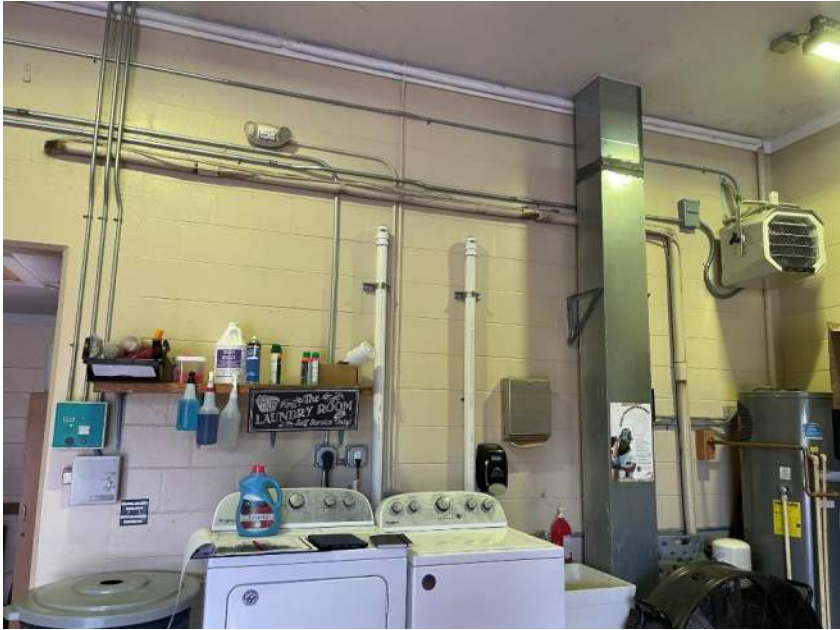
IMG\_4301: Added emergency light

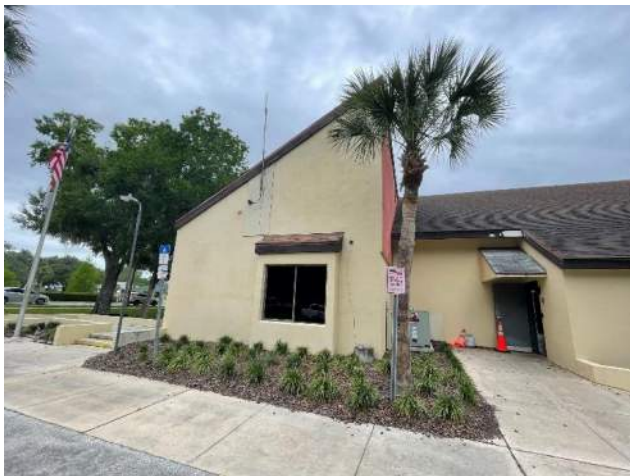
IMG\_4336: Steel pole mounted light

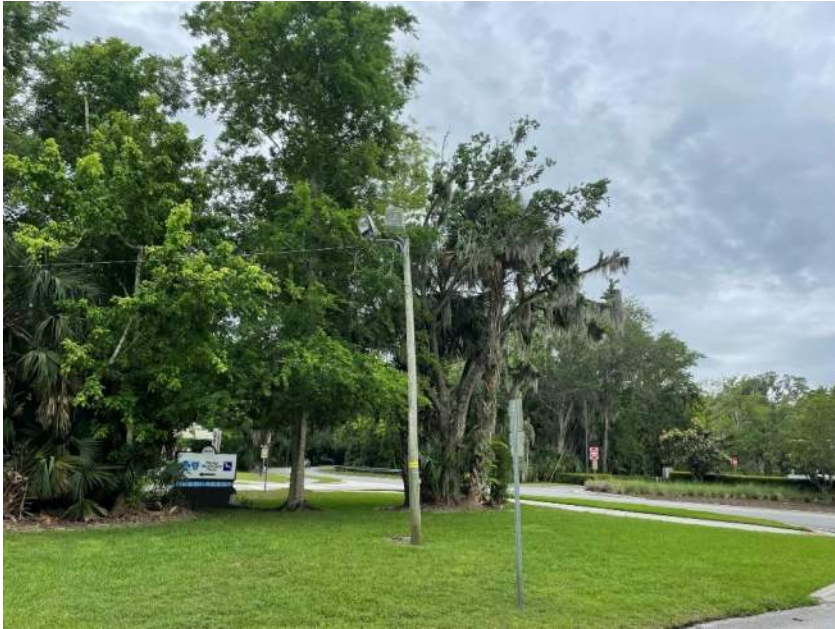
IMG\_4350: Wood pole mounted lights

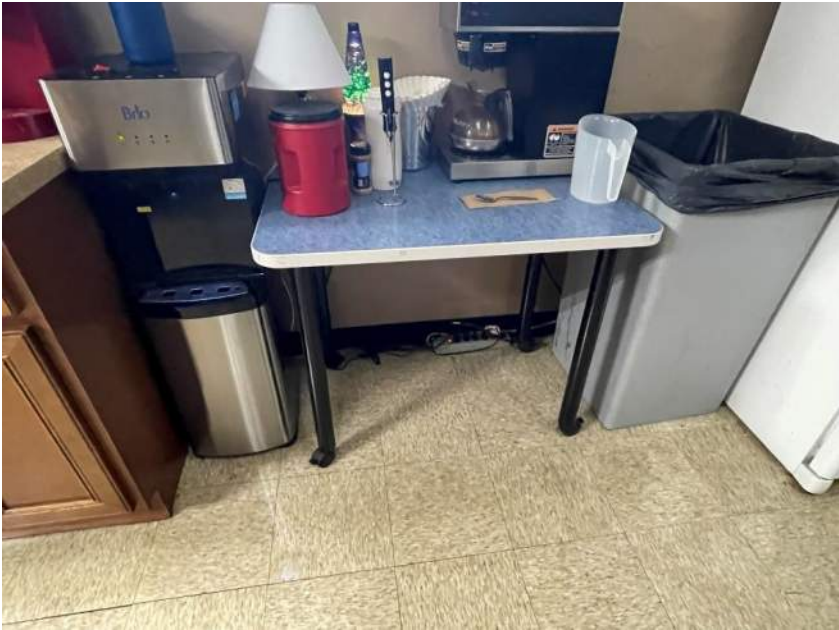
IMG\_4386: Not enough outlets in kitchen

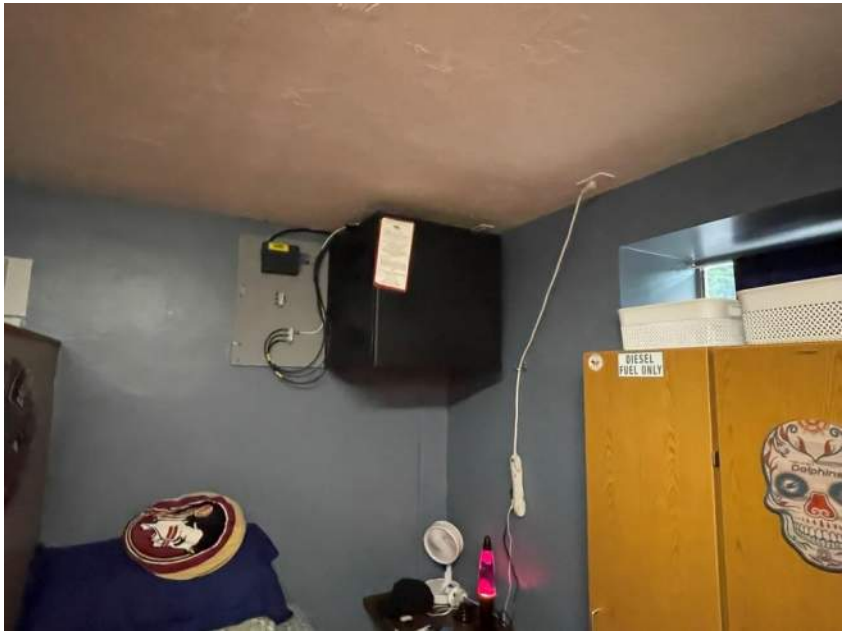
IMG\_4432: Not enough outlets in bunks

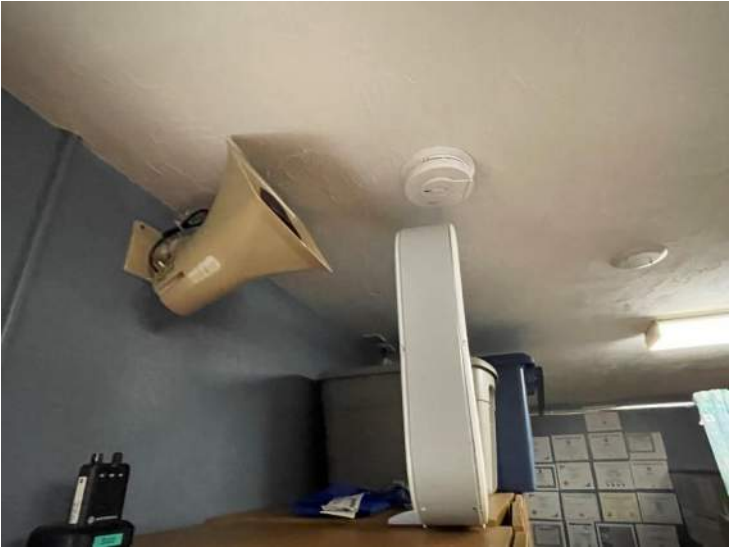
IMG\_4422: Stand alone smoke detector in bunk room

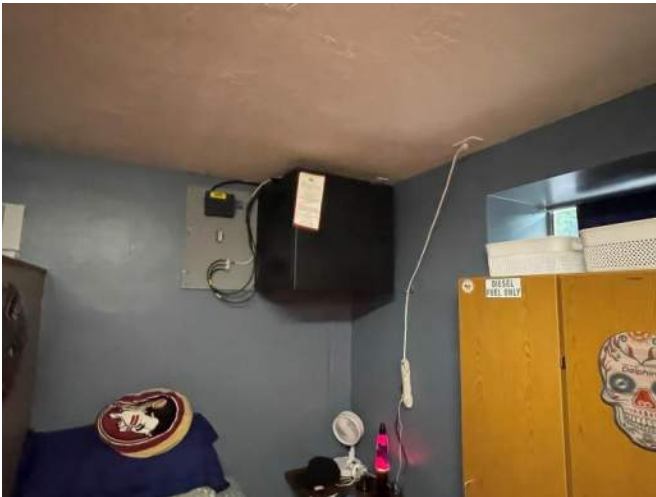
The communication systems was installed not too long ago. The comm and other low voltage systems are located within the Bunk Room. The room is slightly crowded and its unconventional to house the comm equipment within a sleeping area, the system appears to be operating satisfactorily. We believe the cabling for the system should be upgraded to CAT 6.

IMG\_4432: Communication rack located above sleeping bunk

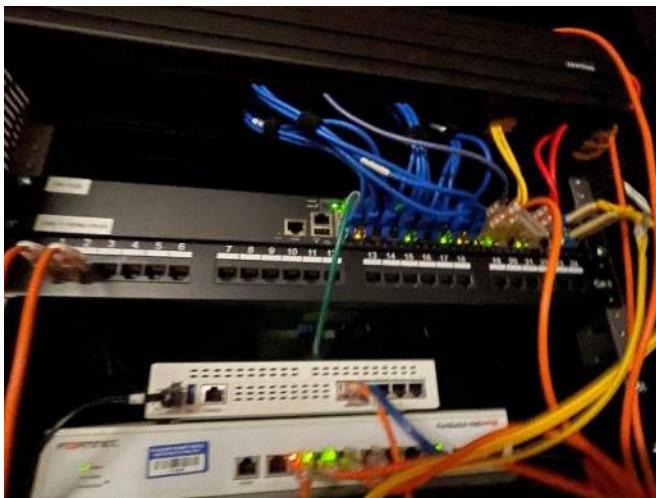
IMG\_4437: Rack interior with patch panel and cabling
