Condition Assessment Old Flagler Hospital, Flagler County

CONFORMING REPORT

DJ Project #02218.02

July 26, 2013

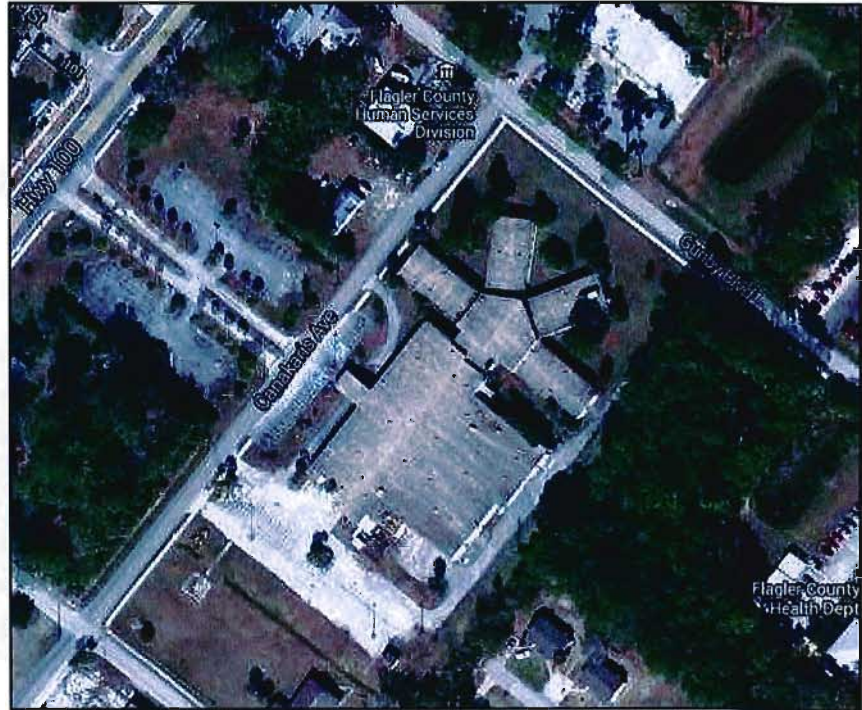
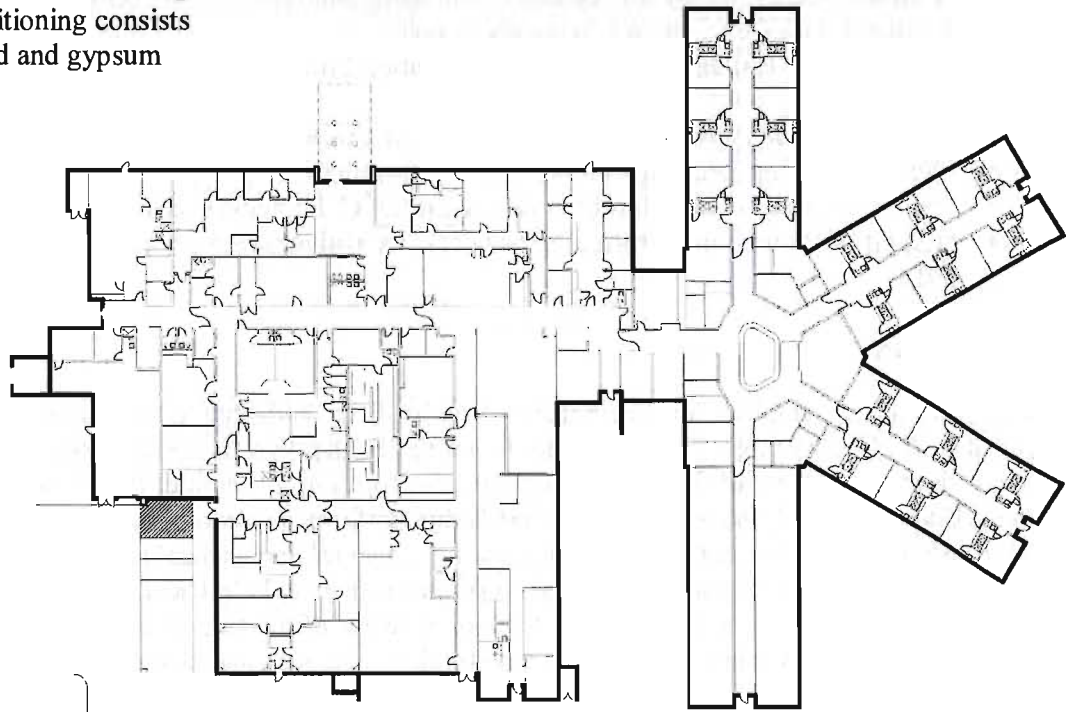
The existing building is divided into two distinct areas; the main building encompasses approximately 35,000 gross square feet (GSF) and the four-winged patient room area contains approximately 21,800 GSF. The building is of non-combustible construction consisting of unreinforced CMU bearing-walls, steel columns, steel beams and bar joists with metal roof-decking and light weight insulating concrete and a low-slope roof. There is no fireproofing on the roof-structure, but several steel columns are protected with gypsum-board. The existing interior partitioning consists of metal stud and gypsum board.

Much of the interior finishes, fixtures and equipment as well as salvageable metals (aluminum, copper, and lead) have been removed over the years. However, the egress corridors and other fire partitions have been retained. While there are numerous holes in the walls, they are largely intact and remained sealed to the structure above and to the exterior walls.

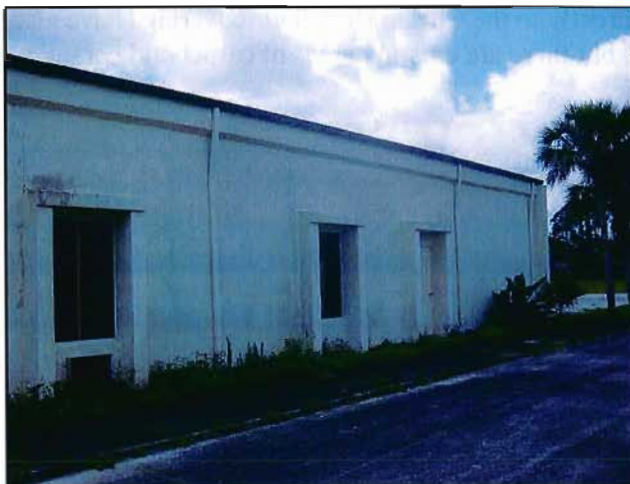
The exterior walls are CMU covered with a 1” Exterior Insulating and Finishing (EIFS) system. The

Styrofoam shows evidence of de-lamination from the CMU substrate in several areas. We found no evidence of insulation in the CMU cavities or attached to the interior surfaces. On June 17, 2013, **GeoTek Services, LLC** performed a Ground Penetrating Radar (GPR) survey of various exterior walls within the building and those results are contained in Appendix ‘A’. On the same day, **CDE** also took further field notes on the condition of the existing structural framing. Details of the current conditions of the facility are outlined in the following structural, mechanical, and electrical sections.
