# UNIVERSAL ENGINEERING SCIENCES

RE: Property Condition Assessment Report – Former Sears Building  
4888 Palm Coast Pkwy NW, Palm Coast, Flagler County, FL  
UES Project No. 0415.1800110.0000  
UES Report No. 161543

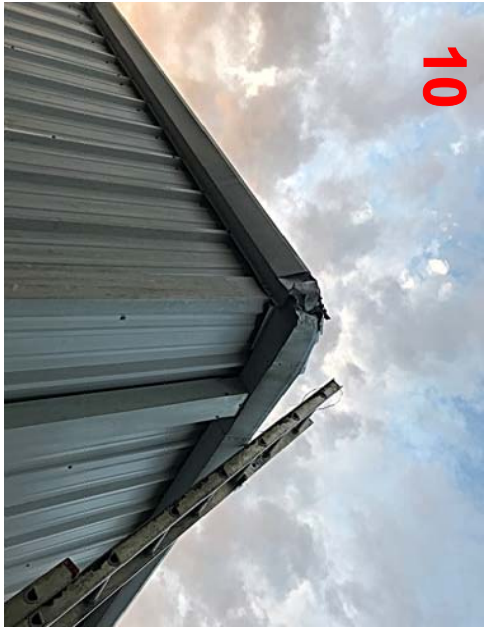
10

The gutter and down spouts have several areas of damage and repairs are necessary as shown in photos 10, 110, 112, 116.
