Subject: SR 100 Pedestrian Overpass Enclosure Sunlight Glare

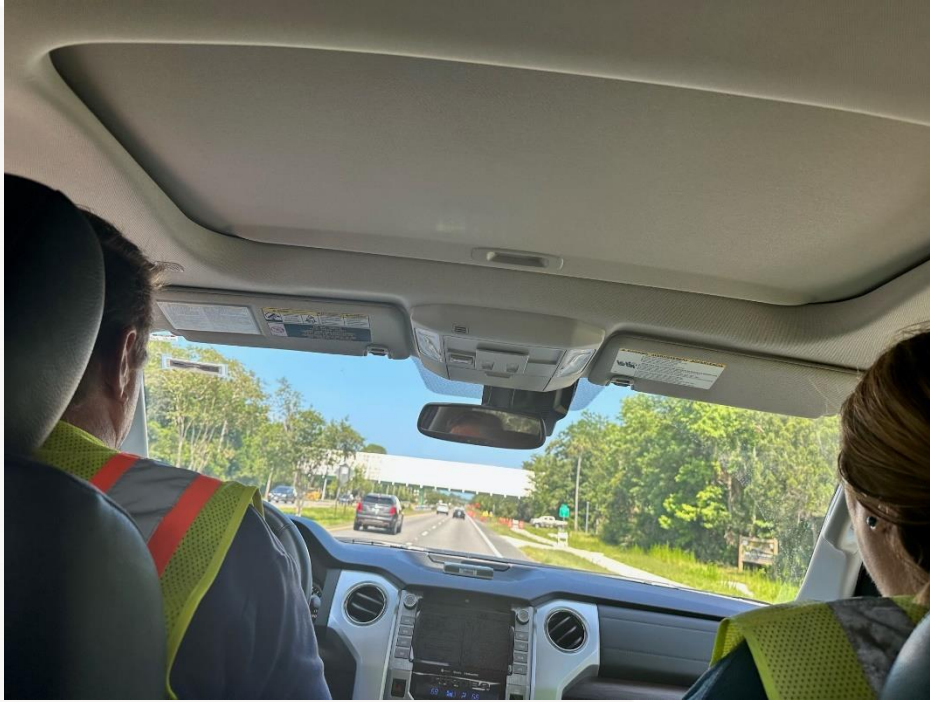
On June 4th, 2023, KCA received notice via e-mail there were concerns associated with sunlight glare observed by drivers on SR 100 associated with the newly installed stainless-steel safety enclosure of the Graham Swamp Trail SR 100 Pedestrian Overpass Bridge. Peek glare was reported to occur between approximately 3:30 to 4:15 pm for drivers traveling in the eastbound direction of SR 100.

Traveling Eastbound Toward Bridge during Period of Intensified Glare

In relation to our observations and discussion, KCA and HKS are in the process of evaluating treatments to reduce sunlight reflectivity from the enclosure relative to the times of day having intensified glare that appear to be of concern to the public as noted by social media comments. These treatments include:

- Application of chemicals to accelerate the process of naturally occurring patina of the stainless-steel surfaces by which the glare would lessen.
- Application of painted coatings that would reflect less sunlight.
- The addition of lettered signage which would reduce the area of the stainless-steel enclosure that is generating glare.

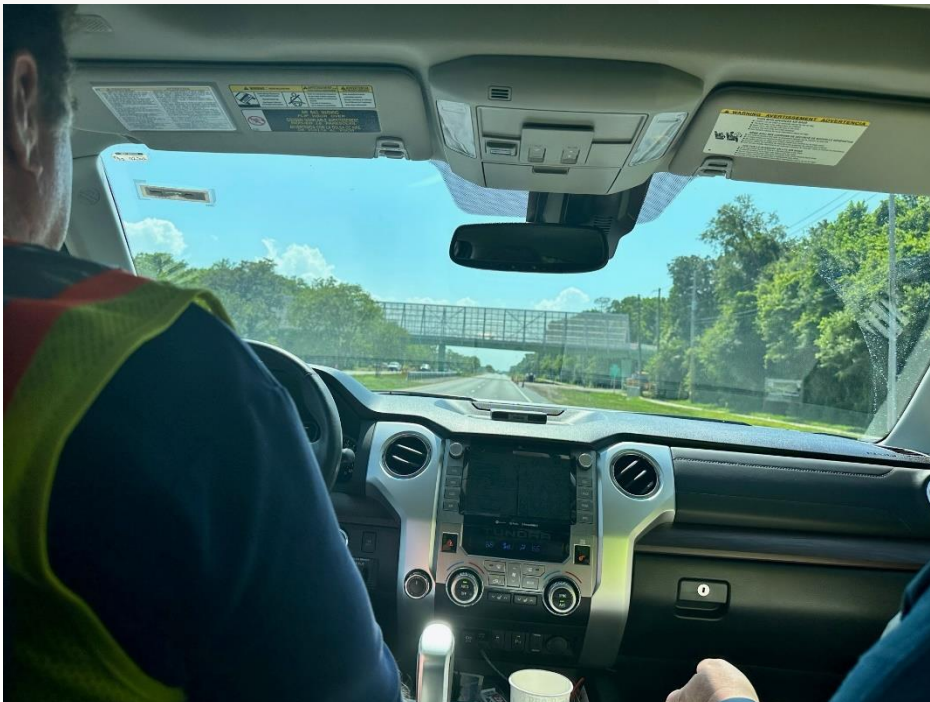
Traveling Westbound Toward Bridge during Period of Intensified Glare

KCA spoke with the England - Thims & Miller (ETM) CEI inspector on site to see if a similar occurrence of intensified glare has been occurring in the mornings relative to westbound traffic. Doug Kellum, ETM Inspector, indicated a similar period of intensified glare does occur from approximately 10:30 am to 11:00 am relative for traffic traveling westbound.
