**Project Observation Minutes & Recommendations from Martin Aquatic
Holland Park IWF - Palm Coast**

Project:	Holland Park IWF		
Location:	Palm Coast, FL		
Report By:	Jonathan "JT" Toavs & Ken Martin		
Attendees:	JT, Ken, Mackenzie, and Drew from Martin Aquatic		
Issue Date:	2022.08.18	Revised Date:	
Subject:	IWF existing conditions Observation		
Weather:	Partly Cloudy

PlanGrid Task Report - Jul 23, 2022

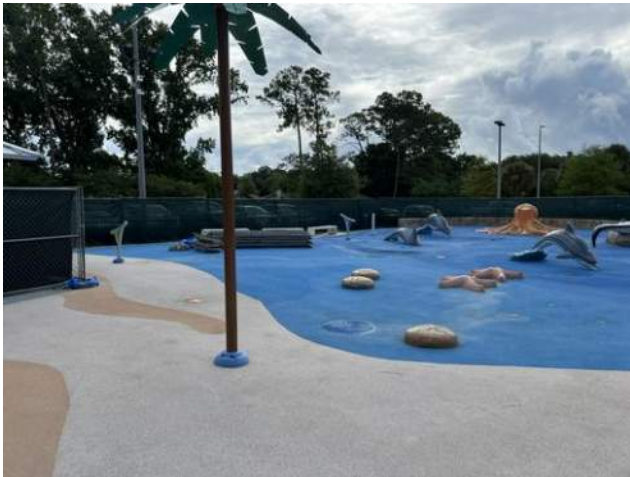
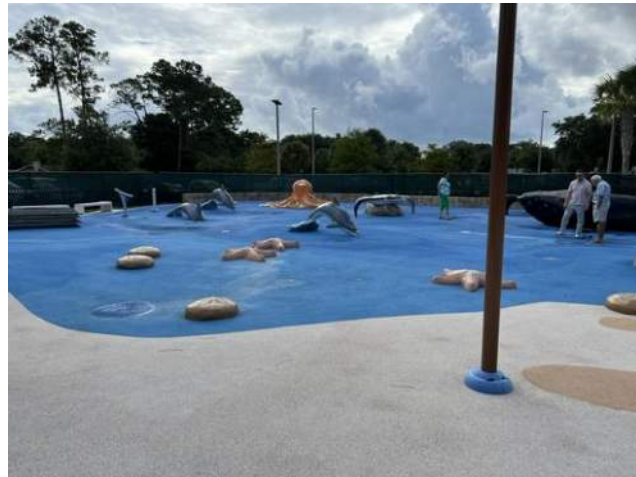
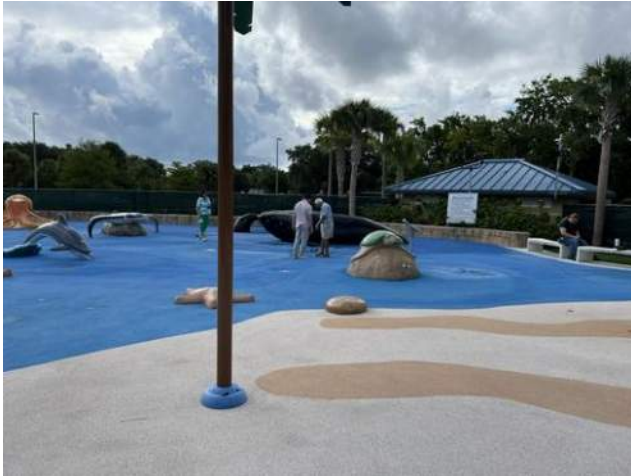
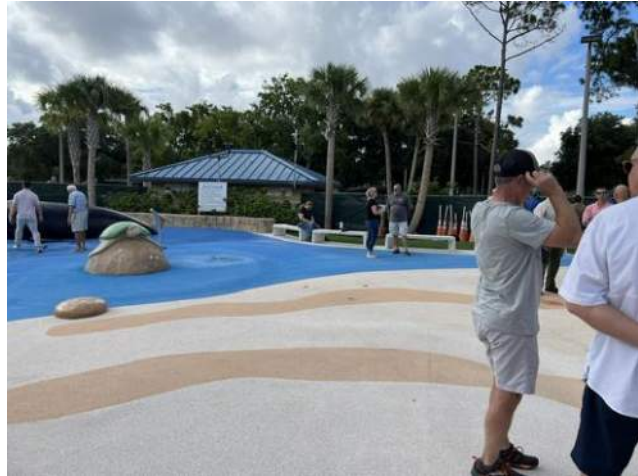
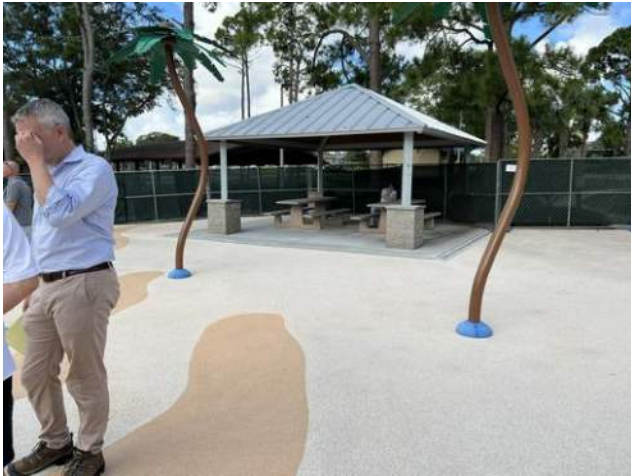
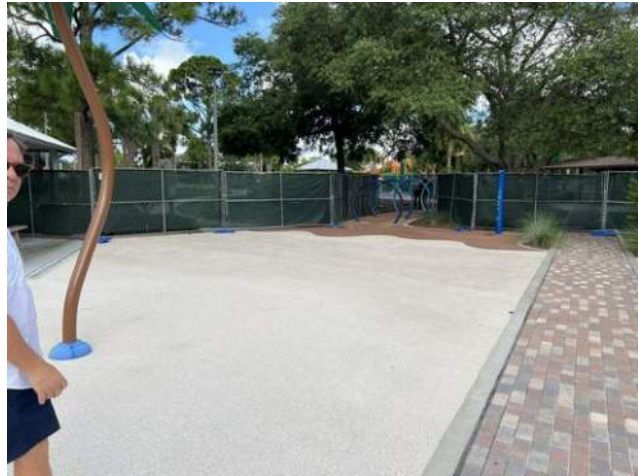
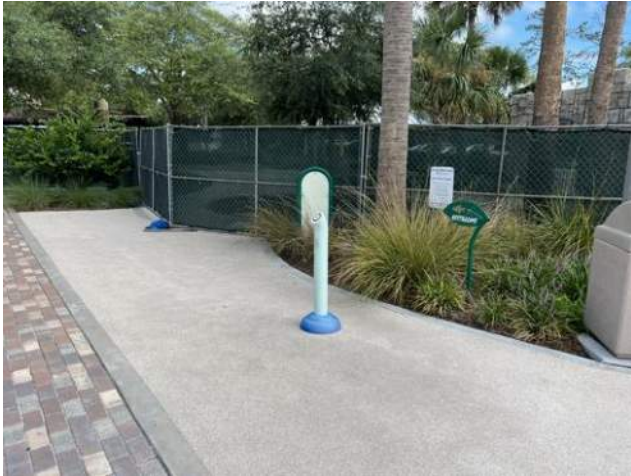
Overview of features - DRY and lack of decking adjacent features.

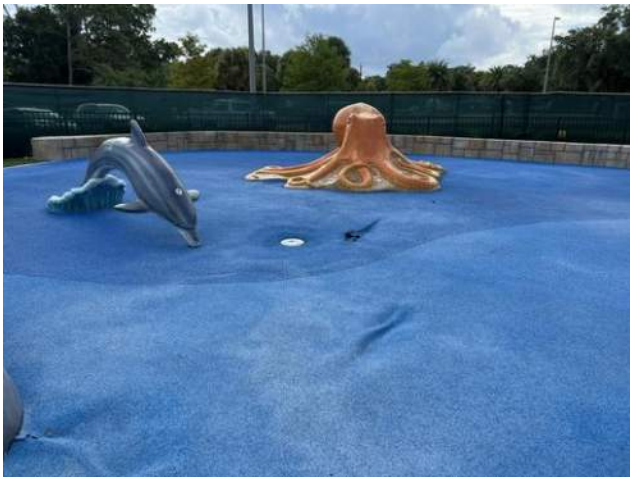
Areas of slope and drainage concern.

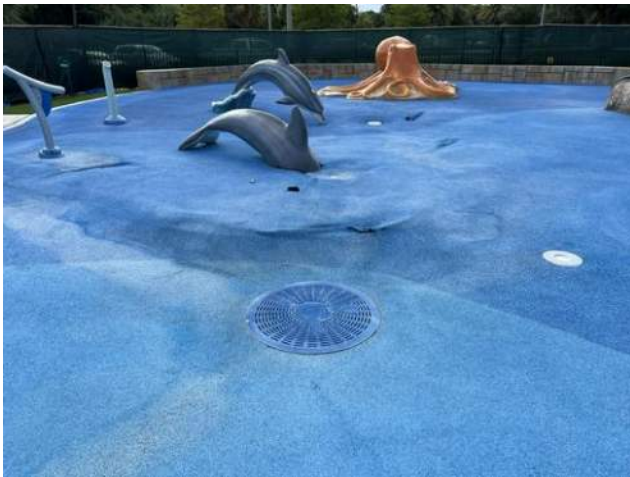
Description
Areas of slope and drainage concern.

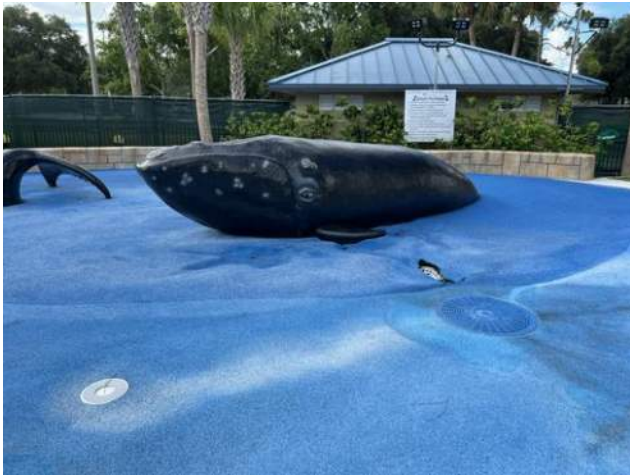
Areas of slope and drainage concern.

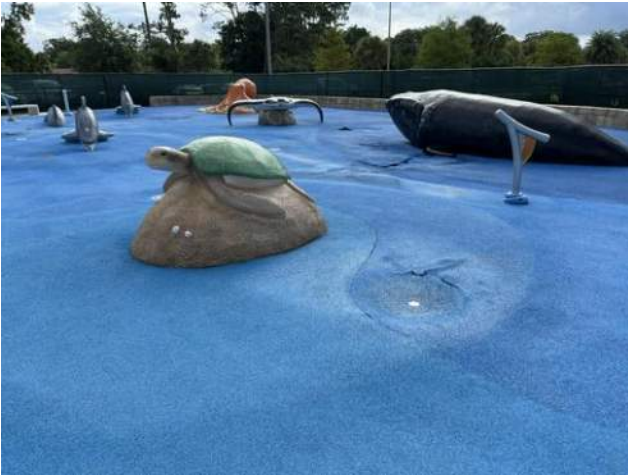
Areas of slope and drainage concern.

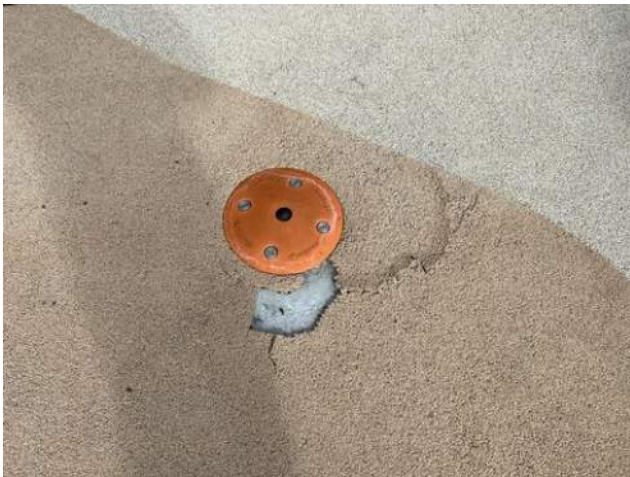
Surface failure and sample location.

4. The No-Fault deck finish surfaces and accompanying No-Fault decking subsurface (installed on the IWF concrete sub-deck) are recommended to be removed and replaced with an alternate NSF-Standard 50 Listed non-porous, code-compliant, impervious non-slip deck surface to help mitigate the current flow-related issues. Replacing the IWF finish deck surface will also reduce, if not eliminate, the deck finish failures and the noted safety concerns. However, the apparent Variance approvals require the Owner to repair portions of the No-Fault finish surfaces' torn and failing deck finishes; however, we do not recommend that such repairs be attempted vs. replacing the failing No-Fault materials.

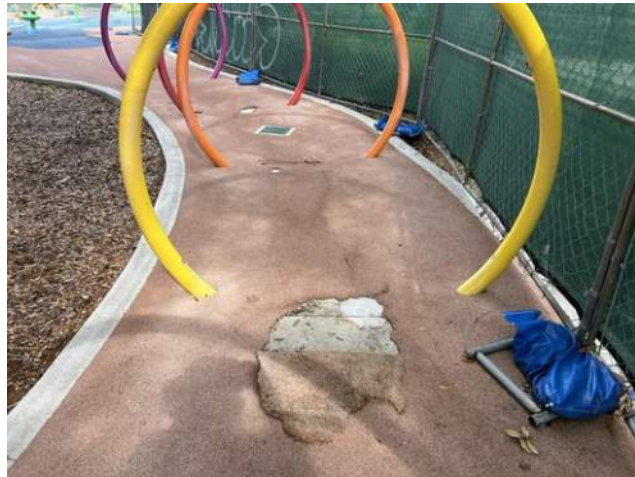
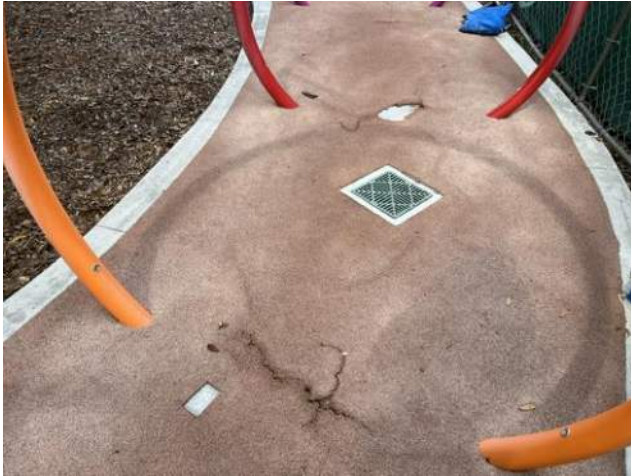
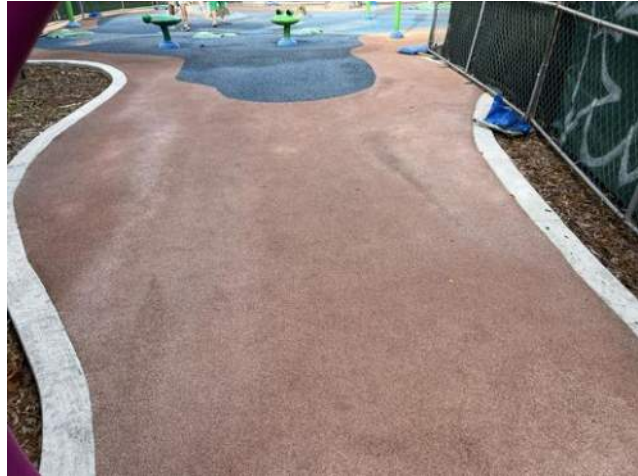
Multiple surface failures and lack of decking adjacent feature.

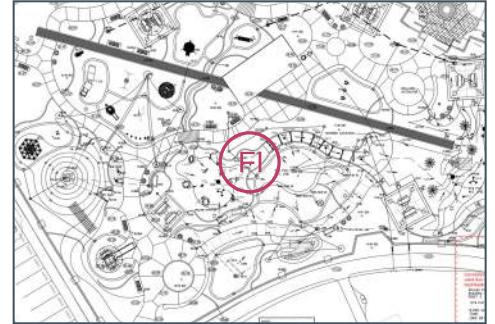
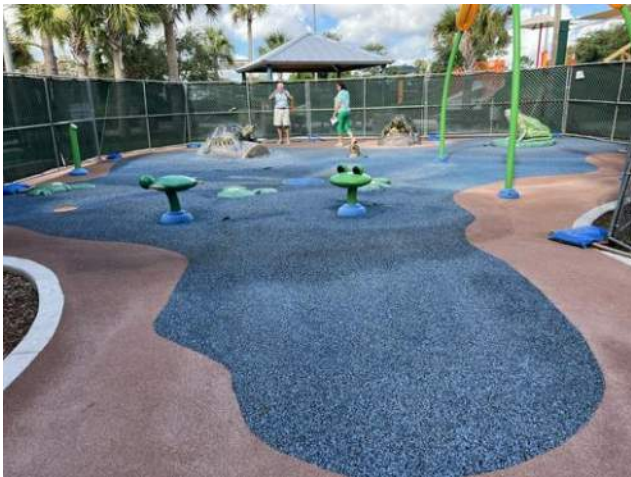
Areas of slope and drainage concern.

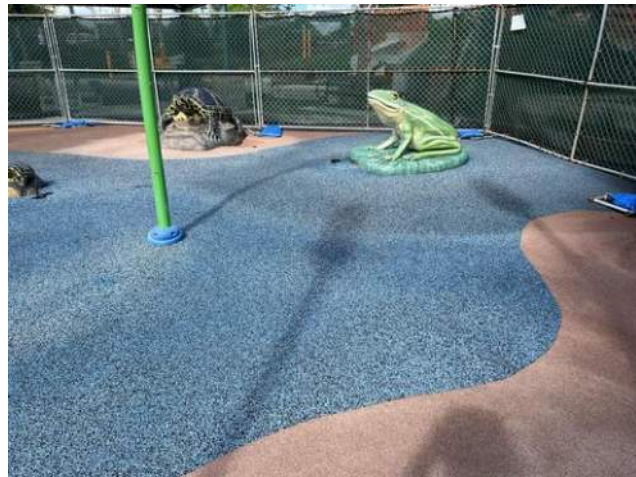
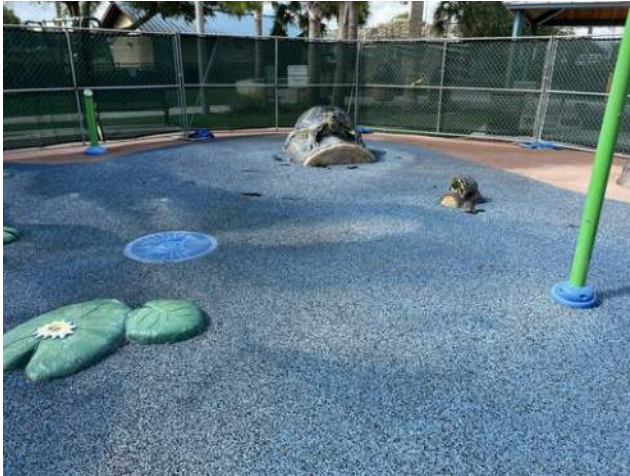
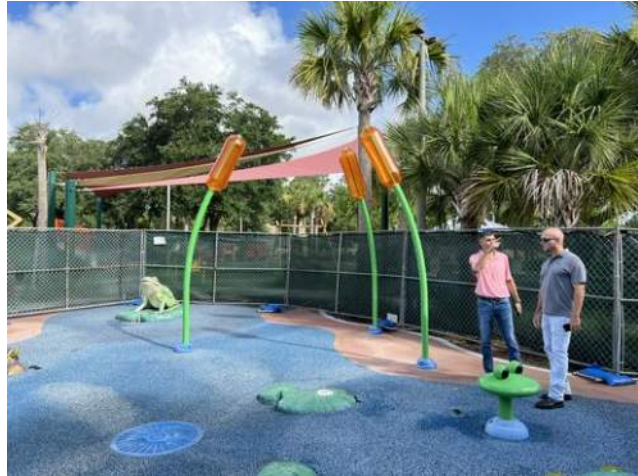
Area of slope and drainage concern and surface failures.

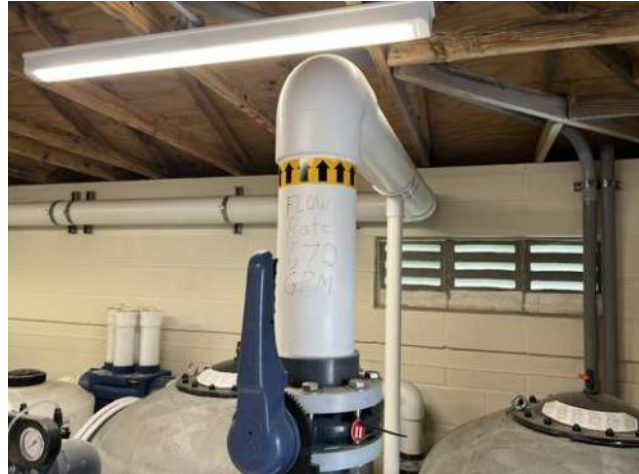
2. There was visible water leakage at the flange of the UV sanitizer unit, which could contribute to an air leak in the system when the pumps are de-activated and possibly contribute to these self-priming difficulties.
3. Adding an air relief valve at the highest point of the discharge piping along with a hose bibb connection on the downstream side of the pump may reduce or eliminate the labor required during daily startup. In addition, this would be addressed if Martin Aquatic is authorized to perform re-engineering.
4. Most filtration systems are operated 24/hours/day, 7 days/week, and 365/days/year, reducing work for the startup but bearing operational costs.
5. The FBC requires the filtration and chemical systems to operate a minimum of 3 hours before bathers are allowed access to the IWF if not operated 24/7 365.

Description
UV Unit / full flow

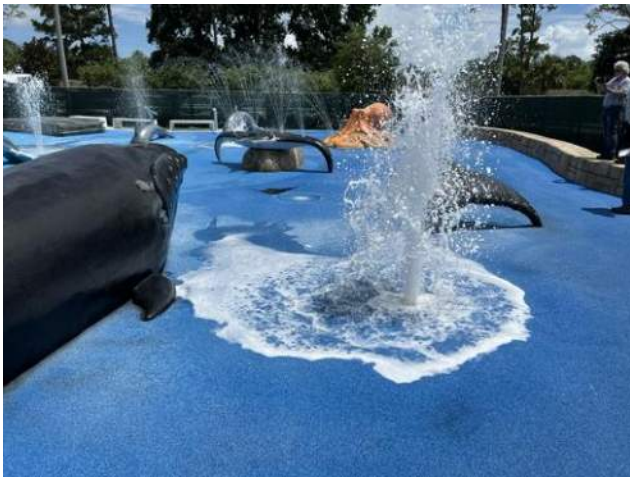
20220630_122551_photo

Area of slope and drainage concern and surface failures.

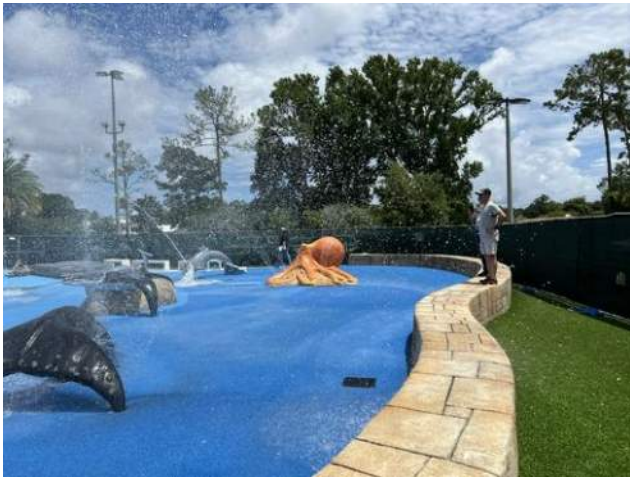
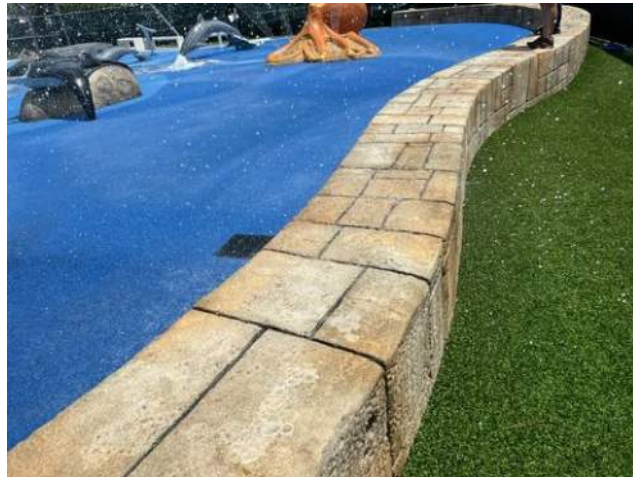
20220630_122645_photo
Martin Aquatic Design & Engineering
Jun 30, 2022 12:26 PM

Area of overspray out of IWF feature boundary, at the area with no wet deck.

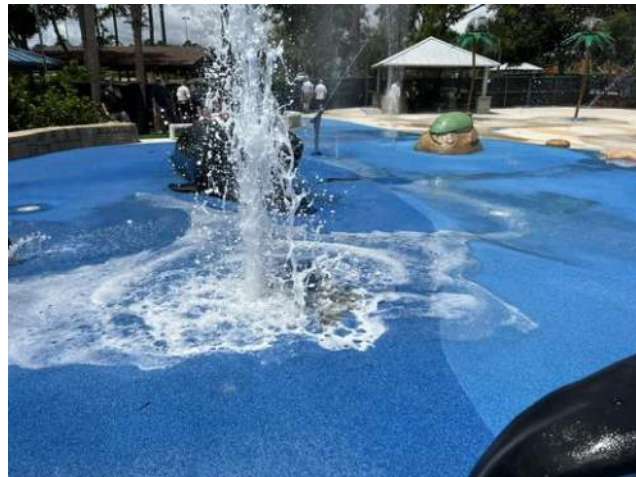
20220630_122802_photo
Martin Aquatic Design & Engineering
Jun 30, 2022 12:28 PM

Area of slope and drainage concern and surface failures.

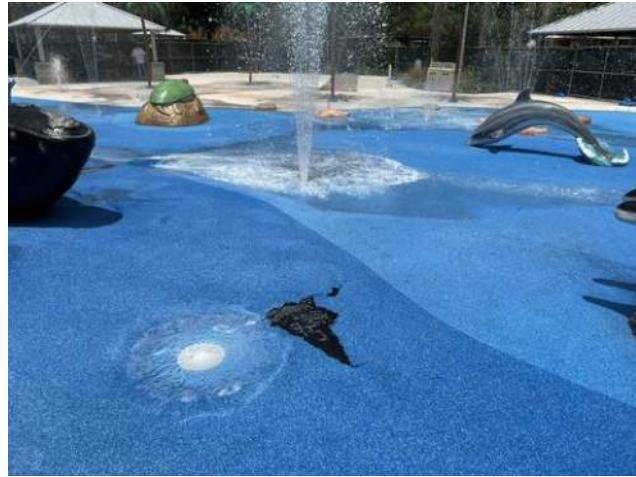
20220630_122905_photo
Martin Aquatic Design & Engineering
Jun 30, 2022 12:29 PM

Area of slope and drainage concern and surface failures.

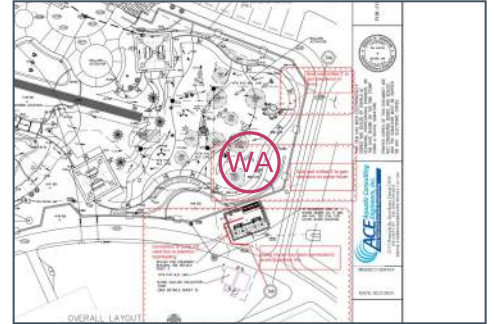
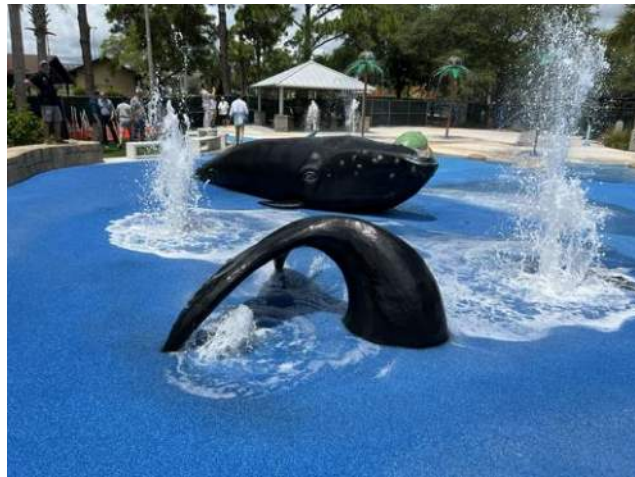
Area of slope and drainage concern and surface failures.

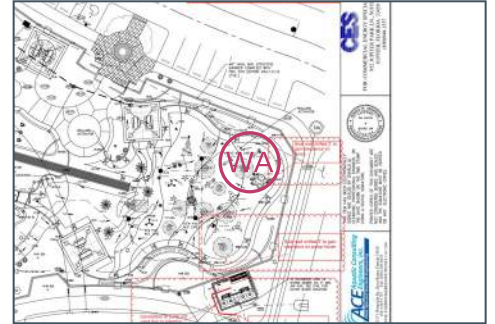
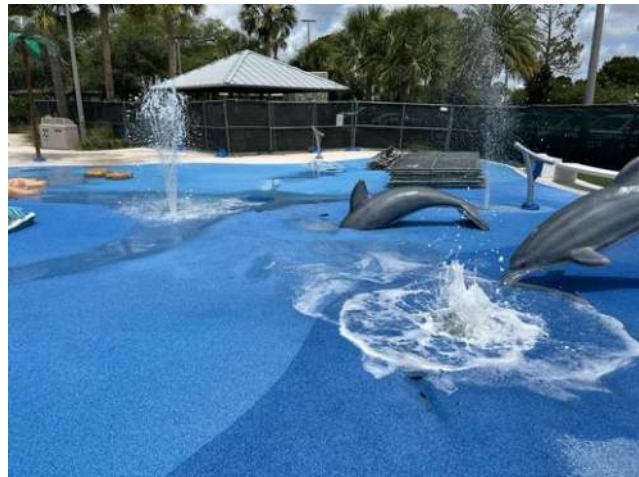
Area of slope and drainage concern and surface failures.

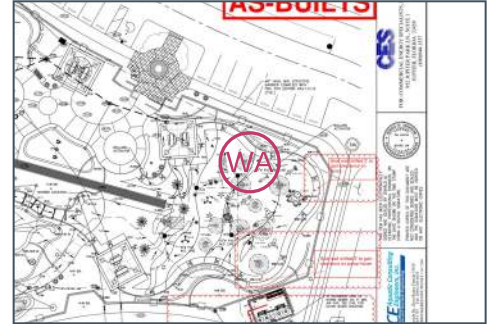
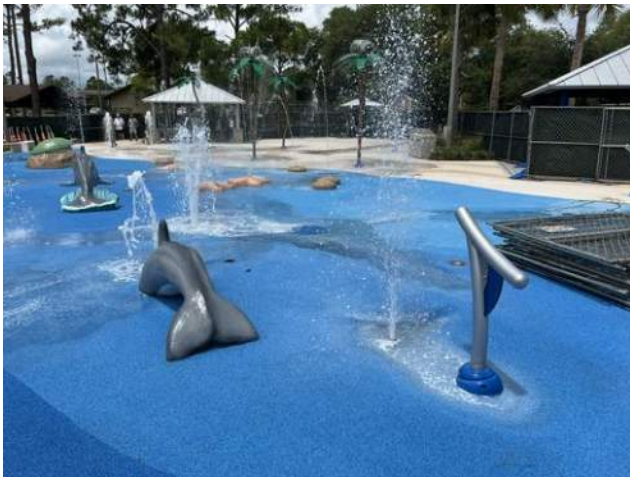
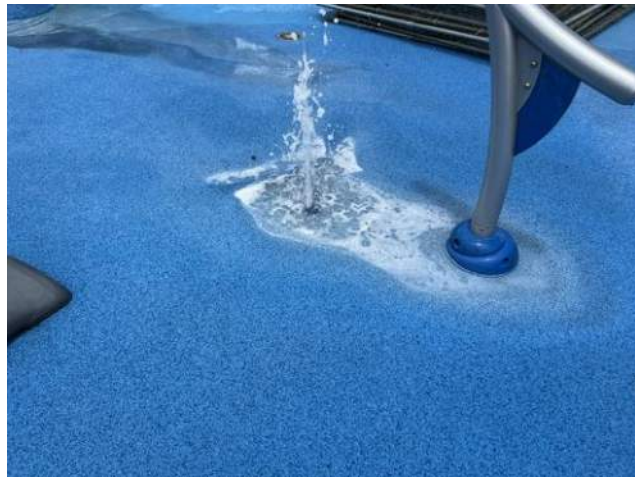
Area of slope and drainage concern and surface failures.

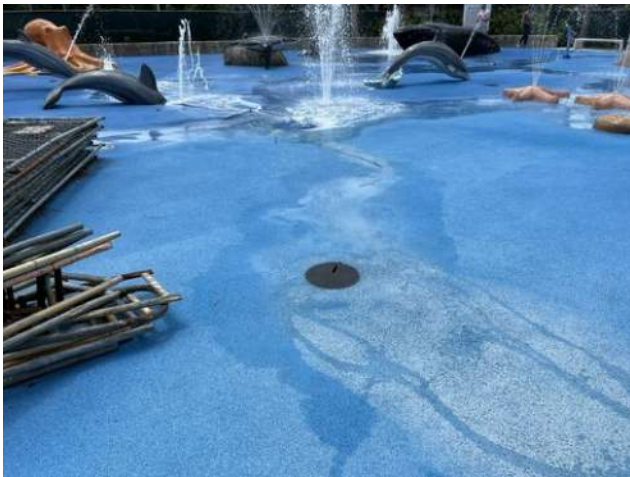
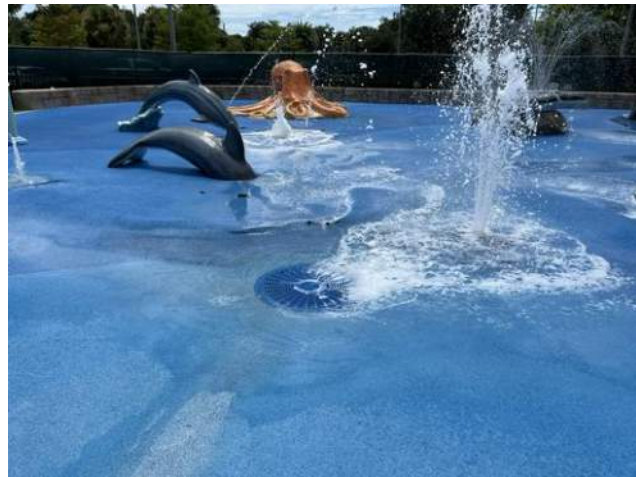
Area of slope and drainage concern and surface failures.

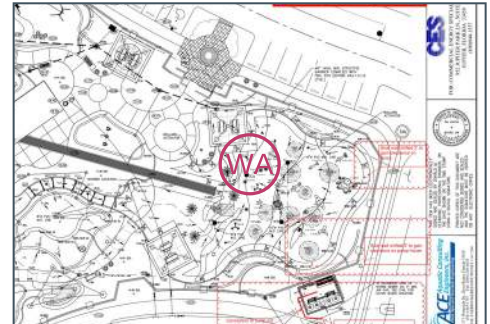
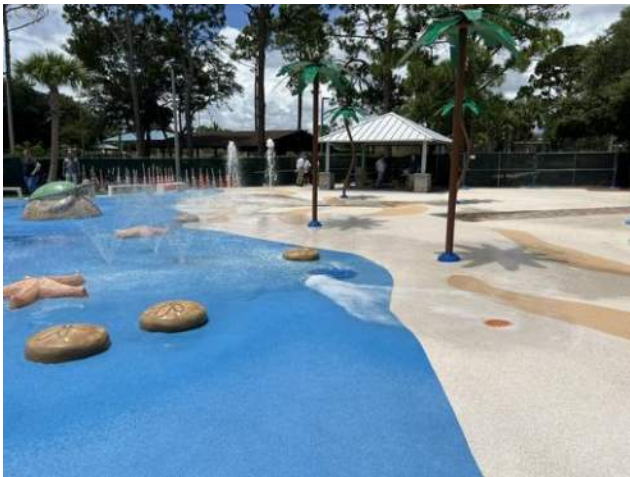
Area of slope and drainage concern and surface failures.

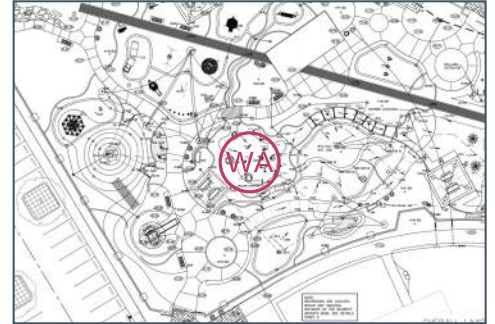
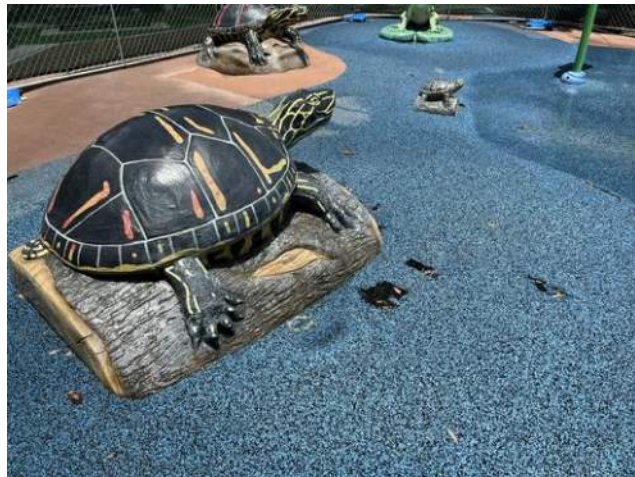
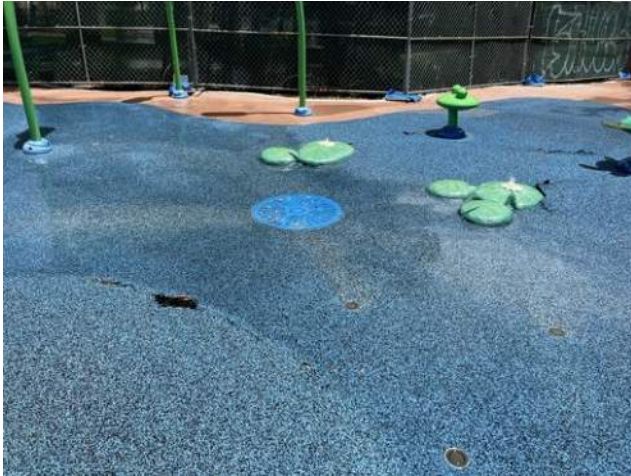
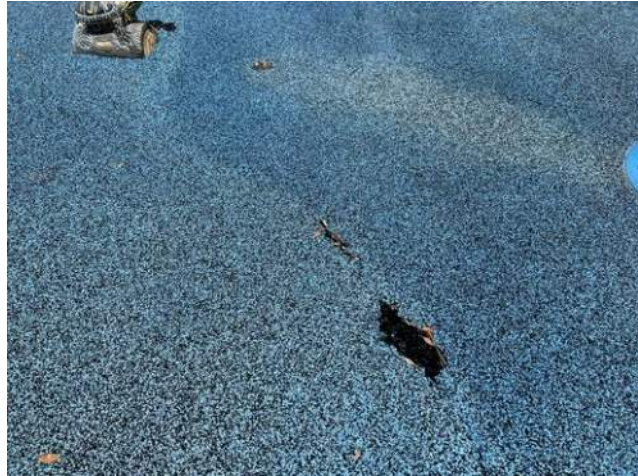
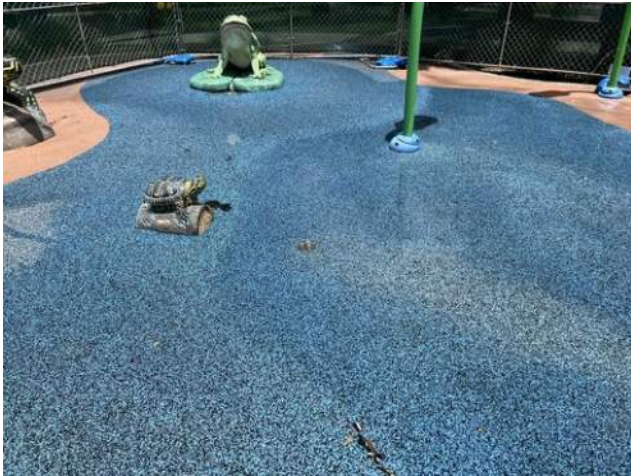
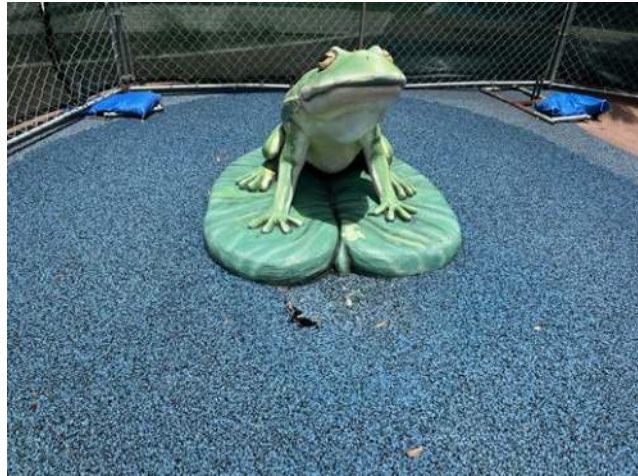
Area of slope and drainage concern and surface failures.

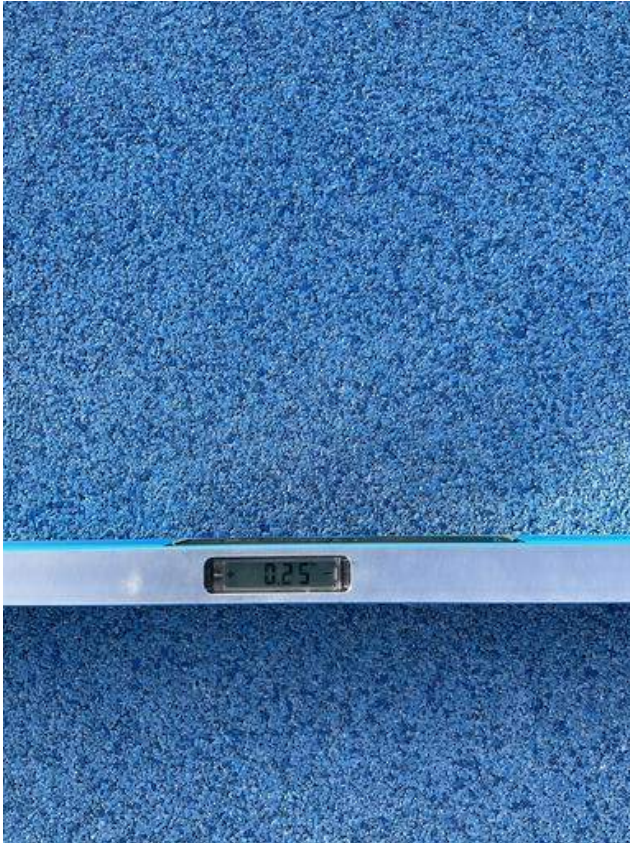
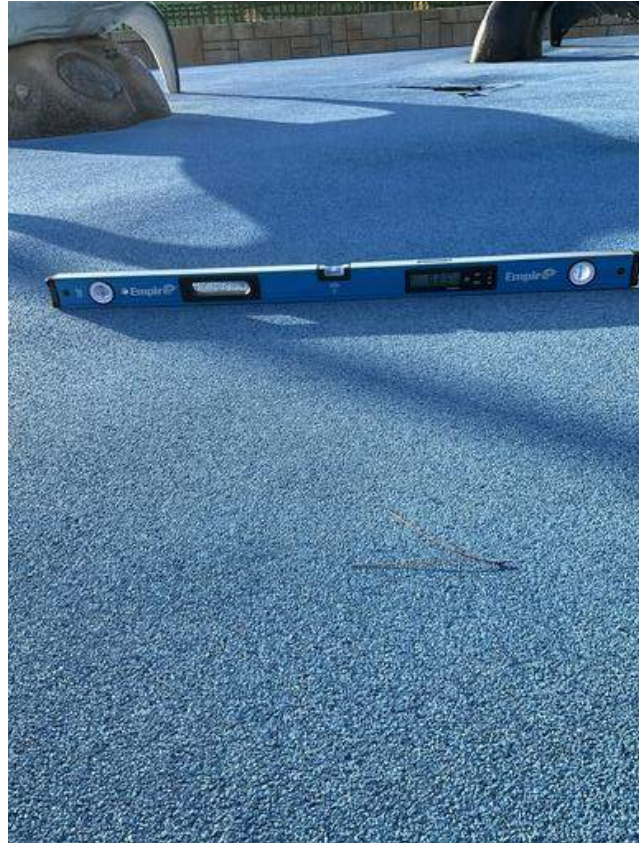
The slope for the record. The flat areas in the feature are capturing water. Insufficient slope per code.

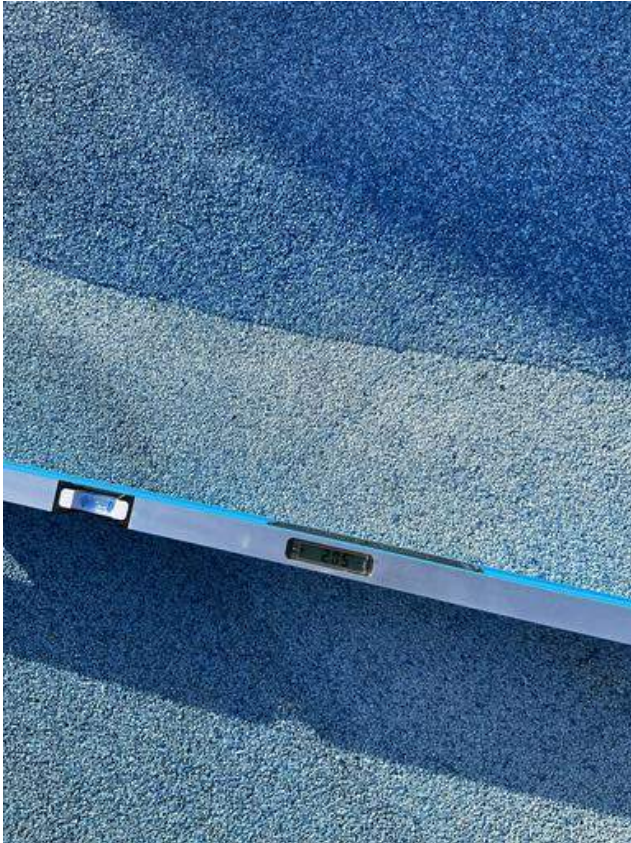
Slope at the drain for the record. The slope at thickened floor area creates trip hazards, typical at all raised floor edge conditions.

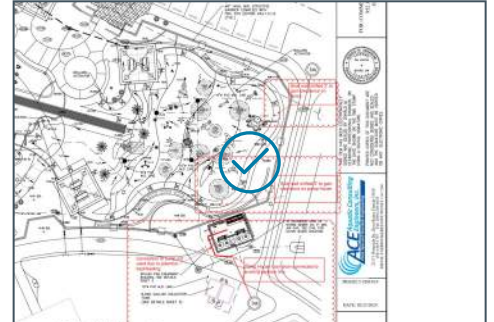
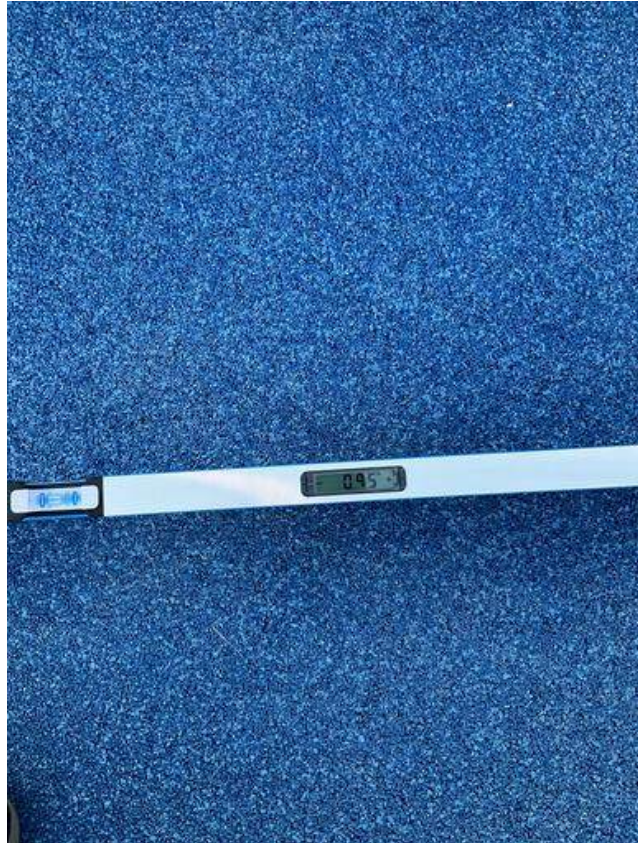
Perimeter decking is required to slope to drain at 2-4%. Slopes are inconsistent and the area does not slope away to drain. Insufficient slop to drain.

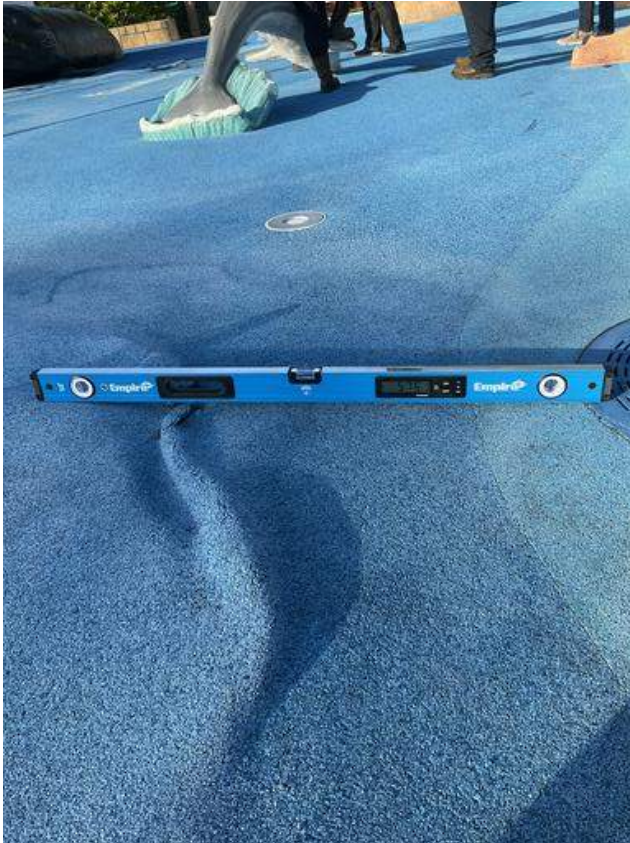
Slope at the drain for the record. The slope at thickened floor area exceeds allowable deck slope.

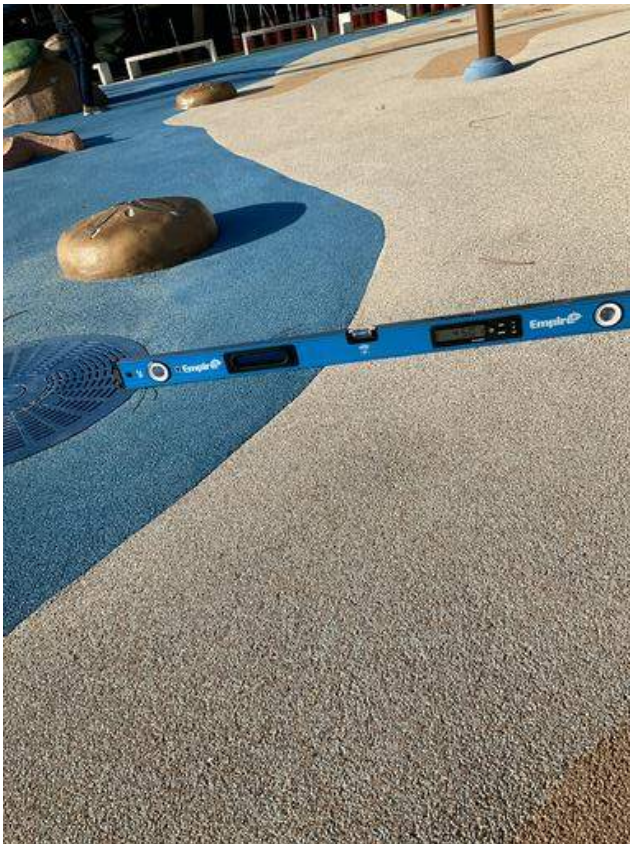
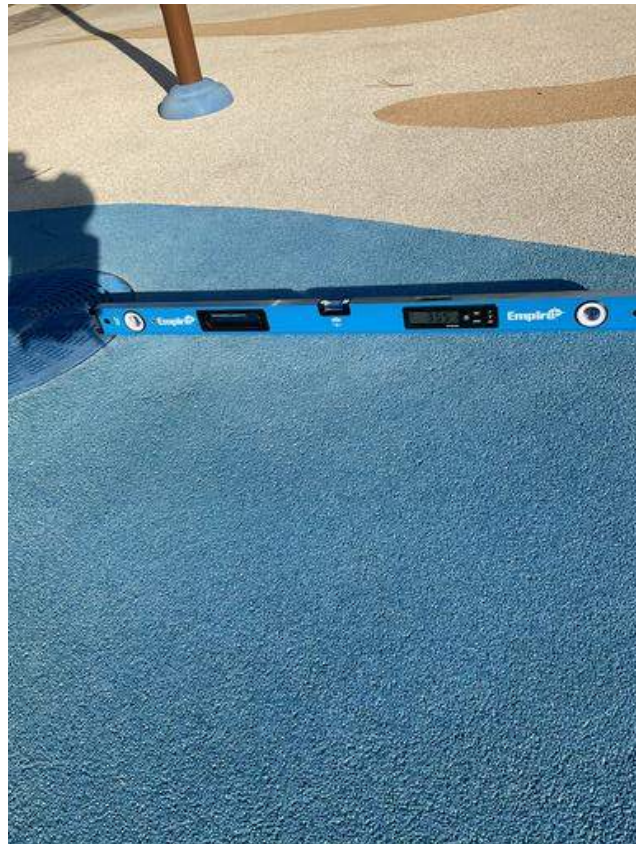
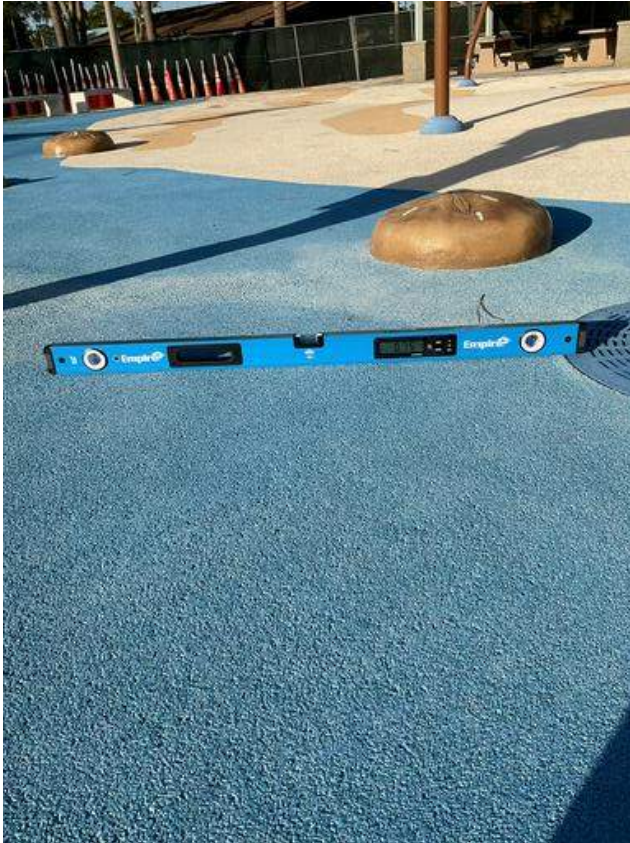
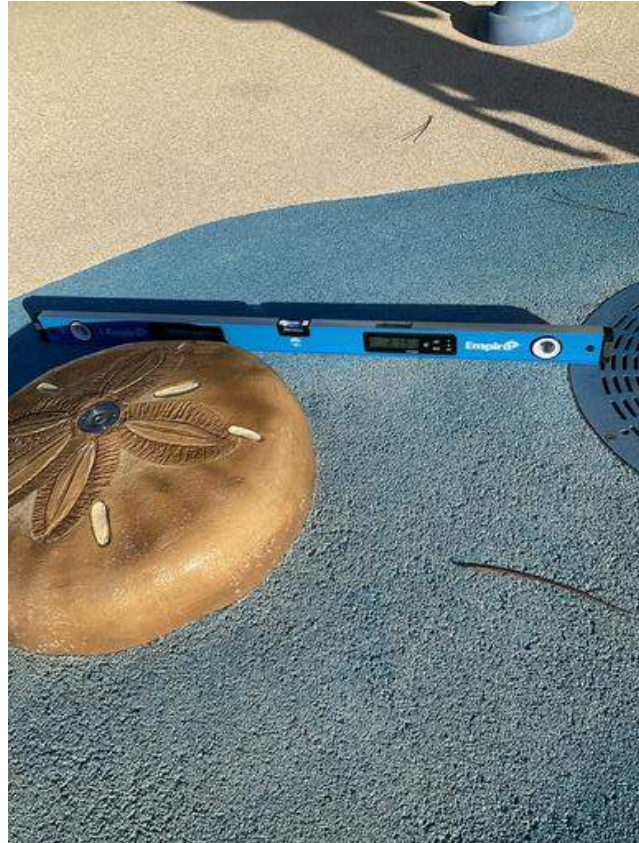
Slope at the drain for the record.

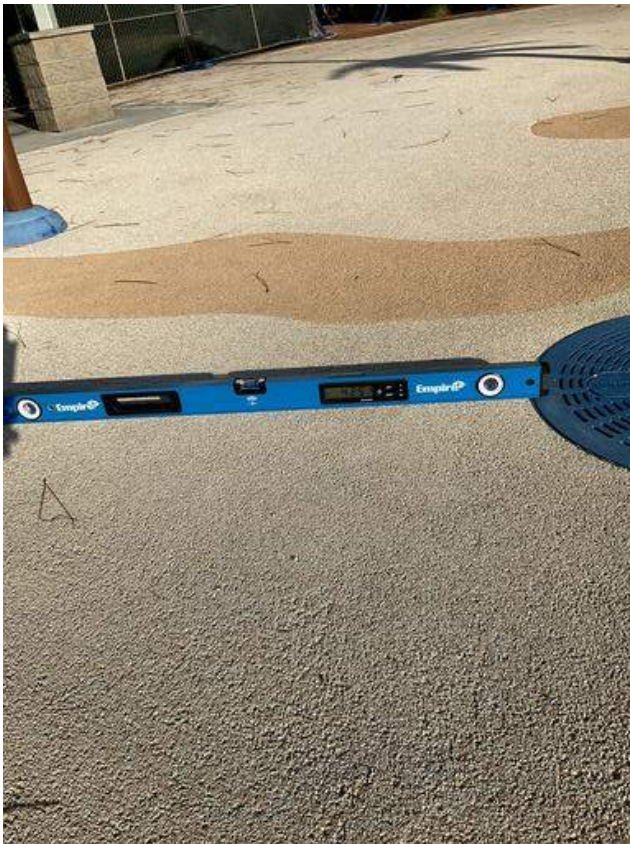
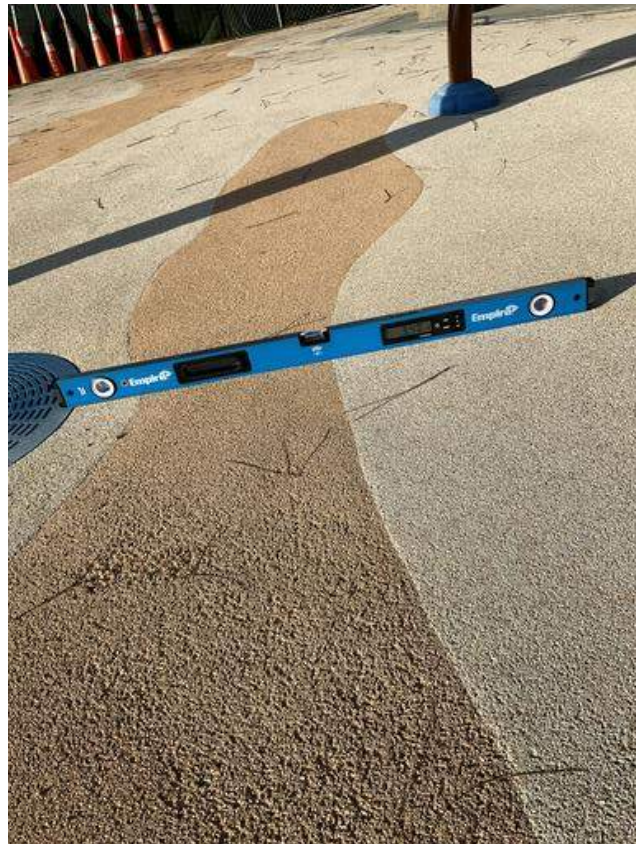
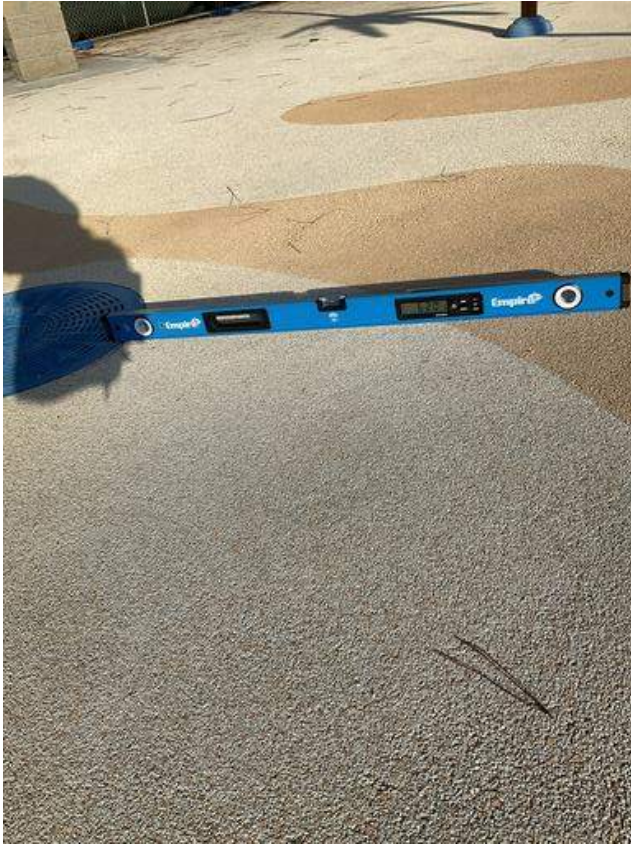
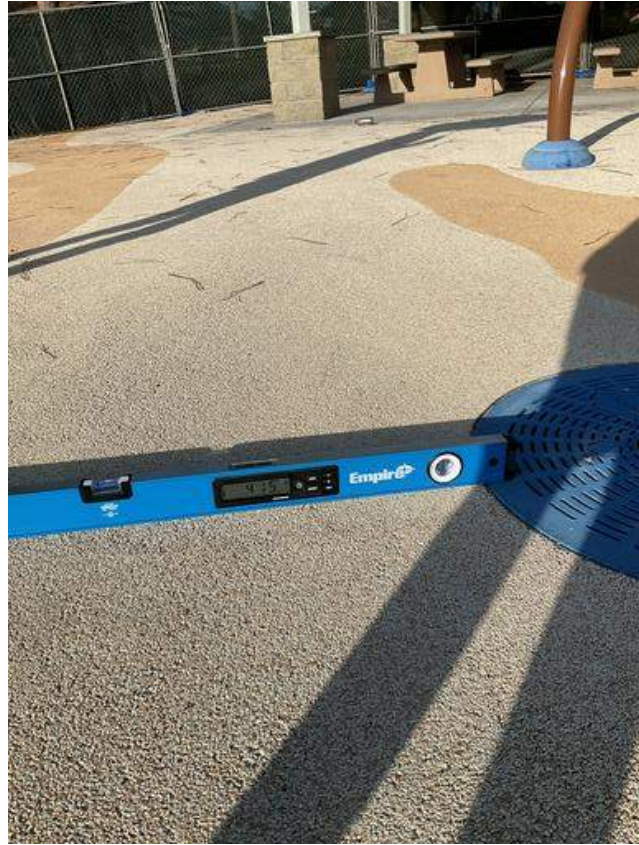
Slope at the drain for the record.

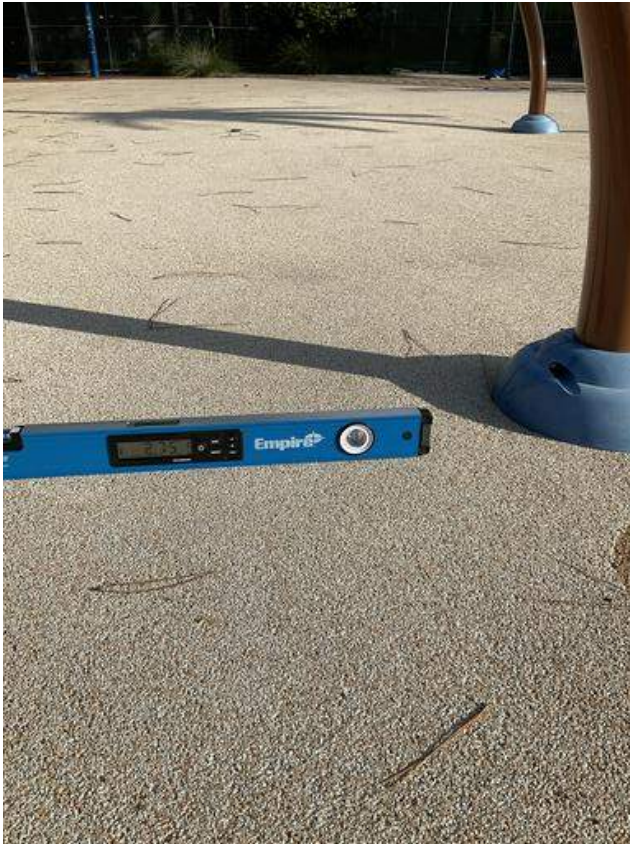
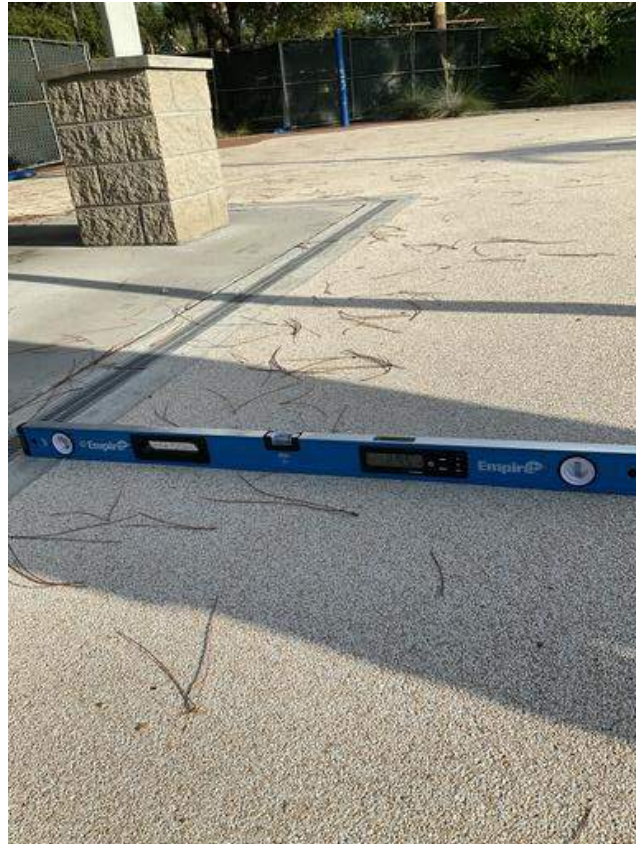
Description
The slope for the record.

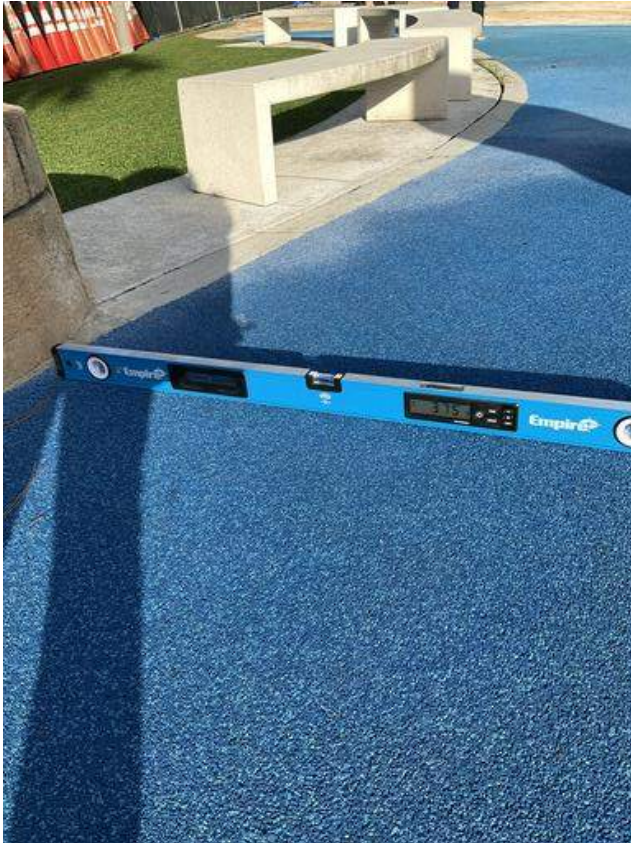
20220708_080449_photo

Perimeter decking is required to slope to drain at 2-4%. The area does not slope away to drain.

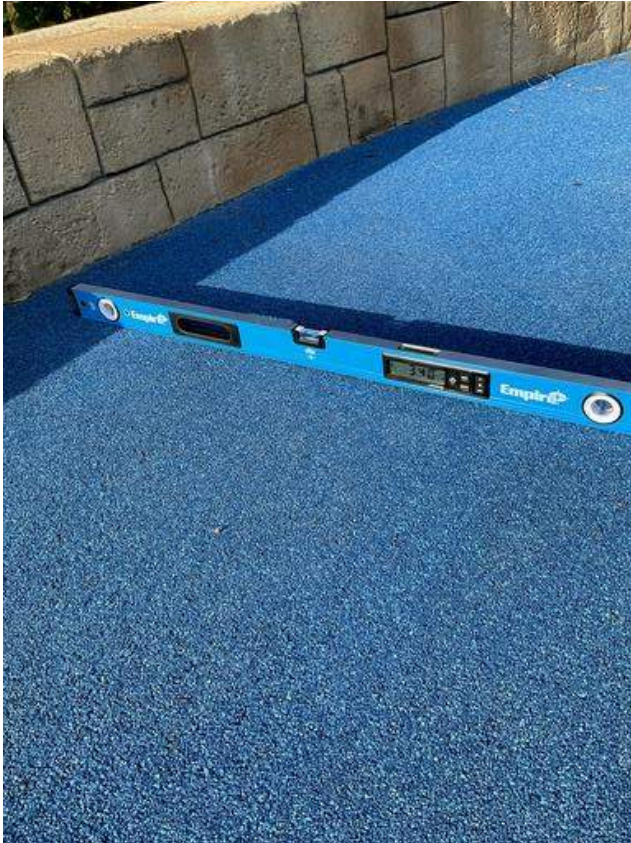
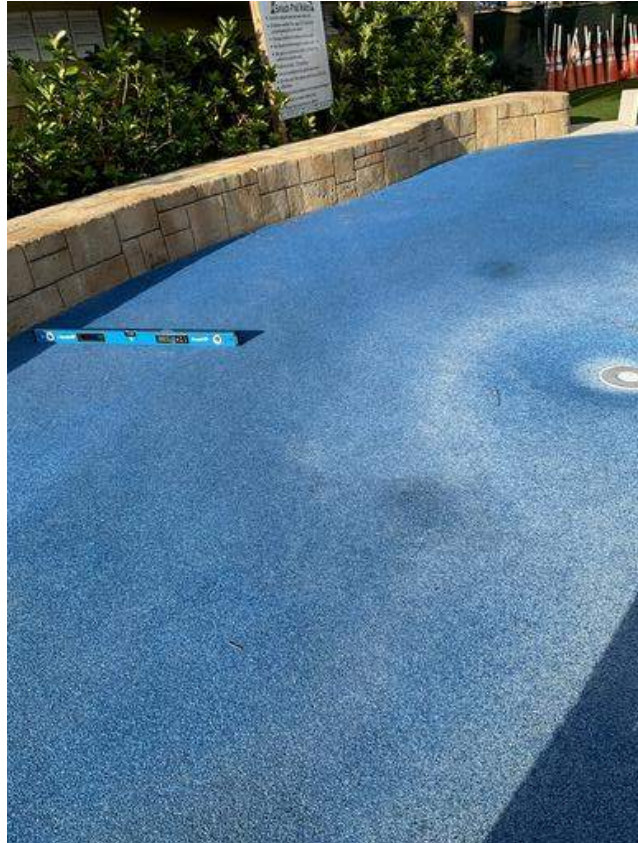
Perimeter decking is required to slope to drain at 2-4%. The area does not slope away to drain.
