**Project Observation Minutes & Recommendations from Martin Aquatic
Holland Park IWF - Palm Coast**

Project:	Holland Park IWF		
Location:	Palm Coast, FL		
Report By:	Jonathan "JT" Toavs & Ken Martin		
Attendees:	JT, Ken, Mackenzie, and Drew from Martin Aquatic		
Issue Date:	2022.08.18	Revised Date:	
Subject:	IWF existing conditions Observation		
Weather:	Partly Cloudy

PlanGrid Task Report - Jul 23, 2022

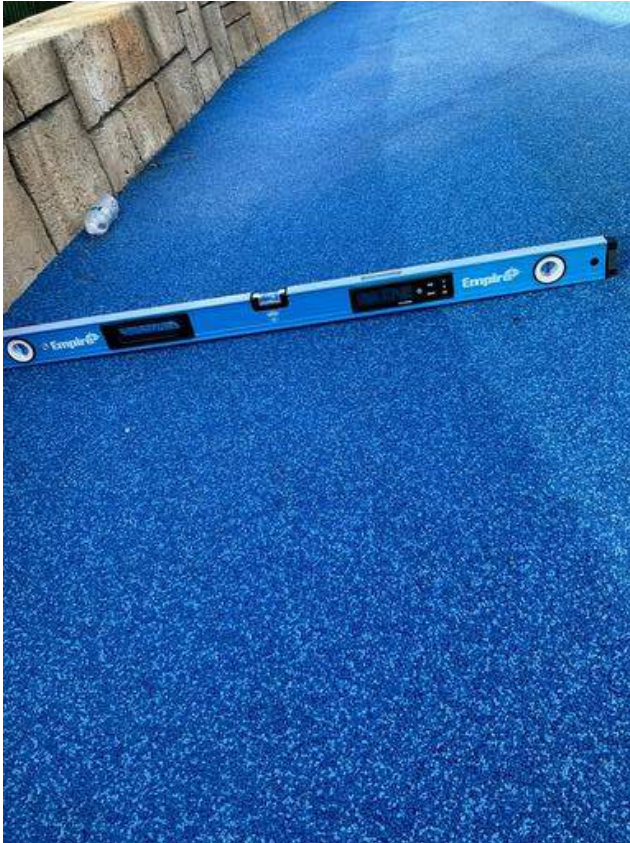
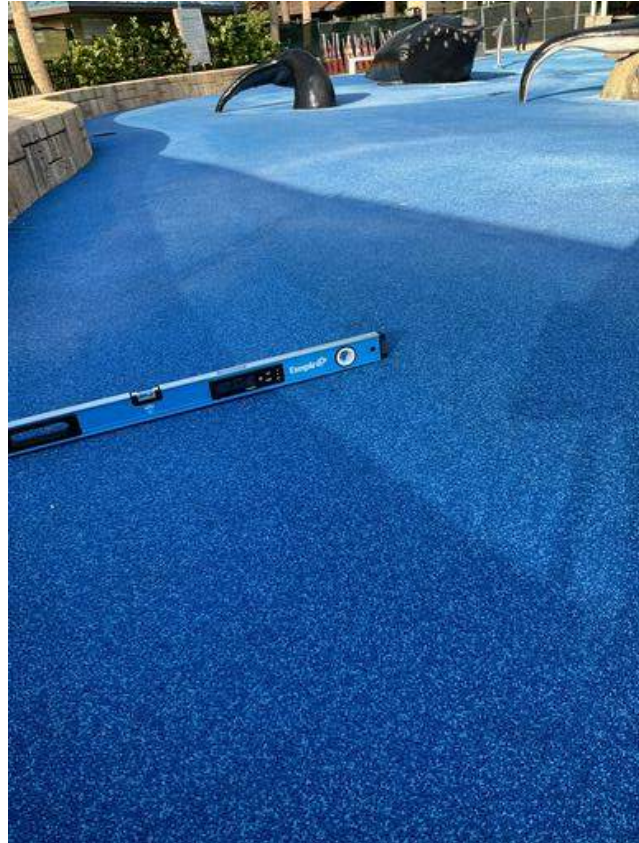
Perimeter decking is required to slope to drain at 2-4%. The area does not slope away to drain.

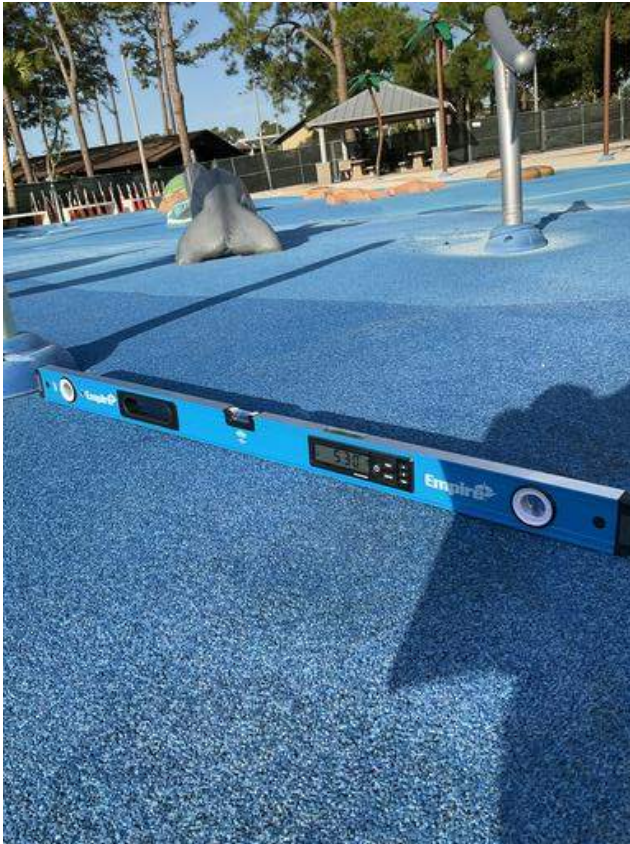
20220708_080907_photo

The slope for the record.

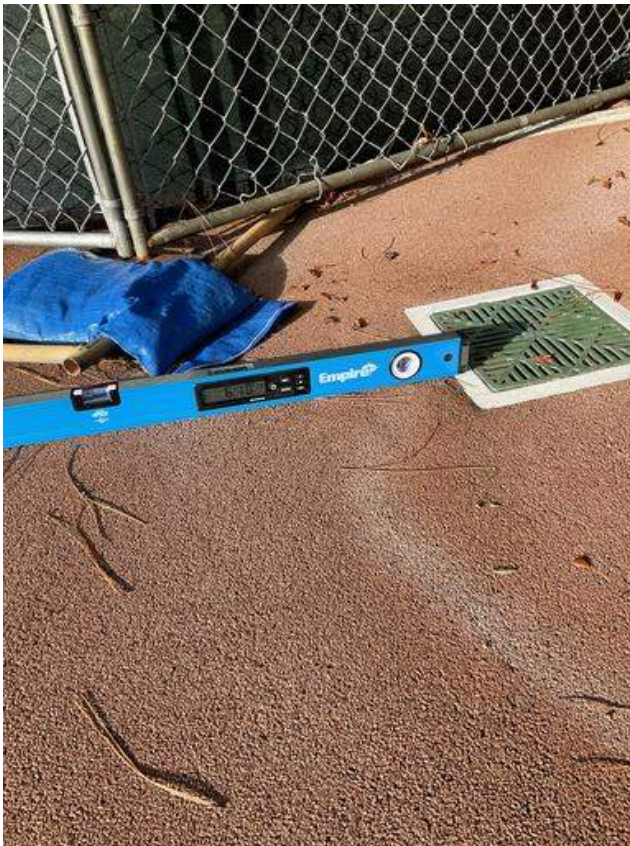
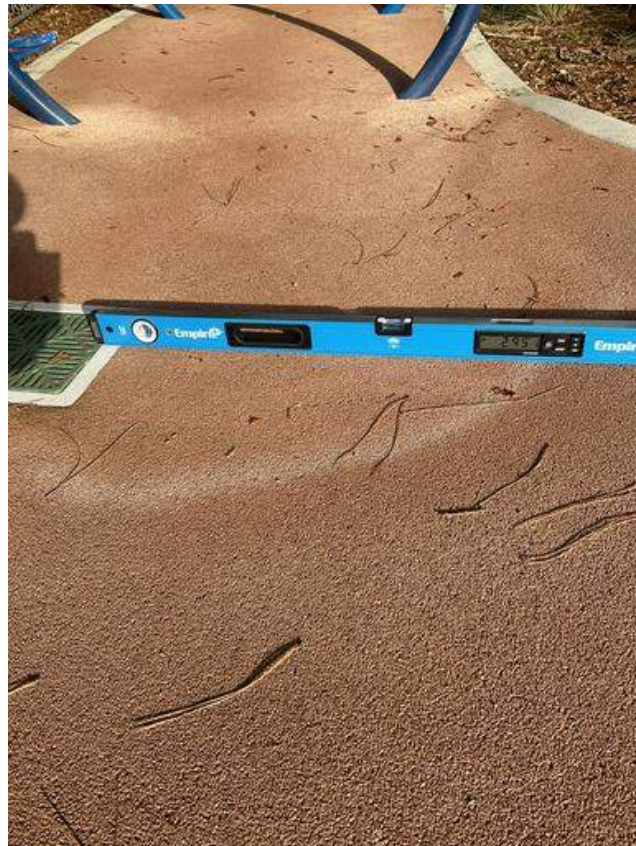
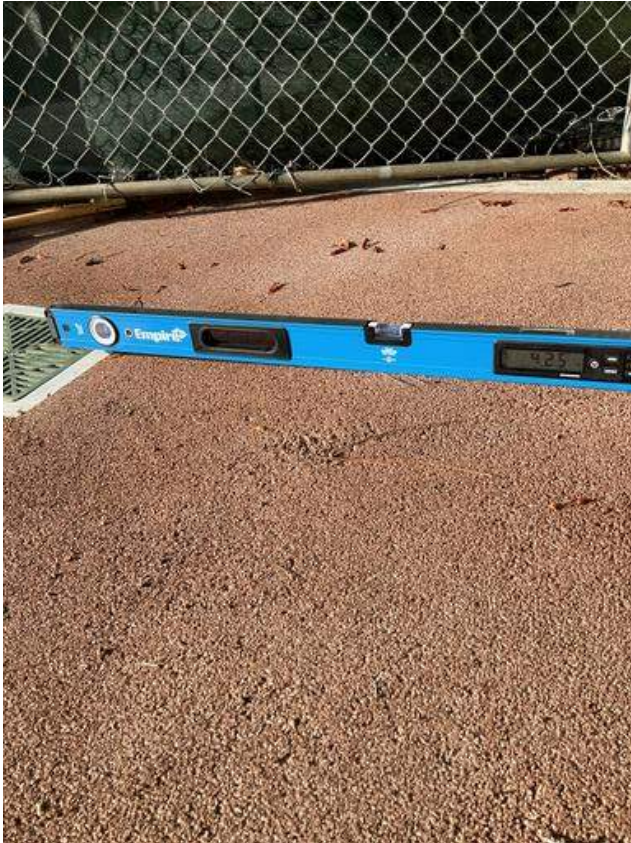
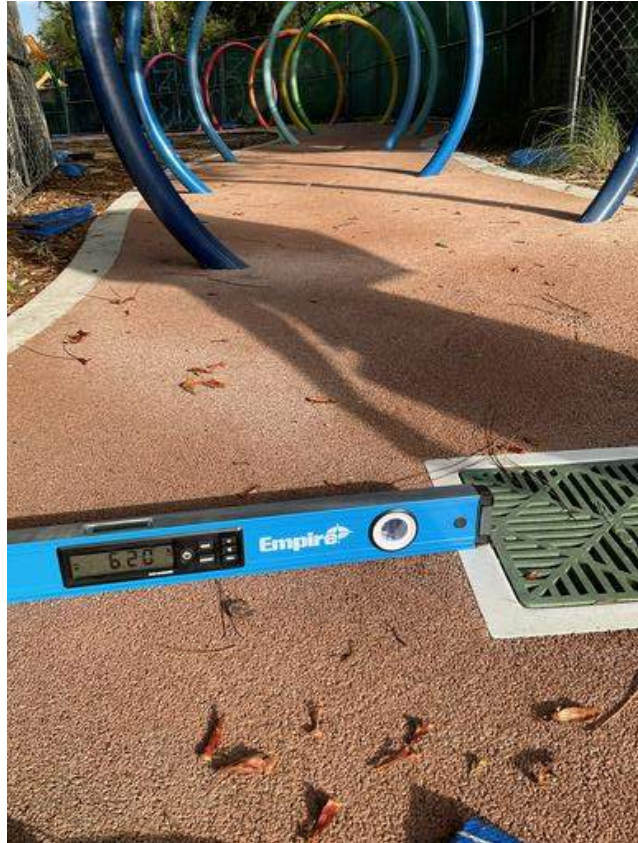
The slope for the record.

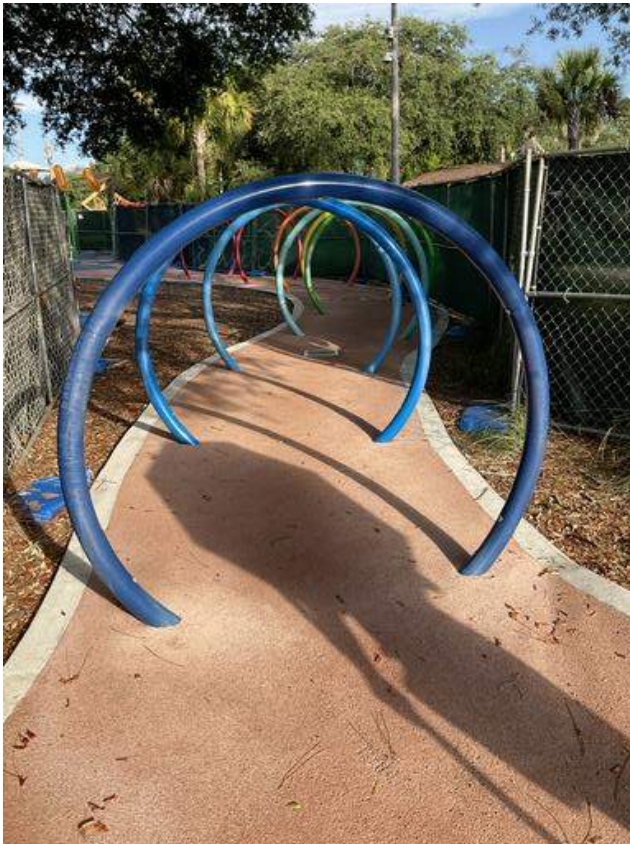
20220708_081218_photo

Area of feature with no deck around it, area floods with run-off from the feature.

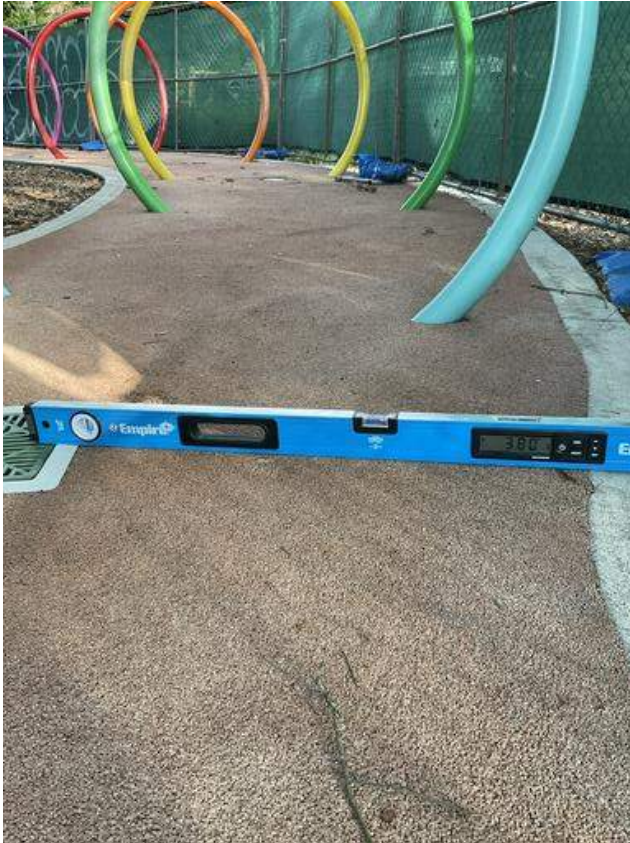
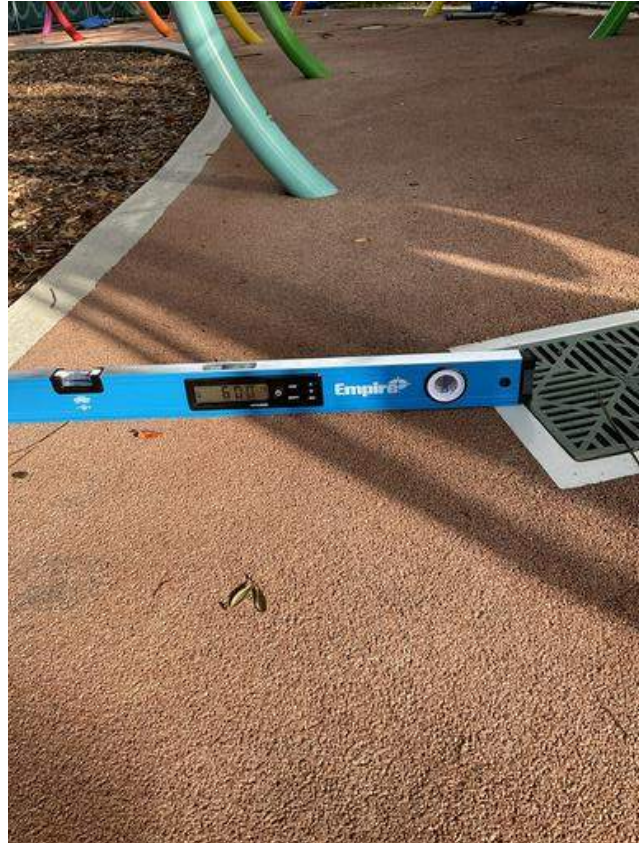
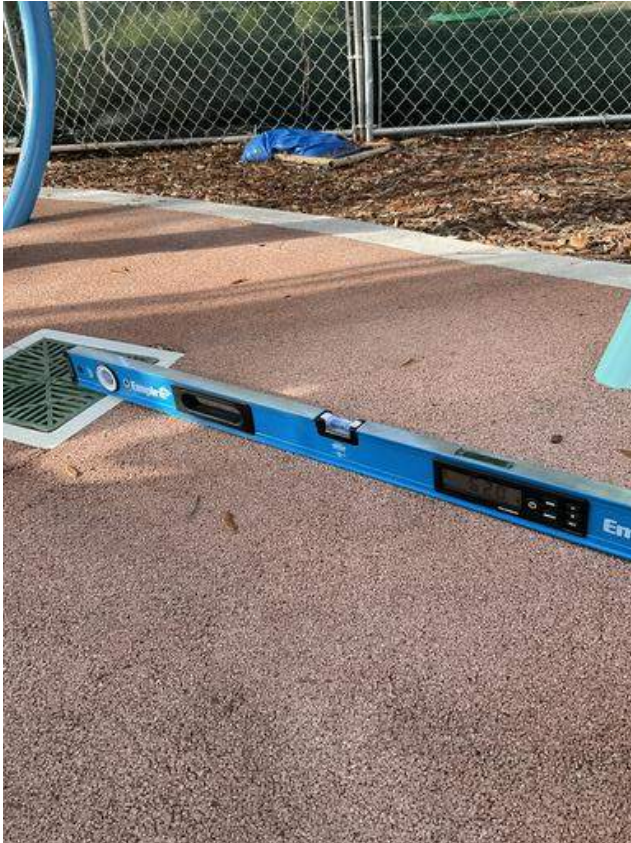
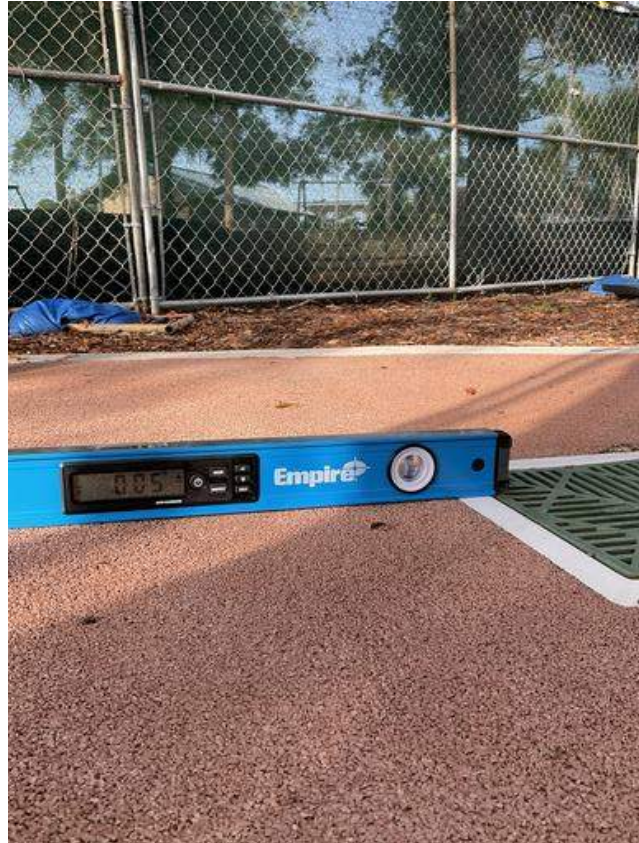
The slope for the record.
There is one area with less
than the code minimum
present.

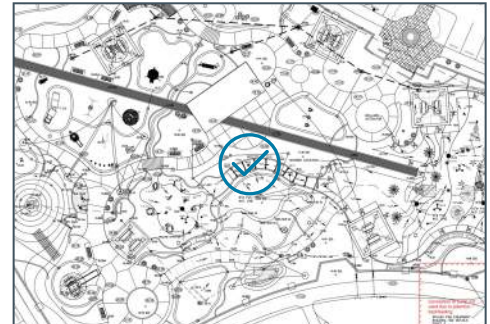
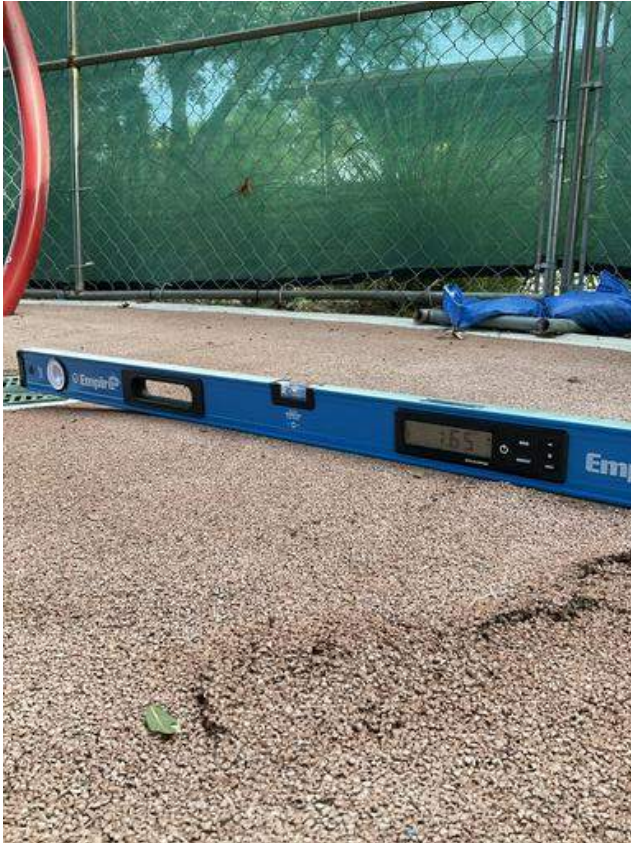
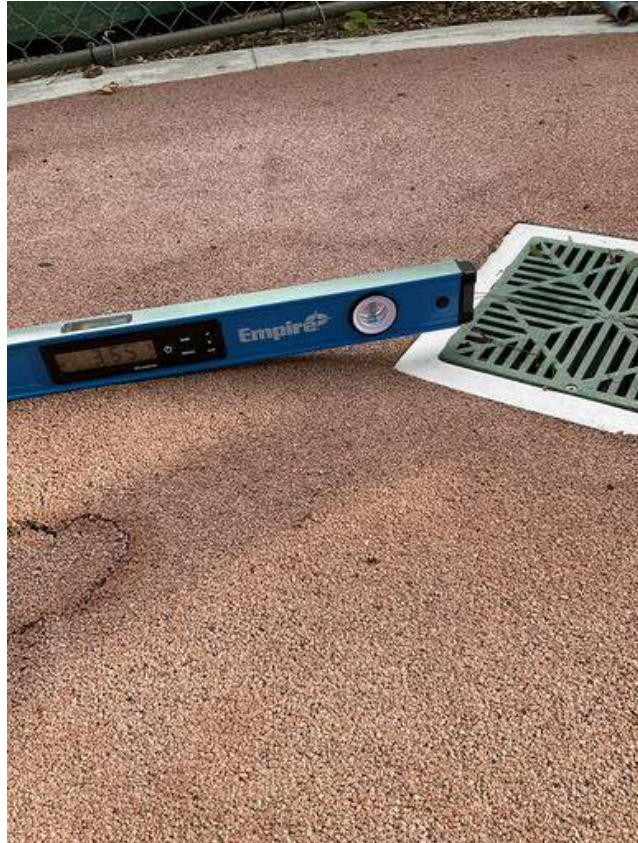
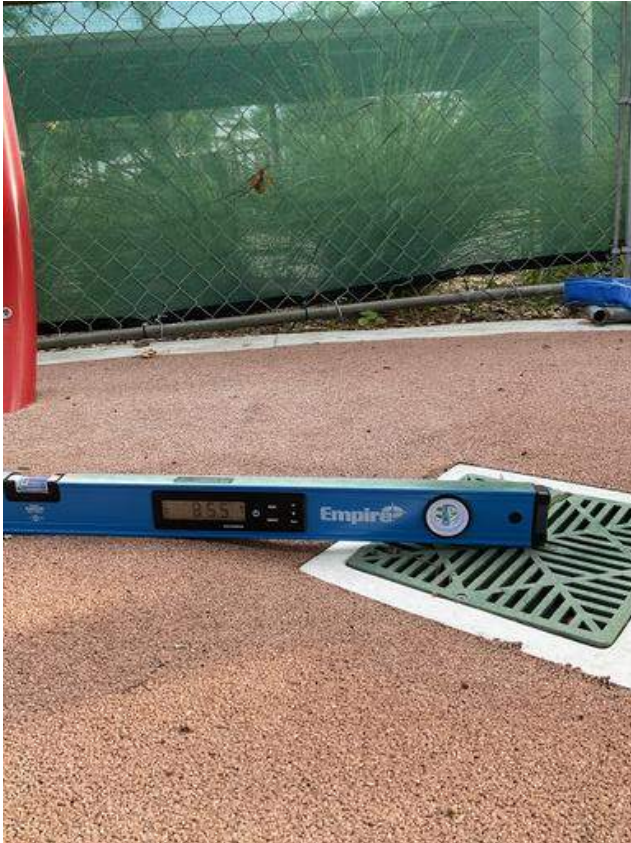
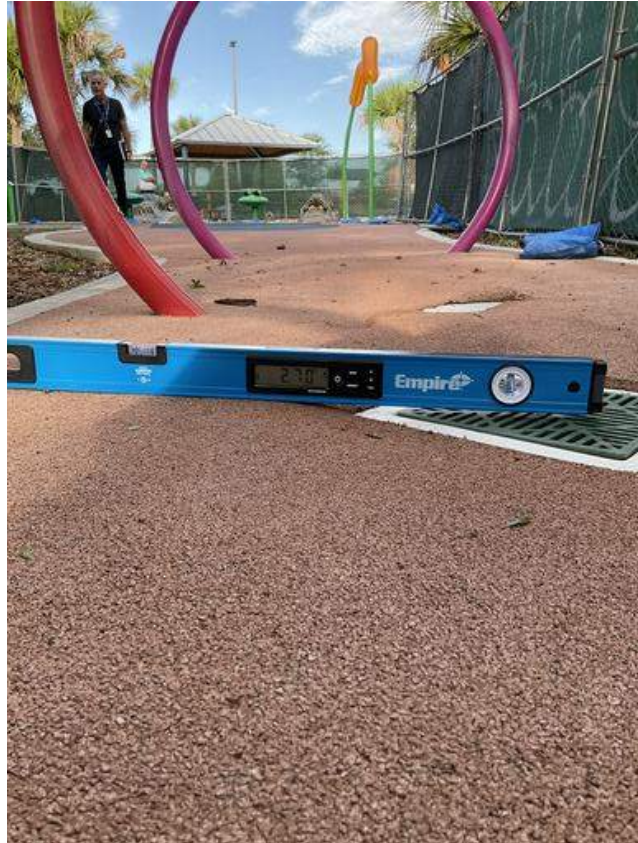
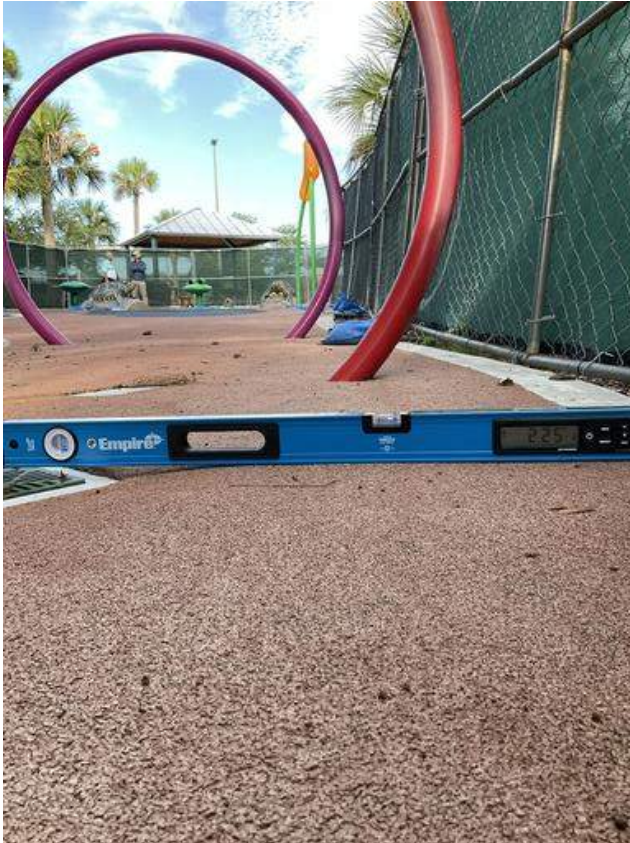
IWF

The slope for the record.
There is one area with less
than the code minimum
present.

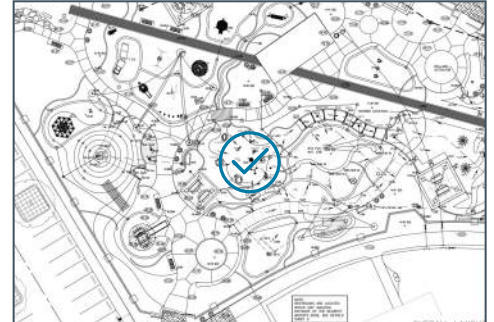
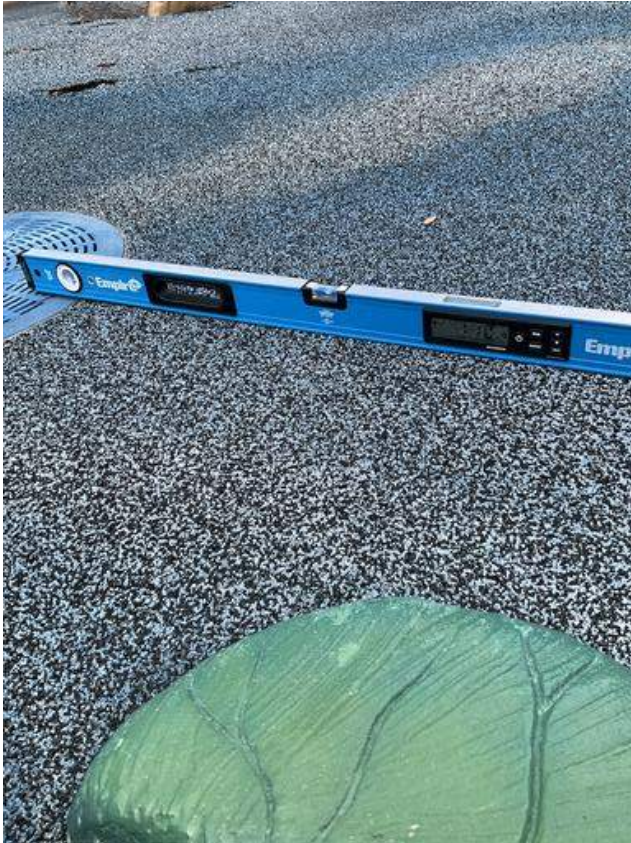
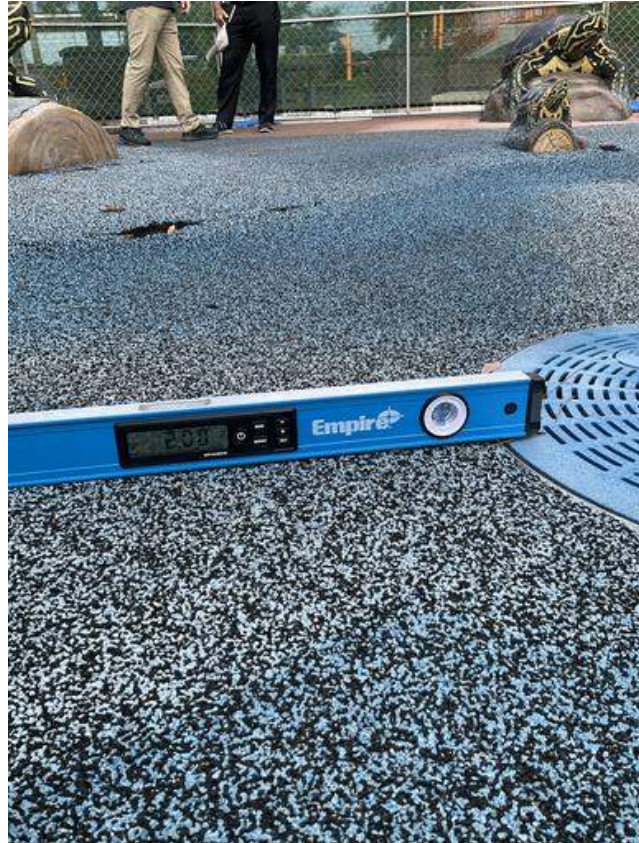
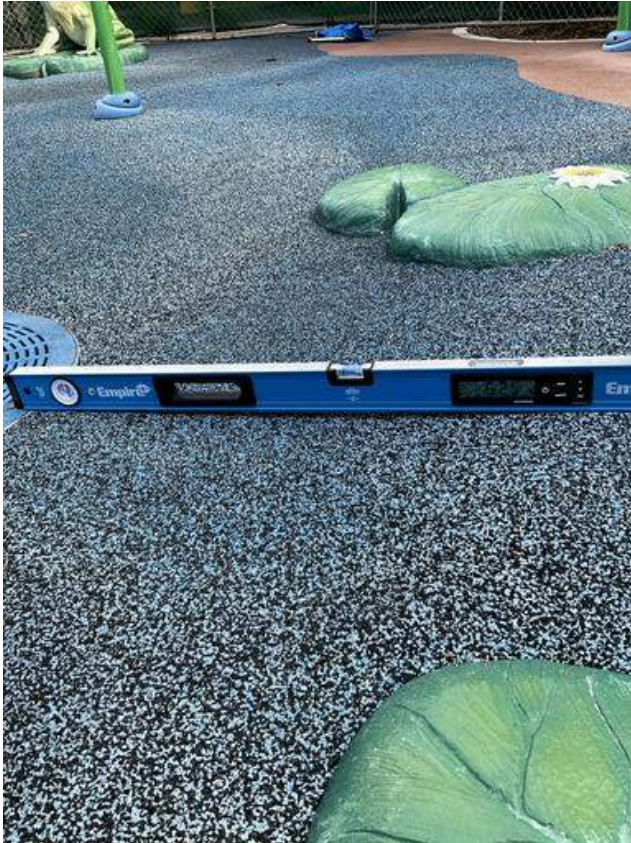
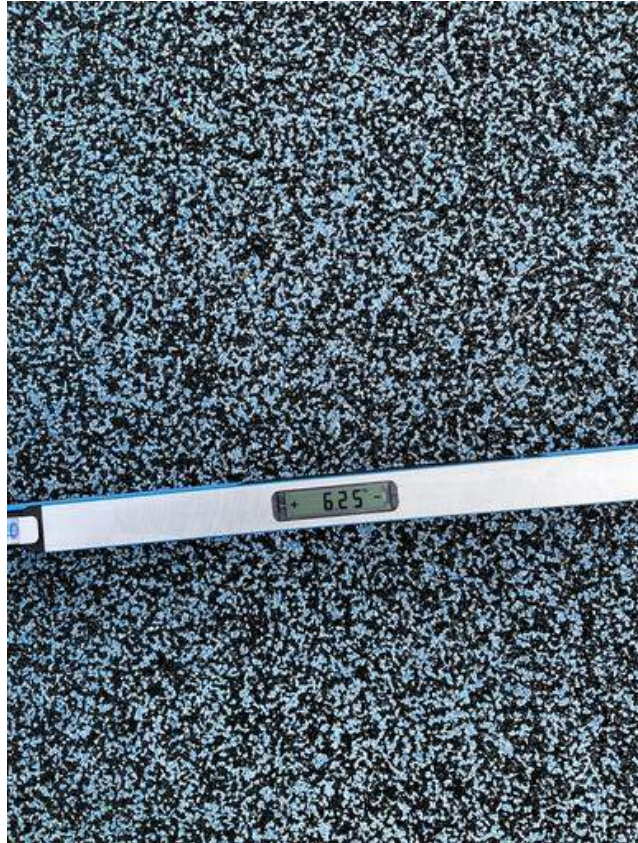
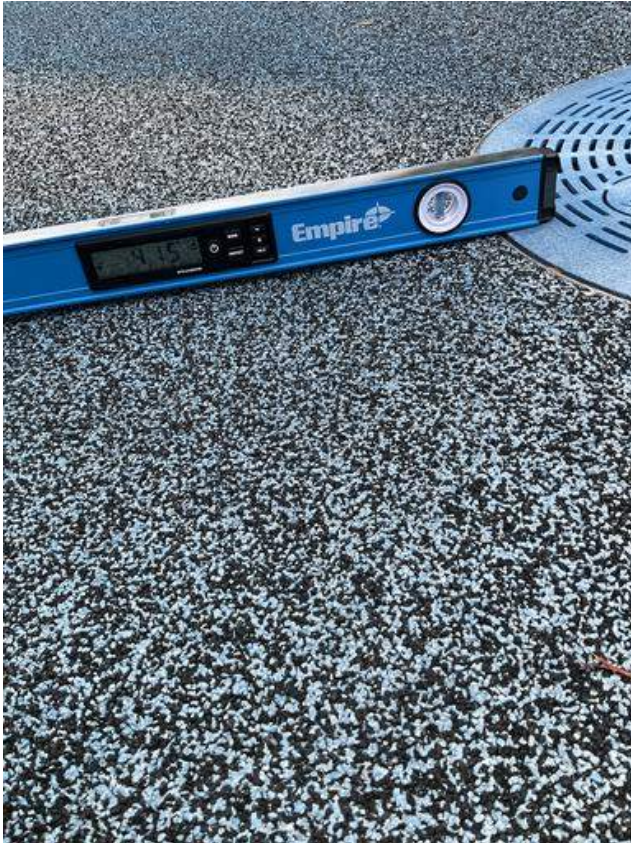
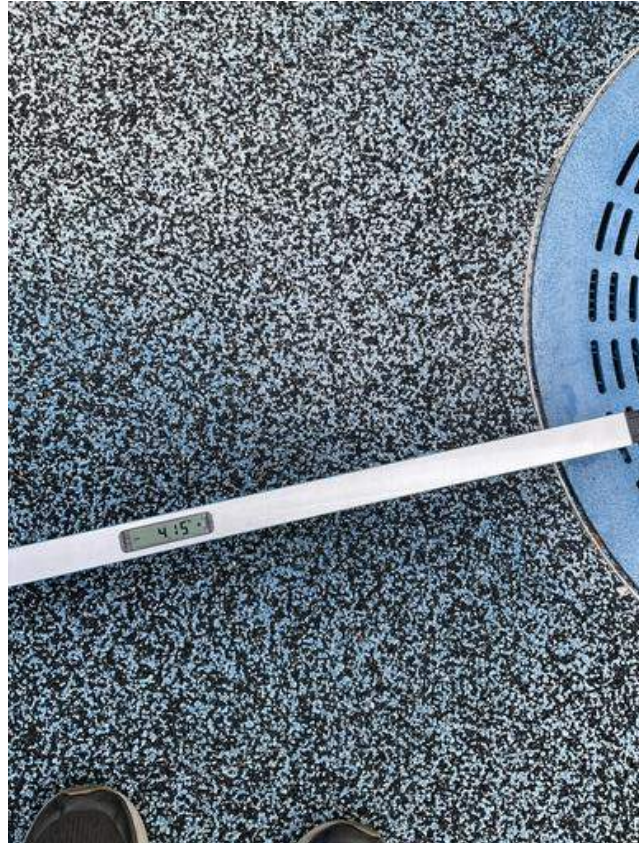
The slope for the record.
There is one area with less
than the code minimum
present.

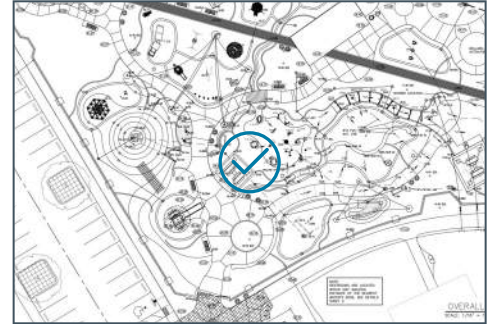
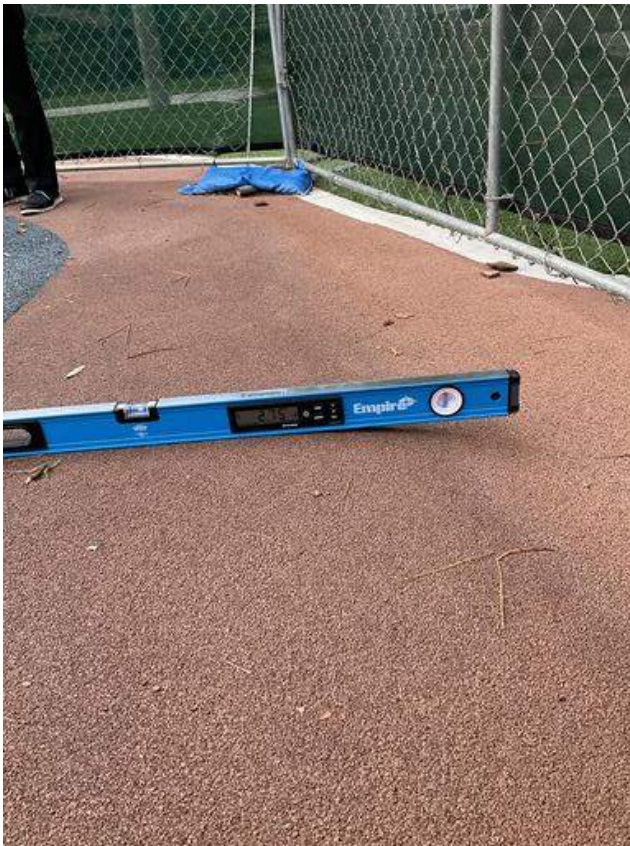
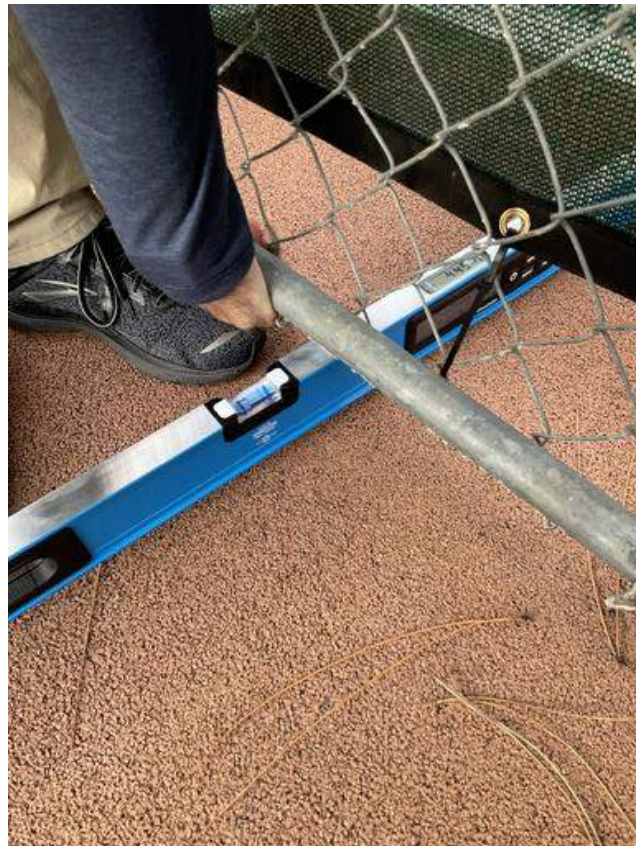
Location
IWF

Description
The slope for the record.

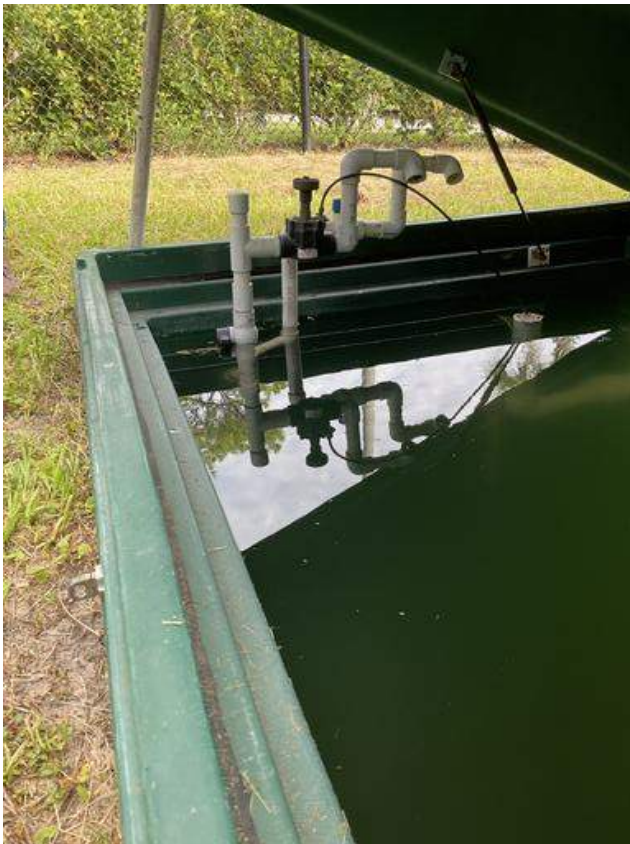
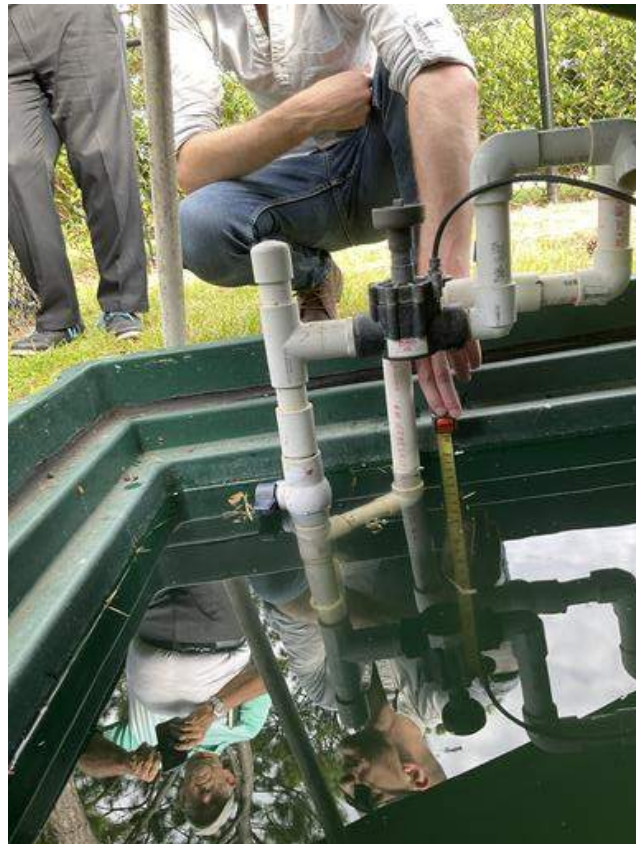
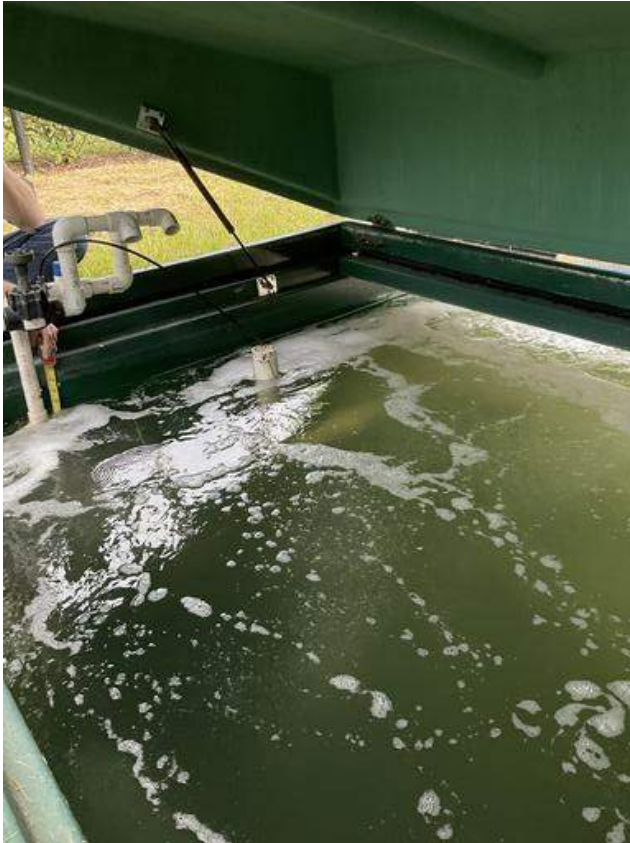
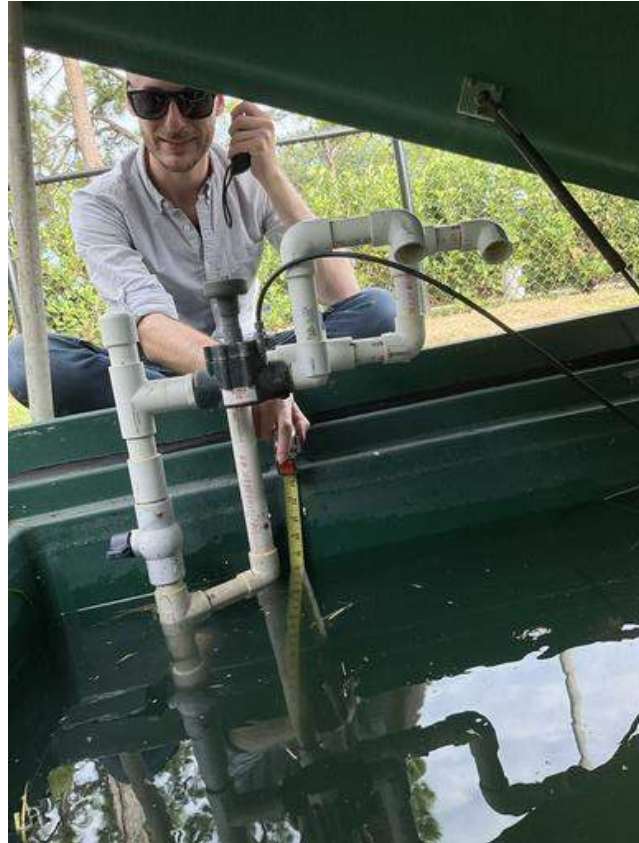
Surge Tank

Started at 24" to determine drawdown in the tank.

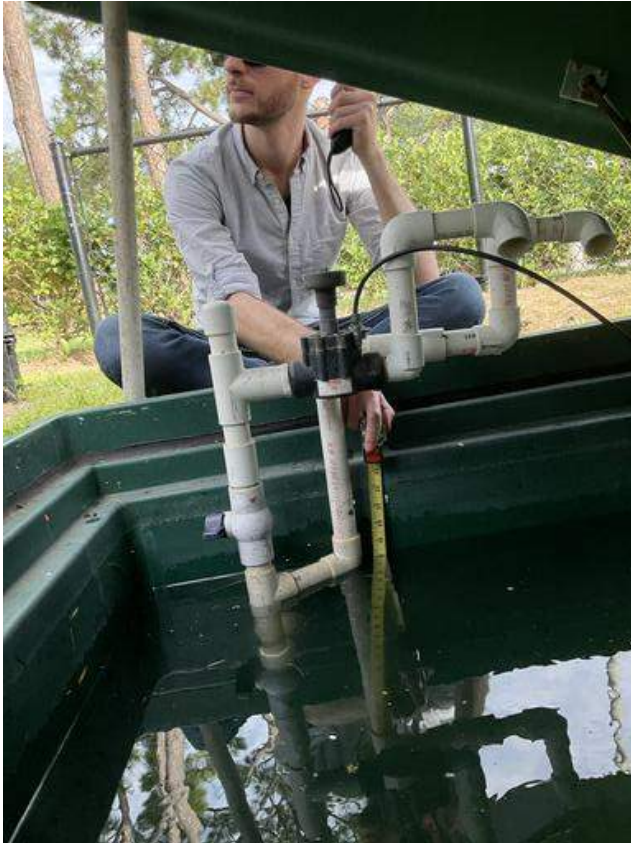
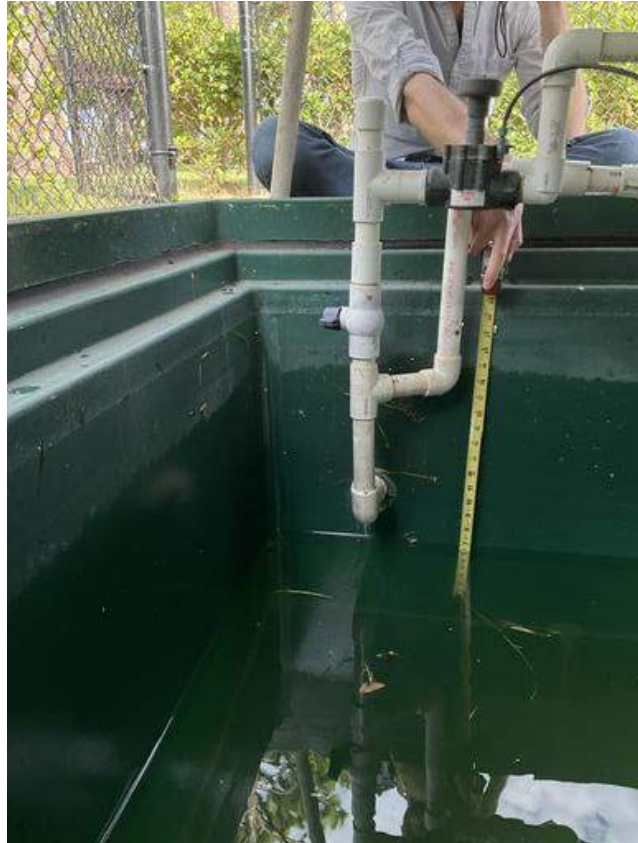
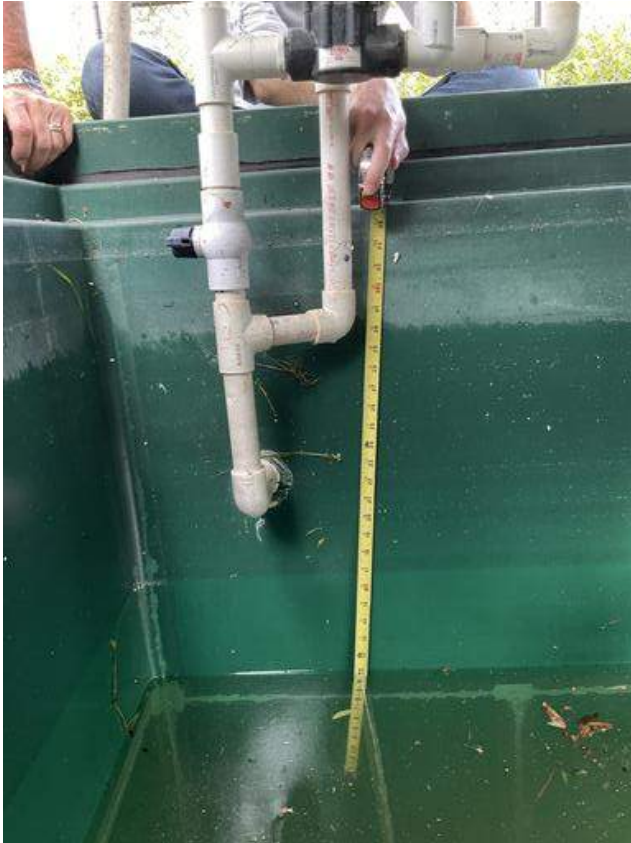
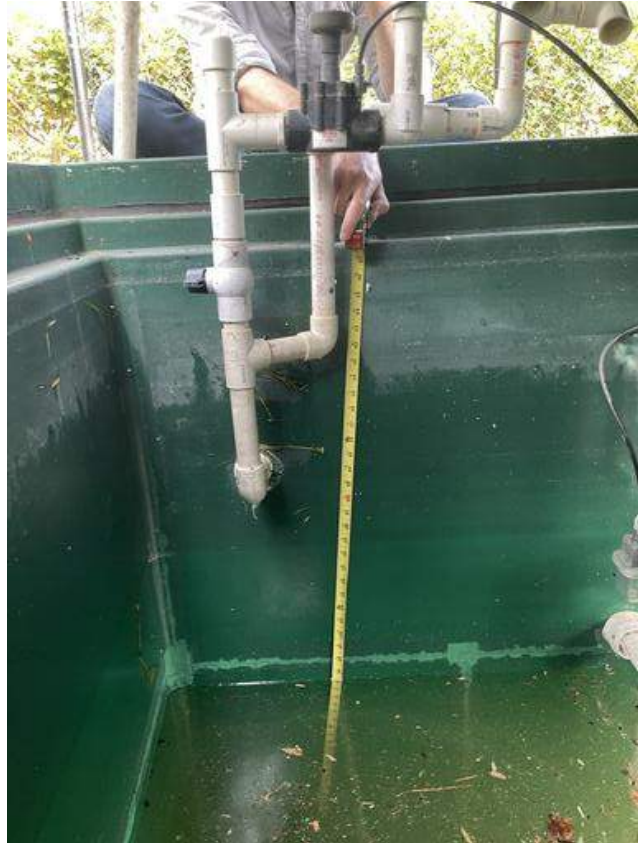
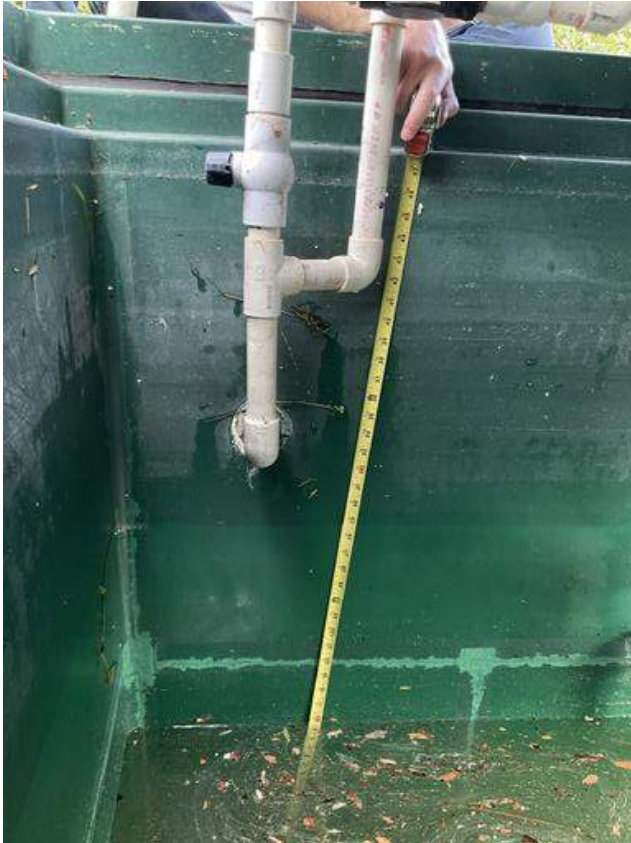
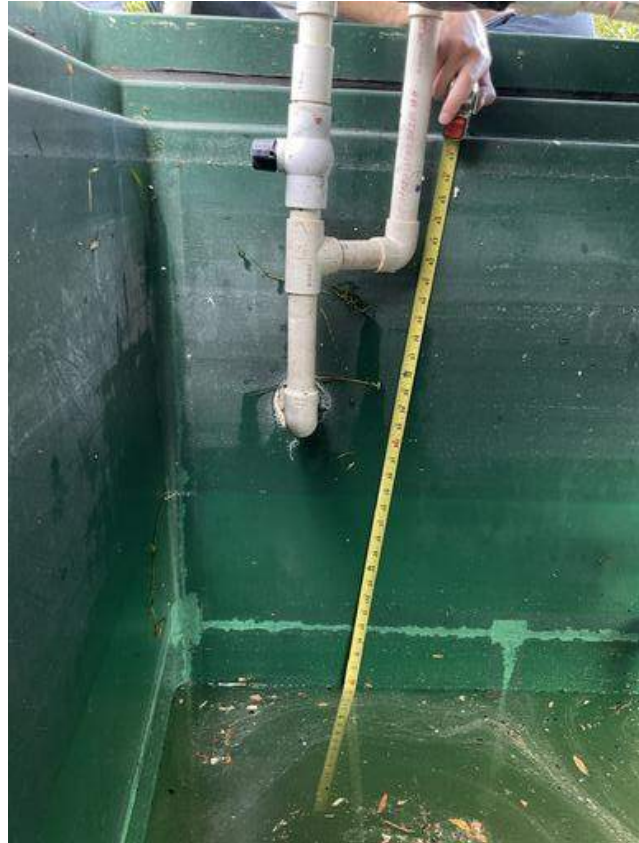
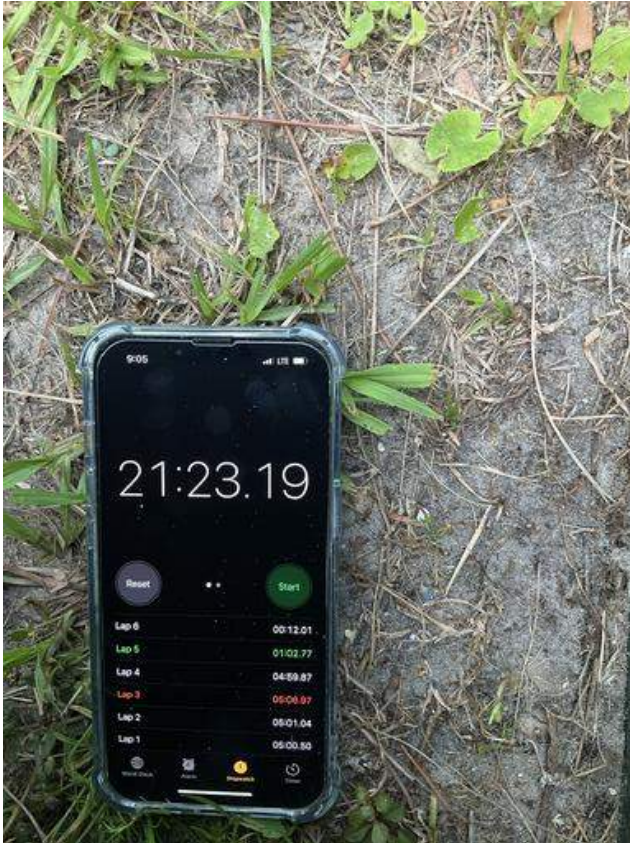
Starting with the filter operating hour 24”(18.5” water level) - 5min increments, we had to increase the overall measurement to 36” after first reading 2x increase 1’ more to 48” second reading
