FIELD INSPECTION

FLAGLER COUNTY COASTLINE

FOLLOWING THE OCTOBER 2025 NOR'EASTER

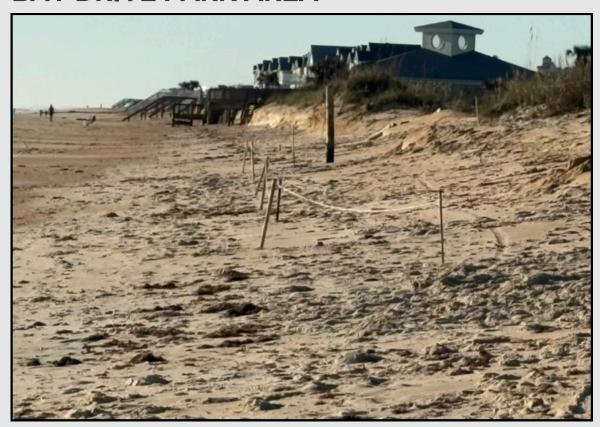
BAY DRIVE PARK AREA

Bay Drive Park area has scarping along dune indicating more erosion and regression of dune.

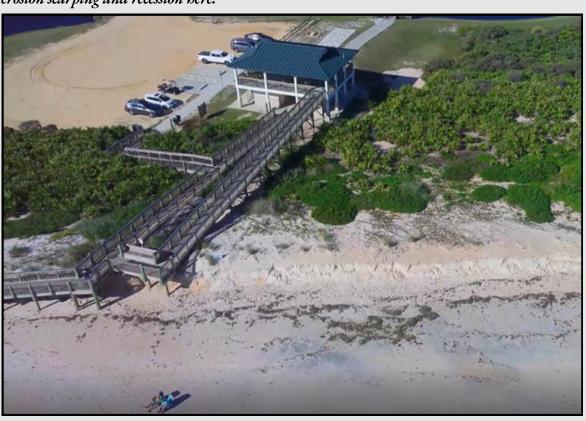
Bay Drive Park reported overtopping, but there was no evidence of it. However, there is dune erosion scarping and recession here.

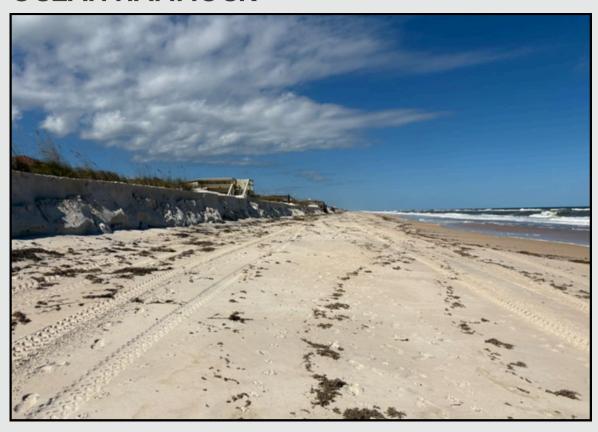
OCEAN HAMMOCK

Ocean Hammock Dune restoration project had about 50% of its sand eroded. Significant dune scarping indicating erosion of dune.

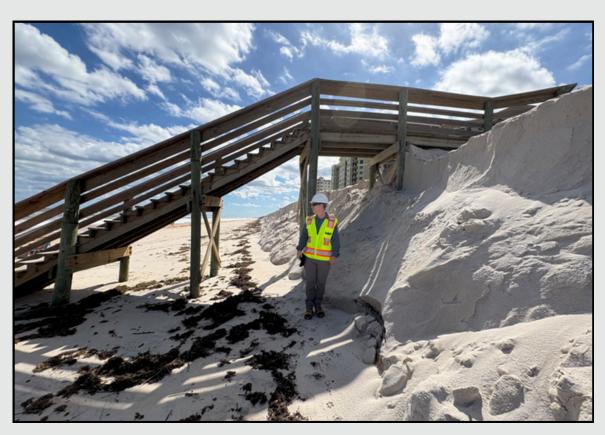
<u>After:</u> The entire area of the foreslope of the dune is gone, and the dune crest width is reduced from 20' to 10-12 feet wide. Approximately 8-foot scarps were observed.

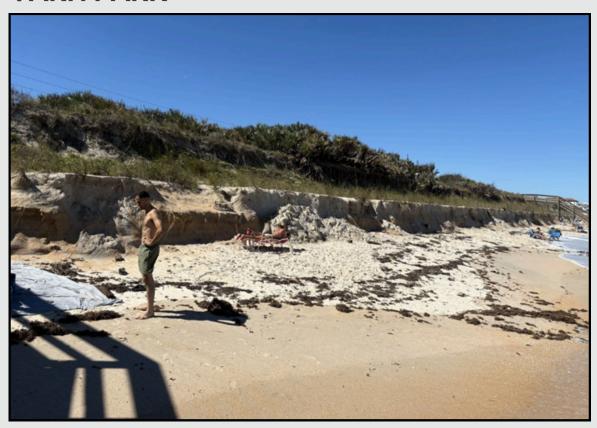
VARN PARK

There is very little beach under mid-tide conditions.

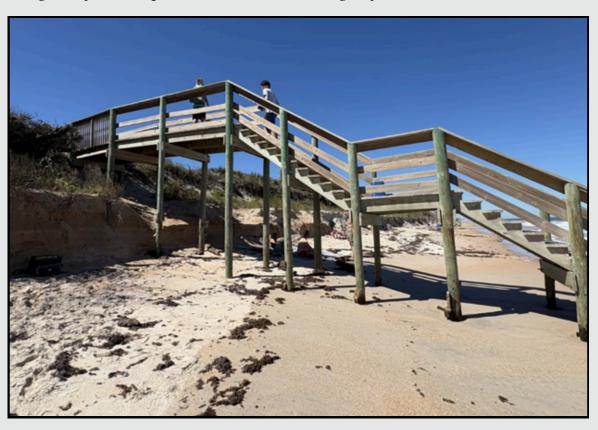
Pilings (12+ feet) are exposed and vulnerable to damage in future nor'easters.

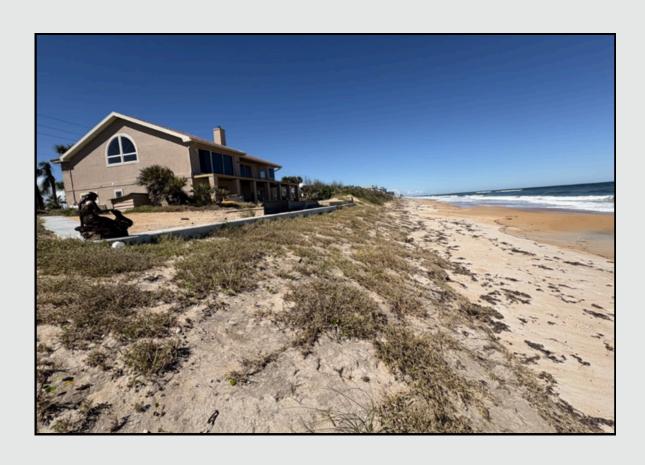
Looking north from "Matthew Seawall" shows north scarping and minimal erosion along the dune and elevated beach.

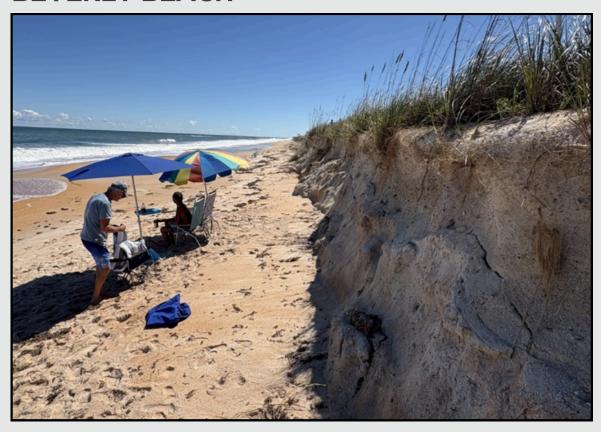
BEVERLY BEACH

Treasure by the Sea Campground shows major scarping (6 to 8 feet high) and dune erosion.

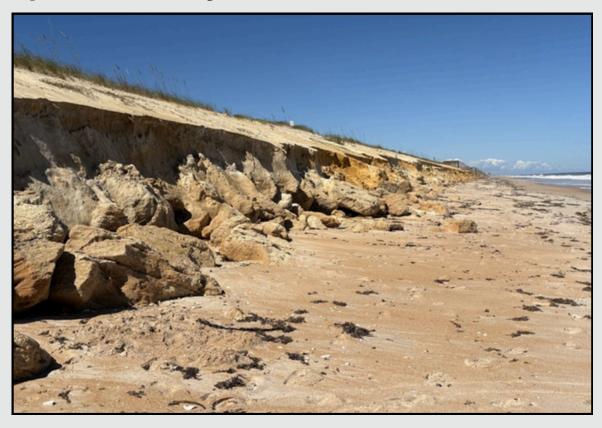
Coquina rock with sand, looking north.

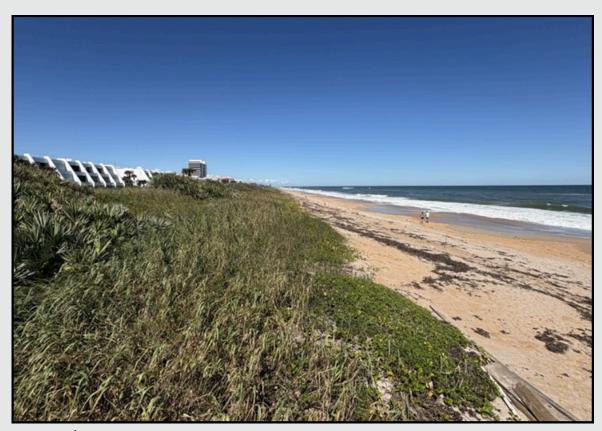
Exposed coquina rock

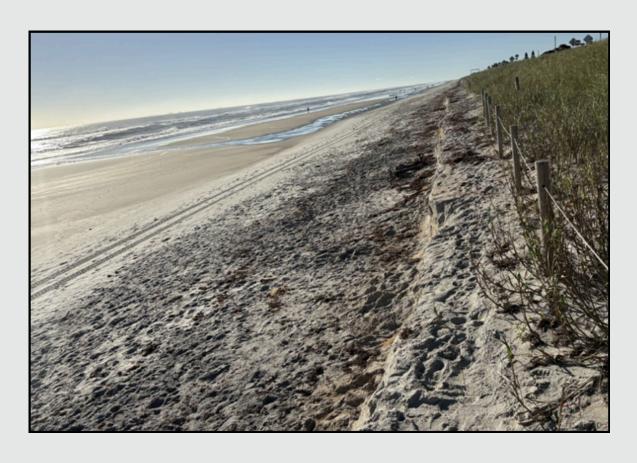
At South 8^{th} Street, the beach has been deflated and observed scarping of dune 2 - 3 feet high.

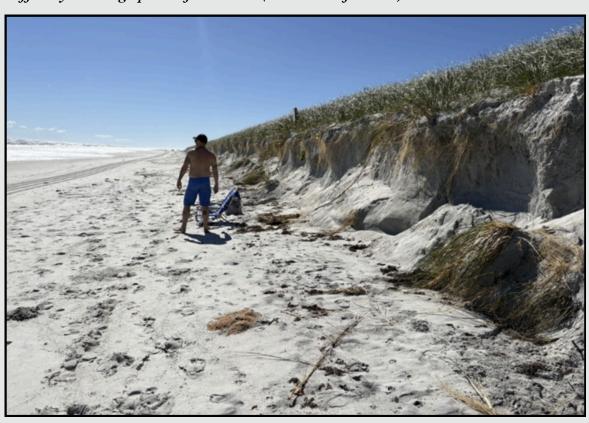
16th Street South access has significant scarping along the project for several blocks in each direction. Scarps are approximately 6 feet tall. Rope and posts are down and stacked at access. Difficulty climbing up access from beach. (Man shown for scale.)

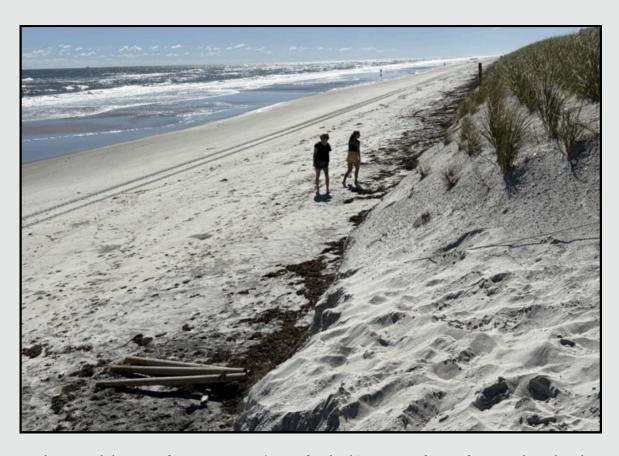
19th St South has significant scarping (4 to 5 feet high). Rope and posts down making beach access difficult.

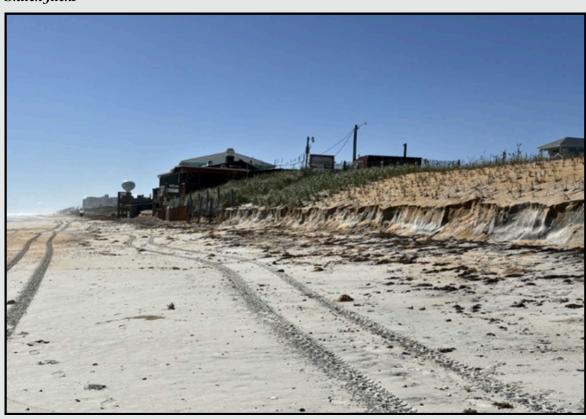
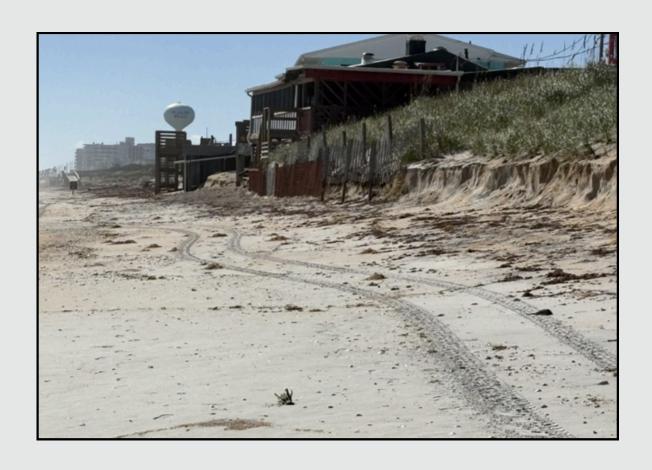
Gamble Rodgers and the area in front of Snack Jacks experienced deflation of the beach, and the dune in front of the southern FDOT seawall in south Flagler County experienced minimal to moderate erosion with 1 – 5 foot scarps along the dune.

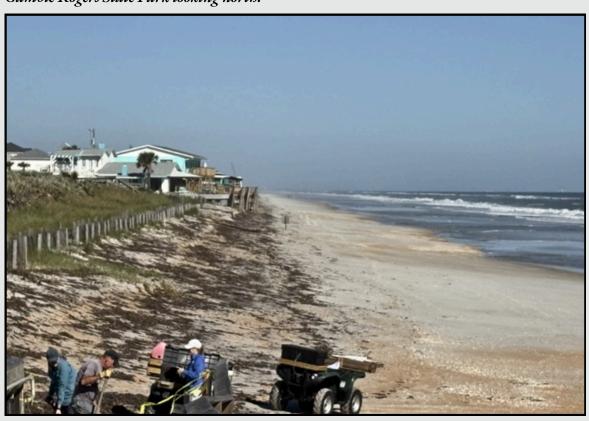
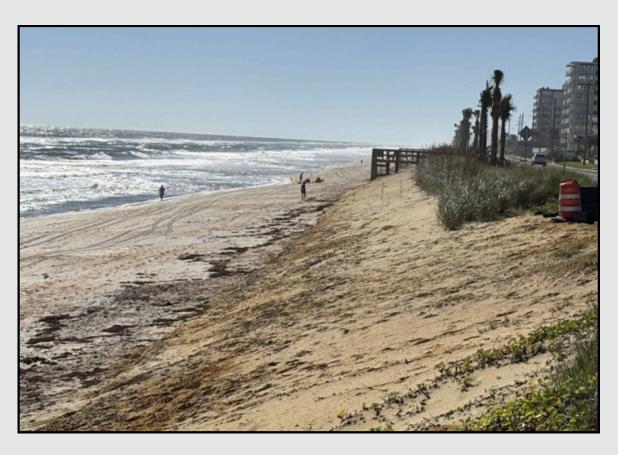
Gamble Rogers State Park looking north.

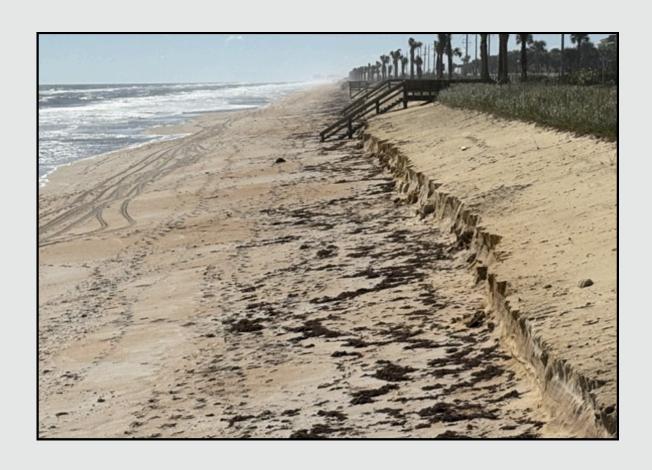
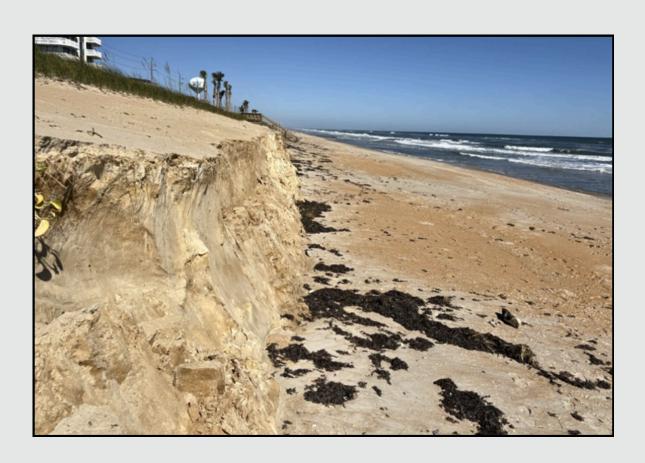
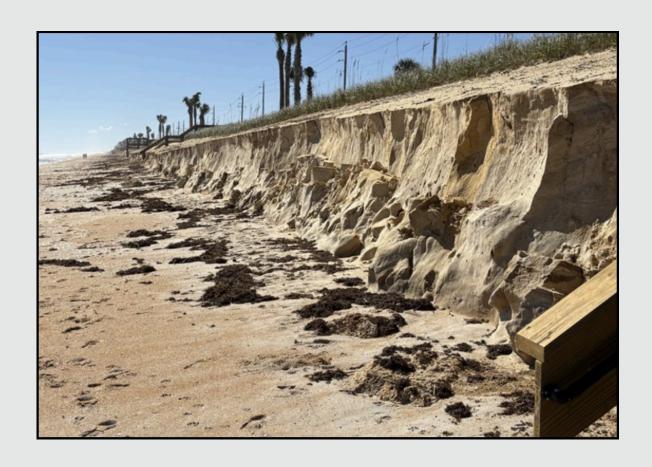
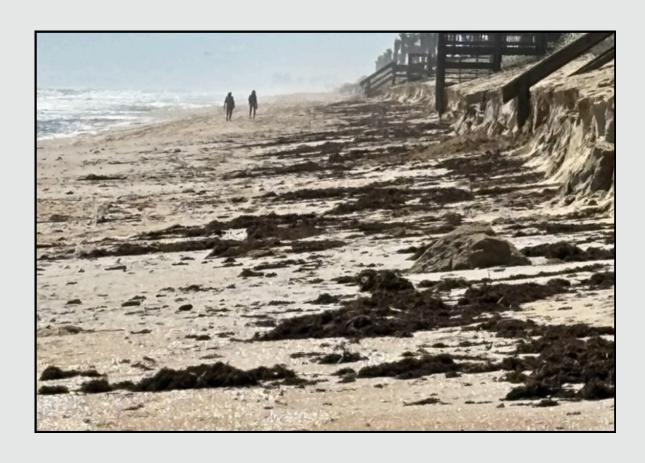
Secant Wall in southern Flagler County has a scarp height varied along the project from minimal scarping to upwards of 4 feet along dune.
