# Palm Coast Fire Station 22

Evaluation of Existing Fire Station 22

**SCHENKELSHULTZ**  
□ □ □ ARCHITECTURE □ □ □

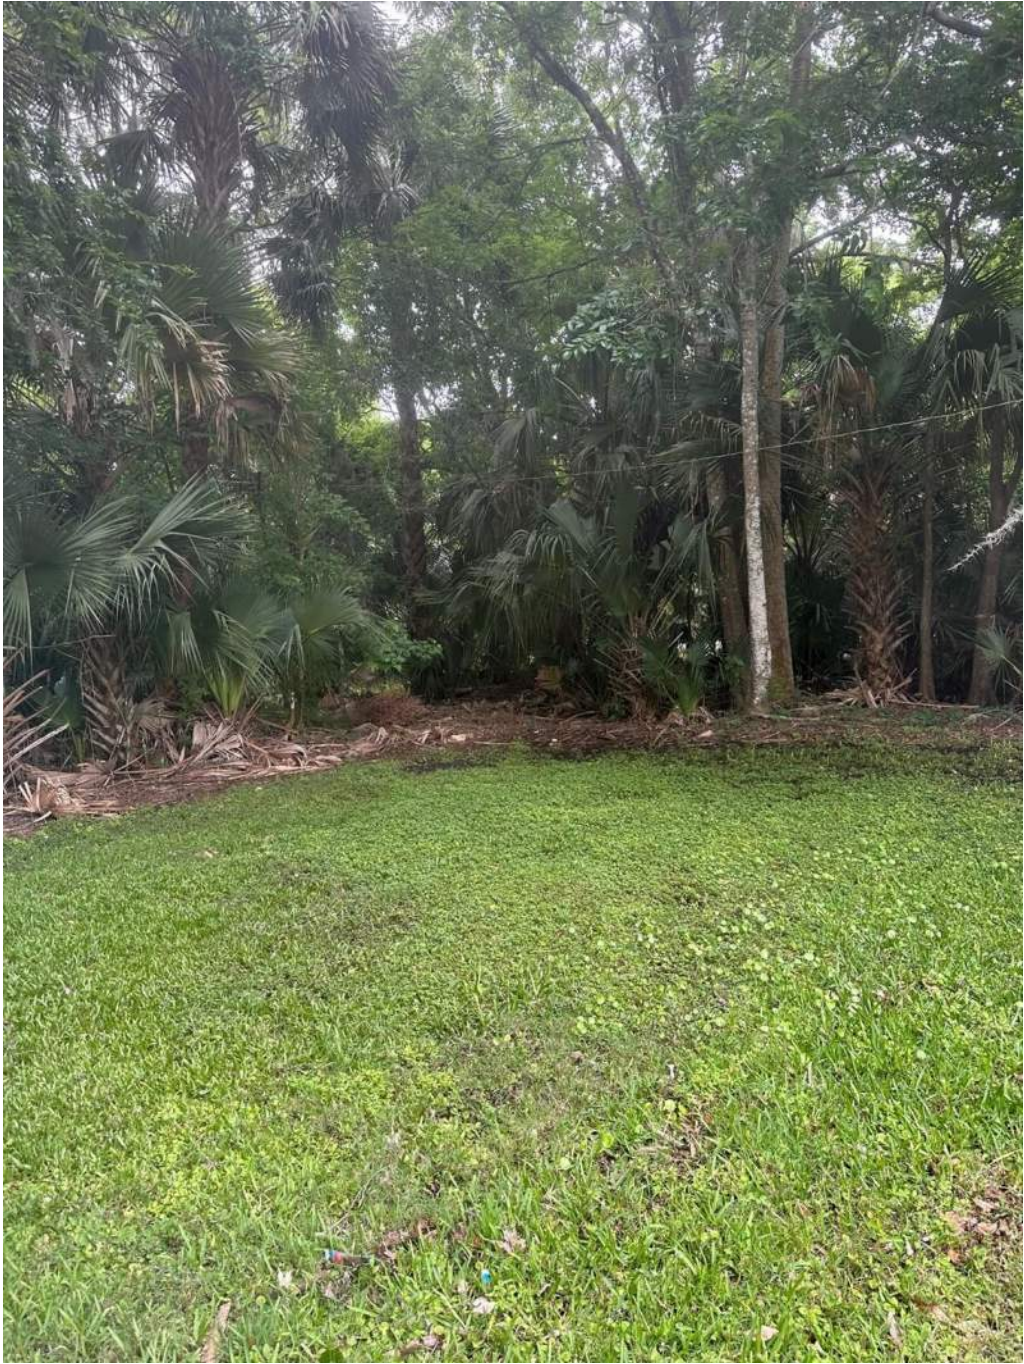
*Undeveloped land facing southeast.*

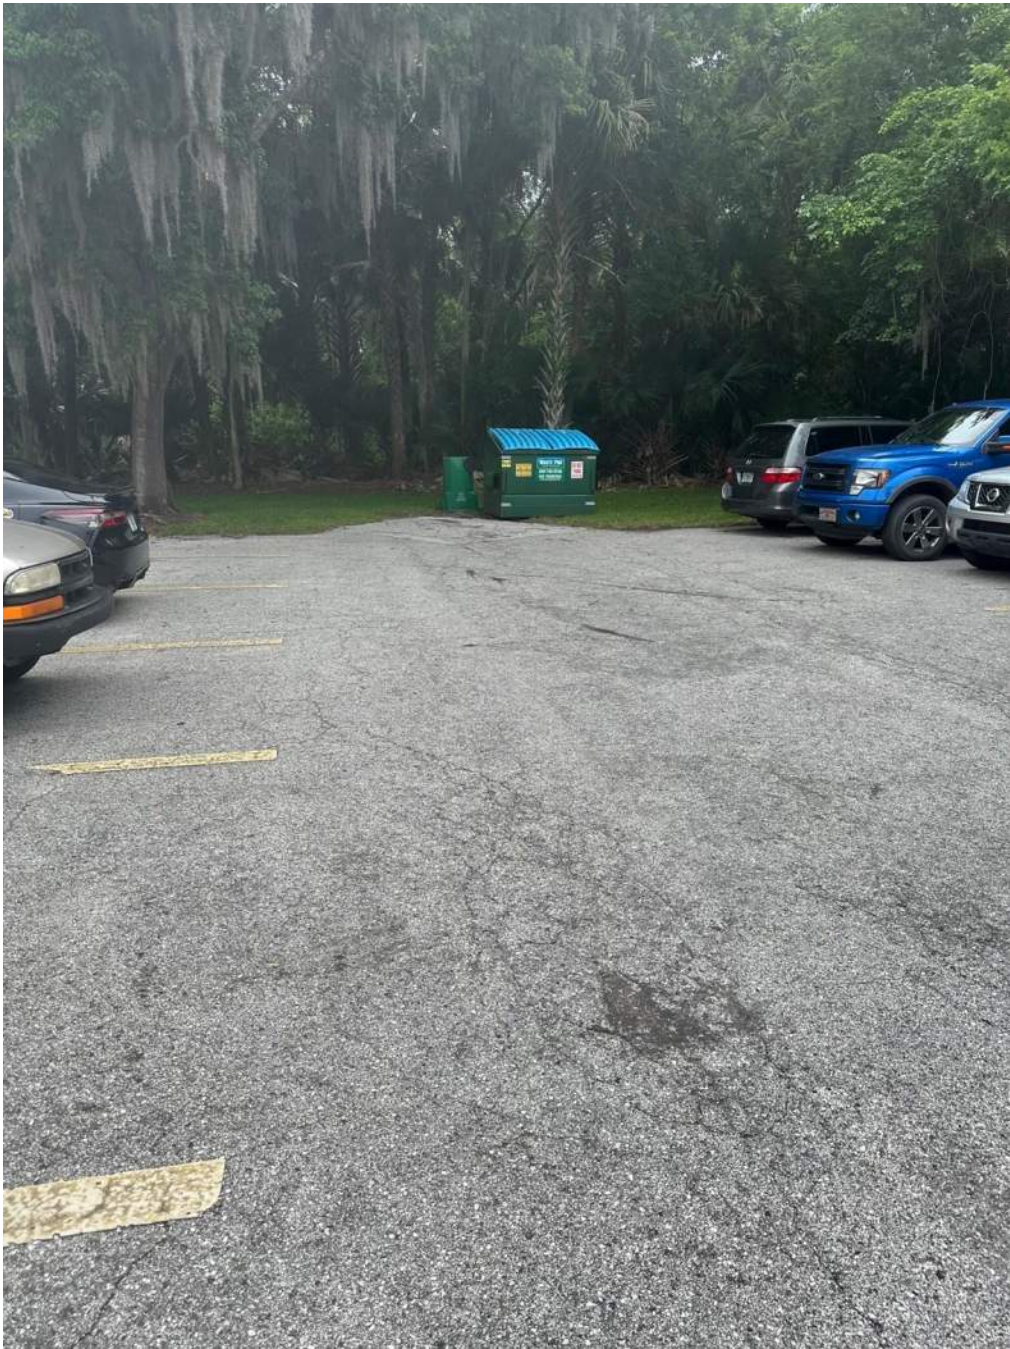
*14 parking spaces 1 handicap space*

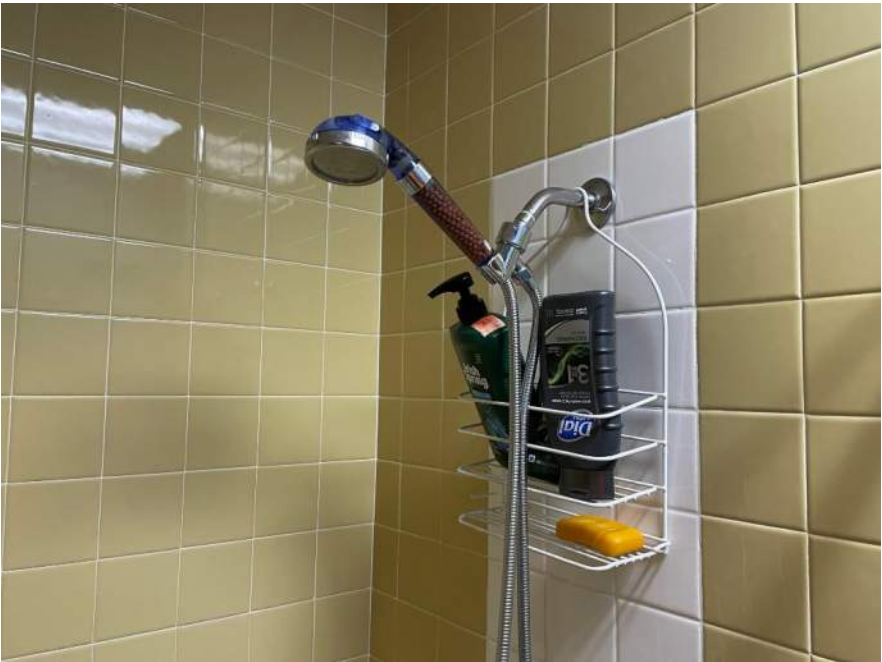
IMG\_4366: ADA Shower

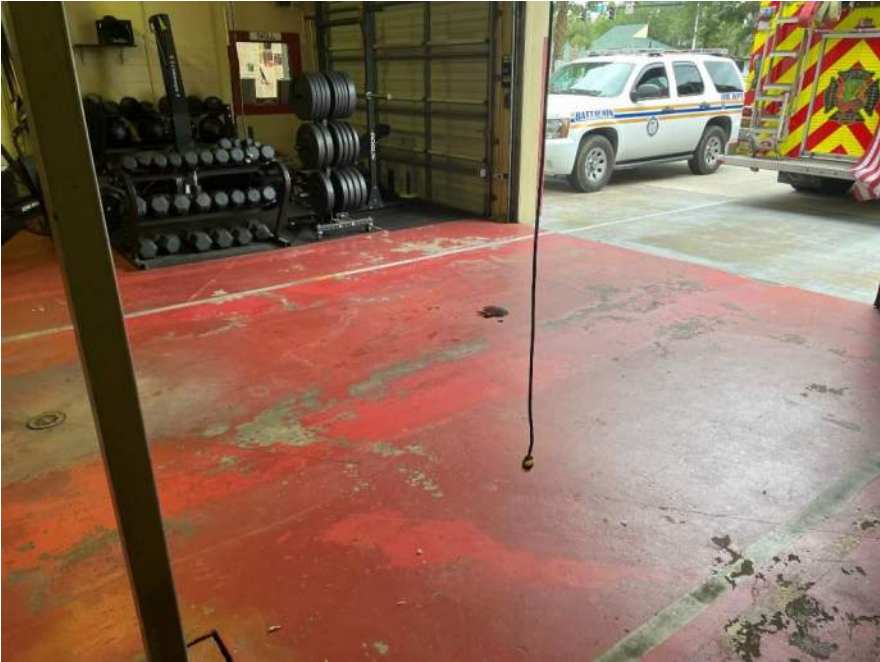
IMG\_4297: Area Drain

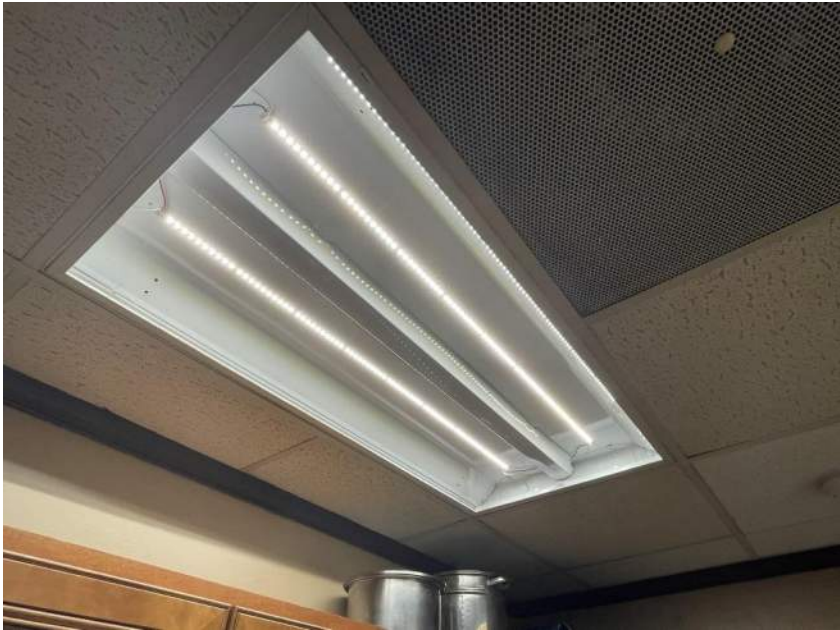
IMG\_4378: LED retrofit of original light fixture

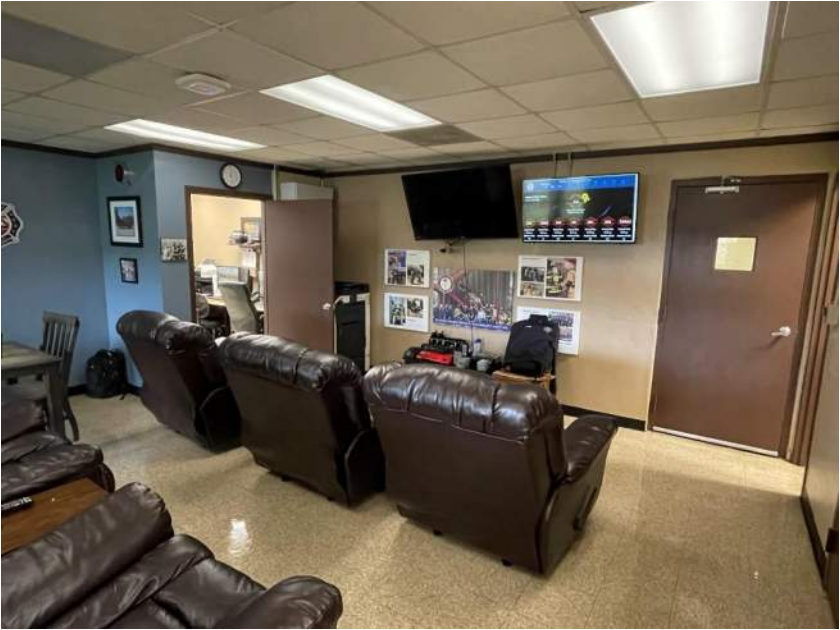
IMG\_4389: Day room lighting

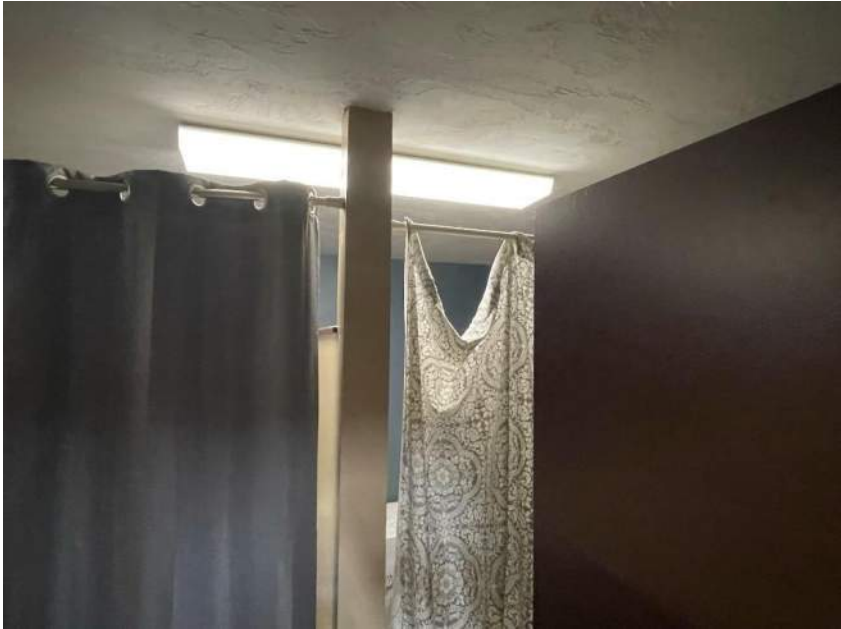
IMG\_4421: Bunk room lighting

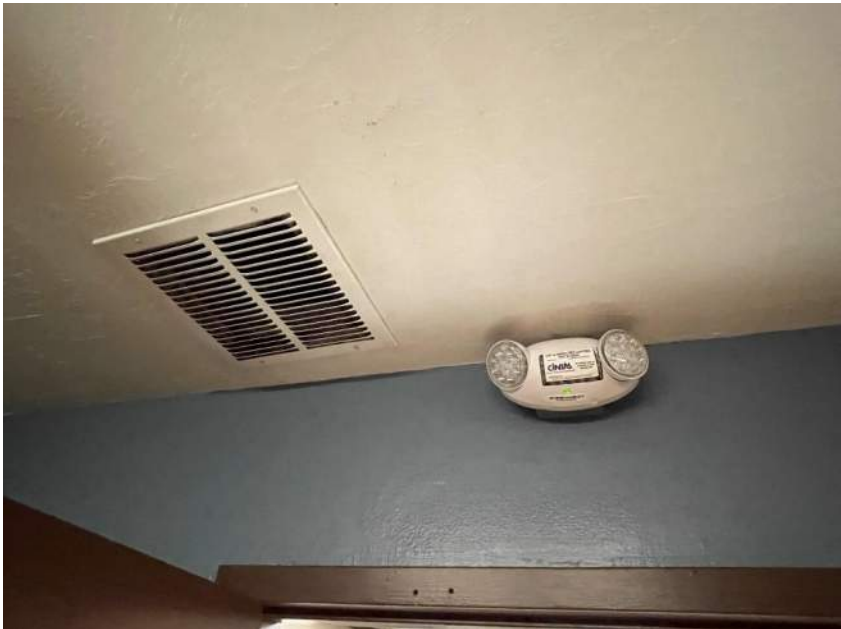
IMG\_4423: Bunk room added emergency lighting

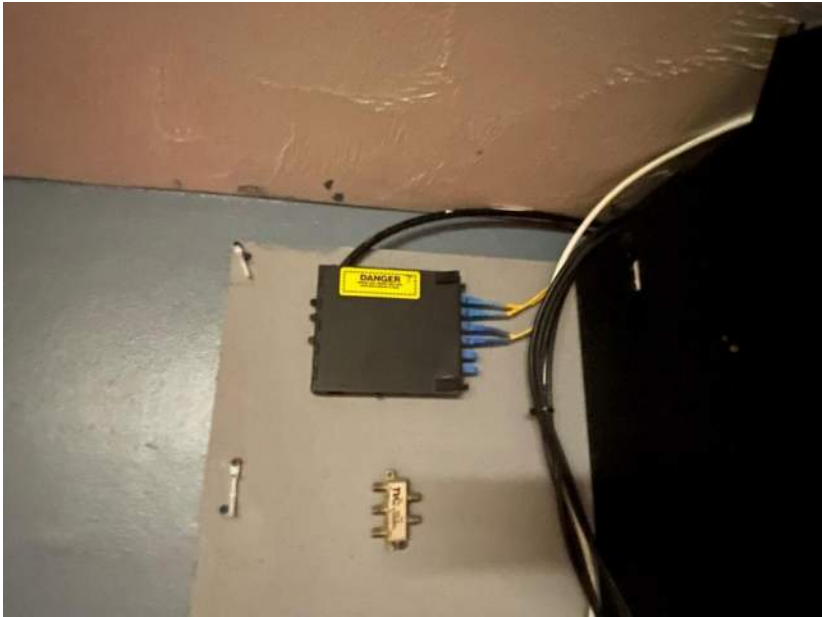
IMG\_4439: Incoming fiber optic service

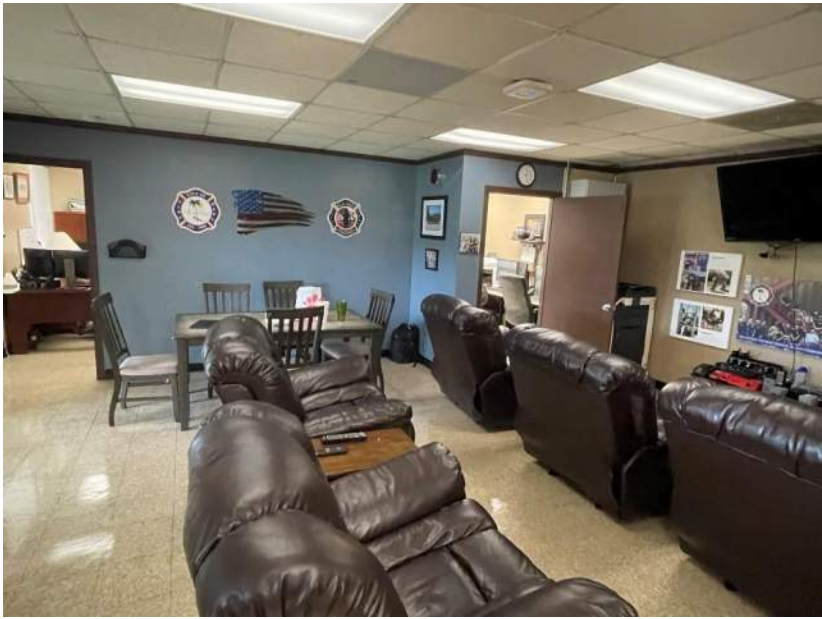
IMG\_4388: WAP on ceiling in Dayroom

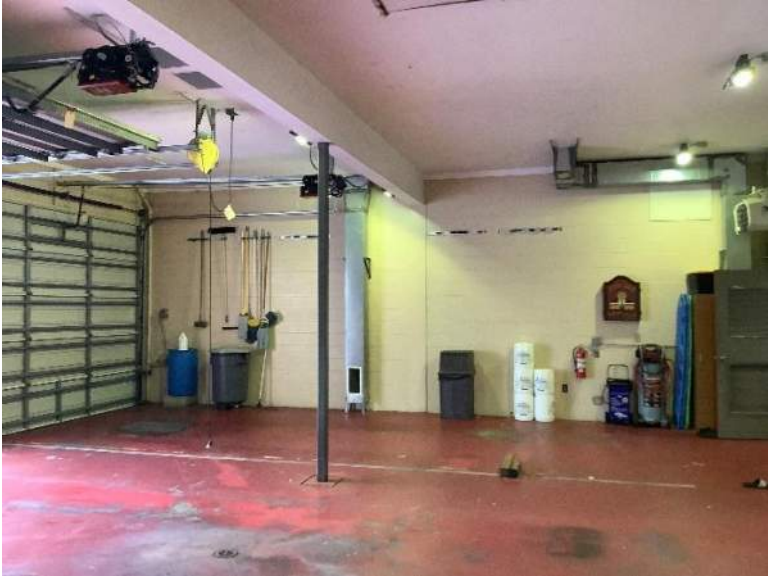
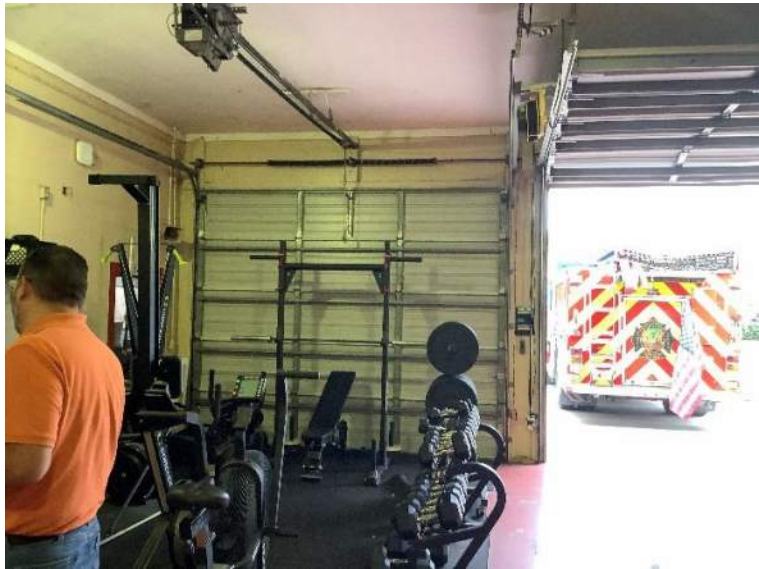
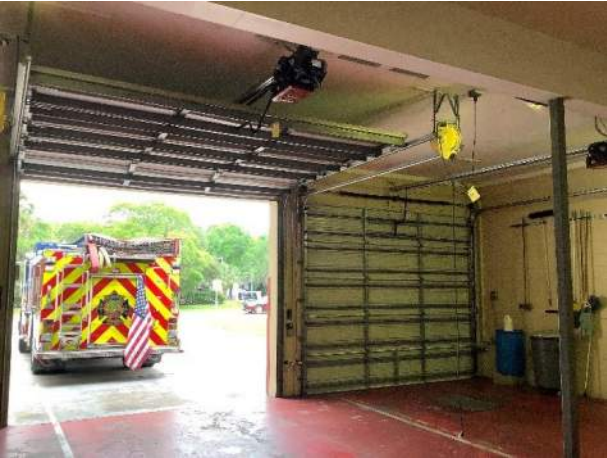
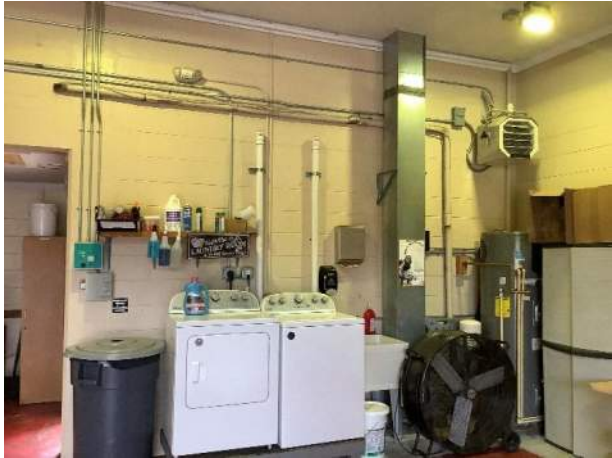
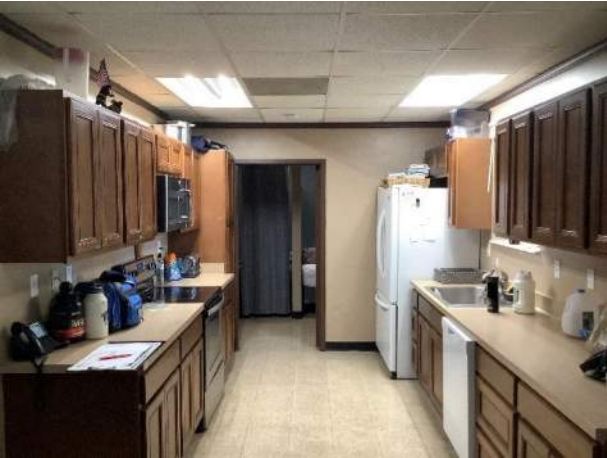
The interior truck bay floor had a singular longitudinal crack which ran from approximately middle of the first truck bay completely through the second truck bay and dissipated in the third truck bay area. This crack is most likely the result of fire engine weight localized on the edge of the bay floor slab at or near the doors. The crack is approximately 3'-0" inside the doors. The crack also appears to somewhat dated and may have occurred some time ago even as early as when the building was new.

The interior walls and slabs appeared to be good condition aside from the crack noted earlier. A review of interior masonry walls did not show signs of cracking or other anomalies.

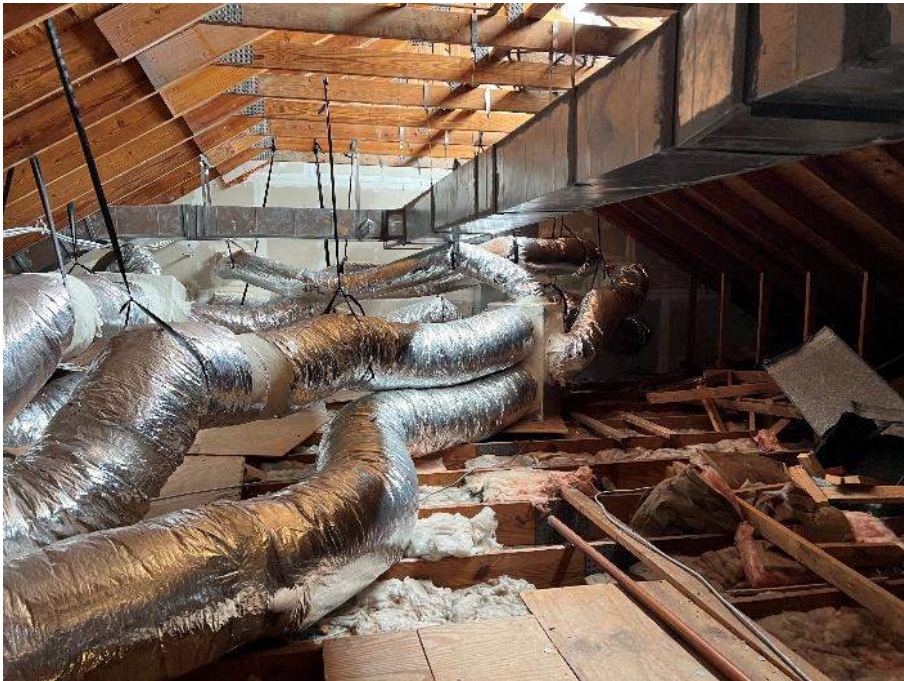
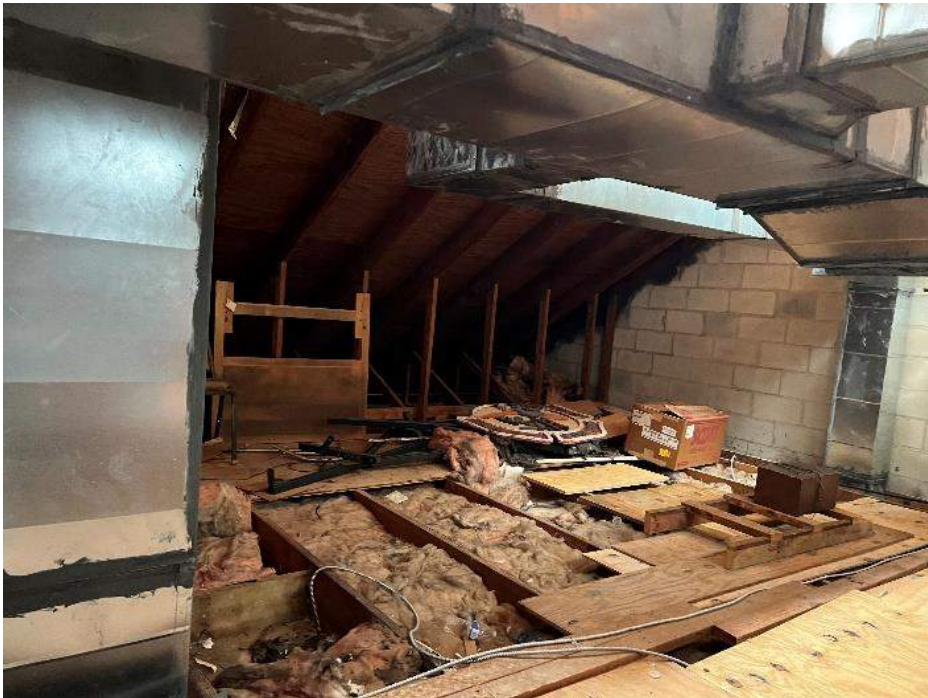
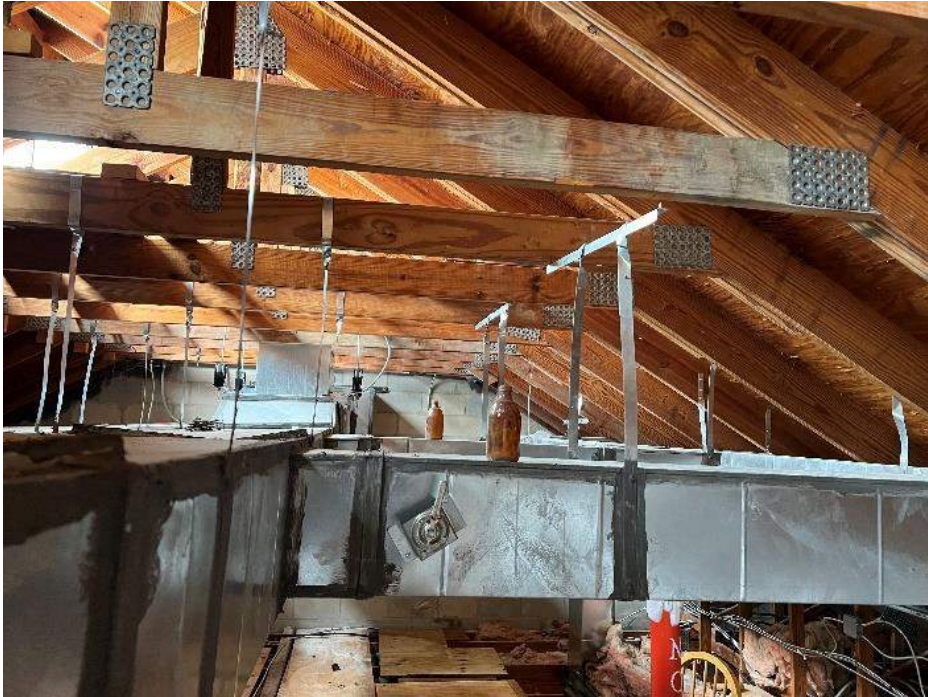
The attic area above the truck bay was accessed and observations in this area did not produce any notable structural conditions and appeared to be well preserved. It was noted this area appeared to have been design as a usable space perhaps a bunk room or possible office space but was currently being used for storage and an open space for duct work to be run unimpeded.

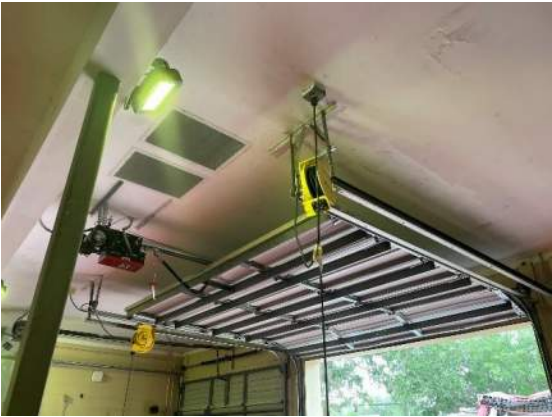
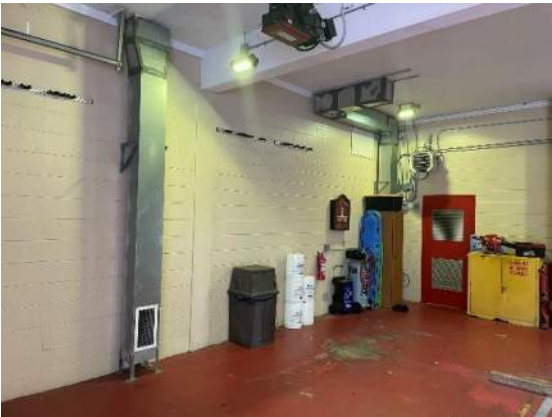
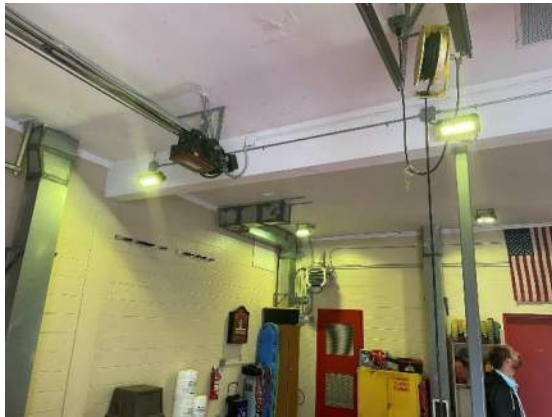
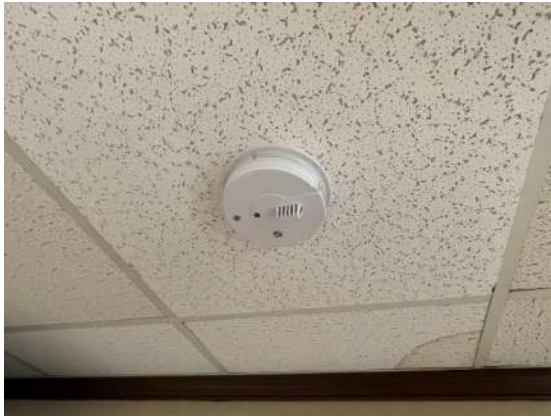
Apparatus bay and apparatus support/storage spaces accessible directly from the apparatus bay gypsum board (hard ceilings). The ceilings have numerous penetrations and attachments from the current use of the facility. Extensive wear and tear noticeable, several patched areas visible. Depending on anticipated future use, ceilings at minimum would need to be patched, repaired and painted, but preferably replaced.

Throughout the rest of the facility ceilings are mostly ACT (acoustical ceiling tile) in generally good condition, with some tiles with more extensive cracking and discoloration. Hard ceilings in bunk spaces and portion of the restrooms is in good condition as well. ACT in restrooms would need to be replaced with hard ceiling.

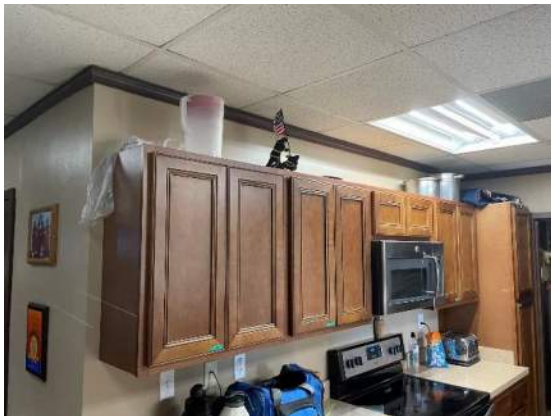
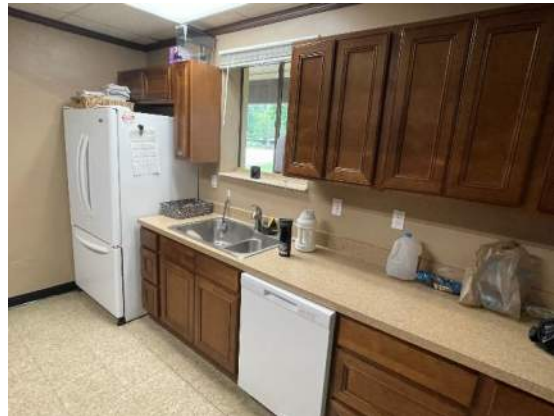
Cabinets in the kitchen are in good working condition. Laminate Countertop has some cracked and peeling locations and is nearing the end of its useful cycle. Recommended the countertop to be replaced. Additional furniture throughout the facility is showing average wear and tear, but is in generally working condition and could be reused depending on future use expectations and requirements.
